## **CBC Asbestos Refurbishment Survey Report Danesholme - Shops, Corby 16<sup>th</sup> May 2019**

Reference:				
Issue			Prepared by	Verified by
V1	Jun 19	DP

CBC undertook an Asbestos Refurbishment Survey at Danesholme - Shops, Corby.

Joseph Quarrinton undertook the survey on 16<sup>th</sup> May 2019.

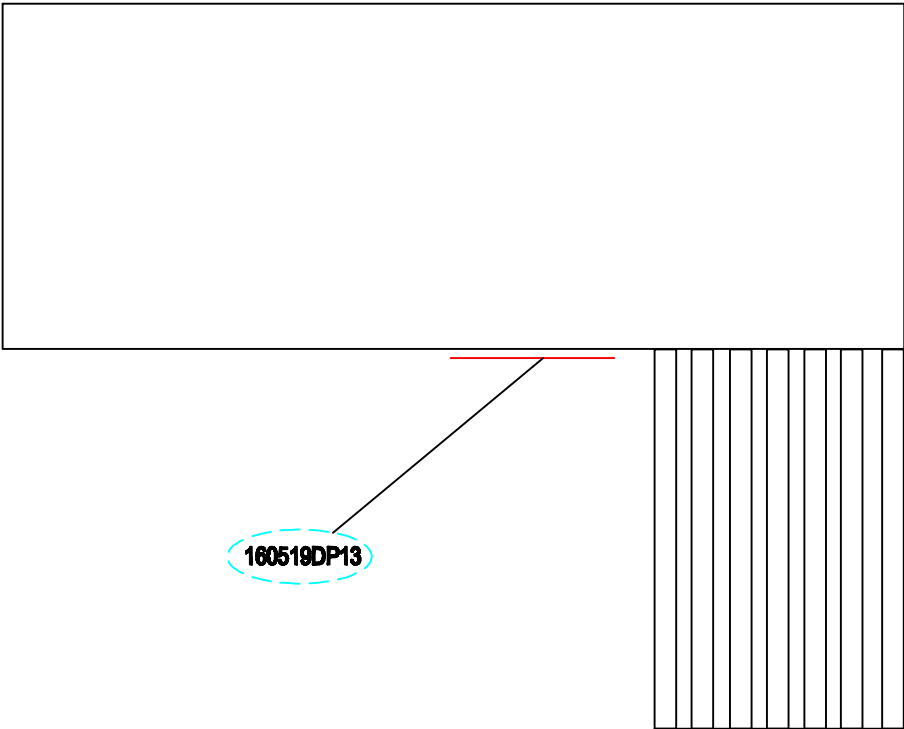
Drawing Title:  
Corby Borough Council  
Asbestos Survey Plan

Textured coating (Render)
