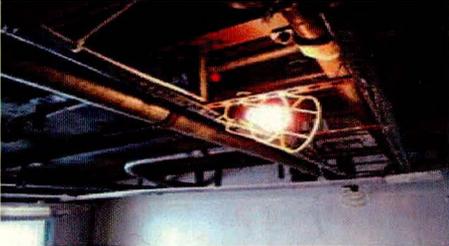
| TASK NO. | TASK/DESCRIPTION | NOTES |
|---|--|--|
| L1.02 | <p data-bbox="411 389 719 421">Training Area Lighting</p> <p data-bbox="411 689 1217 831">Current festoon light strings throughout training areas are not fit for purpose and do not provide the controllability required by training staff. Renew lighting with 110v dimmable LED strip lights and provide individual zone control switches in designated locations (to be identified by training staff during contractor ships visits).</p> <p data-bbox="411 846 1217 902">ALLOW for 8 separate zones and associated fittings. ALLOW for 40 LED light fittings in total.</p> | <p data-bbox="1257 394 1390 510">Working at Height precautions required.</p> |
