CCTV Inspection Report

**WILLINGTON PARISH COUNCIL,
TWYFORD ROAD,
WILLINGTON.
DE65 6BN**

01/06/2023

Job Number: 01/06/23-EG

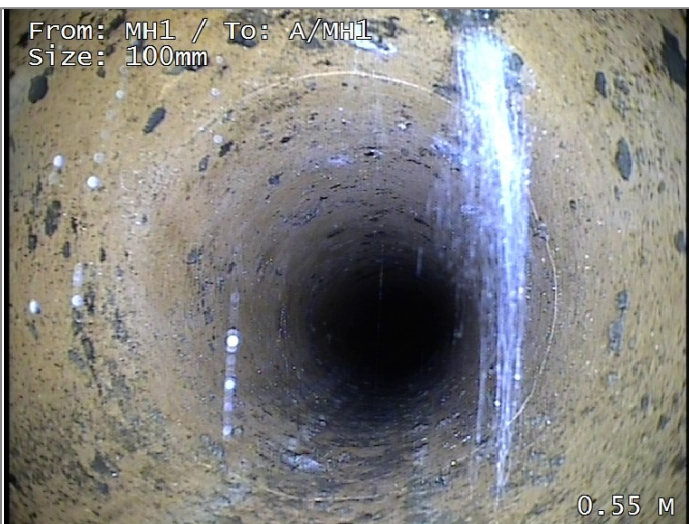
Position	Code	Description	Photo	Type/Grade	
 	0.00	MH	Start node type, manhole, reference MH1	7972717	Comment / 0
	0.00	WL	Water level 0% height/diameter	7972718	Comment / 0
	0.07	LL	Line of drain/sewer deviates left	7972719	Comment / 0
	0.55	CC	Crack circumferential from 6 to 6 o'clock	7972721	Structural / 2
3.69	JN	Junction at 9 o'clock, diameter 100mm	7972722	Comment / 0	
4.57	GYF	Finish node type, gully, reference A/MH1	7972723	Comment / 0

Crack circumferential from 6 to 6 o'clock

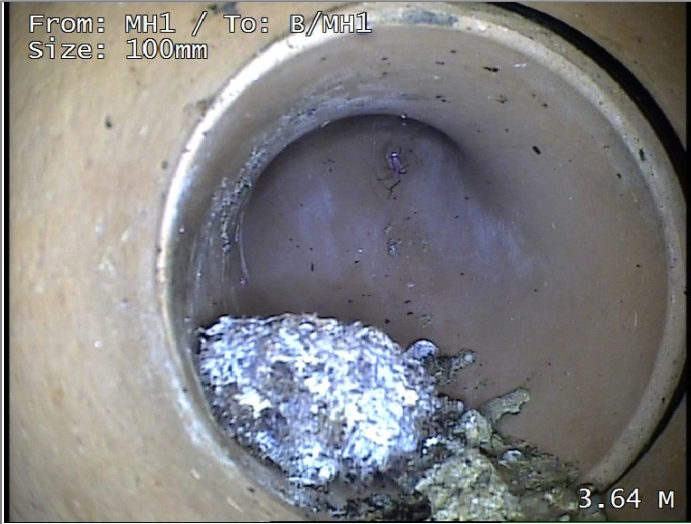
<p>3.64 M</p> <p>Settled deposits coarse 10% cross-sectional area loss</p>			
<p>From: MH1 / To: B/MH1 Size: 100mm</p>

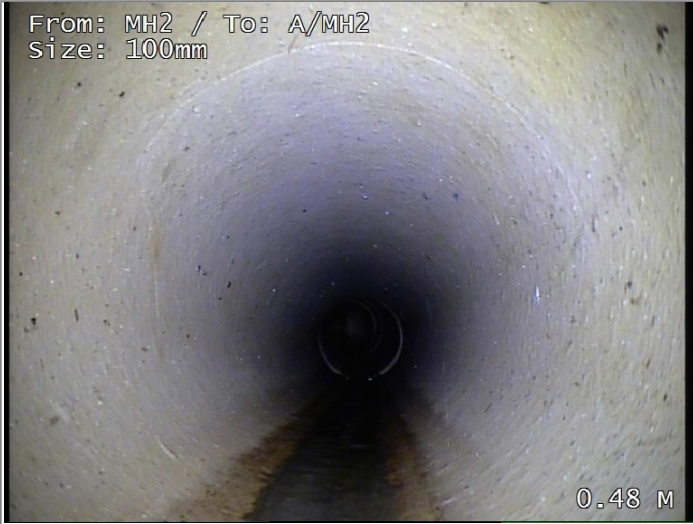
Position	Code	Description	Photo	Type/Grade
0.00	MH	Start node type, manhole, reference MH2	7972736	Comment / 0
0.00	WL	Water level 0% height/diameter	7972737	Comment / 0
0.48	CC	Crack circumferential from 8 to 4 o'clock	7972738	Structural / 2
1.21	OJM	Open joint medium	7972740	Structural / 1
1.76	OJM	Open joint medium	7972741	Structural / 1
1.93	LU	Line of drain/sewer deviates up	7972753	Comment / 0
2.29	OCF	Finish node type, other special chamber, reference A/MH2	7972754	Comment / 0

<p>0.48 M</p> <p>Crack circumferential from 8 to 4 o'clock</p>			
<p>From: MH2 / To: A/MH2 Size: 100mm</p>

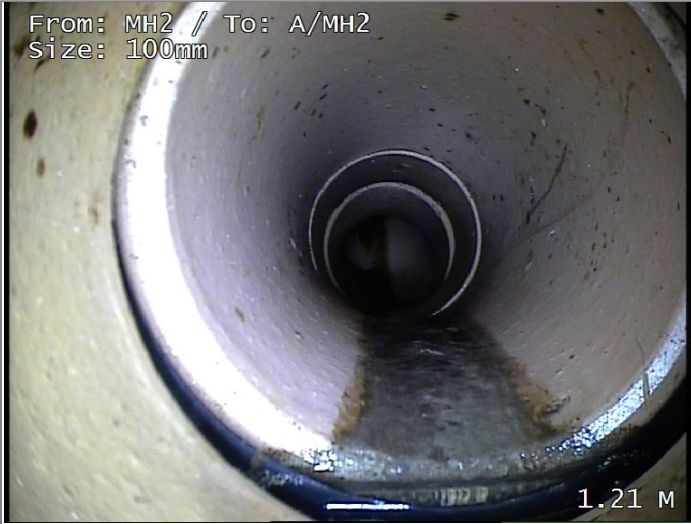
<p>1.21 M</p> <p>Open joint medium</p>			
<p>From: MH2 / To: A/MH2 Size: 100mm</p>

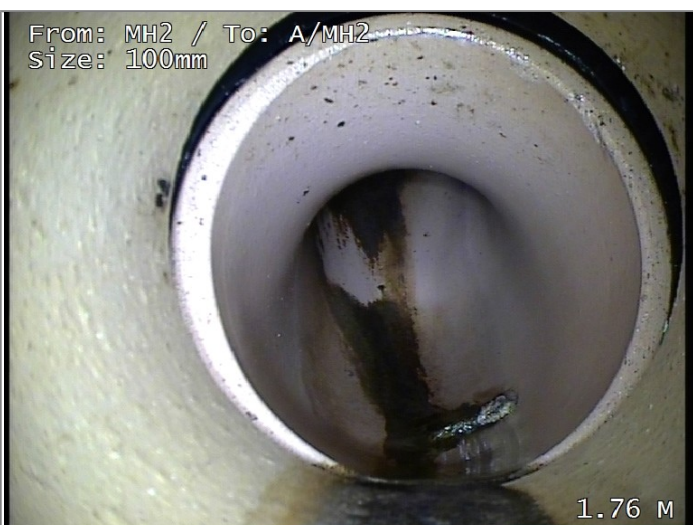
<p>1.76 M</p> <p>Open joint medium</p>			
<p>From: MH2 / To: A/MH2 Size: 100mm</p>

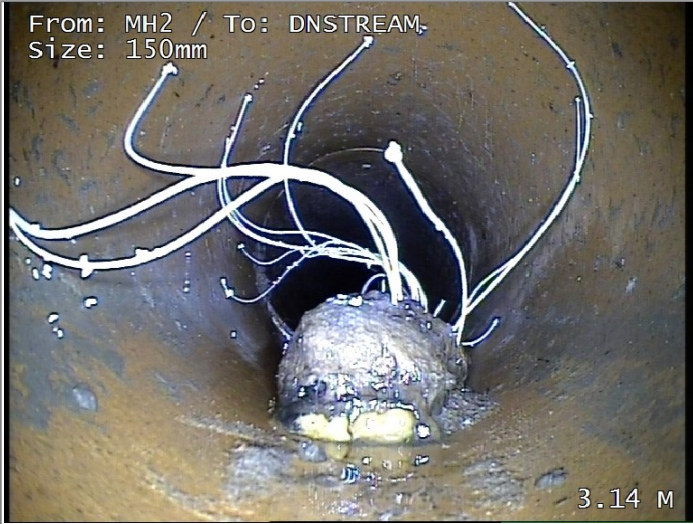
3.14	DEF	Attached deposits, fouling at 6 o'clock 10% cross-sectional area loss	7972757	Service / 3
5.05	JN	Junction at 1 o'clock, diameter 100mm	7972758	Comment / 0

<p>3.14 M</p> <p>Attached deposits, fouling at 6 o'clock 10% cross-sectional area loss</p>			
<p>From: MH2 / To: DNSTREAM Size: 150mm</p>

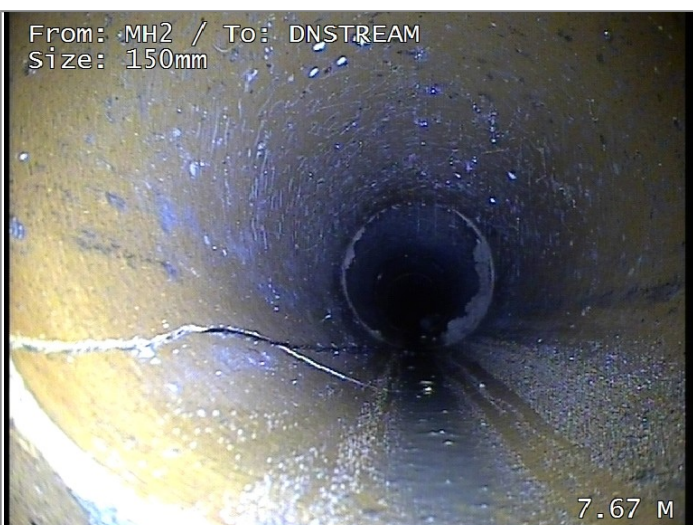
7.67	FL	Fracture longitudinal at 8 o'clock	7972759	Structural / 3
7.90	RF	Roots fine	7972760	Service / 2
8.19	FCJ	Fracture circumferential from 2 to 8 o'clock, at joint	7972761	Structural / 3

<p>7.67 M</p> <p>Fracture longitudinal at 8 o'clock</p>			
<p>From: MH2 / To: DNSTREAM Size: 150mm</p>

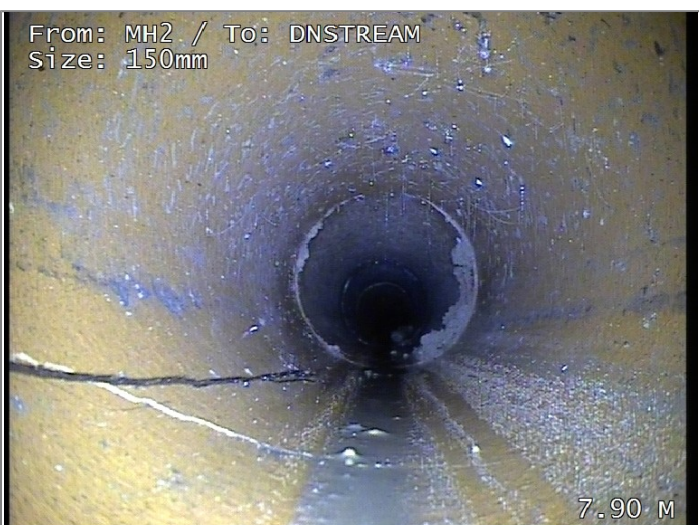
<p>7.90 M</p> <p>Roots fine</p>

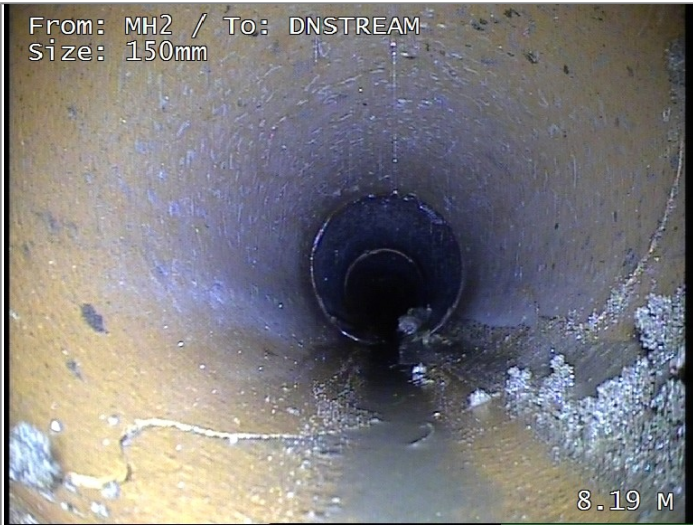
<div>8.19 M</div> <div>Fracture circumferential from 2 to 8 o'clock, at joint</div> </div>			
<div> <div> From: MH2 / To: DNSTREAM Size: 150mm </div>

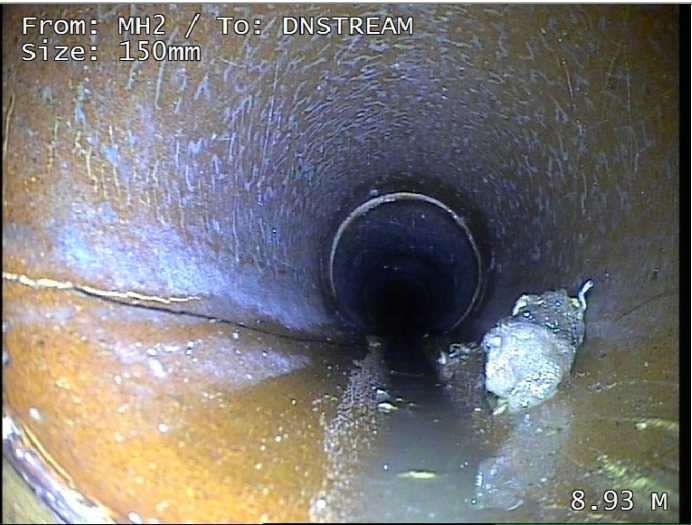
8.93	CL	Crack longitudinal at 9 o'clock	7972762	Structural / 2
8.93	RF	Roots fine	7972763	Service / 2
17.31	RFJ	Roots fine, at joint	7972764	Service / 2
18.83	WL	Water level 5% height/diameter	7972765	Comment / 0

<div>8.93 M</div> <div>Crack longitudinal at 9 o'clock</div> </div>			
<div> <div> From: MH2 / To: DNSTREAM Size: 150mm </div>

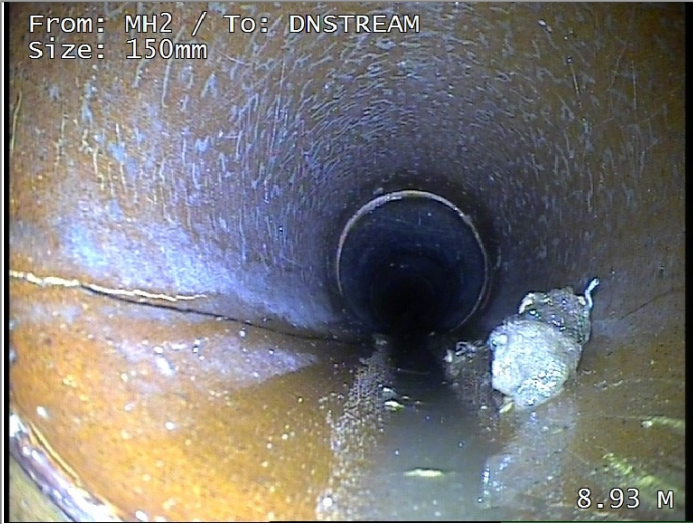
<div>8.93 M</div> <div>Roots fine</div> </div>			
<div> <div> From: MH2 / To: DNSTREAM Size: 150mm </div>

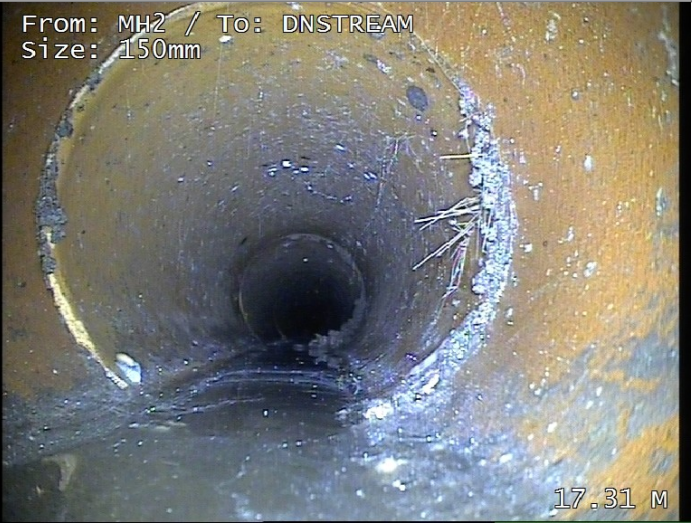
<div>17.31 M</div> <div>Roots fine, at joint</div> </div>			
<div> <div> From: MH2 / To: DNSTREAM Size: 150mm </div>

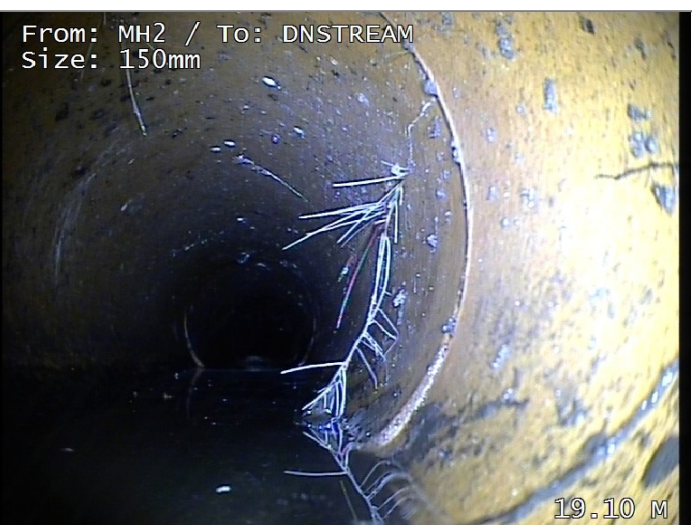
<div>19.10 M</div> <div>Roots fine</div> </div>

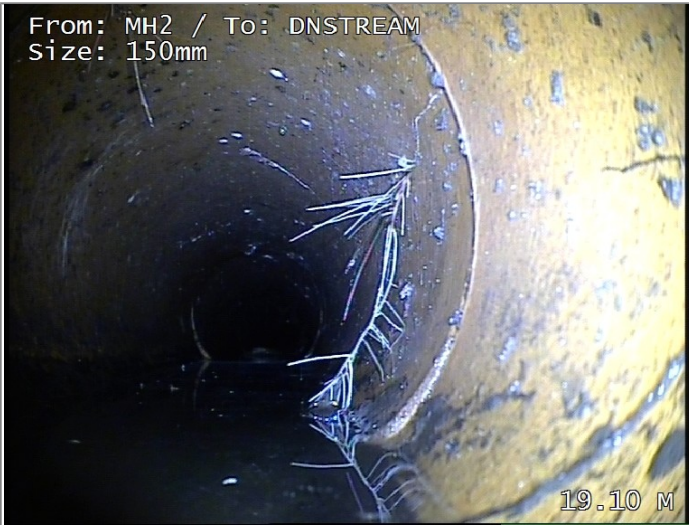
19.10	RF	Roots fine	7972766	Service / 2
19.10	CCJ	Crack circumferential from 1 to 5 o'clock, at joint	7972769	Structural / 2
20.05	DES	Settled deposits fine 10% cross-sectional area loss	7972770	Service / 3

<div>19.10 M</div> <div>Crack circumferential from 1 to 5 o'clock, at joint</div> </div>			
<div> <div> From: MH2 / To: DNSTREAM Size: 150mm </div>

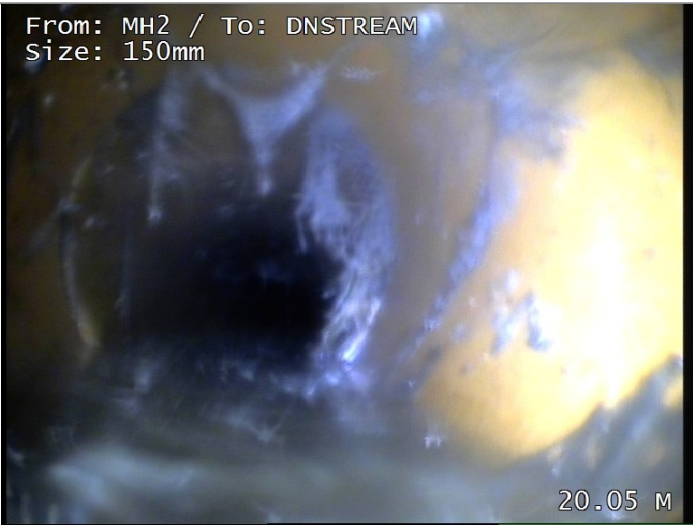
<div>20.05 M</div> <div>Settled deposits fine 10% cross-sectional area loss</div> </div>			
<div> <div> From: MH2 / To: DNSTREAM Size: 150mm </div>

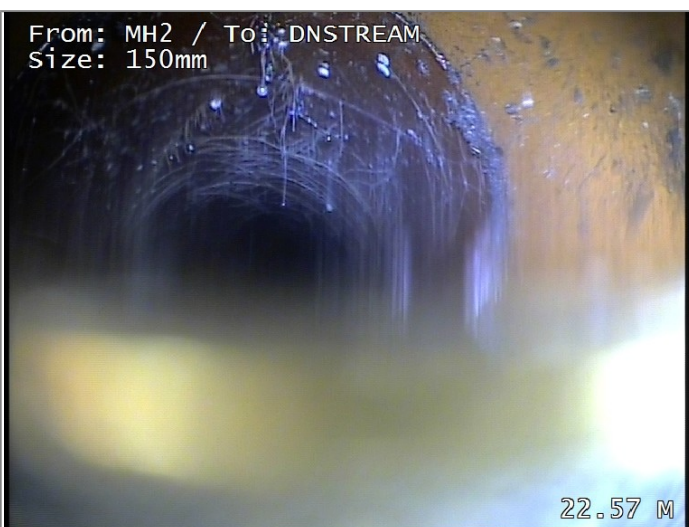
<div>22.57 M</div> <div>Roots fine</div> </div>			
<div> <div> From: MH2 / To: DNSTREAM Size: 150mm </div>

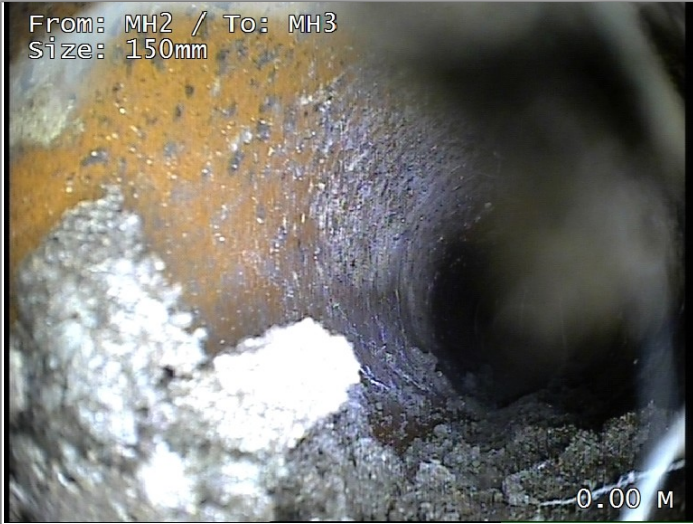
<p>Settled deposits fine 10% cross-sectional area loss, Start</p>			
<p>From: MH2 / To: MH3 Size: 150mm</p>

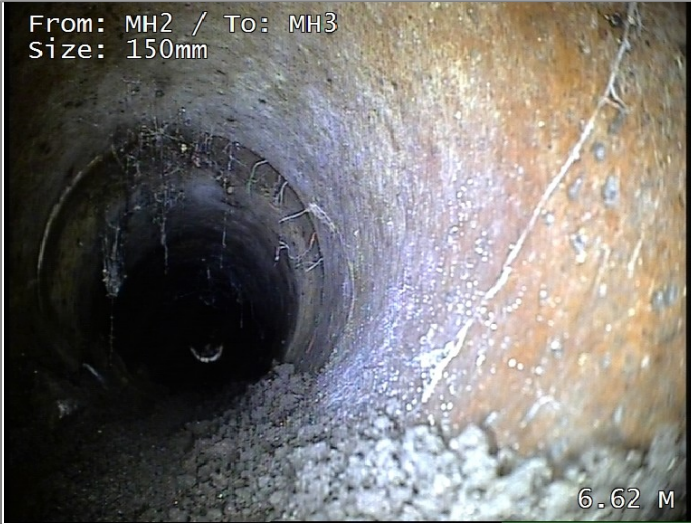
<p>Roots fine</p>			
<p>From: MH2 / To: MH3 Size: 150mm</p>

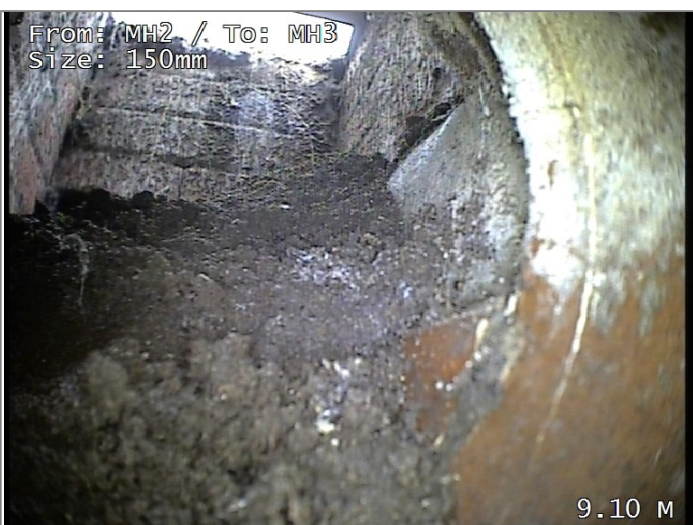
<p>Settled deposits fine 10% cross-sectional area loss, Finished</p>			
<p>From: MH2 / To: MH3 Size: 150mm</p>

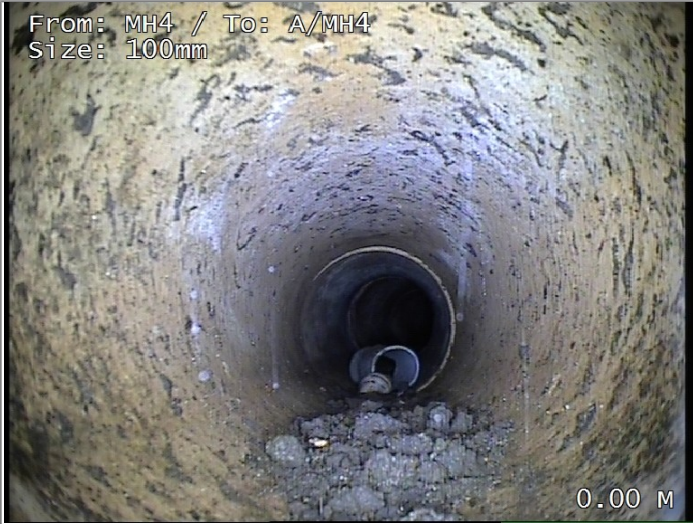
<p>0.00 M</p> <p>Settled deposits fine 5% cross-sectional area loss</p>		<p>From: MH4 / To: A/MH4 Size: 100mm</p>

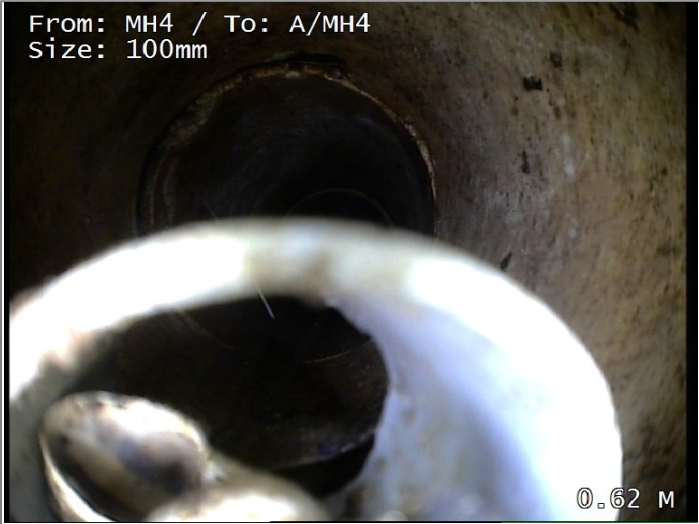
<p>0.62 M</p> <p>Other settled deposits 20% cross-sectional area loss - Remark: PIECE OF PVC PIPE</p>	
<p>From: MH4 / To: A/MH4 Size: 100mm</p>

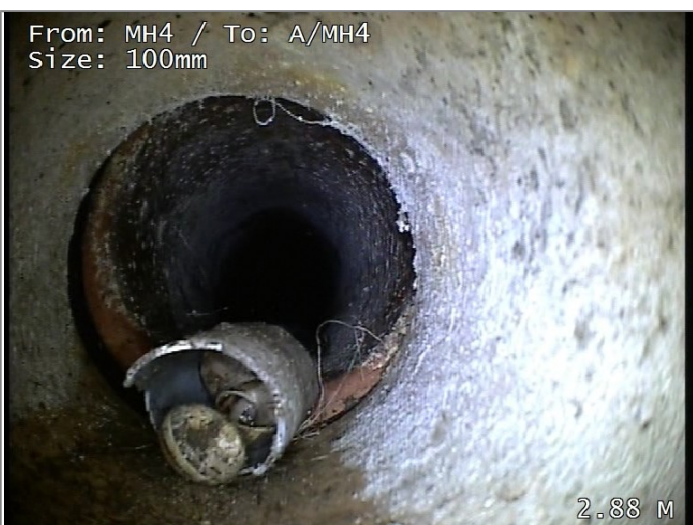
<p>2.88 M</p> <p>Joint displaced medium</p>		<p>From: MH4 / To: A/MH4 Size: 100mm</p>

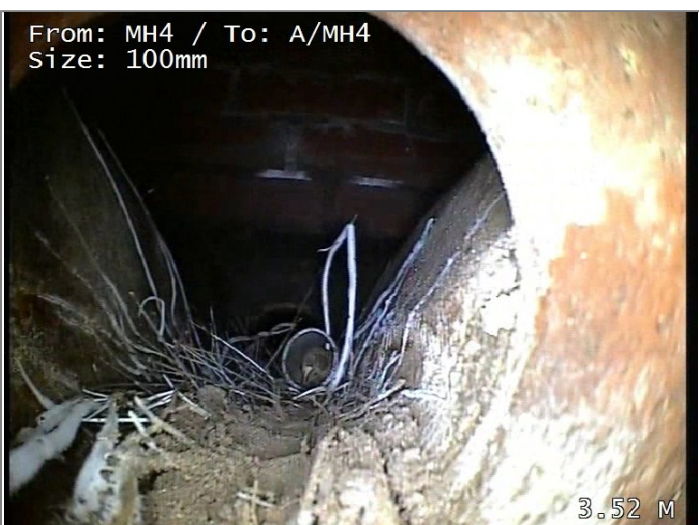
<p>3.52 M</p> <p>BURIED MANHOLE</p>

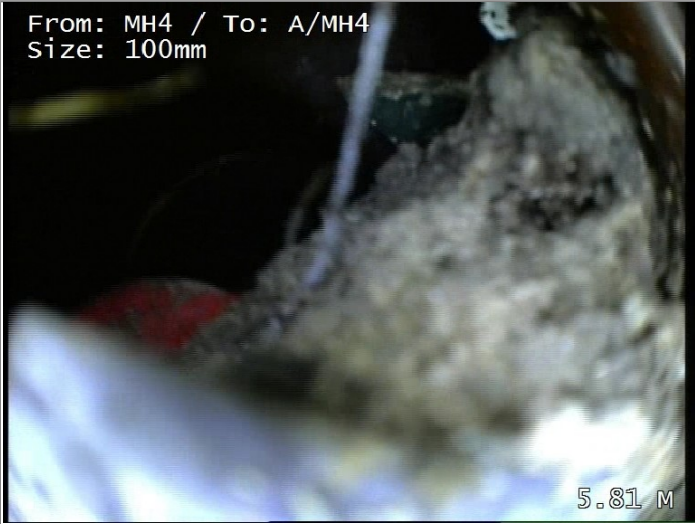
<div>5.81 M</div> <div>Roots mass 75% cross-sectional area loss</div> </div>			
<div> <div> From: MH4 / To: A/MH4 Size: 100mm </div>

<div>5.81 M</div> <div>Survey abandoned - Remark: DUE TO ROOTS</div> </div>

<p>5: Pipe is already or will shortly be impermeable: Eg. collapsed pipe, deeply rooted pipe or other drainage obstructions. Pipe loses water or danger of backwater in basements etc.</p> <p>REHABILITATION IS URGENT AND SHORT-TERM. IN ORDER TO PREVENT FURTHER DAMAGE, NECESSARY TEMPORARY SPOT REPAIR HAS TO BE CONDUCTED ON EMERGENCY LEVEL.</p>

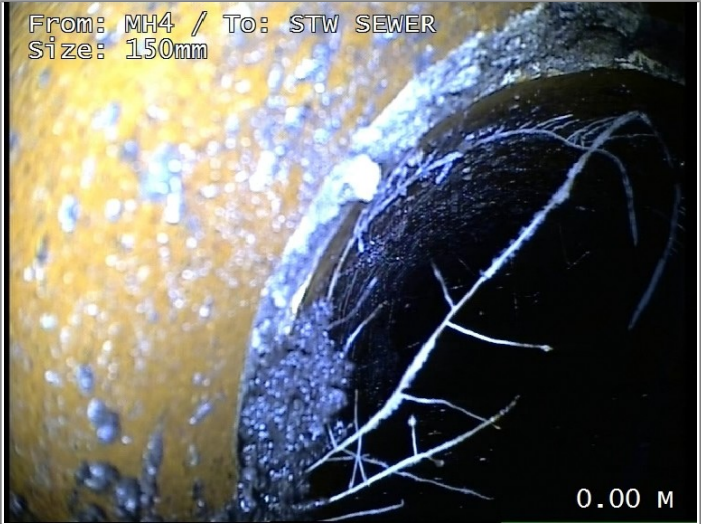
<p>0.00 M</p> <p>Roots fine</p>			
<p>From: MH4 / To: STW SEWER Size: 150mm</p>

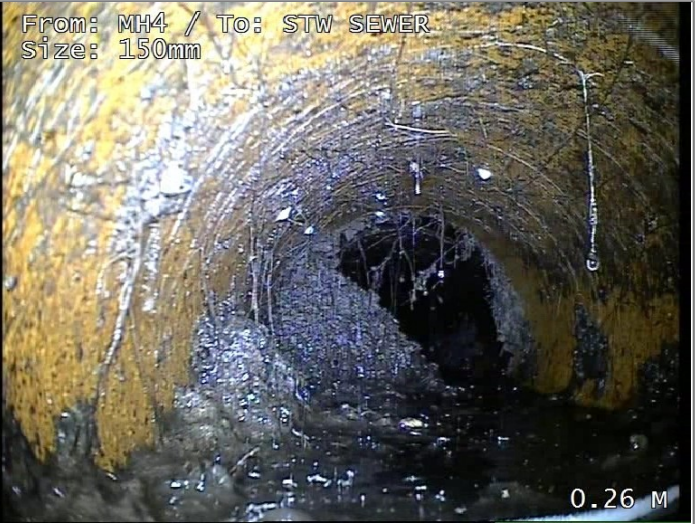
<p>0.26 M</p> <p>Settled deposits fine 50% cross-sectional area loss</p>			
<p>From: MH4 / To: STW SEWER Size: 150mm</p>
