**BUILDING SURVEY REPORT  
DEPOT HOUSE, SOUTH ST,  
OWSTON FERRY, DONCASTER  
DN9 1RP  
27 July 2023**

**Environment  
Agency**

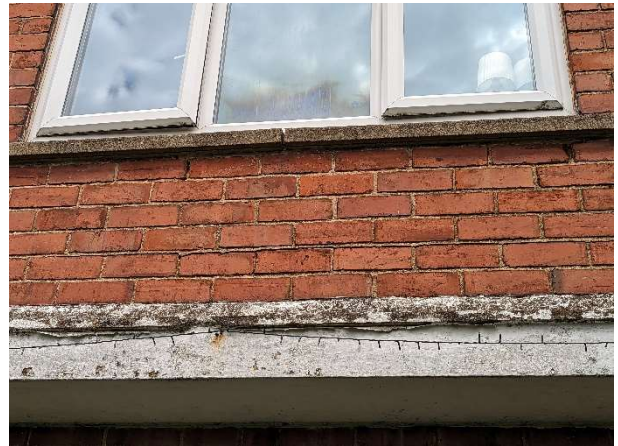
Horizontal cracking was noted on the southern elevation above the concrete canopy and below the windowsill, with a slight bulge/bowing of the external leaf visible. This would usually suggest some form of potential wall tie failure.

Photo 2 – Horizontal crack at upper level to the front elevation.

On the Southern elevation, we noted the horizontal crack and a slight bulging/bowing of the wall, which led to the introduction of the cavity wall survey. The findings of the investigations showed there is evidence of disruption due to wall tie corrosion of the galvanised mild steel wire type ties and fish tail type tails. This can result in the expansion of the metal embedded in the outer leaf, which can sometimes split the bed joints and causing the bowing movement that is apparent with this building. It can also reduce the strength and stability of the wall, and so remedial works are required immediately. Further information can be referred to the cavity wall report in Appendix A. The cracking can be repointed once remedial works have been completed. ***We would recommend carrying remedial works which would entail the locating and isolating of all existing mild steel fish tail type ties to the front, rear and both gable elevations. Drill for and insert new stainless-steel remedial ties in accordance with current codes of practice, remote from and forming an alternate grid pattern to the original.***

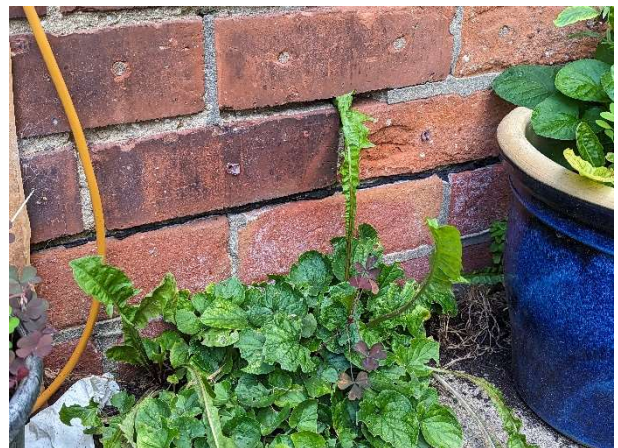
Photo 4 – Missing mortar throughout the exterior of the building.

The external walls are in fair general condition although some repointing works are required at low-level throughout all elevations where this has deteriorated above the block paving. ***We would recommend that patch repointing of approximately 40m<sup>2</sup> is undertaken to repair any damaged, missing, or deteriorated pointing.***

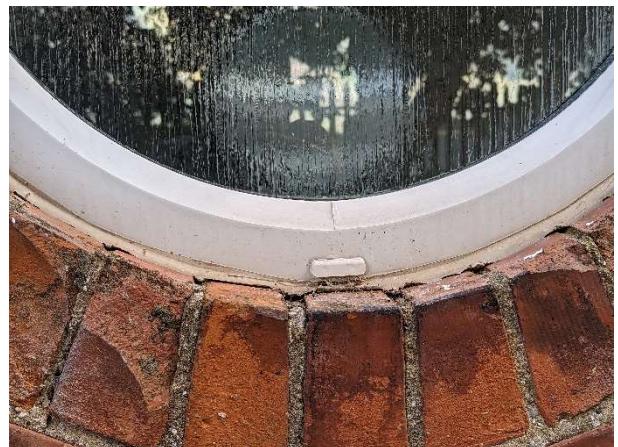
Photo 6 – Mastic/Sealant become loose to several windows.

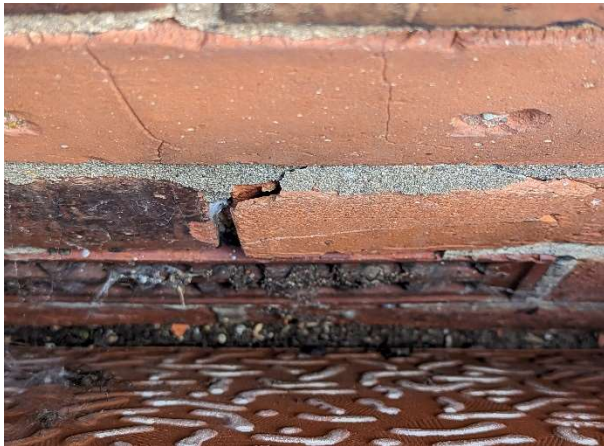
Photo 7 – Example of airbricks blocked by a clay panel.

Although we did not note any visible defects to the flooring at time of inspection. ***We would recommend carrying out remedial works to prevent possible decay. This will involve removing the covers from the airbricks, ensure the airbricks are clear of obstructing.***

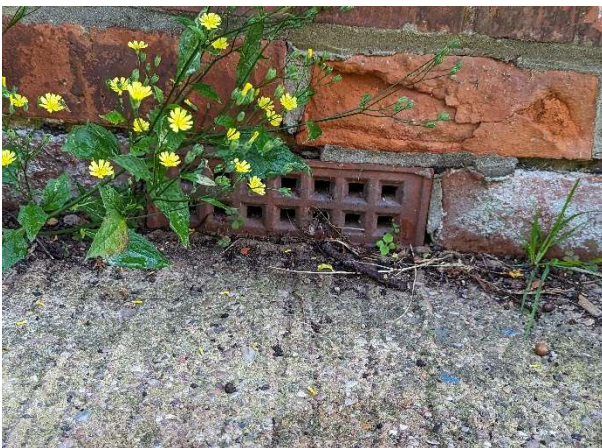
We were not able to view/inspect the underside of the floor. however, we believe the flooring to where the lounge is located is a suspended timber floor, which has been finished with ceramic tiles. We also noted several airbricks have been blocked, therefore preventing cross ventilation / airflow to the underside of the timber floor. This will in turn contribute to an increase in the existing moisture content, which, in turn, can lead to decay. We also noted two air bricks partially blocked by the paved concrete on the western elevation.

Photo 9 – Airbricks partially blocked by paved concrete on the western elevation.

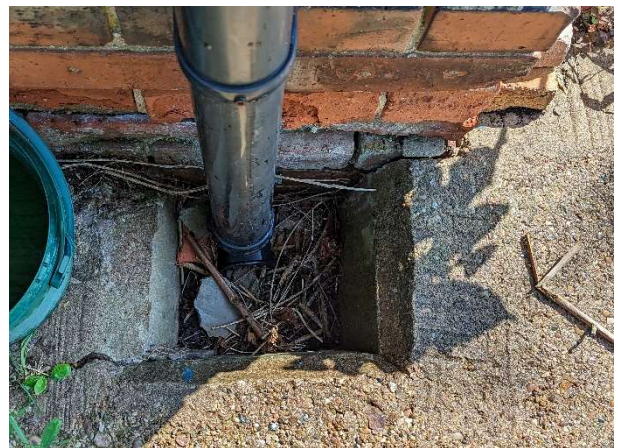
We noted vegetation causing blockages to localised areas of the lead lined valley gutters and uPVC guttering. We also noted a gully on the south elevation blocked by debris. Remedial/clearing works are required to ensure rainwater is suitably discharged into the drainage system. ***We would recommend that you take the opportunity to clear the guttering and the drainage gullies to ensure rainwater is suitable discharged.***

Photo 10 – Drainage channel blocked by debris on the western elevation.

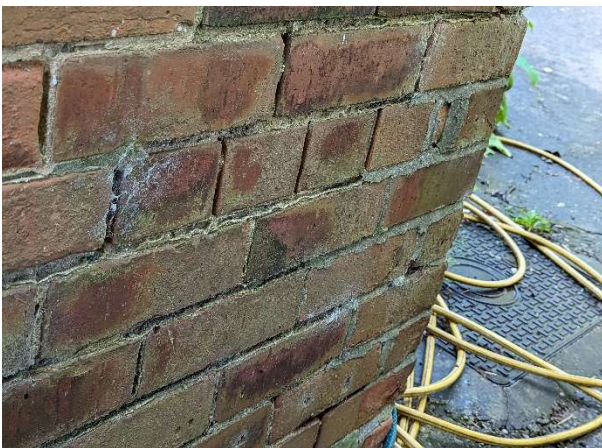
Photo 15 – Further examples of mortar missing at low level.

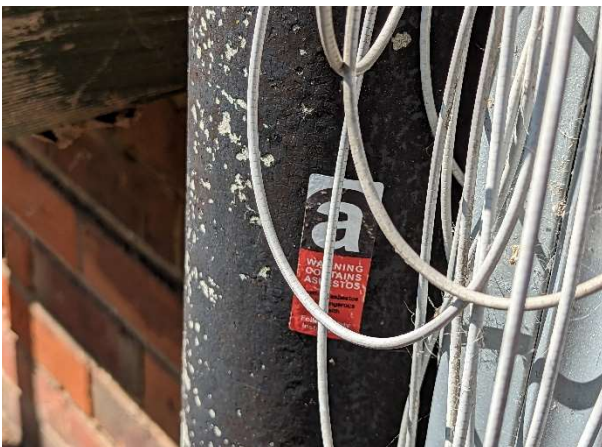
Photo 17 – SVP on the eastern elevation confirmed to contain asbestos.

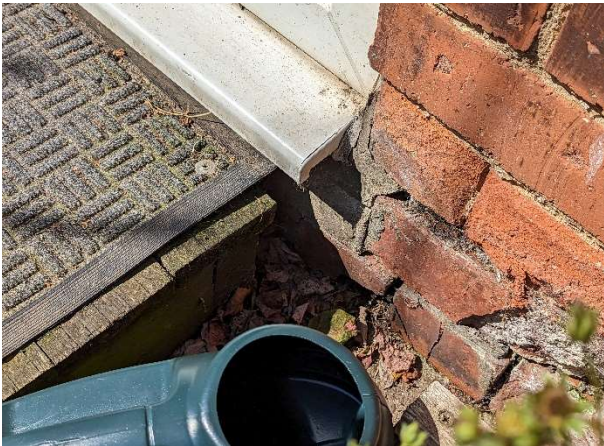
Photo 19 – Further examples of mortar missing at low level.

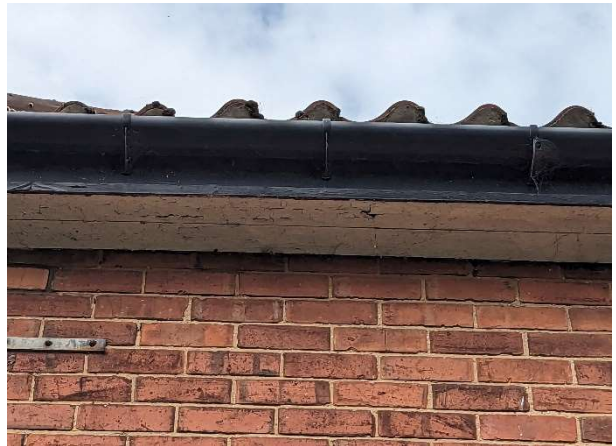
It was noted that the paint finish to the timber soffit and fascia has deteriorated, with some sections are rotten due to decay. ***We would recommend that you take the opportunity to replace the fascia and soffit around the full perimeter of the building.***

Photo 20 – Overview of timber soffit/fascia.

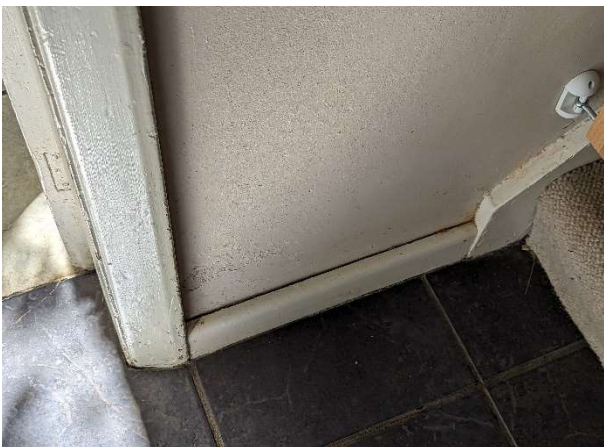
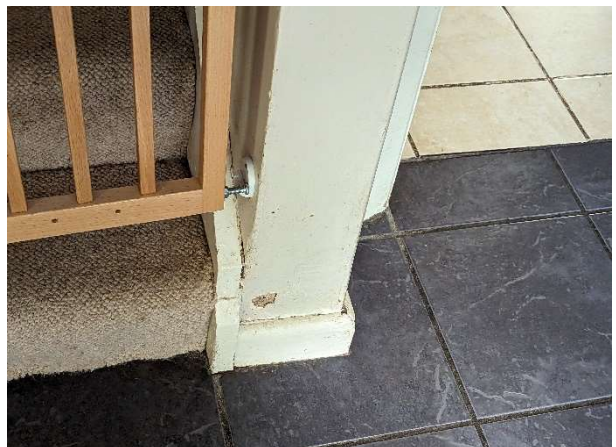
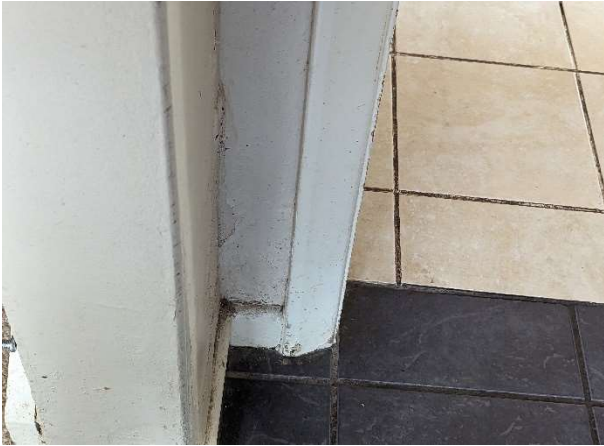
Generally, the walls are in fair condition with no visible defects although, we noted some paint blistering on the internal wall where the staircase is located at low level. We assume this is likely due to condensation build up. In the kitchen, combined with a lack of mechanical ventilation present, which can exacerbate the condensation build up. Additionally, a pantry is located on that side, which is unheated, therefore would generally be considered a cold space, in turn, making the internal wall cold as well.

Photo 35 – Blistering and elevated moisture levels to walls at low level of front porch area,

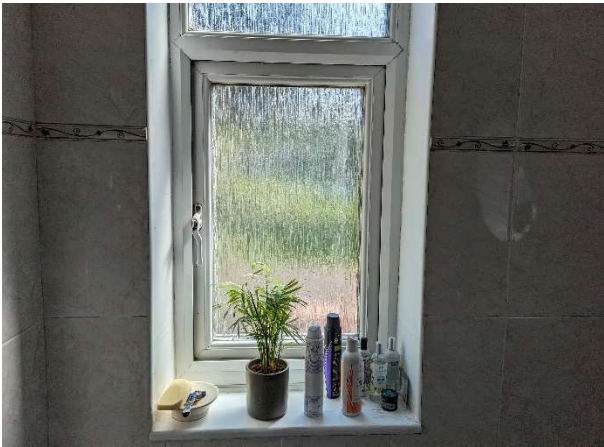
Windows were found to be in reasonable condition, as they are modern uPVC units, however there were three glazing panels that were blown in the bathroom, and two of the bedrooms which require immediate replacement, as the airtightness has been compromised.

Photo 39 – Blown glazing panel to bathroom window.

We also noted several glazing panes that had blown meaning that they will require immediate remedial works. The affected windows were in the Master Bedroom and the Front Bedroom where one glazing panel was blown. This requires immediate attention, as the thermal efficiency of the windows have been compromised allowing heat to escape. ***We would recommend retrofitting all uPVC units to promote more natural ventilation in the property and carry out remedial works to the blown glazing to improve the thermal efficiency.***

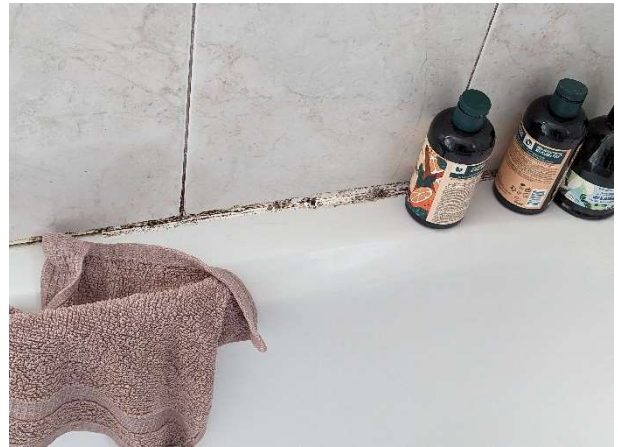
Photo 40 – Mildew build up to grouting around tiles and bathtub.

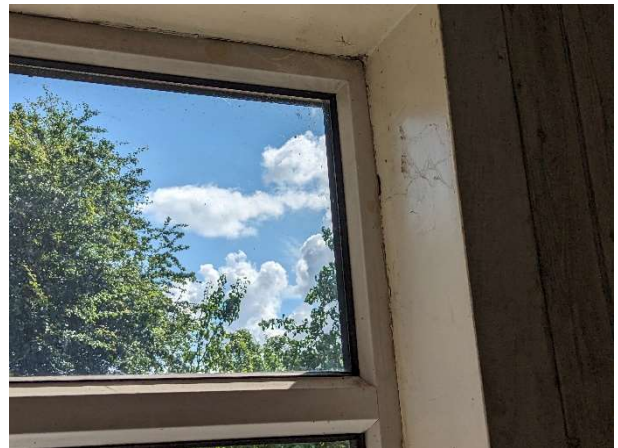
Photo 42 – Flaking paint to window reveal at high level.

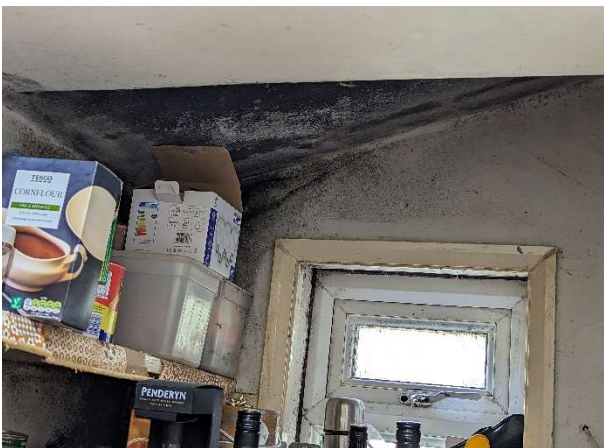
Photo 45 – Black mould to wall/ceiling to the Pantry located in the kitchen.

- Remove existing door to kitchen pantry and replace with a louvered alternative interior door to promote more natural ventilation.
- Replace blown glazing panels to the windows located in the bathroom and bedrooms to improve thermal efficiency and mitigate heat loss.

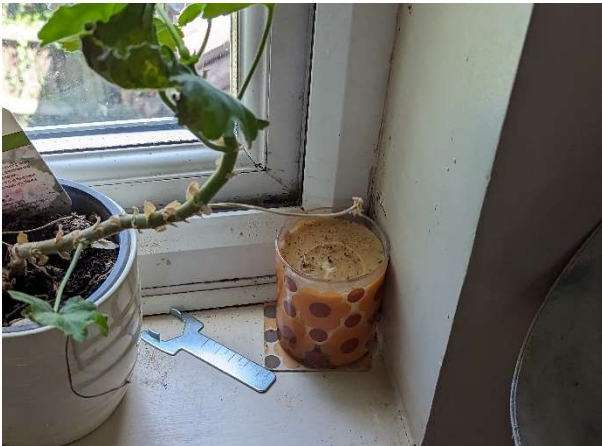
We also noted presence of black mould to all the bedrooms in various different locations. Upon inspection, we noted the doors and windows were kept closed, preventing further natural ventilation. As mentioned previously, there are lack of trickle vents to all bedroom windows, which is another mitigating factor. Recommendations have been noted under section 8.9 ventilation.

Photo 49 – Close up of black mould affecting the window reveal of Bedroom 2.

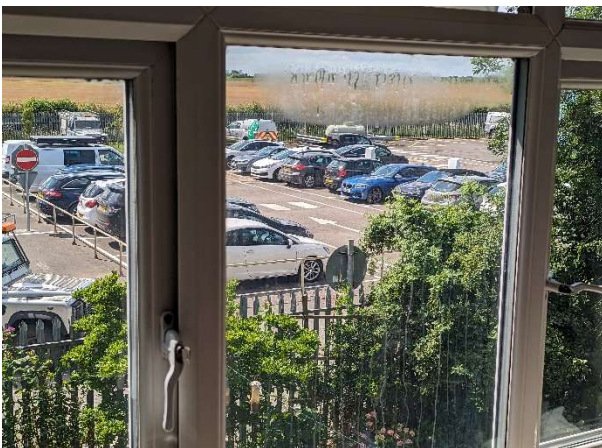
Photo 51 – Blown glazing panel to window unit located in Bedroom 2.

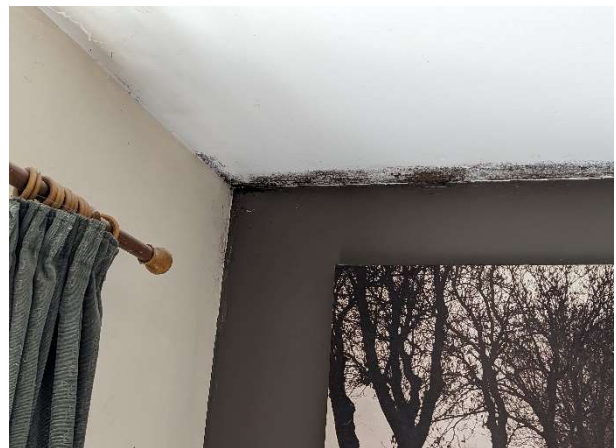
Photo 52 – Black mould to ceiling and walls, predominantly in the corners of Bedroom 2.

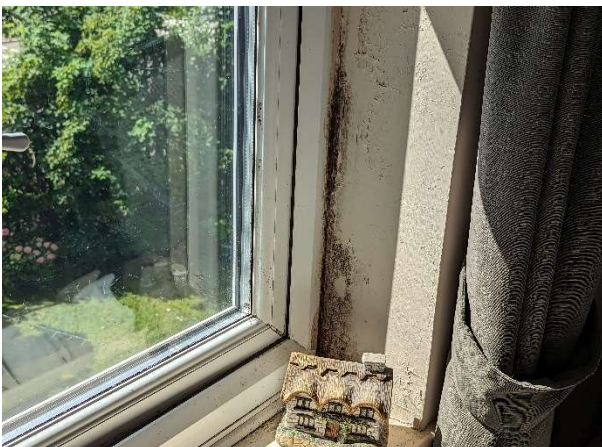
Photo 53 – Black mould to window reveal to Bedroom 2.

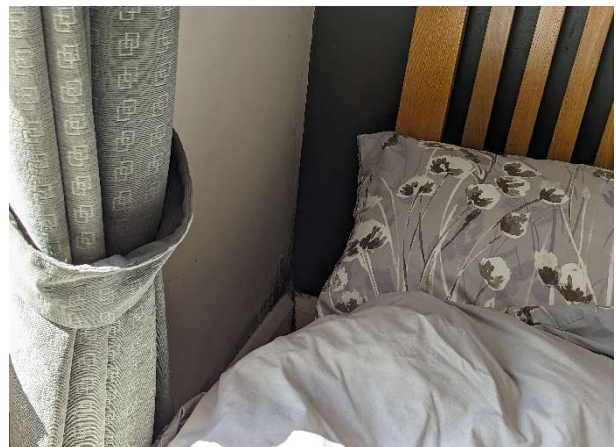
Photo 54 – Black mould to external wall at low level adjacent to bedroom 2.

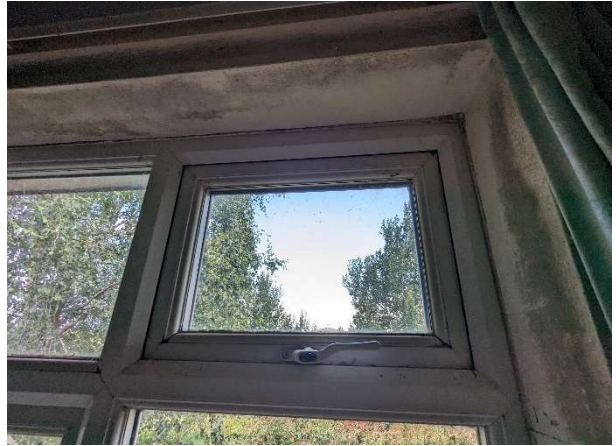
Photo 56 – Black mould to window reveal.

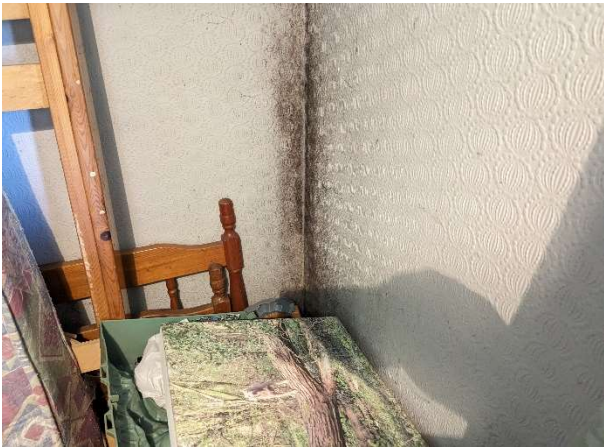
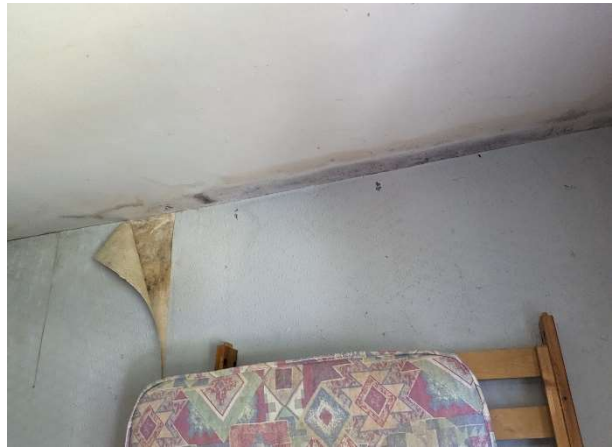
Photo 57 – Black mould to walls and ceilings to Bedroom 3.

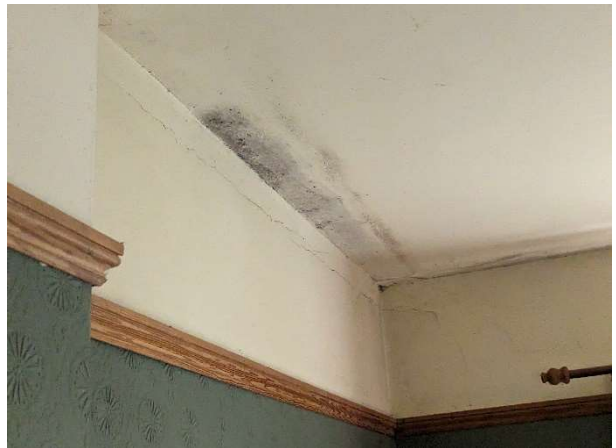
Photo 60 – Black mould present to ceiling and walls.
