Our ref: 13722/PBC/lc/Reports

6<sup>th</sup> September 2016

**Re: ST LEONARDS CHURCH, NEWTON ABBOT**

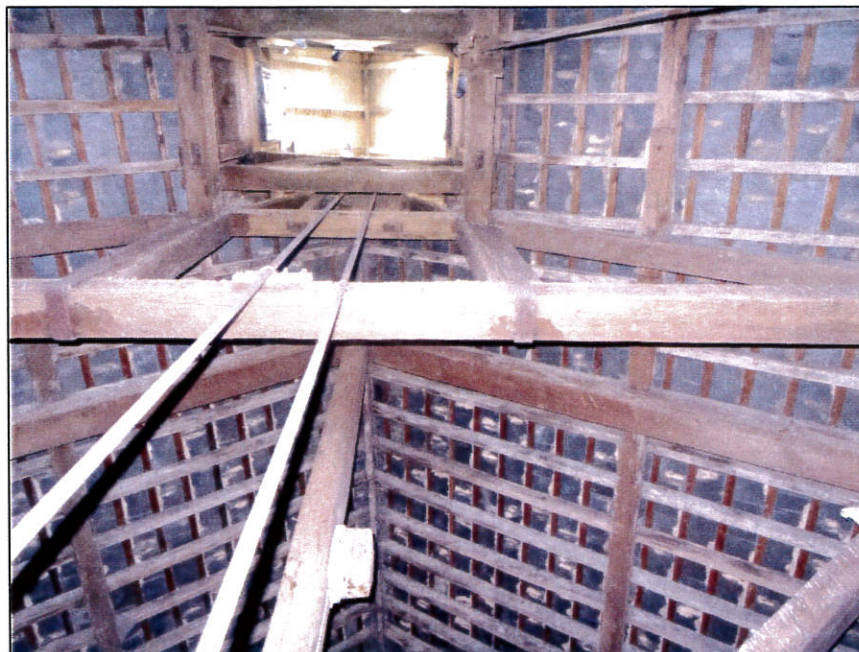
2. The general construction of the building is very typical of the local Victorian vernacular.
3. The roof is generally pitched west - east and covered with natural slate supported on battens, rafters, purlins and principal timber king post trusses, set at regular centres, also supporting the vaulted faceted ceiling.

**Principal truss and purlin roof structures covered with natural slate**

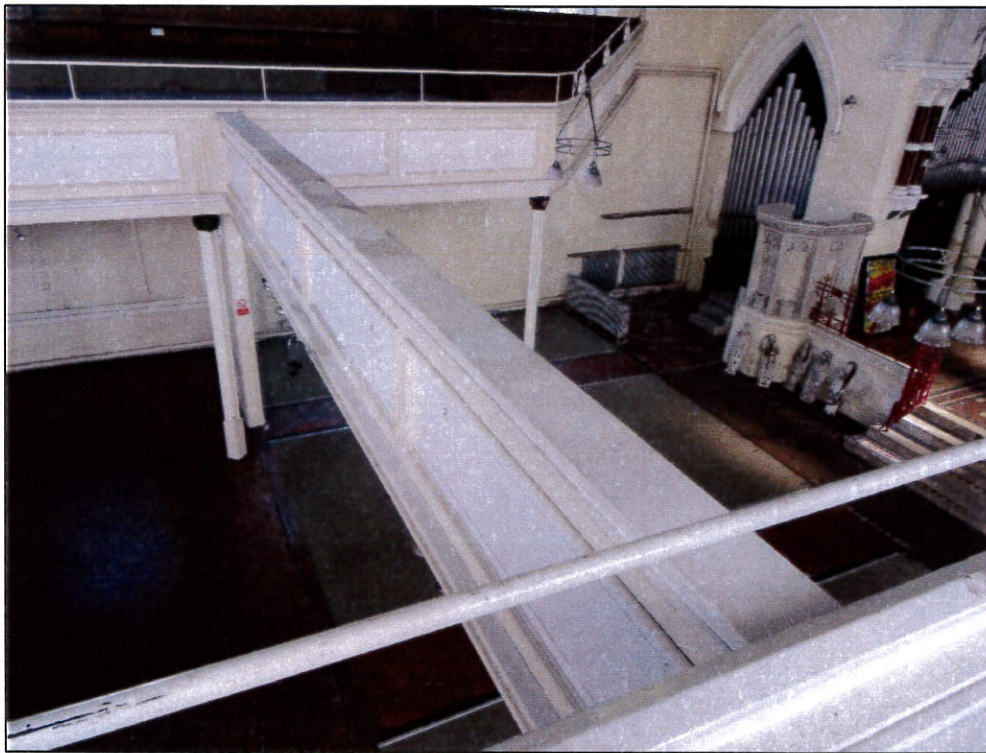
7. It is thought that the tiered first floor balcony is probably original, but may well have been modified in the 1876 alterations, with the transverse parapet wall to act as a head to a ground floor folding screen arrangement obviously added, probably in the latter part of the 20<sup>th</sup> century. This later parapet should be able to be removed without compromising other elements of the original structure.

Transverse parapet wall, 20<sup>th</sup> century

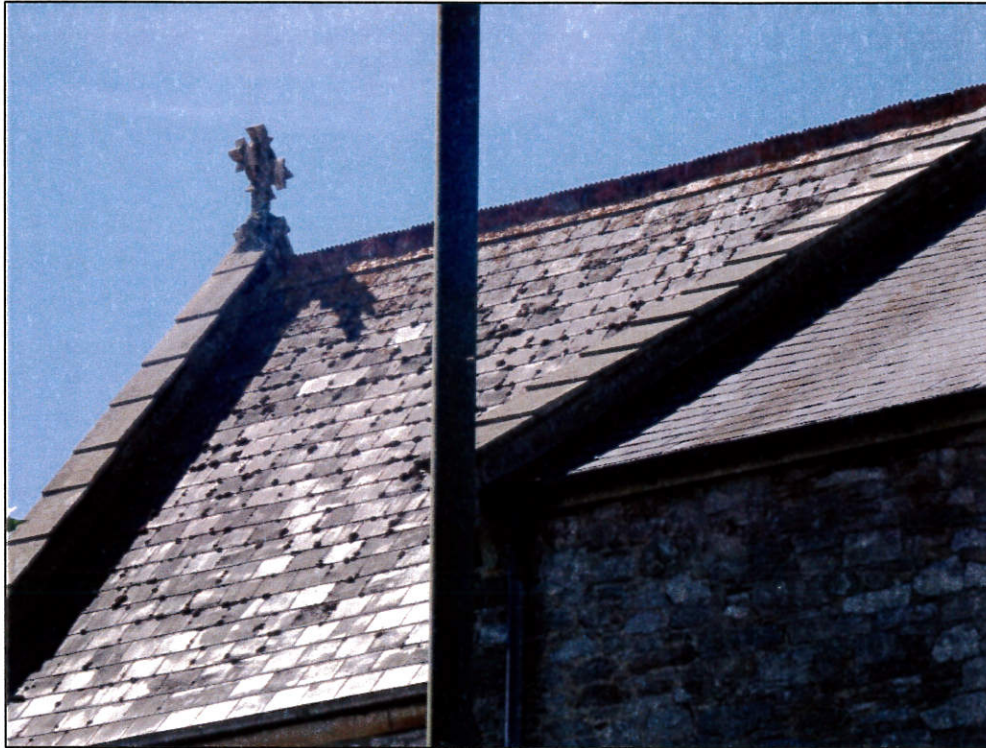
9. Generally, we consider the building in its original form to be in quite fair condition, with the principal walls reasonably true to line and no significant undulations or distortions.
10. It is thought that the original roof structure is probably quite weak and there is evidence of a marginal dip in the roof slopes, but this is unlikely to be of structural concern.

**Marginal 'dip' in roof slopes**

11. As part of upgrading the building and reordering it for its new use, we feel it is essential that the roof covering is in good order and probably re-slatted in its entirety. As outlined, currently the principal roof has no felt under the slate, and it is noticeable that there are defects within the principal roof covering.

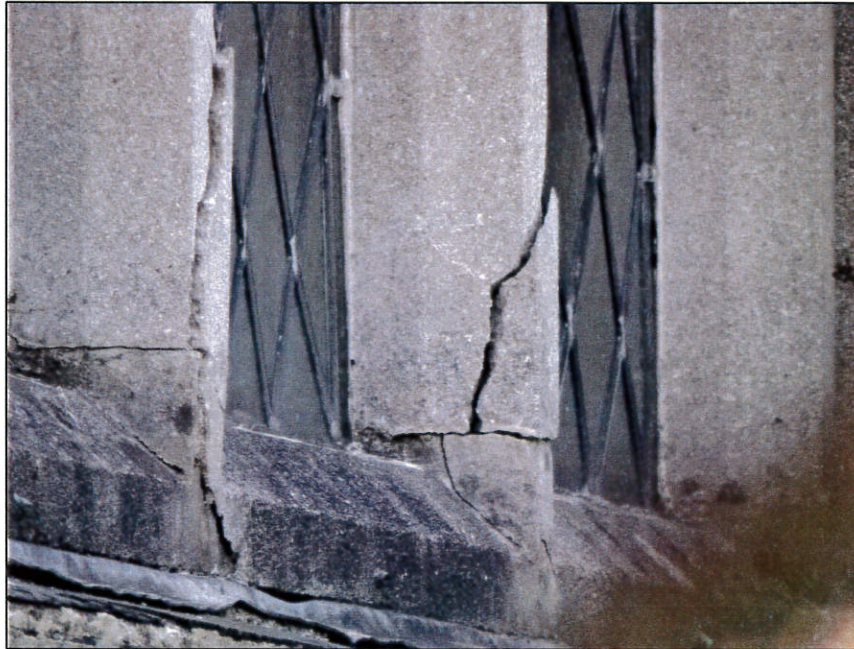
**Render and leadwork repairs required**

14. The principal walls are probably founded at a relatively shallow depth, with the masonry substructure walls widening onto reasonable bearing strata, as there is little evidence of significant subsidence or settlement of concern.
15. Repairs will be required, in areas, to the external walls, with sporadic lime repointing, together with renewing elements of render.
