Refurbishment Survey

Survey Reference Number: L-31546RV1

Survey Date: 11 March 2024

St Newlyn East Village Hall
Neeham Road
Newquay
Cornwall
TR8 5LE

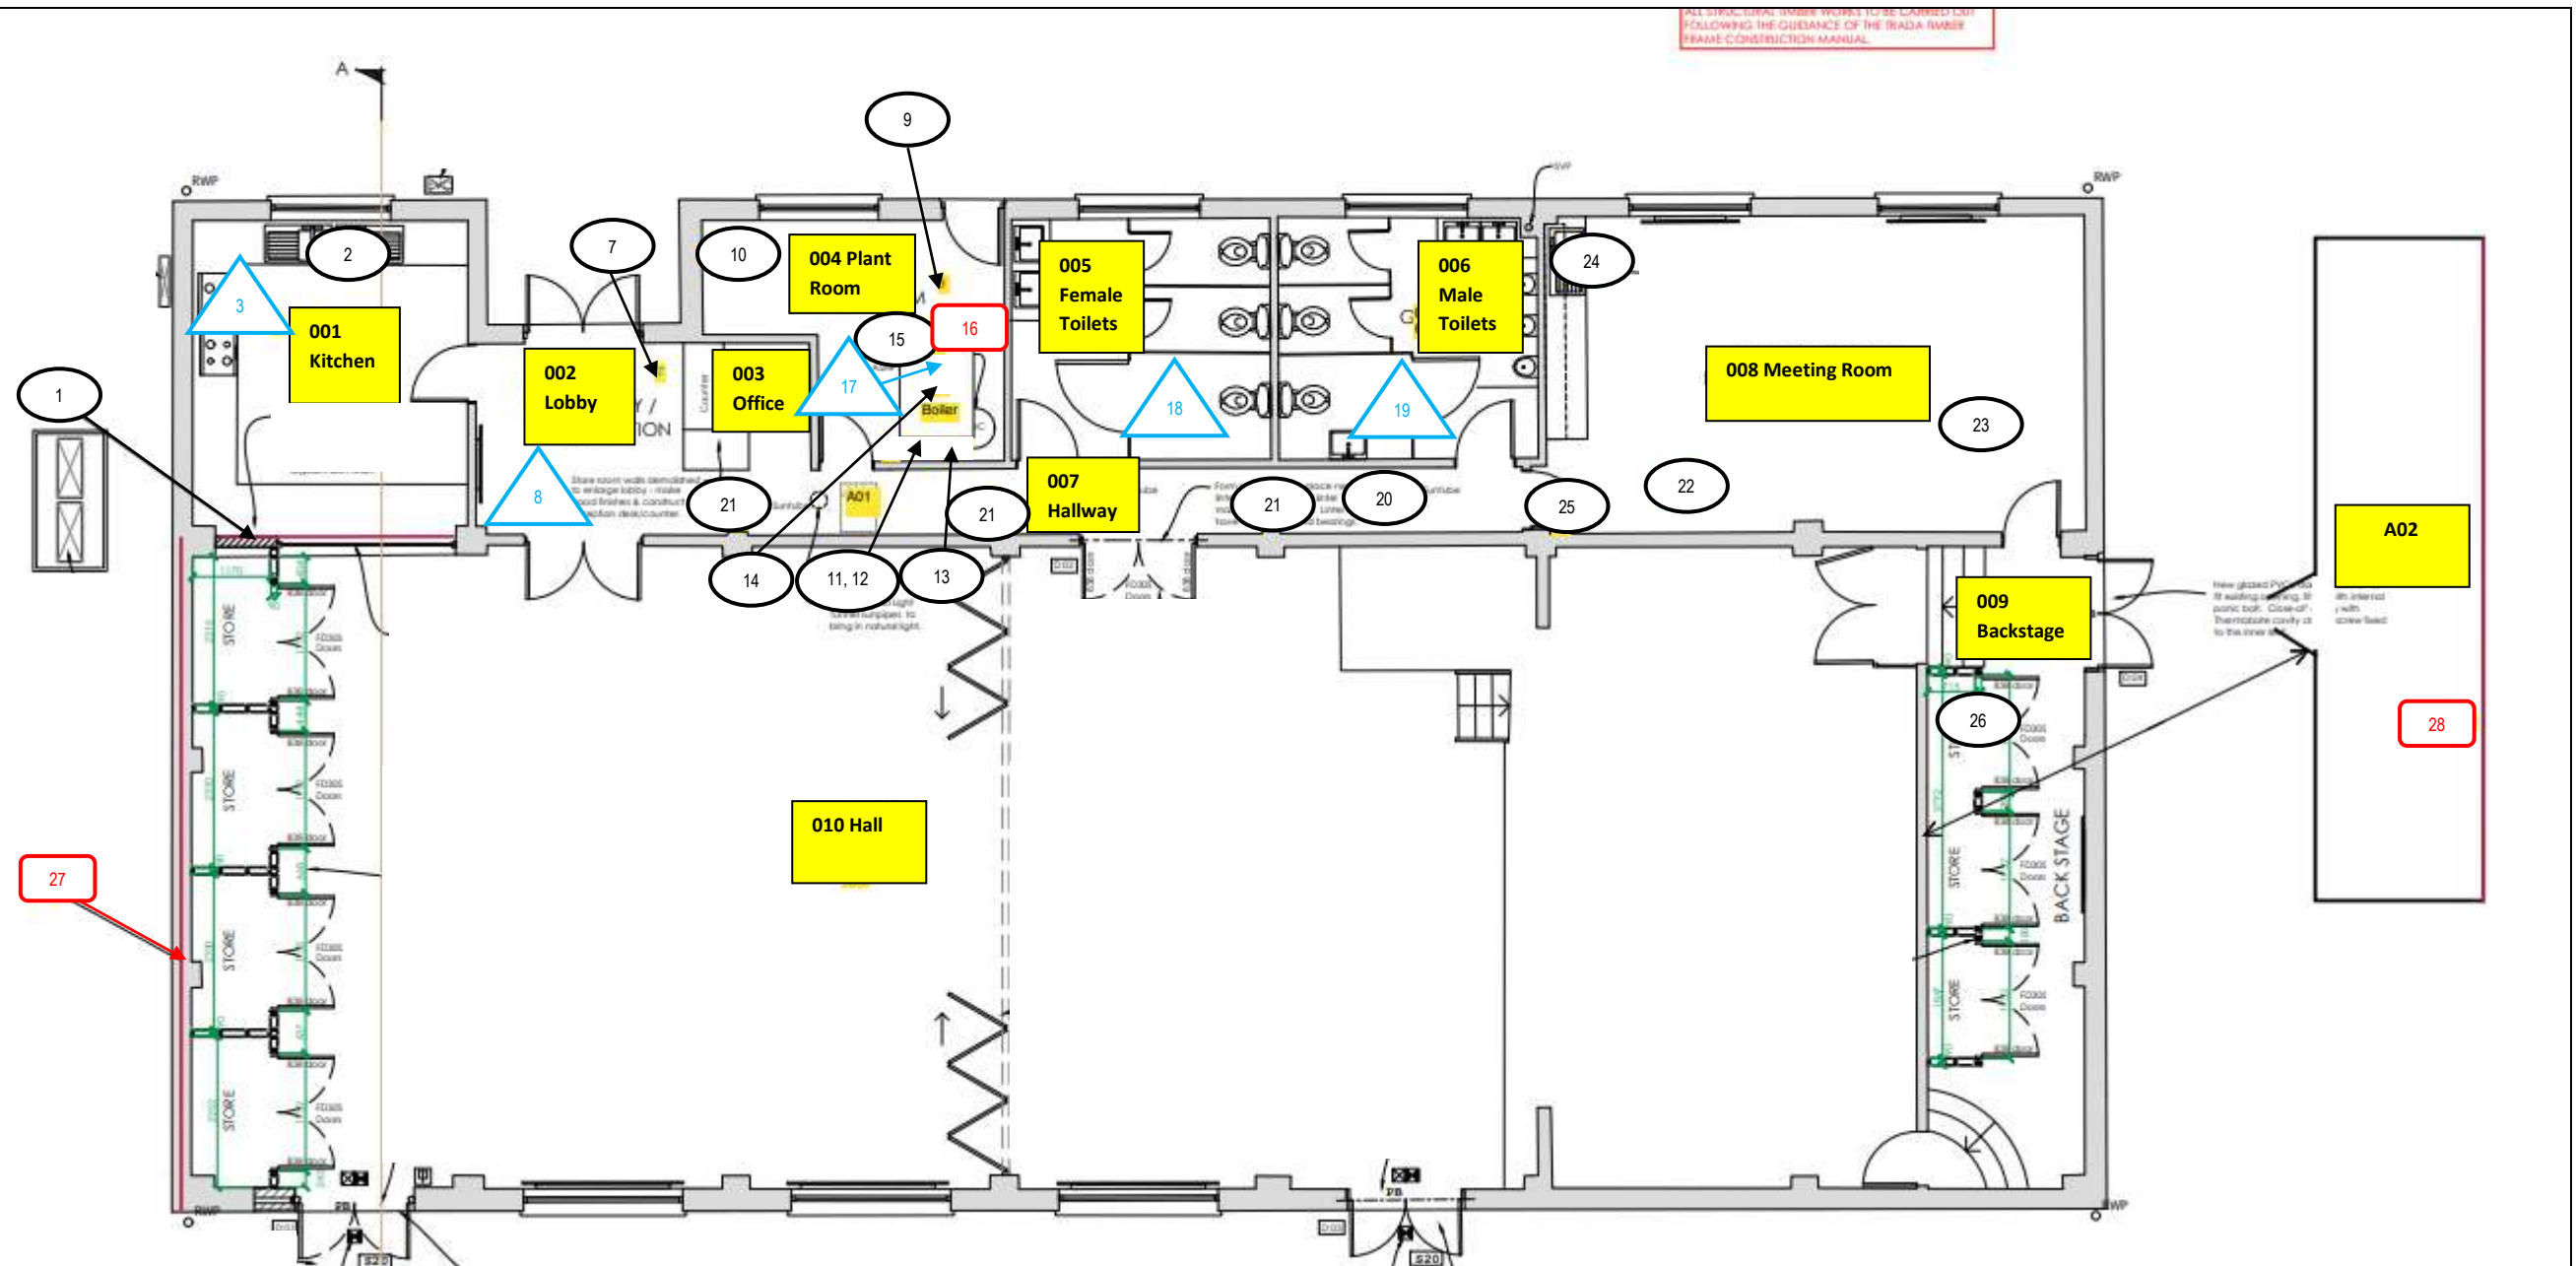
Site:	St Newlyn East Village Hall Neeham Road Newquay Cornwall TR8 5LE
Building:	Circa 1980's block built detached building with a pitched roof.
Floor Level / Area:	Ground Floor & Roof Space
Ref No & Plan No:	L-31546RV1 Page 1 of 2
KEY	
Positive ACMs /items	
Non Asbestos / Negative ACMs	
No Access / Limited Access	
Areas excluded from the survey

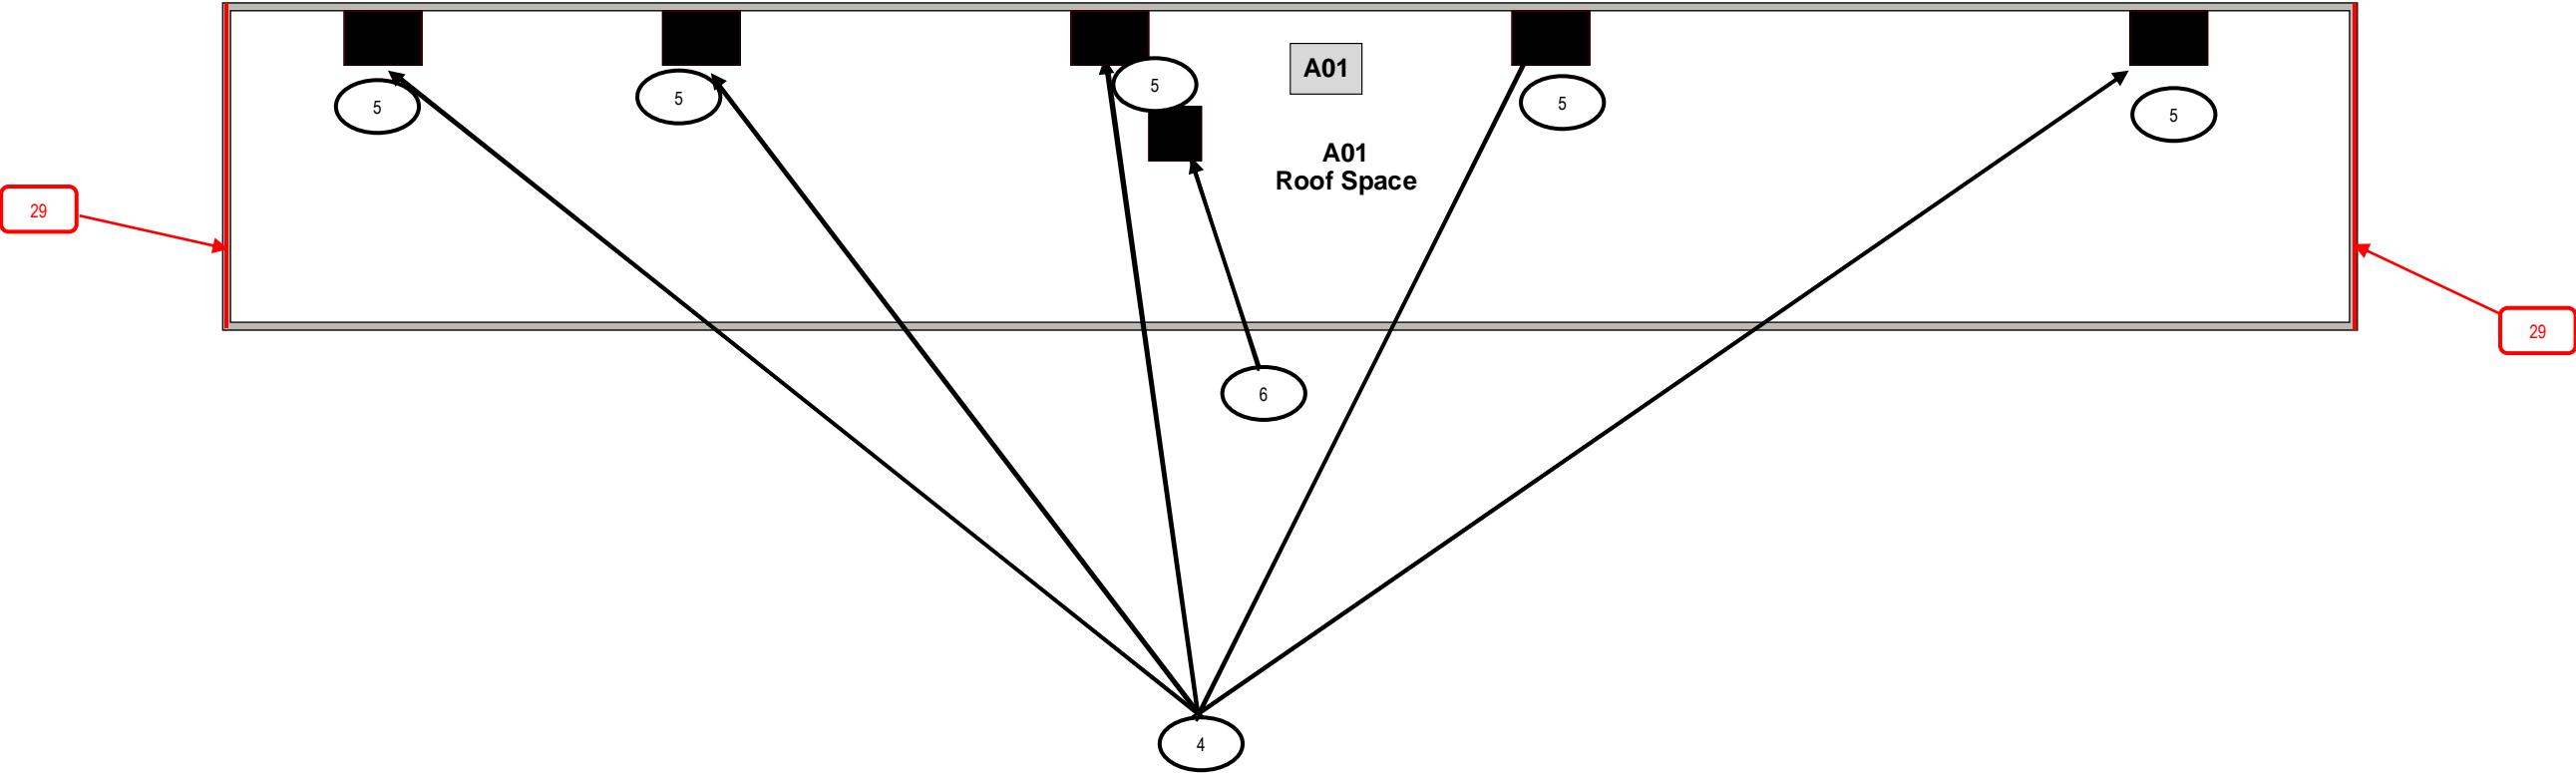
Site:	St Newlyn East Village Hall Neeham Road Newquay Cornwall TR8 5LE
Building:	Circa 1980's block built detached building with a pitched roof.
Floor Level / Area:	Roof Space
Ref No & Plan No:	L-31546RV1 Page 2 of 2
KEY	
Positive ACMs /items
