**Asbestos Management Survey for**  
**Wiltshire Council**  
**at**  
**Westbury High Street Short Stay Car Park**  
**And Public Convenience**  
**Wiltshire**

Project Number: 20309S1-2012

# Asbestos Register and Survey / Inspection Report

Block 01 is a public convenience and the building consists of a flat mineral felt roof, solid walls, non asbestos bitumen damp proof course, plastic fascia & soffits and plastic rain water goods.

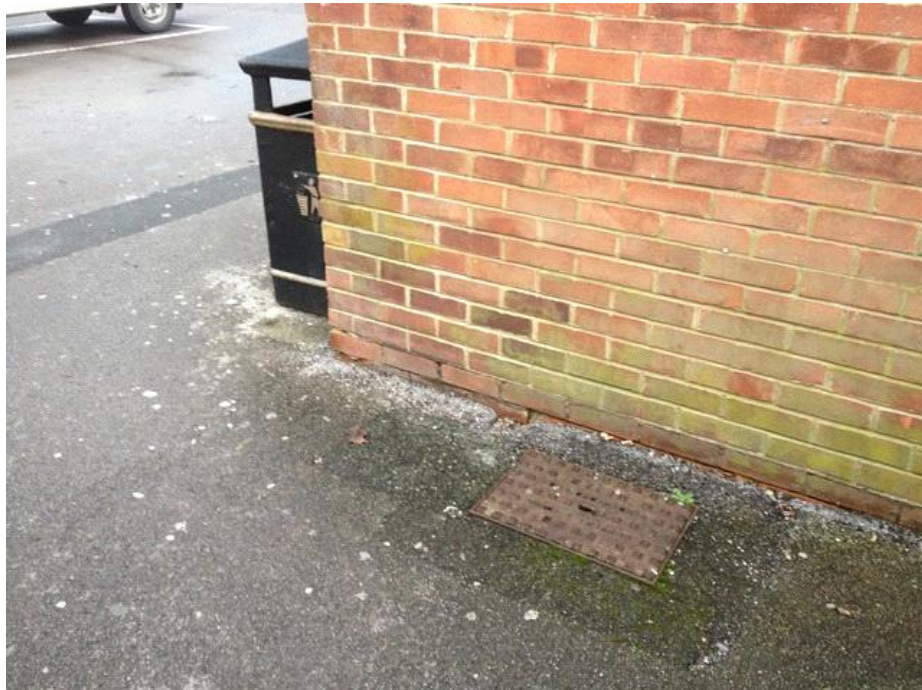
| Area: | Block 01 | Damage: | No Asbestos Detected |

Material Comments: Non Asbestos Bitumen (damp proof course to brickwork)

Action: No Action Required
