23 April 2010
IG09/309/JH/le

J P Chick & Partners Limited
Consulting Civil & Structural Engineers

STRUCTURAL INVESTIGATION REPORT

**ST PETERS CHURCH
THETFORD**

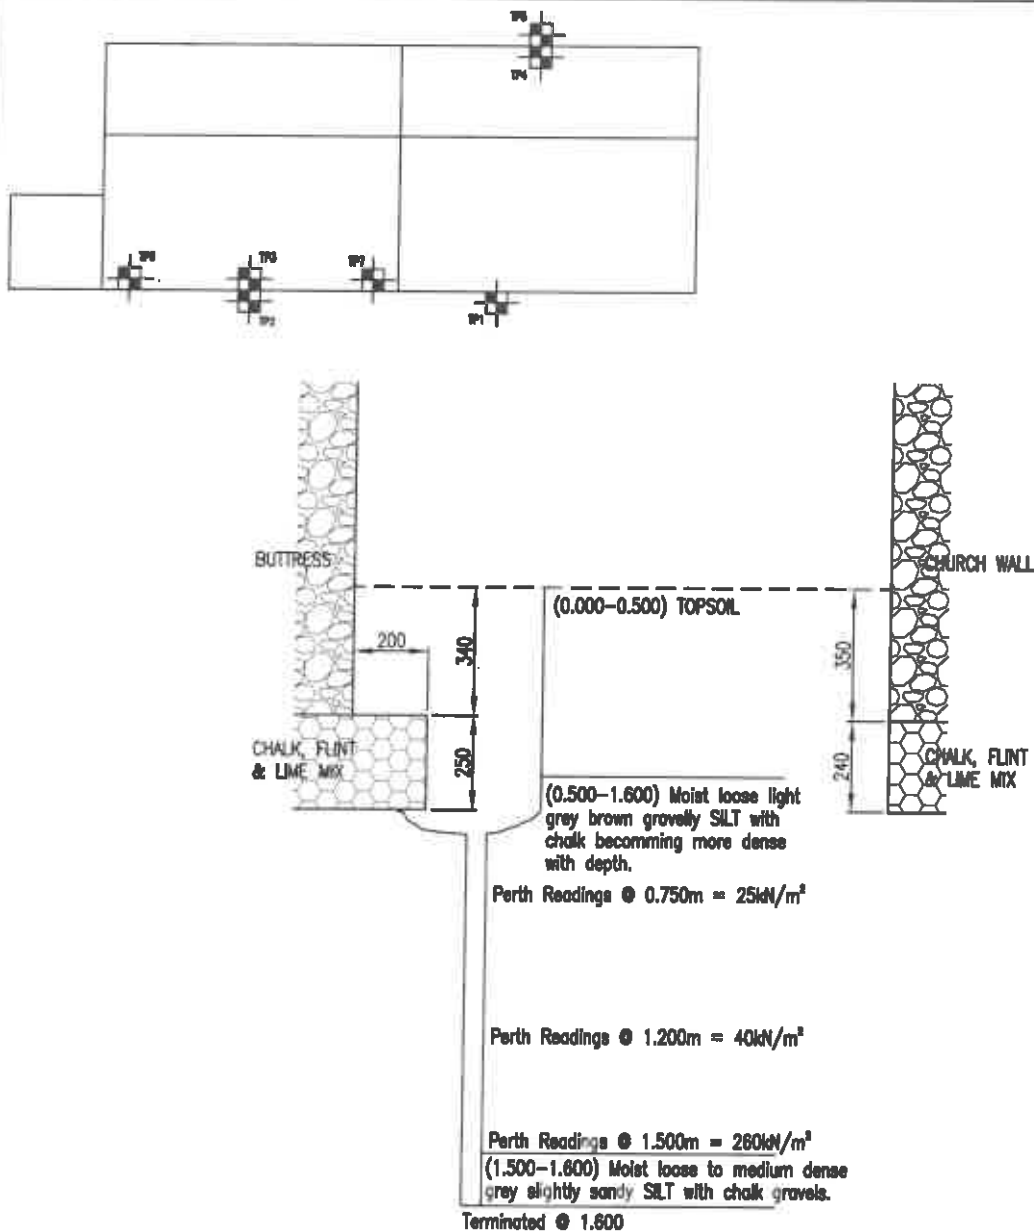
TRIAL PIT 1

- 5.03 Trial pit 1 was undertaken at the intersection between the external wall of the chancel and the most Westward buttress of the three. This revealed that the wall of the chancel continued including its chalk flint and lime foundation to a depth of 590mm below ground level. The wall was found to be vertically plane and as such had no projections as would typically be found with more contemporary foundation arrangements. The buttress was proven to continue to the same depth with the same construction thicknesses in terms of the chalk flint foundation, although this had a toe projection of 200mm. Soils were found to comprise the following: -

Insitu strength testing was undertaken at the trial pit location with the use of a Perth Penotrometer. Findings indicate that at foundation depth soil bearing is in the region of 25kN/m² increasing gradually with depth to the lower level where readings of 260kN/m² were recorded.

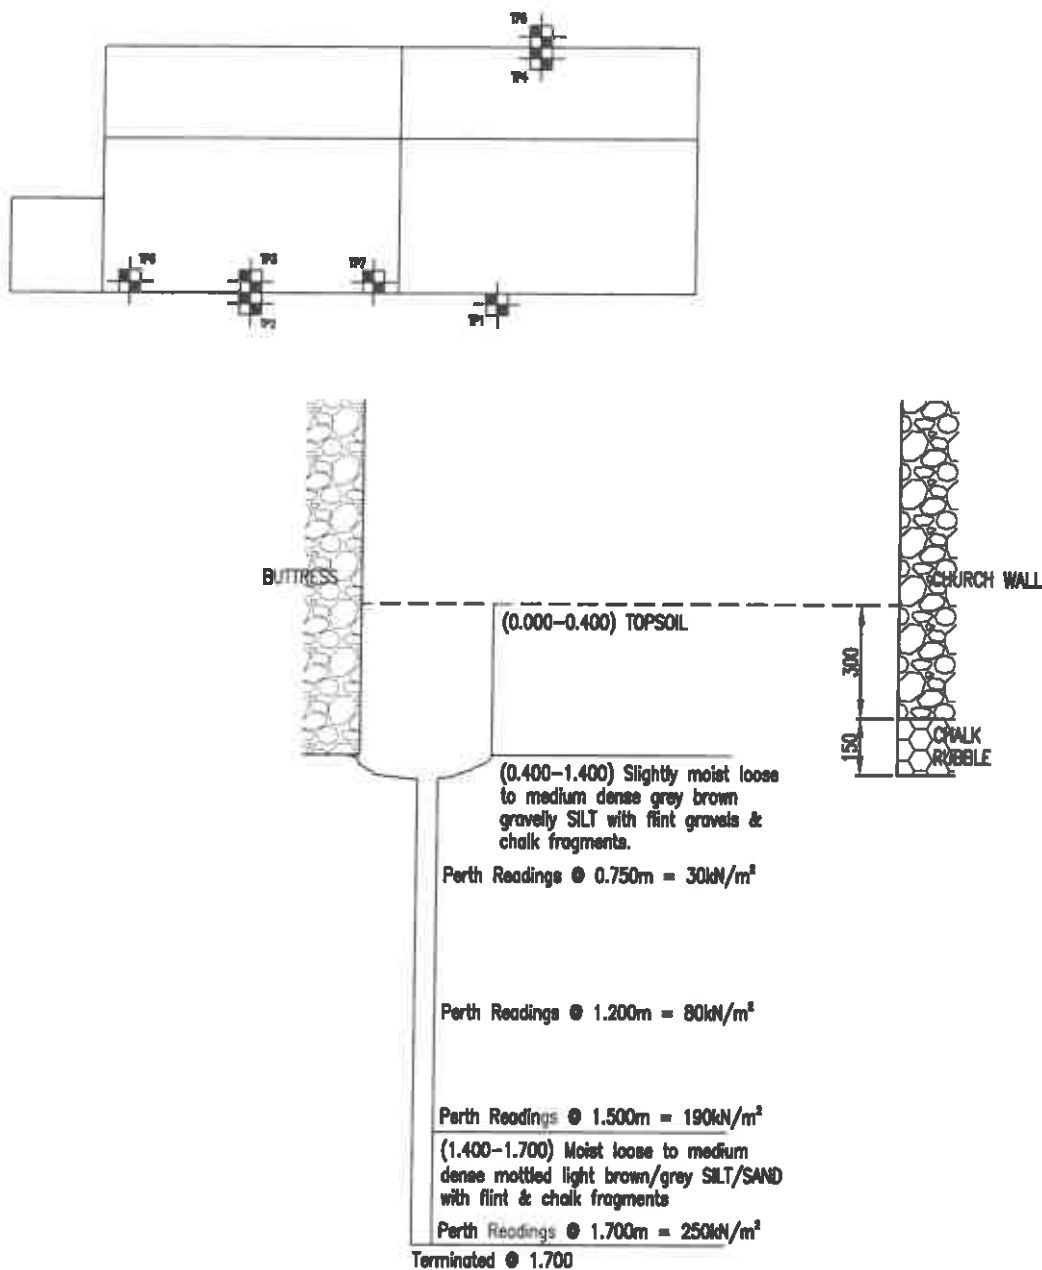
TRIAL PIT 2

- 5.04 Trial pit 2 was undertaken against the nave positioned centrally against the buttress. At this location it was proven that the wall of the nave continued to a total of 450mm below ground level. There is no toe projection with a chalk rubble foundation providing a thickness of 150mm beneath the wall itself. The buttress penetrates the ground by a similar depth and was found to have no toe projection or perceptible foundation and terminated with flint work. Soils comprised of the following: -

Insitu bearing capacities were ascertained with the use of a Perth Penotrometer and readings of 30kN were obtained at 750mm increasing with depth to 190kN/m² at 1.5m to in excess of 250kN/m² at 1.7m.

Significant voiding was noted directly beneath the wall of the nave. This voiding was found to continue horizontally by up to 500mm where further masonry was encountered and vertically continued to approximately 1.5m below ground level. A further internal trial pit directly adjacent trial pit 2 was undertaken within the nave and was numbered TP3.

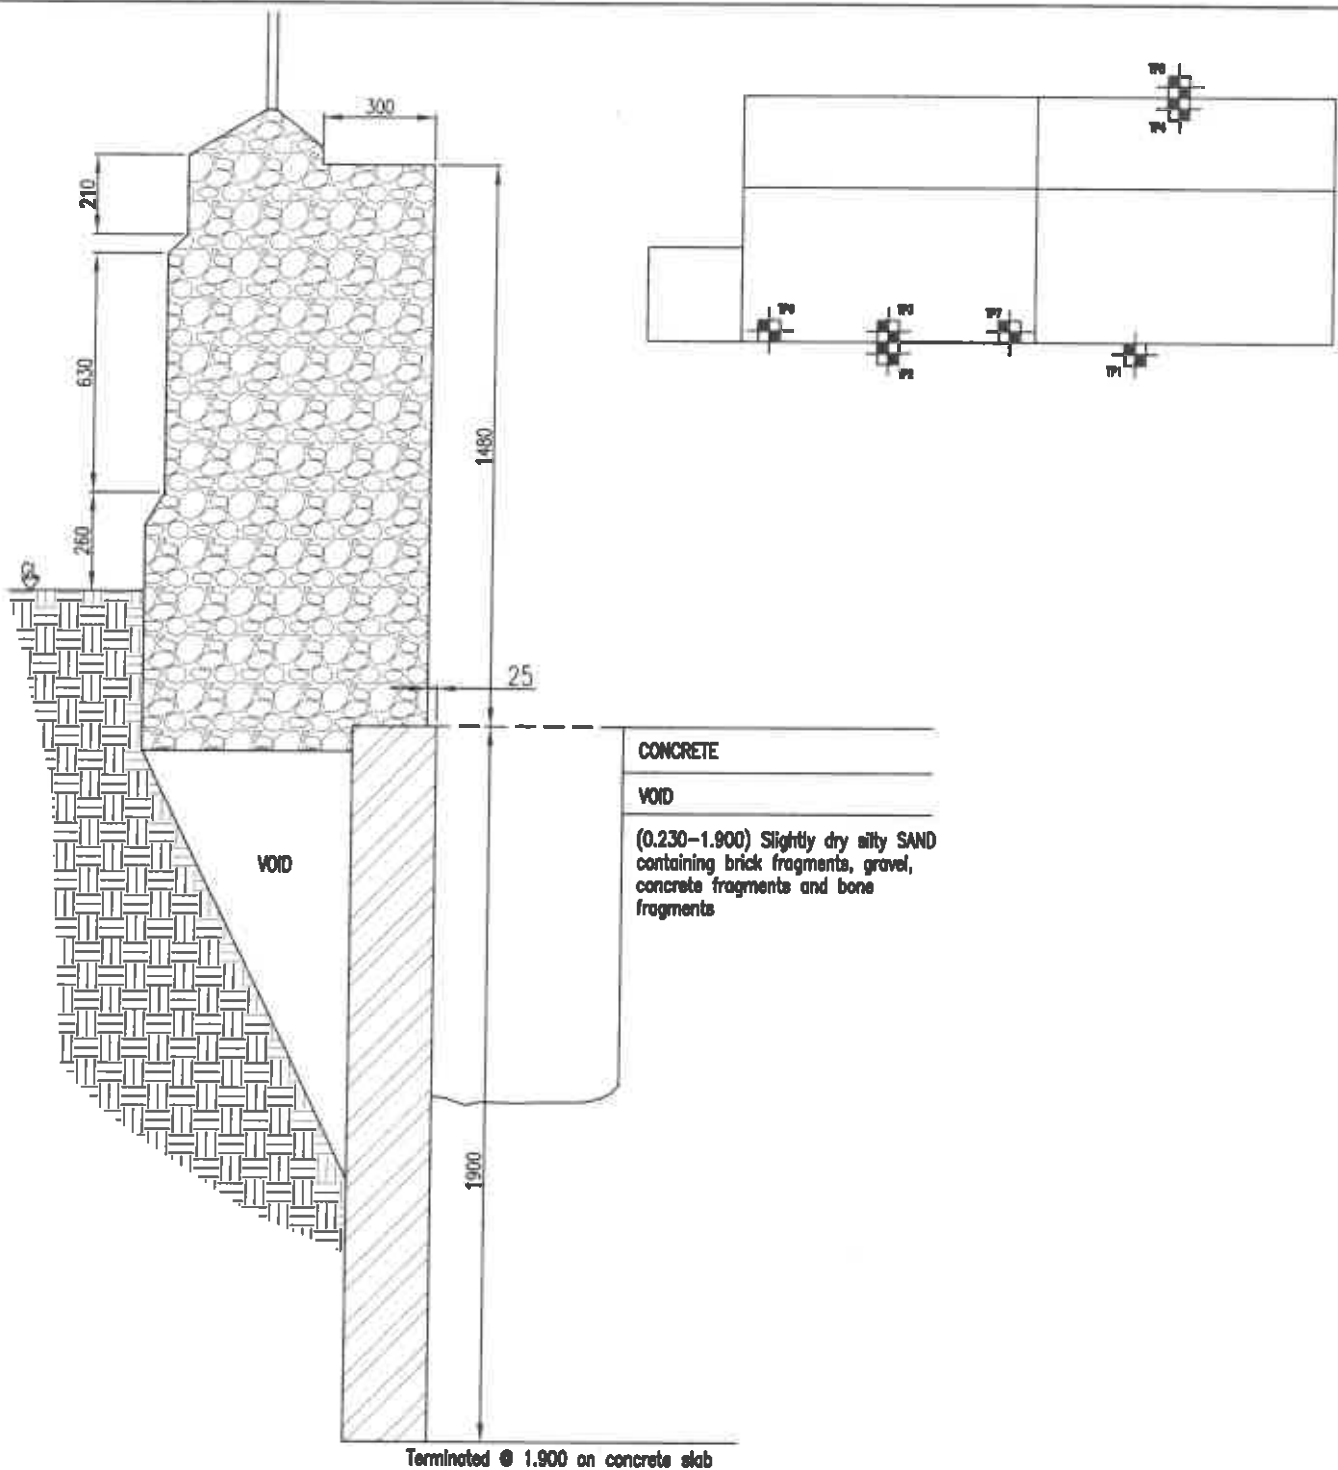
TRIAL PIT 3

- 5.05 Trial pit 3 was undertaken internally to the South wall of the nave immediately adjacent the location of trial pit 2 externally. The floor construction of the nave comprises of 120mm thick concrete slab which is poured directly upon a crushed brick sub-base. Against the wall a void of 110mm was noted between the concrete slab and the subgrade beneath. Directly beneath floor level the wall continued with its internal face consisting of red bricks laid in a lime mortar. This continued to 1.9m below finished floor level. These appeared well laid with consistent jointing in what appeared to be Flemish bond. At the base of this wall there was a concrete foundation or slab upon which the wall is situated. The wall can be confirmed as being 215mm or 9 inches thick and projects beyond the inner finished face of the main wall of the church by 25mm.

- 5.06 Material beneath the concrete slab comprised mainly of dry brown clayey silty sand with concrete and brick fragments and from approximately 600mm below finished floor level bones and bone fragments were encountered.

- 5.07 The wall above floor level was also exposed to determine its composition and this can be confirmed as being of more traditional walling associated with church structures comprising flints and clunch stone set in lime based mortars. From this exposure it can be noted that there appeared to be possibly up to three render coats on the internal wall of the church providing an overall thickness of approximately 60mm. The most recent of these and thickest appears to be a sharp sand cement mix.

- 11.03 The floor within the Nave has suffered movement and failure in places and from our investigations voids can be seen. Some of these voids are associated with the presence of what we consider to be an old tomb or crypt which appears to have been indiscriminately backfilled. We would recommend that the floor either be replaced or stabilised in a similar manner to external walls using a polyurethane injection procedure.

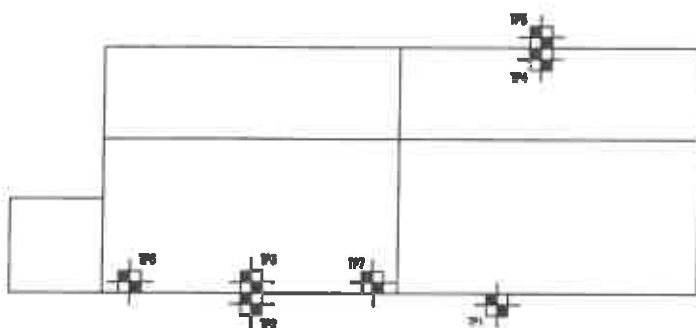
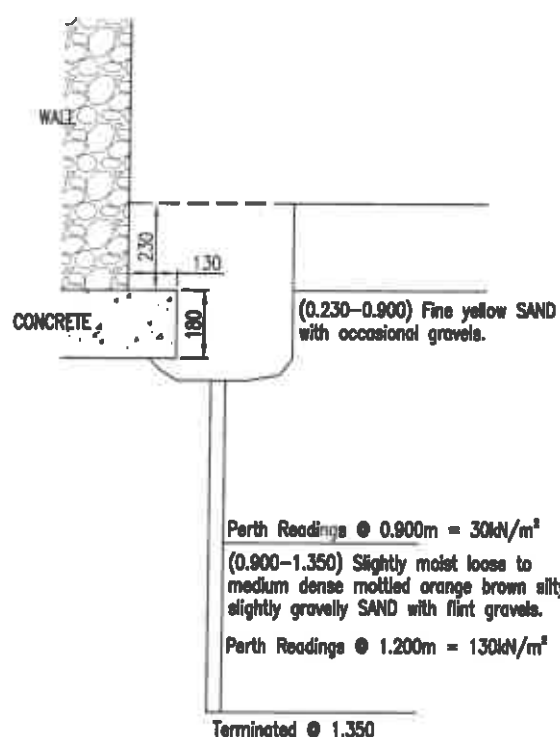
TRIAL PIT 4

- 5.09 Trial pit 4 was undertaken internally within the North aisle adjacent to the chancel. An external hole (see trial pit 5) was dug to the external aspect in order to provide a cross section representation of this area. Internally a concrete strip foundation was exposed, situated 230mm below finished floor level with a toe projection of 130mm at an overall thickness of 180mm. This was founded on the following material: -

- 5.10 At this location the insitu bearing capacity of the subsoils were established with the use of a Perth Penetrometer. Material directly below foundation depth provided readings of approximately 40kN/m² increasing to approximately 120kN/m² at 1m depth and continuing with similar values beyond this.

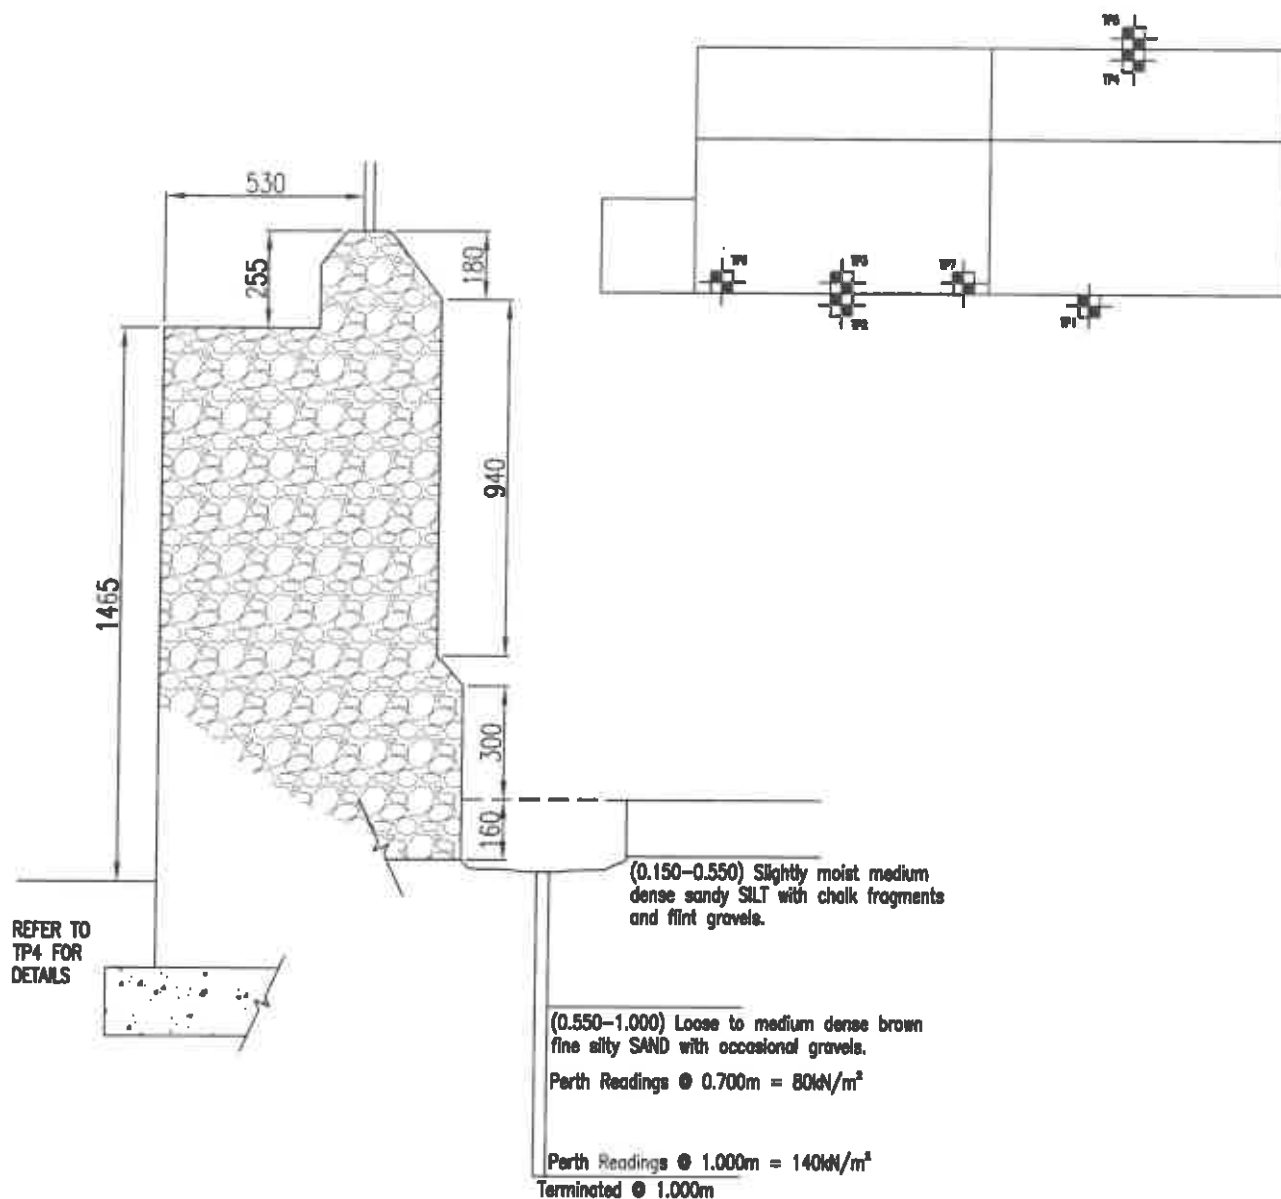
TRIAL PIT 5

- 5.11 Trial pit 5 was excavated externally against the North Aisle adjacent trial pit 4. This proved a plain flint and mortar foundation to extend only 160mm below external ground level. This was founded on the following materials: -

- 5.12 The borehole was terminated at 1.5m depth and insitu strength testing was undertaken with the use of a Perth Penetrometer. This recorded values in the region of 100kN/m² at approximately 600mm increasing gradually to approximately 140kN/m² at 900mm and continuing to a greater depth with similar values.

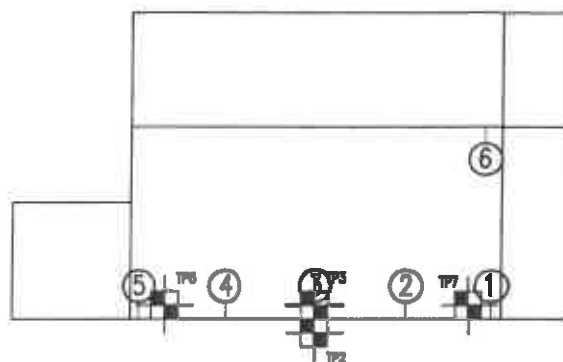
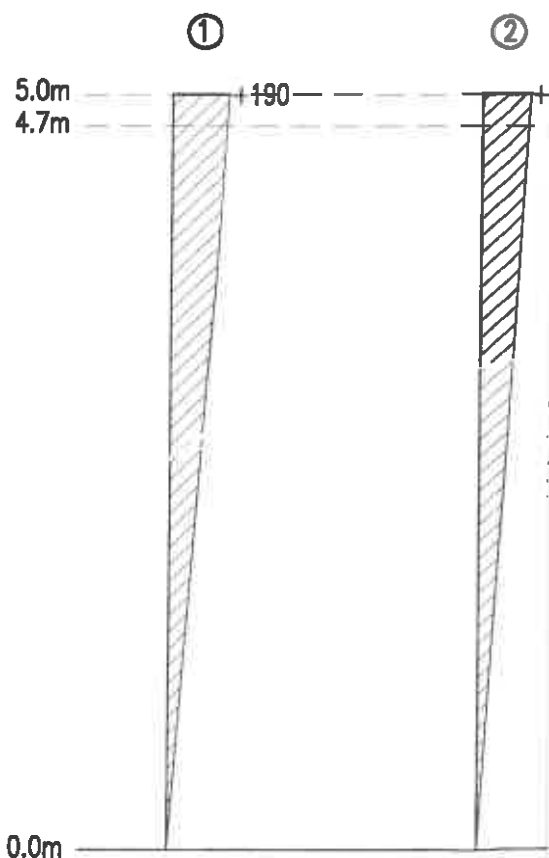
PLAN SHOWING VERTICALITY RE

- 6.01 As part of the investigative works a verticality survey of the South wall to the nave was undertaken. Verticality readings were taken at intermittent positions to the South wall of the nave to a height of 5m. The first reading was taken to the eastern end of the wall progressing westward, terminating at position number 5 abutting the tower.
- 6.02 Readings confirm that rotation of the wall has occurred and that this is most significant to the eastern end and reduces at a relatively constant rate toward the West. Maximum distortion is recorded at 190mm over 5m height reducing to 150mm, 120mm, 60mm and 45mm at successive points. Readings are presented on drawing number IG09/309/SK07 in Appendix C.

- 6.03 At the maximum point of rotation, that being to the eastern end of the wall a further verticality was taken to the opposing North wall at the same location. To this North side rotation of 130mm was recorded at a height of 4.7m. This is clearly not as significant as that occurring to the Southern wall.

- 9.06 Rotational movement of the Nave walls is not as dramatic as it would visually appear. The maximum distortion recorded was measured as 190mm over its height. Given the construction thickness this does not represent movement sufficient to cause instability issues. It can therefore be concluded that the walls are currently stable.

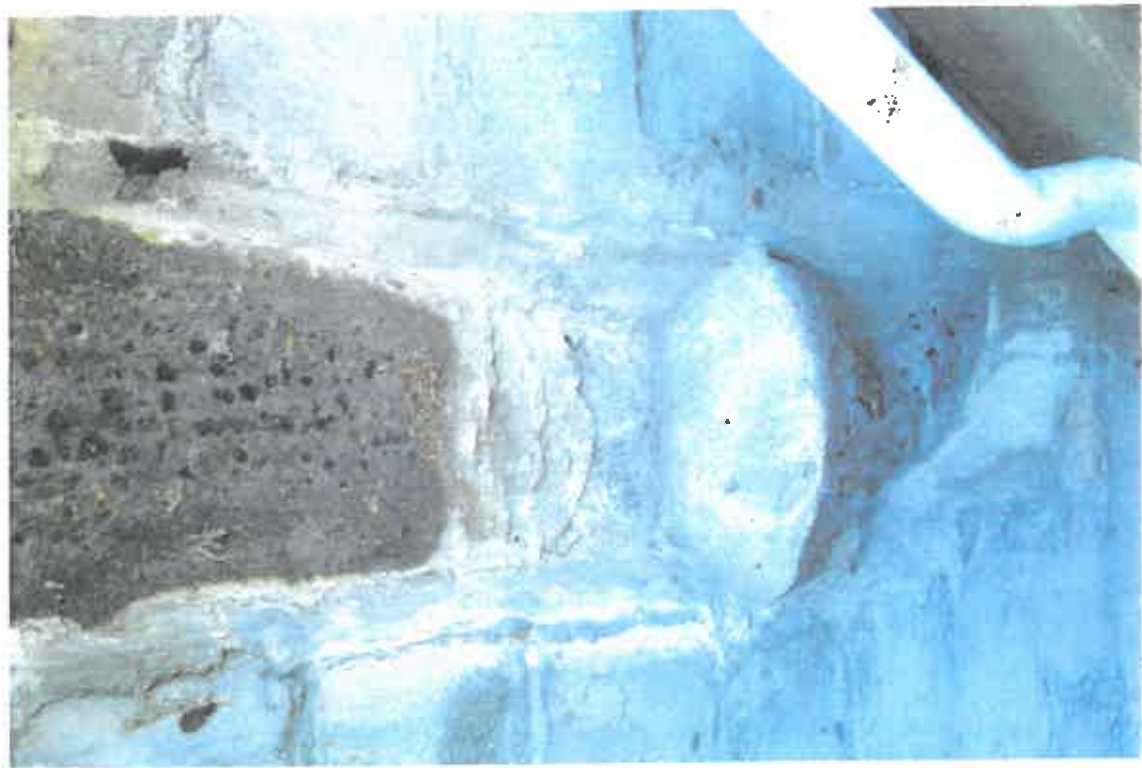
RWP 1

- 7.04 Surface water drainage comprises of seven rainwater down pipes all of which are considered to connect to soakaways. Rain water pipes 1 and 2 are considered to connect to a soakaway located somewhere in close proximity to the church.

- 11.09 We would recommend that the remainder of soakaways serving the rainwater pipes to the South side of the church and to the North aisle are excavated, grubbed out and replaced with a modern soakaway system, which may require design for acceptance by the local authority.

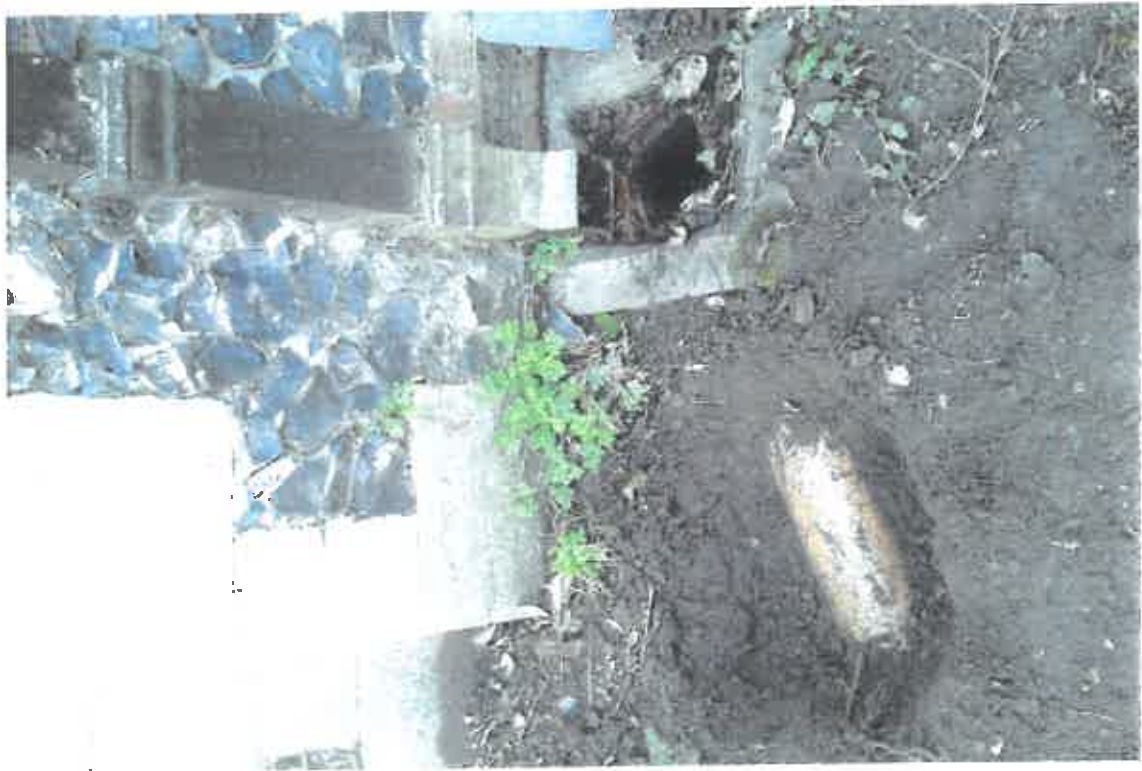
RWP 3

- 7.05 Rainwater pipe 3 discharges to a soakaway measured as being 1.8m from the gully. It is considered that rainwater pipe 4 to the rear which discharges directly into pipework below ground may be linked to this soakaway also, although this underground drain was found to be full of soil and debris and totally ineffective.
