# *Building Survey Report*

**Plymouth MARJON University**

Plymouth Studio School, 140 Plymbridge Lane, Plymouth, PL6 8DD

August 2022

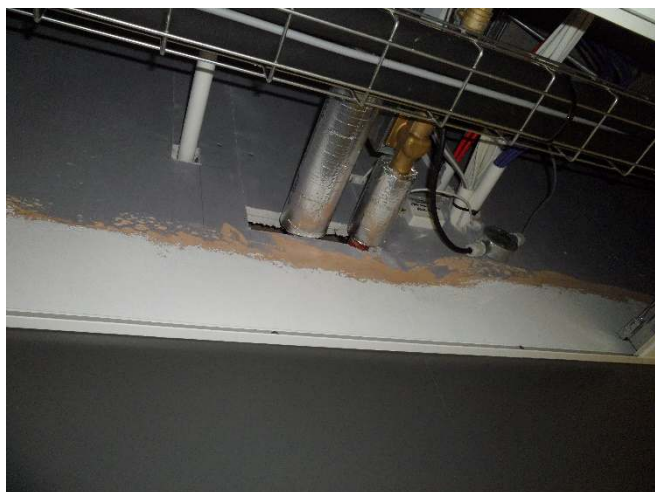
- (v) From our visual inspection, within the classrooms, there were isolated inadequacies with fire stopping due to service penetrations above the suspended ceiling and we recommend that the ceiling voids are reviewed and any

19. Un-stopped service penetrations

| (xiii) | From our visual inspection, within the classrooms, there were isolated inadequacies with fire stopping due to service penetrations above the suspended ceiling and we recommend that the ceiling voids are reviewed and any service penetrations that are not provided with fire stopping are provided with an intumescent foam seal or similar. | Purchaser | |

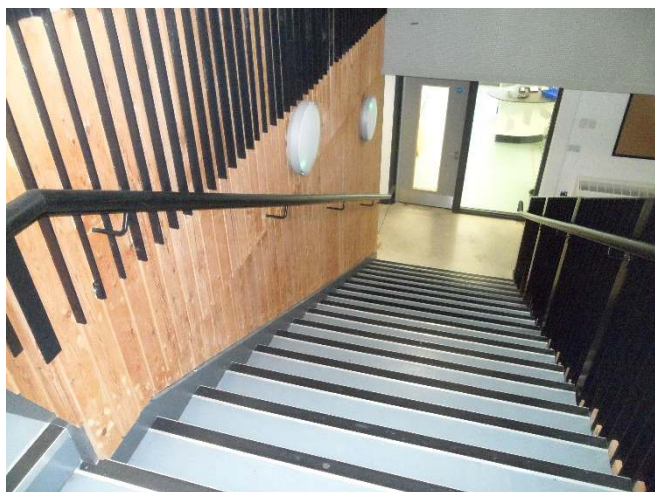
- (i) The rubberised coating to the main staircase is deteriorated and will require redecoration in the short term.
- (ii) Isolated cracking was noted between the individual segments to the means of escape staircase and although superficial in nature should be infilled during the next cyclical round of redecoration.
- (iii) No other defects were noted to the existing staircases.

23. Main stairs

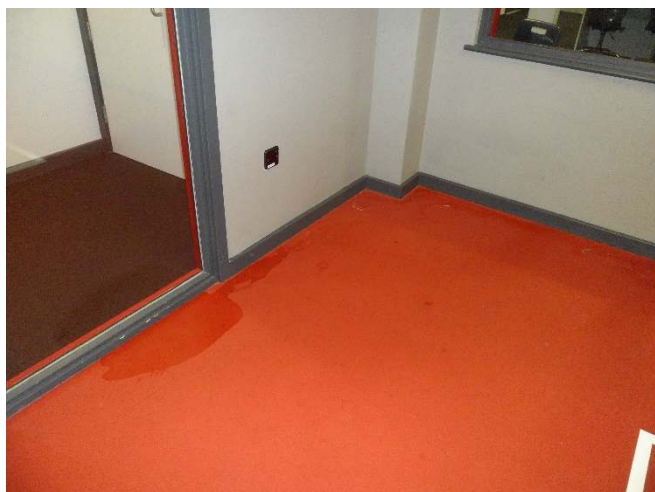
27. Staining to gym floor

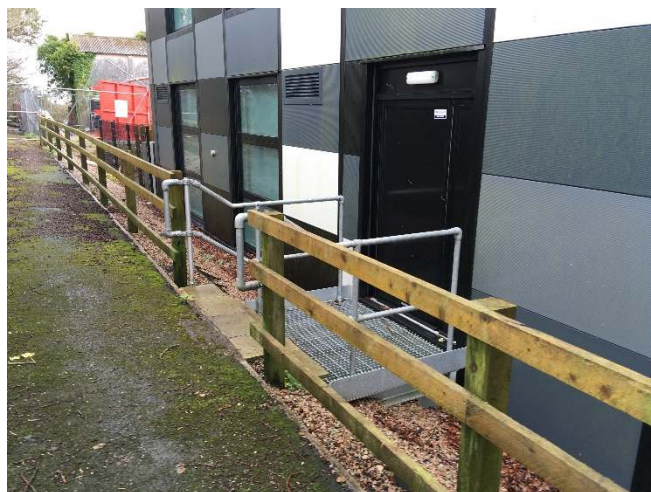
- (i) The existing external areas were found to be in a generally satisfactory condition with no significant defects noted. That said, the existing kitchen discharges over a galvanised metal grate to an adjoining footpath and we could not determine from our visual inspection the ownership of this footpath and whether any easements or rights of way exist to traverse the footpath in order to gain access and egress from the escape point.
- (ii) Weed growth was noted to the building perimeter and this should be sprayed with biocide.
- (iii) A cracked coping was noted to the access ramp and this should be replaced.
- (iv) We recommend that the vendor removes the previous occupier's trade signage to the building perimeter and totum prior to your acquisition.
- (v) Soft landscaping was generally found to be overgrown and will require tending as part of a proactive maintenance regime.

28. Means of escape from kitchen
