gleeds

Client Name	The National Museum of the Royal Navy (NMRV)
Client Address	HMS Naval Base (PP66), Portsmouth, PO1 3NH
Property Address	Fleet Air Arm Museum, RNAS Yeovilton, Ilchester BA22 8HT
Date of Inspection	09 March and 23 March 2021
Surveyor Involved	Claire Ramsay MRICS, Associate Director, Gleeds
Other Consultants	Amanda McLoughlin – Promode Building Services Consultants Limited
Involved	Graham Crisp – Promode Building Services Consultants Limited
Weather Conditions	Weather conditions at the time of survey were clear and dry.
Brief and Scope	This Planned Maintenance Programme was prepared under instruction from NMRN. The report is intended to provide an assessment of the condition of the various components of the property / properties and an indication of the likely works required in the future.
	Budget costs are provided to assist with future cost planning. These costs are provided as budget costs only and are not subject to detailed design or open market tendering.

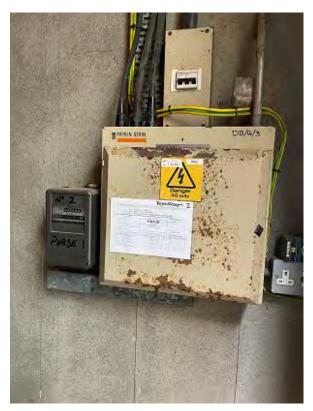
2 Museum Building office lighting
