## REFURBISHMENT SURVEY FOR ASBESTOS-CONTAINING MATERIALS

**CLIENT:** National Museums Liverpool

**SITE:** Juniper Street 1, Juniper Street, Liverpool, L20 8EL

**TYPE OF SURVEY:** Refurbishment

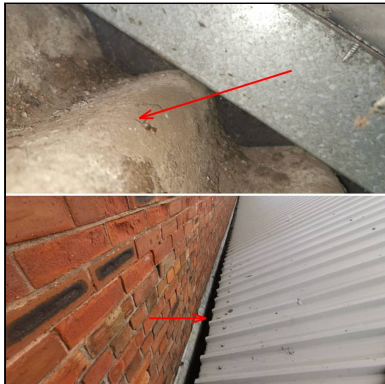
Assessment details				Comments	Photograph
Building	Juniper Street 1	Floor/ room	External / Roof B	Area covers 2no roofs which form area of roof B

Assessment no.	0001	Accessibility	Occasionally likely to be disturbed		
Material Risk					
Identification	Identified	Condition	Low Damage		
Extent	1400m²	Asbestos Type	Chrysotile		
Location/ position	Profiled cement sheets to roof below profiled metal				
Surface treatment	Surface Sealed				
Product type	Cement				
Material risk	Very low	Material risk score	4		
Action	Remove

In the areas where the survey was undertaken with regard to refurbishment of the survey site area, the recommendation is that all asbestos containing materials are removed from site prior to refurbishment in compliance with the Control of Asbestos Regulations 2012.

Although the asbestos material is a non-licensed asbestos product any work upon, or removal of, the material will need to be done by competent persons and items removed disposing of as asbestos waste. Removal of non-licensed asbestos materials may require notification to the relevant enforcing authority prior to works being carried out.
