Asbestos Management Survey Report

Survey, Sampling and Assessment of Asbestos Containing Materials

At
MRCC Liverpool
Hall Road West
L23 8SY

Report Reference Number: AP000499-01-003

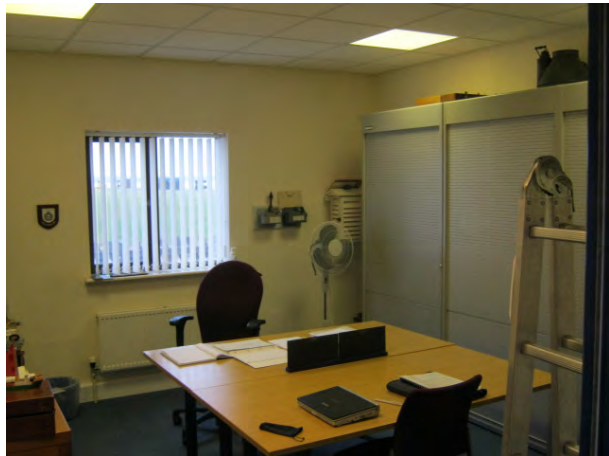
Sample Information	
Site Name/Building Name	MRCC Liverpool / Maritime Rescue Co-ordination Centre
Location	Room 0.3 Exam Room, 0.2 Room next to reception, Room 0.4 Exam Room
Floor	Ground
Position	Throughout - See Comments
Int/Ext	Int
Description	No suspect ACM detected
Product Type	
Extent (actual)	No Asbestos Detected
Identification	No Suspect ACM
Sample Ref	No Sample Taken
Visually Similar to Sample

Material Risk Assessment	As Per HSG 264
Product Category	0 - Non Asbestos
Damage/Deterioration	0 - No Visible
Surface Treatment	0 - Not Applicable
Asbestos Type(s)	0 - No Asbestos Detected
Material Score	0
Material Risk Category	Non asbestos

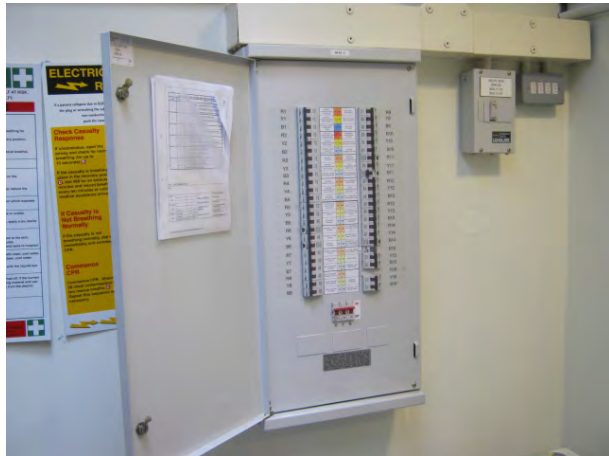
Sample Information	
Site Name/Building Name	MRCC Liverpool / Maritime Rescue Co-ordination Centre
Location	Room 0.11 Large Meeting Room
Floor	Ground
Position	Wall mounted trip switch box
Int/Ext	Int
Description	No suspect ACM detected
Product Type	
Extent (actual)	No Asbestos Detected
Identification	No Suspect ACM
Sample Ref	No Sample Taken
Visually Similar to Sample

Material Risk Assessment	As Per HSG 264
Product Category	0 - Non Asbestos
Damage/Deterioration	0 - No Visible
Surface Treatment	0 - Not Applicable
Asbestos Type(s)	0 - No Asbestos Detected
Material Score	0
Material Risk Category	Non asbestos

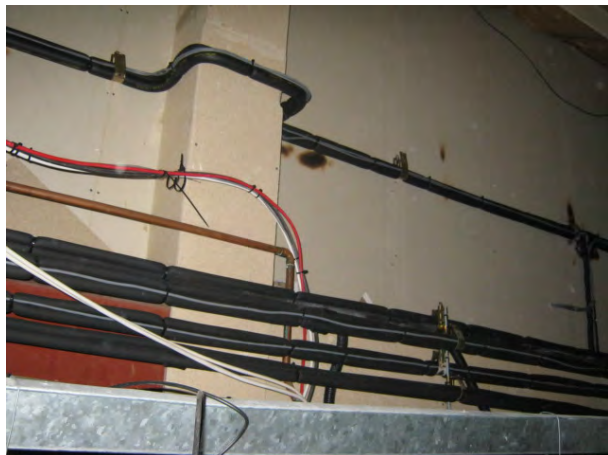
Sample Information	
Site Name/Building Name	MRCC Liverpool / Maritime Rescue Co-ordination Centre
Location	Room 0.27 Corridor
Floor	Ground
Position	Ceiling void above MMMF suspended ceiling tiles - to RSJs and steel supports.
Int/Ext	Int
Description	Vermiculite Boarding
Product Type	Insulating Board
Extent (actual)	50.00 m ²
Identification	Sampled
Sample Ref	AP000499-01-003/0009
Visually Similar to Sample

Material Risk Assessment	As Per HSG 264
Product Category	2 - Insulating Board
Damage/Deterioration	2 - Medium
Surface Treatment	2 - Unsealed Board
Asbestos Type(s)	0 - No Asbestos Detected
Material Score	0
Material Risk Category	Non asbestos

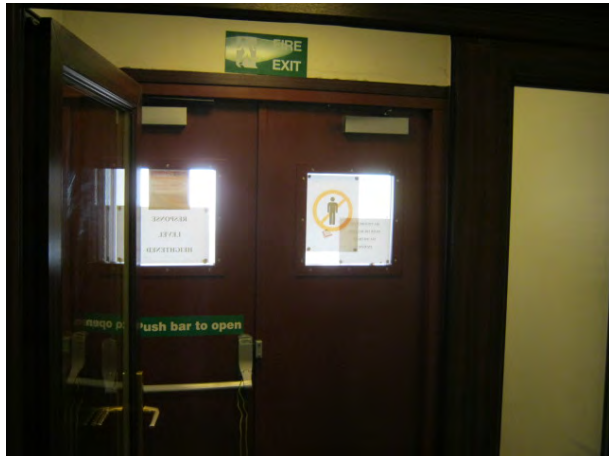
Sample Information	
Site Name/Building Name	MRCC Liverpool / Maritime Rescue Co-ordination Centre
Location	Room 0.15 Porch
Floor	Ground
Position	Throughout - See Comments
Int/Ext	Int
Description	No suspect ACM detected
Product Type	
Extent (actual)	No Asbestos Detected
Identification	No Suspect ACM
Sample Ref	No Sample Taken
Visually Similar to Sample

Material Risk Assessment	As Per HSG 264
Product Category	0 - Non Asbestos
Damage/Deterioration	0 - No Visible
Surface Treatment	0 - Not Applicable
Asbestos Type(s)	0 - No Asbestos Detected
Material Score	0
Material Risk Category	Non asbestos

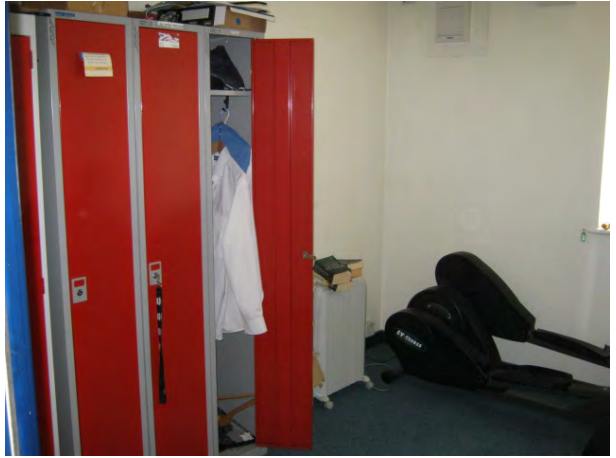
Sample Information	
Site Name/Building Name	MRCC Liverpool / Maritime Rescue Co-ordination Centre
Location	Room 0.13 Locker Room
Floor	Ground
Position	Throughout - See Comments
Int/Ext	Int
Description	No suspect ACM detected
Product Type	
Extent (actual)	No Asbestos Detected
Identification	No Suspect ACM
Sample Ref	No Sample Taken
Visually Similar to Sample

Material Risk Assessment	As Per HSG 264	Priority Risk Assessment	Mean Scores Only, Calculated as per HSG 227.
Product Category	0 - Non Asbestos	Normal Occ Activity	0
Damage/Deterioration	0 - No Visible	Likelihood Disturbance	0
Surface Treatment	0 - Not Applicable	Human Exposure Potential	0
Asbestos Type(s)	0 - No Asbestos Detected	Maintenance Activity	0
Material Score	0	Priority Score	0
Material Risk Category	Non asbestos

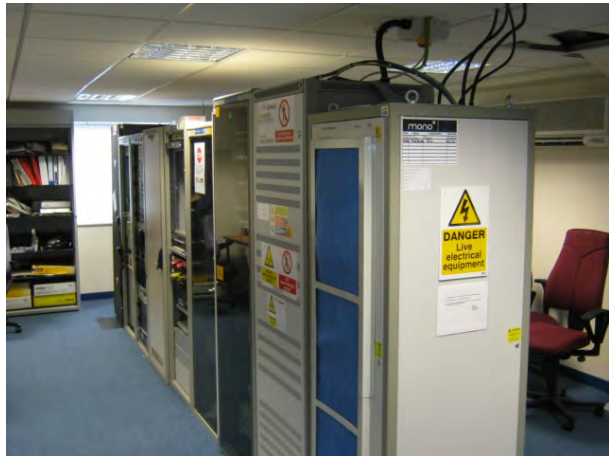
Sample Information	
Site Name/Building Name	MRCC Liverpool / Maritime Rescue Co-ordination Centre
Location	Room 0.12 Radio Room
Floor	Ground
Position	Throughout - See Comments
Int/Ext	Int
Description	No suspect ACM detected
Product Type	
Extent (actual)	No Asbestos Detected
Identification	No Suspect ACM
Sample Ref	No Sample Taken
Visually Similar to Sample

Material Risk Assessment	As Per HSG 264
Product Category	0 - Non Asbestos
Damage/Deterioration	0 - No Visible
Surface Treatment	0 - Not Applicable
Asbestos Type(s)	0 - No Asbestos Detected
Material Score	0
Material Risk Category	Non asbestos

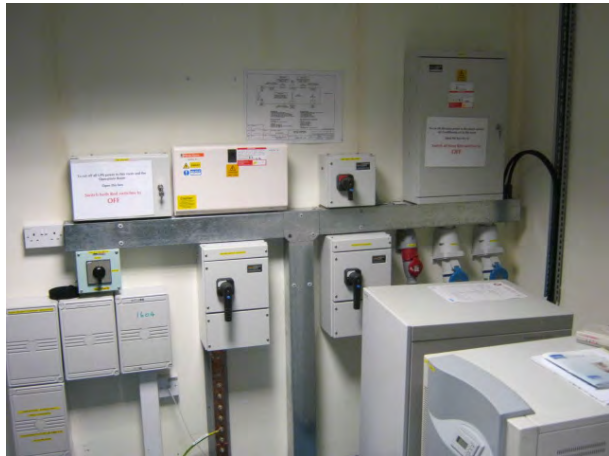
Material Risk Assessment	As Per HSG 264
Product Category	0 - Non Asbestos
Damage/Deterioration	0 - No Visible
Surface Treatment	0 - Not Applicable
Asbestos Type(s)	0 - No Asbestos Detected
Material Score	0
Material Risk Category	Non asbestos

Comments
Modern live installations - all concealed with metal/ plastic panelling/ insulation No visible ACM observed by surveyor
