# Safety Inspection Report

Annual Inspection

## Bonnymead Recreation Ground Playground

25 September 2024

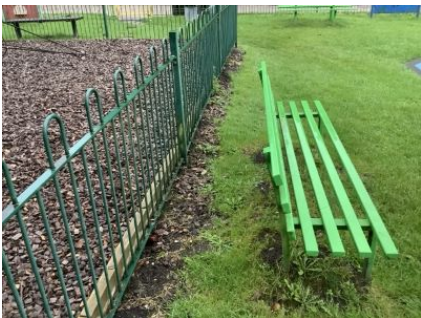
RoSPA recommend a minimum distance of 1 m between seat and fence. This is to reduce the likelihood of children vaulting the fence via the seat.

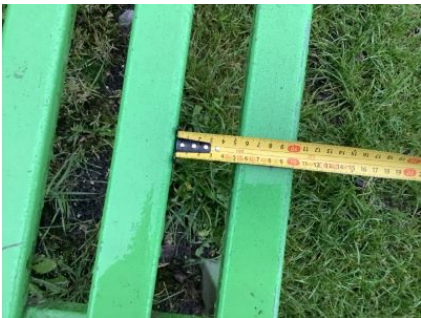
The gaps between the slats exceed 30 mm and are known to cause entrapments.

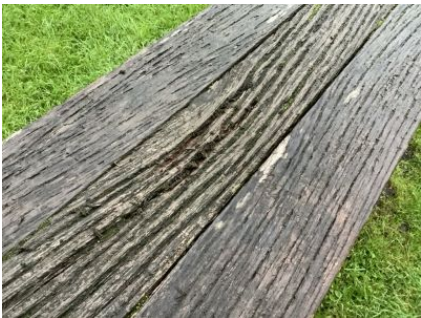
Timber is decayed.

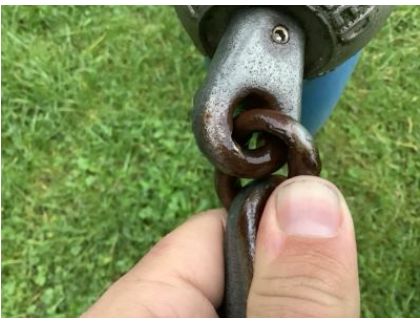
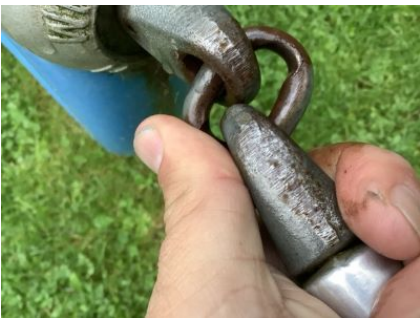
Some chain wear.

Monitor for further deterioration and replace before 40% wear.

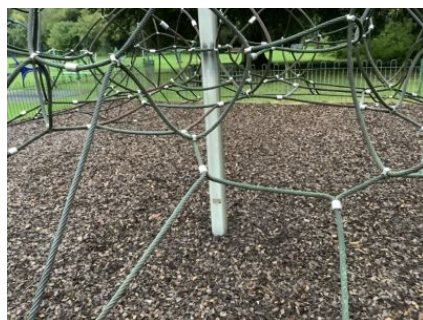
Loose in ground.

## Repair.

Further re-tensioning of unit, will help stability.

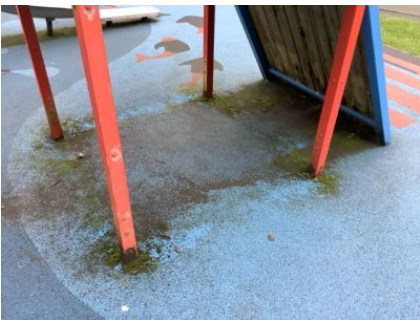
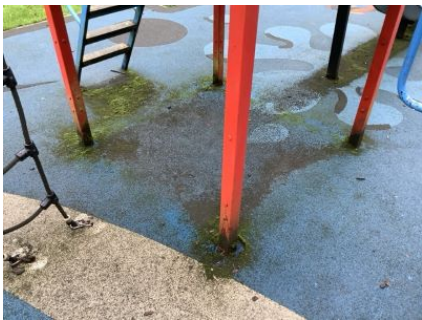
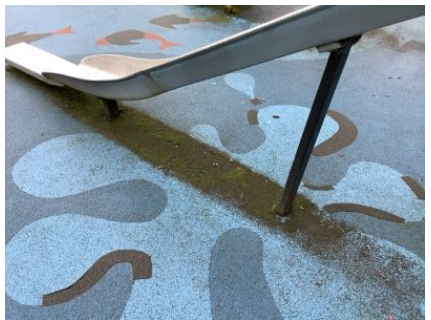
Algae growth giving slippery conditions.

Powerwashing is recommended. Care should be taken to ensure that the material can sustain high pressure washing.

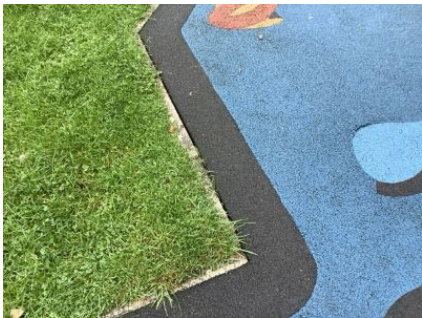
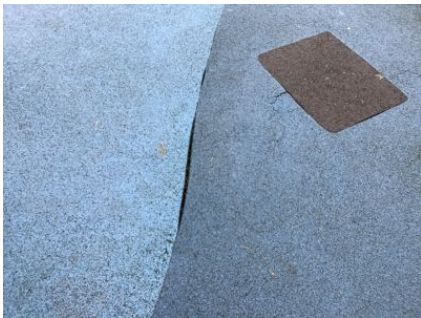
Shrinkage / separation of the surface. This may give a trip hazard.

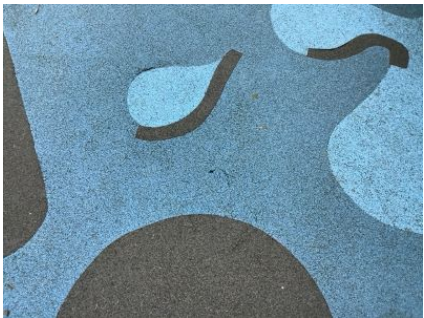
The surface is cracking.

Repair.

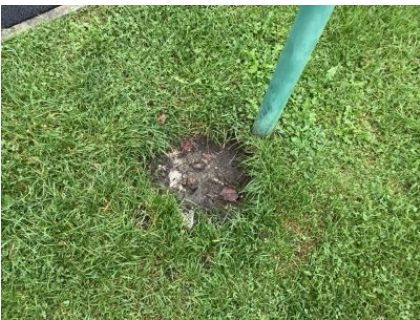
Worn ground areas.

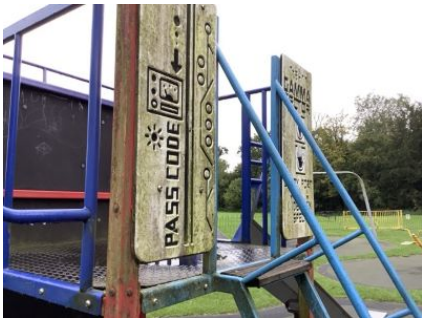
Fixtures loose or missing.

Secondary fixing missing from hand grips.

Replace.

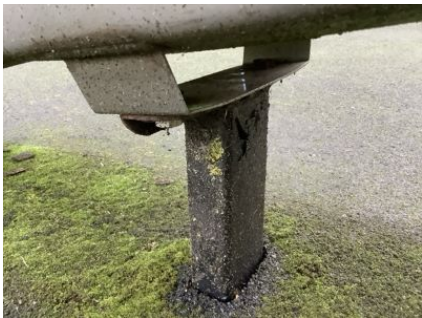
Item is rusting in places.

De-scale back to good metal and coat with lead free paint, using appropriate precautions. Repairs may be necessary where corrosion is severe.

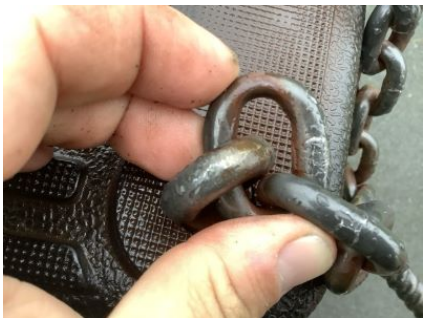
Some chain wear.

Monitor for further deterioration and replace before 40% wear.

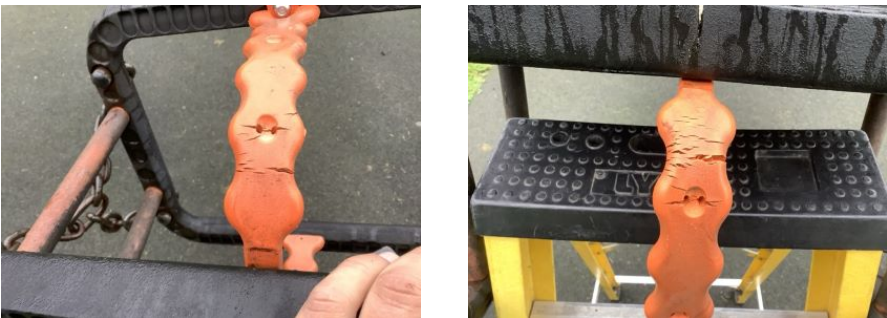
**Description**  
The swing seat has been damaged, but does not require immediate replacement.

**Tasks**  
Monitor and replace when hard material is exposed.

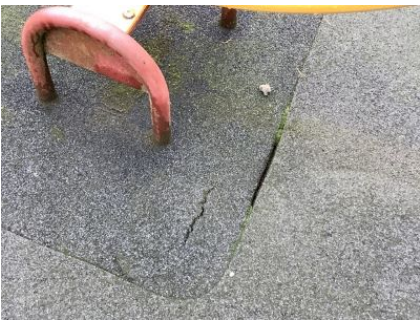
Shrinkage / separation of the surface. This may give a trip hazard.

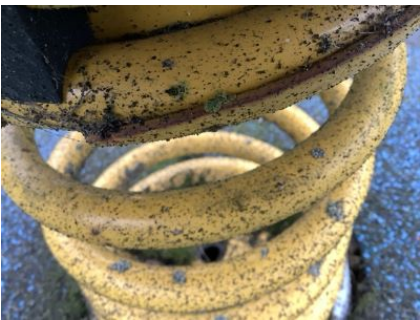
The spring is rusty. These have been known to fail without warning, leading to a collapse of the unit.

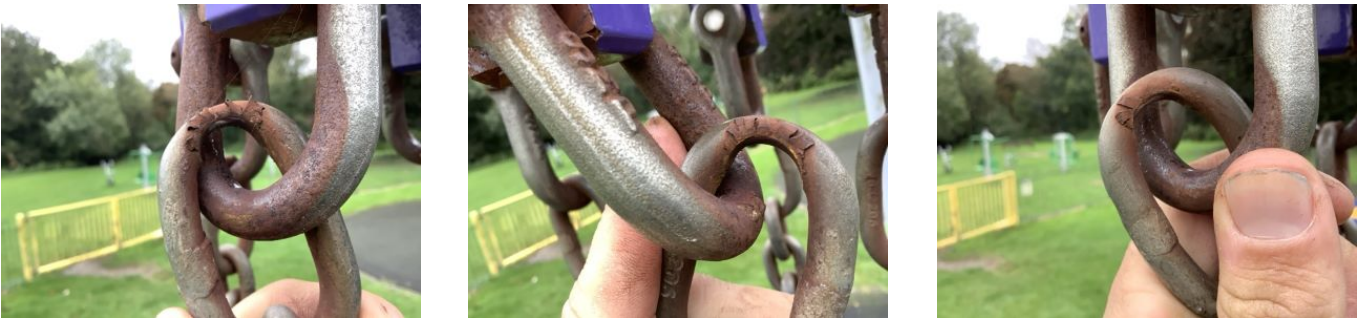
There is considerable wear to the chains.

Replace the worn chains or links.

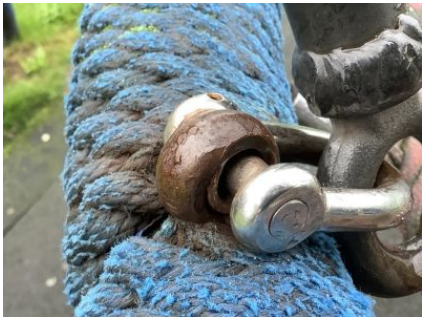
There is wear in the bushes.

Remove shackle bolt and check bush and shackle pin wear, replacing as necessary.

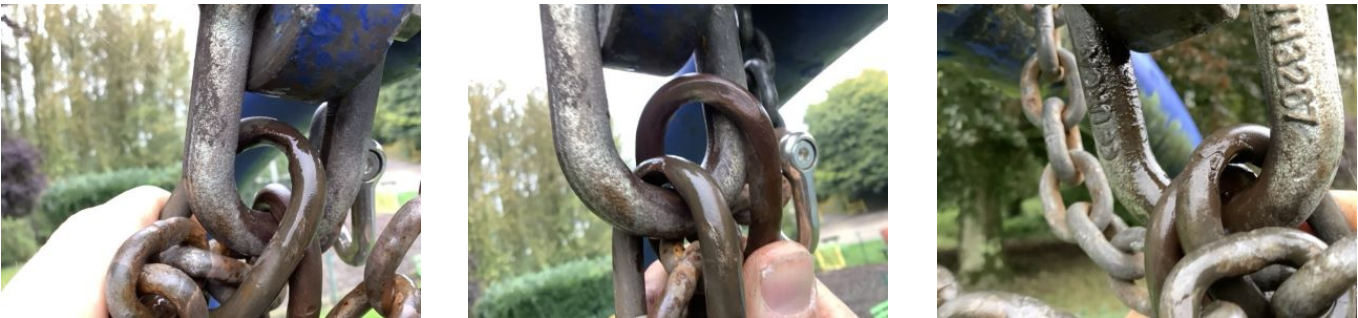
Some chain wear.

Monitor for further deterioration and replace before 40% wear.

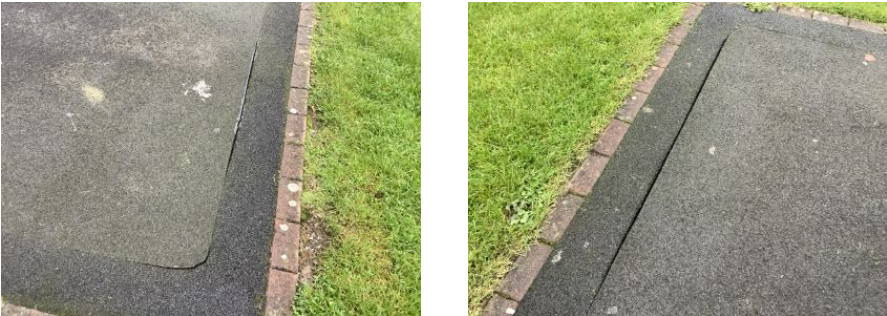
Shrinkage / separation of the surface. This may give a trip hazard.

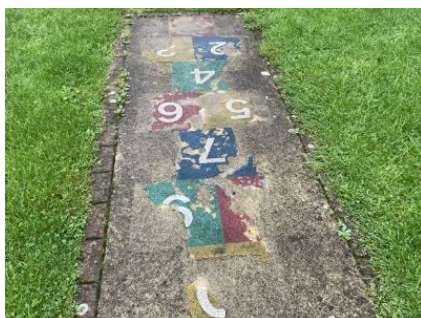
Surface is wearing.

Number squares.

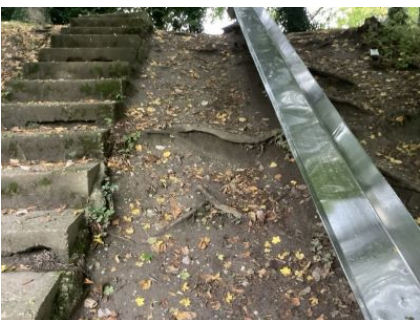
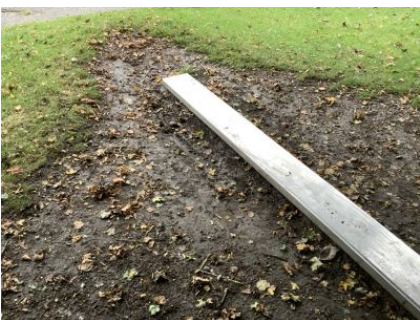
Worn ground areas.

Build up ground levels to remove trip hazard.
