REFURBISHMENT ASBESTOS SURVEY

27th July 2015

AREA 2 CONTRACT – Drainage Refurbishment Survey

**A30 Rawridge
MP: 239/9 – 241/1
N/B and S/B**

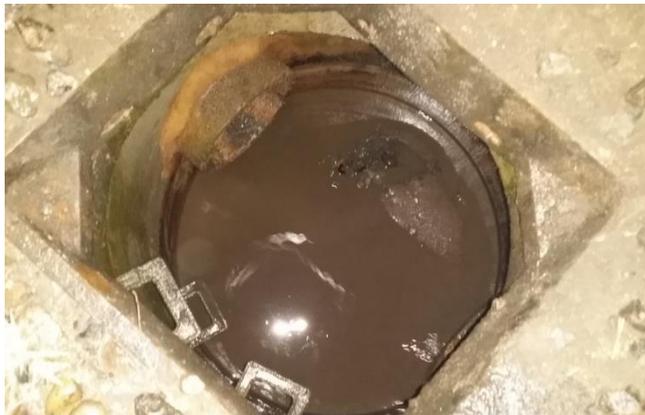
Remarks / Recommended Action: The manholes located between marker posts 239/9 and 241/1 were of the same construction with a concrete carrier drain running through them and a concrete and brick construction surrounding them. No asbestos was located within any of the Manholes.

Photo 01 - Manhole

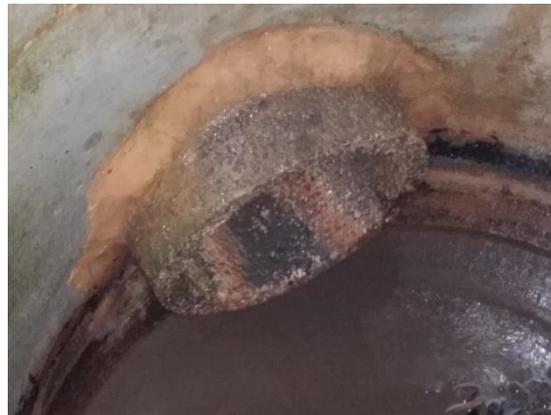
Photo 02 – Concrete Carrier Pipe

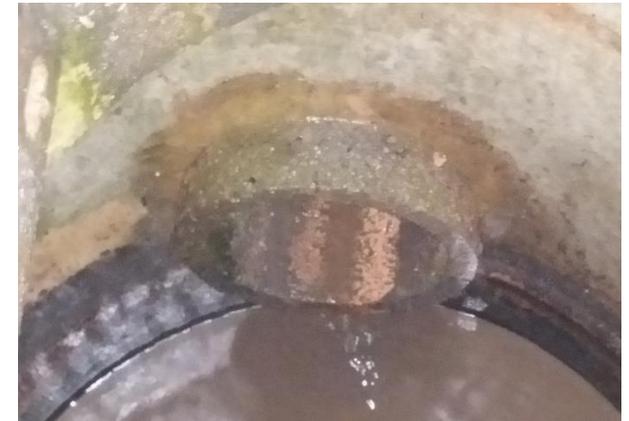
Photo 03 – Concrete Carrier Pipe

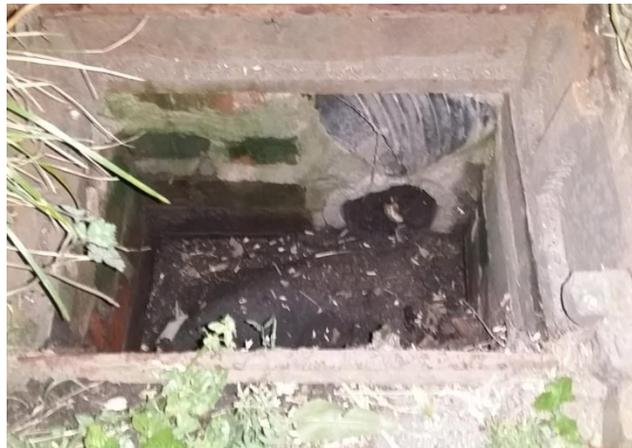
Remarks / Recommended Action: The gullies located between marker posts 239/9 and 241/1 were of the same construction with a concrete outlet pipe below a PVC outlet pipe. No asbestos was located within any of the Gullies.

Photo 04 - Gully

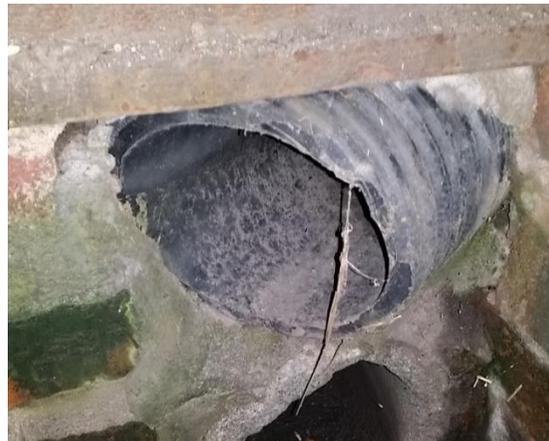
Photo 05 – PVC Pipe

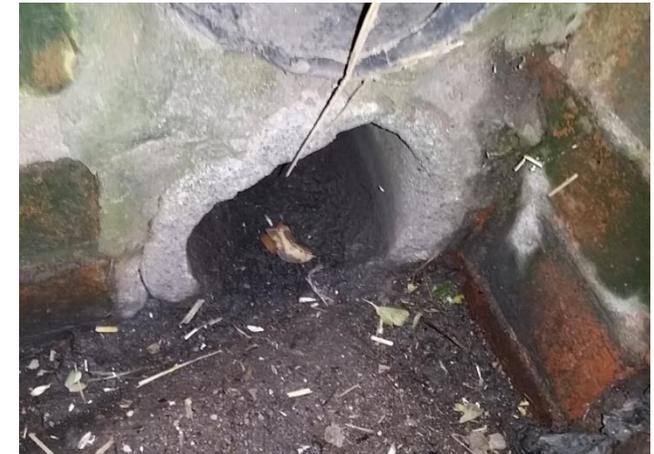
Photo 06 – Concrete Pipe

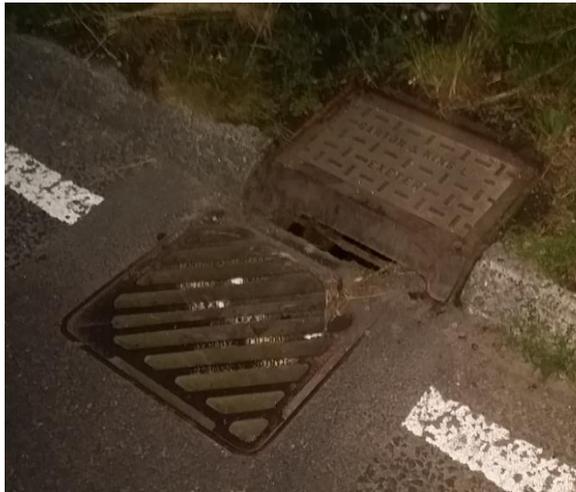
Remarks / Recommended Action: The Catchpits located between marker posts 239/9 and 241/1 were of the same construction with a PVC inlet pipe leading from the Gully and a concrete outlet pipe with a PVC cap leading to the carrier drain within the manhole. No asbestos was located within any of the Catchpits.

Photo 07 - Catchpit

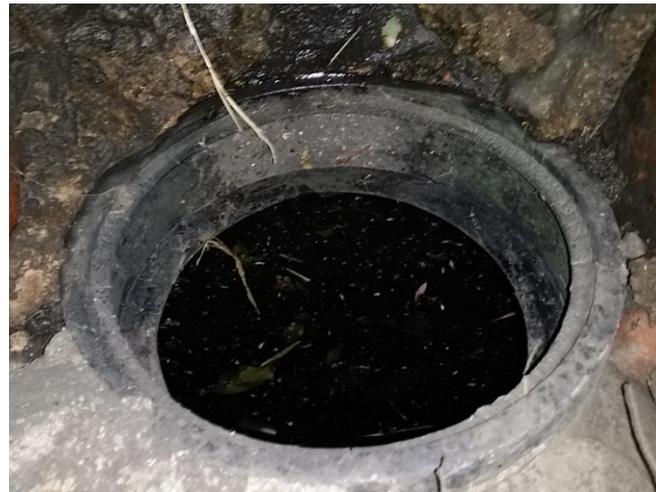
Photo 08 – PVC inlet

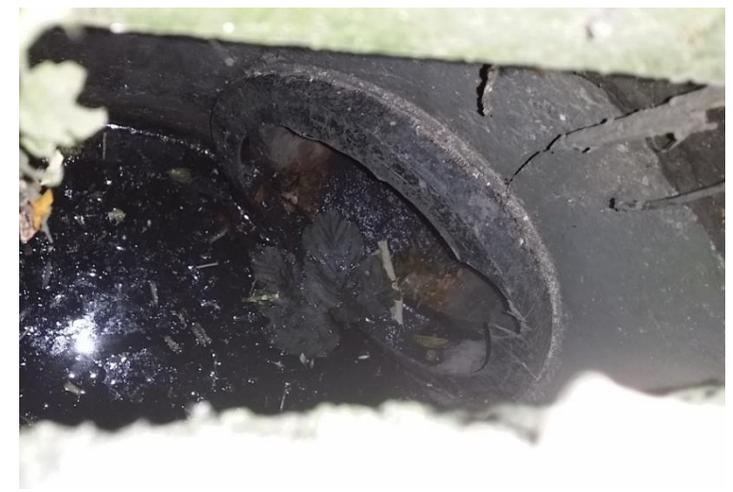
Photo 09 – Concrete Outlet leading to Manhole
