STRUCTURAL REPORT

MJC 4049
Roof Structure Assessment
The Pavillion,
Meadowcroft Community Centre
Addison Crescent, Swindon,
SN27JX

1. Structural Inspection Report

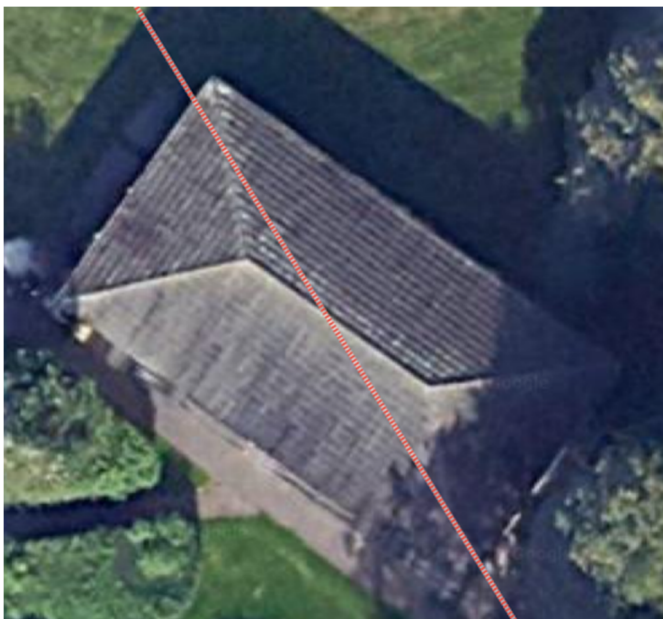
- 3.3 Upon inspection it is evident that the areas proposed for installation extends over the main building. The PV panels proposed to the original main pitched roof of the main building.

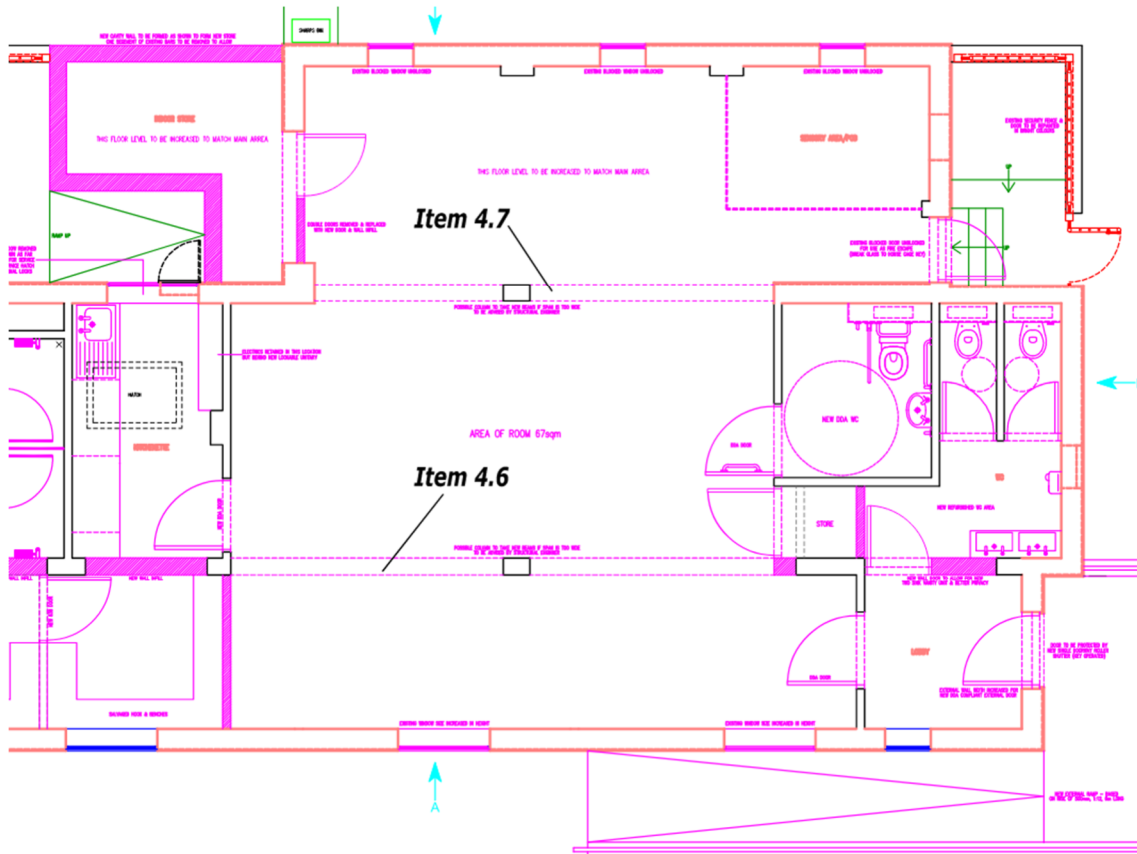
4.6 All the internal wall appeared to be solid 100mm thick, supporting the ceiling joists that span from front to back. Therefore, for the new proposal, a trimmer beam or precast lintel will be required to support the opening.

4.7 The internal solid wall approximate 250mm thick located between the store and the changing room appears to be load bearing wall, supporting the roof truss. Based on the proposed layout; to create opening, steel beam and column will be required to support the existing roof structure.
