Refurbishment Survey For

13 Station Road, Southwold, Suffolk, IP18 6AX

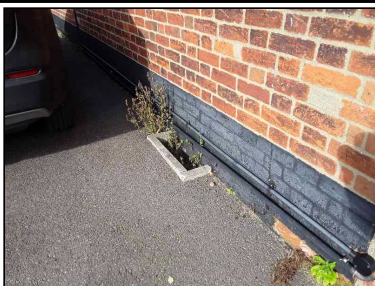
Survey Date:		Lead Surveyor	Survey Type	Floor	Analysis
	9 Mar 2020		Shaun Applegate	Refurbishment Survey	External	No Asbestos Detected
	Building		Room	Item	Quantity	
	Main Building		Elevations .	Low Level Black Paint to Side Elevation .	NQ	
	Item Number	Sample No (S,SP,P,As)	Product Type	Surface Treatment	Condition	Accessibility
	1	SA001663 (S)	N/A	N/A	N/A	N/A
	Material Risk Score					
N/A						
Recommended action		No further action required				
Surveyor comments		Sampled as it is known that some bituminous paints contain asbestos.

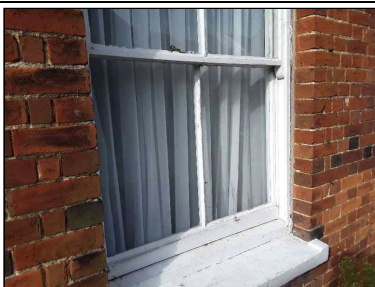
Survey Date:		Lead Surveyor	Survey Type	Floor	Analysis
	9 Mar 2020		Shaun Applegate	Refurbishment Survey	External	No Asbestos Detected
	Building		Room	Item	Quantity	
	Main Building		Elevations .	Window Putty .	Throughout	
	Item Number	Sample No (S,SP,P,As)	Product Type	Surface Treatment	Condition	Accessibility
	2	SA001664 (S)	N/A	N/A	N/A	N/A
	Material Risk Score					
	N/A					
Recommended action	No further action required					
Surveyor comments	Presume same to all where present.

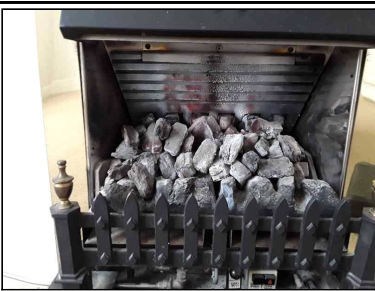
Survey Date:		Lead Surveyor	Survey Type	Floor	Analysis
	9 Mar 2020		Shaun Applegate	Refurbishment Survey	Ground Floor	No Asbestos Detected
	Building		Room	Item	Quantity	
	Main Building		G1 Lounge	Imitation Coal & Back Panel to Gas Fire .	NQ	
	Item Number	Sample No (S,SP,P,As)	Product Type	Surface Treatment	Condition	Accessibility
	3	SA001665 (S)	N/A	N/A	N/A	N/A
	Material Risk Score					
N/A						
Recommended action		No further action required				
Surveyor comments		Not deemed to contain asbestos. This sample was obtained to confirm this presumption & to alleviate any concerns regarding asbestos content.

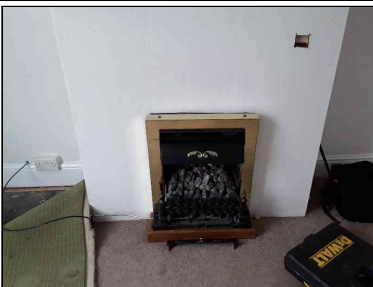
Item Number	Building	Floor	Sample No (S,SP,P,As)	Room/Area	Recommendation
4	Main Building	Ground Floor	Visual (P)	G1 Lounge, Gas Fire - Not Dismantled	D-Presume Asbestos Present

Survey Date:		Lead Surveyor	Survey Type	Floor	Analysis
	9 Mar 2020		Shaun Applegate	Refurbishment Survey	Ground Floor	N/A
	Building		Room	Item	Quantity	
	Main Building		G1 Lounge	Gas Fire - Not Dismantled	1

Item Number	Sample No (S,SP,P,As)	Product Type	Surface Treatment	Condition	Accessibility
	4	Visual (P)	N/A	N/A	N/A	N/A
	Material Risk Score					
N/A						
Recommended action		Any areas/items where inspection access was not obtained must (by default) be presumed to contain asbestos until proven otherwise				
Surveyor comments		Survey protocols dictate that any areas/items where inspection access was not obtained must (by default) be presumed to contain asbestos until definitively proven otherwise. Subsequently, any no access areas or items must be managed or (where required) removed in accordance with ACOP L143, Managing & working with asbestos. Any rooms/areas or suspect materials that could not be accessed will require inspection prior to disturbance, e.g. further sampling/analysis &/or inspection. Any plant & electrical items not dismantled for inspection will need to be managed or removed in accordance with the Regulations. See SECTION 6 for details regarding plant & electrical items & SECTION 9, Recommendations regarding managing & removing asbestos containing materials.

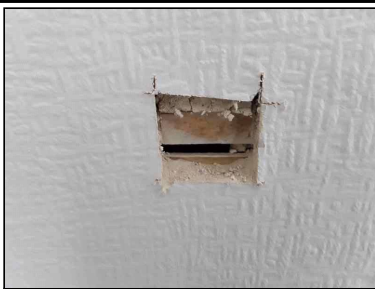
Survey Date:		Lead Surveyor	Survey Type	Floor	Analysis
	9 Mar 2020		Shaun Applegate	Refurbishment Survey	Ground Floor	No Asbestos Detected
	Building		Room	Item	Quantity	
	Main Building		Throughout Where Present .	Original Plaster to Ceilings & Walls .	Throughout	
	Item Number	Sample No (S,SP,P,As)	Product Type	Surface Treatment	Condition	Accessibility
	5	SA001666 (S)	N/A	N/A	N/A	N/A
	Material Risk Score					
N/A						
Recommended action		No further action required				
Surveyor comments		Not deemed to contain asbestos. This sample was obtained to confirm this presumption & to alleviate any concerns regarding asbestos content. Presume same to all where present.

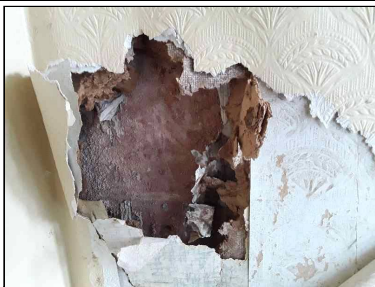
Survey Date:		Lead Surveyor	Survey Type	Floor	Analysis
	9 Mar 2020		Shaun Applegate	Refurbishment Survey	Ground Floor	No Asbestos Detected
	Building		Room	Item	Quantity	
	Main Building		G4 Dining Room	Fibreboard Wall Panelling .	Throughout	
	Item Number	Sample No (S,SP,P,As)	Product Type	Surface Treatment	Condition	Accessibility
	6	SA001667 (S)	N/A	N/A	N/A	N/A
	Material Risk Score					
N/A						
Recommended action		No further action required				
Surveyor comments		Not deemed to contain asbestos. This sample was obtained to confirm this presumption & to alleviate any concerns regarding asbestos content. Presume same to all where present.

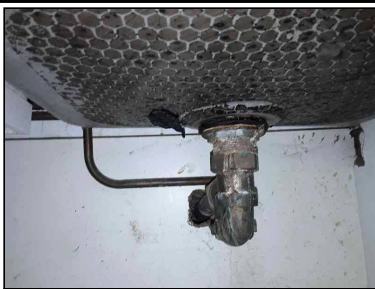
Item No	Building	Floor	Room	Sample No (S,SP,P,As)	Item	Material	Risk assessment Score	Recommendations
7	Main Building	Ground Floor	G5 Kitchen	SA001668 (S)	Bituminous Sink Pad, .	Reinforced Composite	VERY LOW (3)	A-Remove utilising trained & competent personnel

Survey Date:		Lead Surveyor	Survey Type	Floor	Analysis
	9 Mar 2020		Shaun Applegate	Refurbishment Survey	Ground Floor	Chrysotile (1)
	Building		Room	Item	Quantity	
	Main Building		G5 Kitchen	Bituminous Sink Pad .	Small amounts	
	Item Number	Sample No (S,SP,P,As)	Product Type	Surface Treatment	Condition	Accessibility
	7	SA001668 (S)	Reinforced Composite (1)	Completely Sealed (0)	Low Damage (1)	Easily disturbed
	Material Risk Score					
3 (VERY LOW RISK)						
Recommended action		Remove in accordance with ACOP L143, Managing & working with asbestos utilising trained & competent personnel				
Surveyor comments		Mostly removed from sink with a small area remaining & larger area beneath drainer.

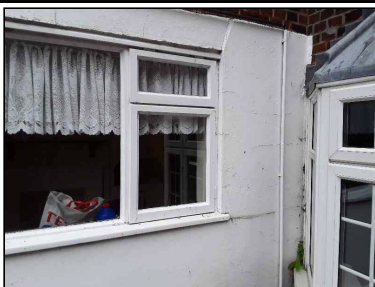
Survey Date:		Lead Surveyor	Survey Type	Floor	Analysis
	9 Mar 2020		Shaun Applegate	Refurbishment Survey	External	No Asbestos Detected
	Building		Room	Item	Quantity	
	Main Building		Elevations .	Textured Paint to Concrete Render .	NQ	
	Item Number	Sample No (S,SP,P,As)	Product Type	Surface Treatment	Condition	Accessibility
	8	SA001669 (S)	N/A	N/A	N/A	N/A
	Material Risk Score					
N/A						
Recommended action		No further action required				
Surveyor comments		Present to concrete render to rear of building.

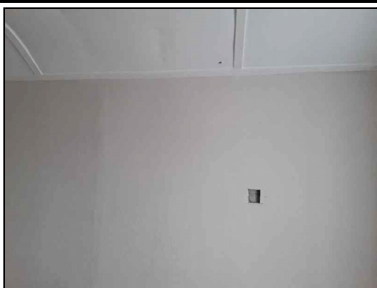
Survey Date:		Lead Surveyor	Survey Type	Floor	Analysis
	9 Mar 2020		Shaun Applegate	Refurbishment Survey	1st Floor	No Asbestos Detected
	Building		Room	Item	Quantity	
	Main Building		F1.1 Rear Bedroom	Fibreboard Panelling to Ceiling & Wall .	NQ	
	Item Number	Sample No (S,SP,P,As)	Product Type	Surface Treatment	Condition	Accessibility
	9	As SA001667 (SP)	N/A	N/A	N/A	N/A
	Material Risk Score					
N/A						
Recommended action		No further action required				
Surveyor comments		Not deemed to contain asbestos. This sample was obtained to confirm this presumption & to alleviate any concerns regarding asbestos content. Presume same to all where present.

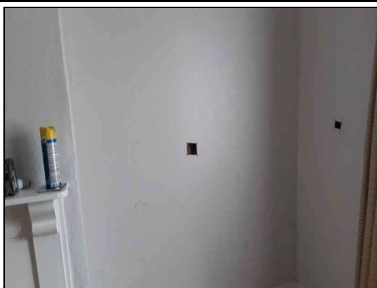
Survey Date:		Lead Surveyor	Survey Type	Floor	Analysis
	9 Mar 2020		Shaun Applegate	Refurbishment Survey	1st Floor	No Asbestos Detected
	Building		Room	Item	Quantity	
	Main Building		F1.2 Middle Bedroom	Fibreboard Panelling to Ceiling & Wall .	NQ	
	Item Number	Sample No (S,SP,P,As)	Product Type	Surface Treatment	Condition	Accessibility
	10	As SA001667 (SP)	N/A	N/A	N/A	N/A
	Material Risk Score					
N/A						
Recommended action		No further action required				
Surveyor comments		Not deemed to contain asbestos. This sample was obtained to confirm this presumption & to alleviate any concerns regarding asbestos content. Presume same to all where present.

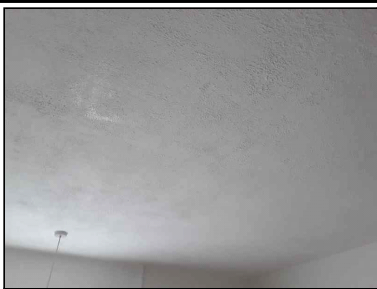
Survey Date:		Lead Surveyor	Survey Type	Floor	Analysis
	9 Mar 2020		Shaun Applegate	Refurbishment Survey	1st Floor	No Asbestos Detected
	Building		Room	Item	Quantity	
	Main Building		F1.2 Middle Bedroom	Textured Coating to Ceiling .	12 m²	
	Item Number	Sample No (S,SP,P,As)	Product Type	Surface Treatment	Condition	Accessibility
	11	SA001670 (S)	N/A	N/A	N/A	N/A
	Material Risk Score					
	N/A					
Recommended action	No further action required					
Surveyor comments	See drawings for orientation.
