ASBESTOS REFURBISHMENT & DEMOLITION SURVEY REPORT

**FOR
THE TIMBER STORAGE SHED
AT
BEACH GARDENS SPORTS PARK**

AUGUST 2017

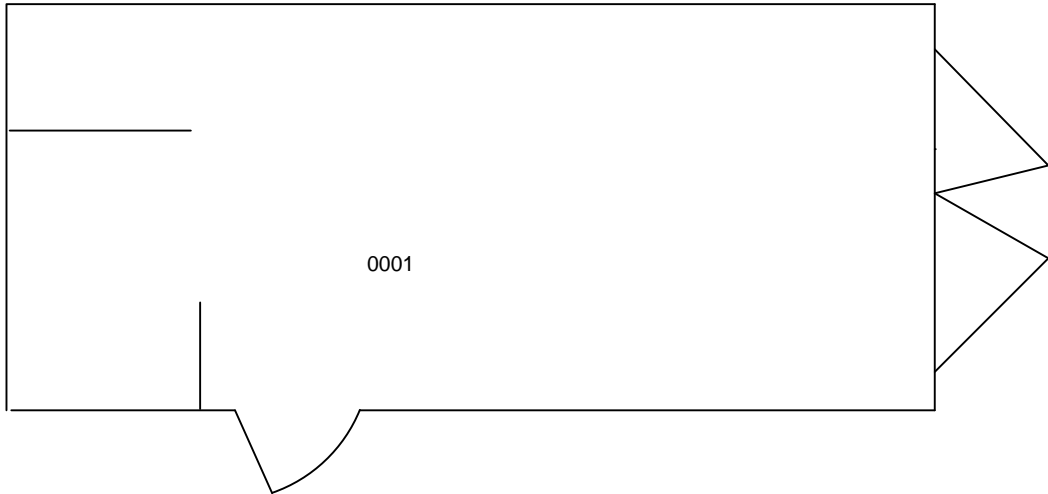
Block A

Building Location Information					Material Information			Comments & Risk Information	
Block	Room	Sample Ref No	Description	Hazard Status	Hazard Location	Material	Sub Type	Recomendations/Comments	RA
A	0001		Storage Shed	Hazard Not Detected				No suspected asbestos containing materials detected	
A	Ext		Storage Shed	Hazard Not Detected				No suspected asbestos containing materials detected

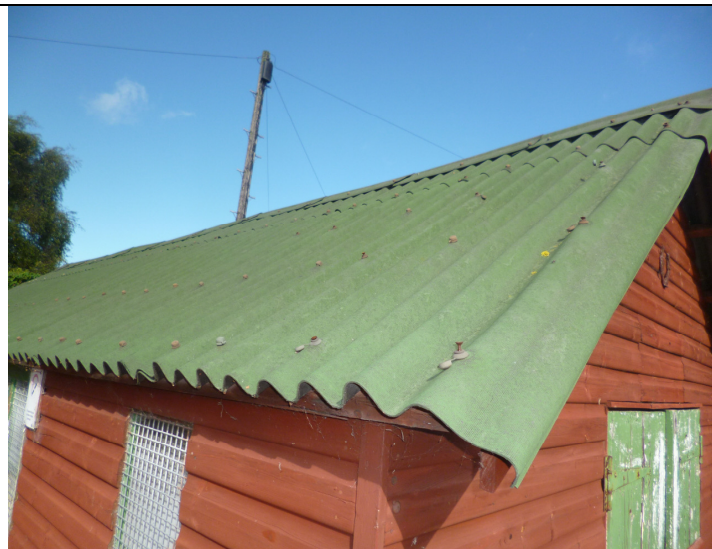
Modern fibre corrugated sheet roofing panels.

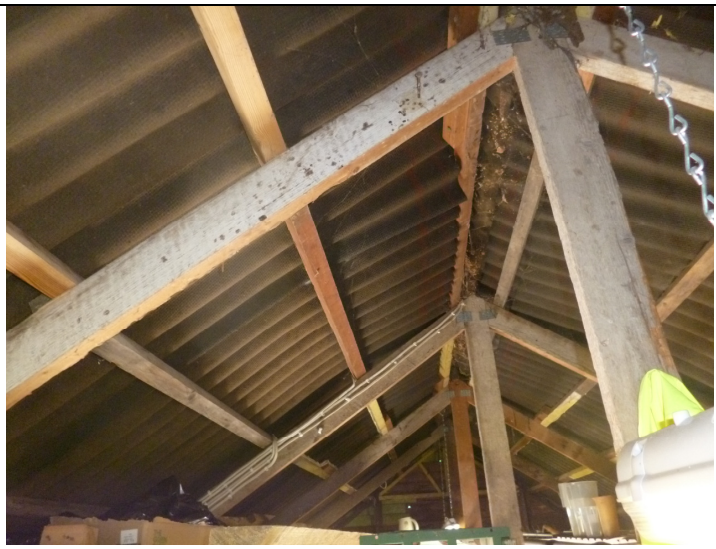
Timber framed roof structure and no sarking felt to underside of roof covering.

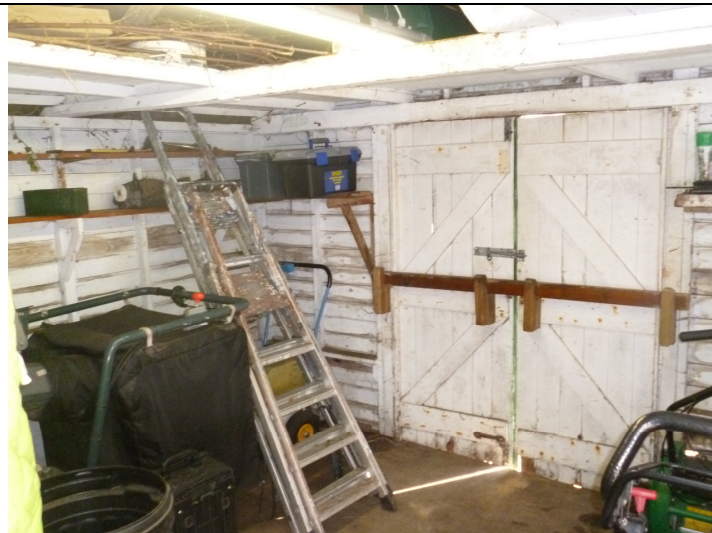
Timber inner wall structure, no wall voids and a solid concrete floor slab.

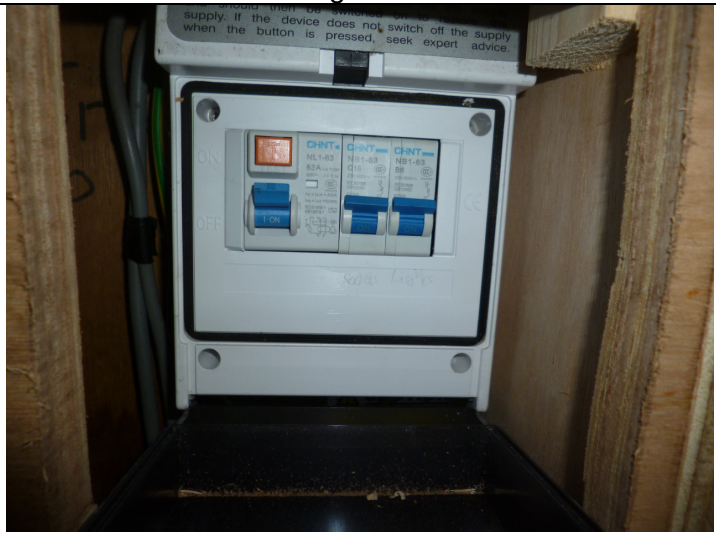
Modern electrical switch gear.
