Our Ref: JB/23/52720/CS

RE: RAVEN HOUSE, ROCKINGHAM ROAD, CORBY

Further to our report dated 29th August 2023, with regards to the subsidence movement noted to the above property, we confirm having carried out the further site investigations by way of trial holes and a CCTV Survey on Monday 18th September 2023.

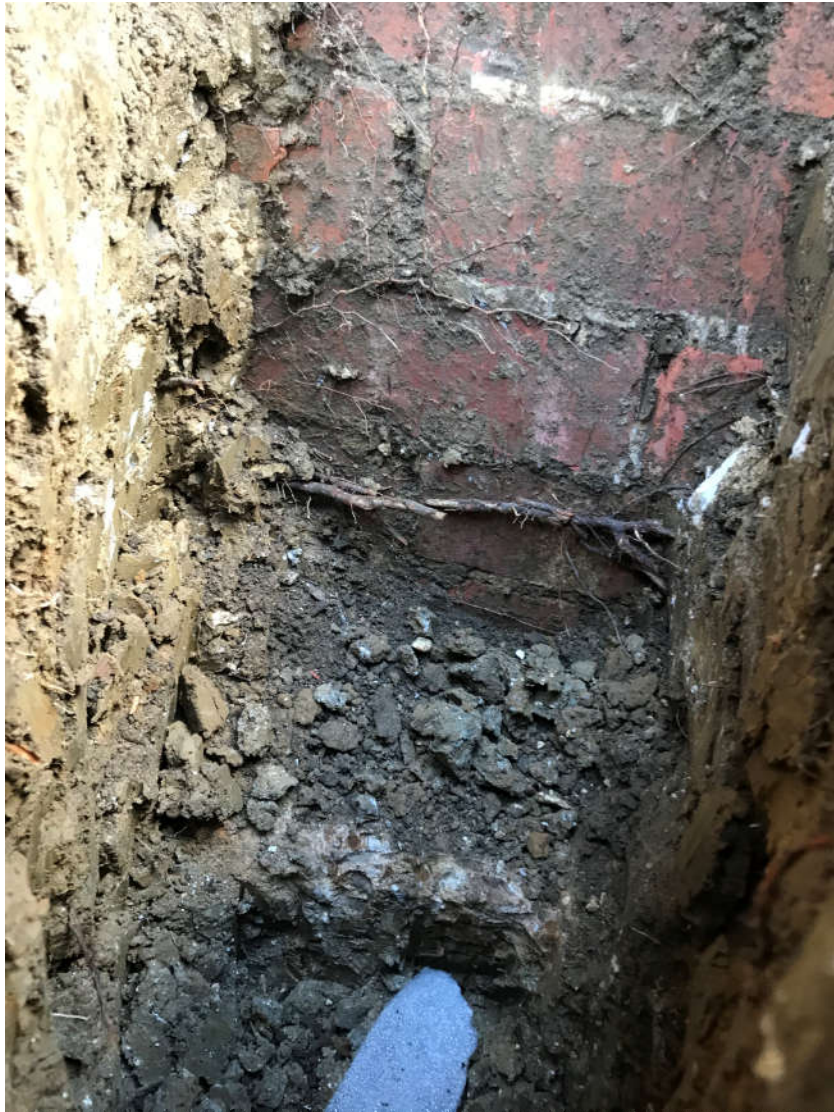
Photograph 1

- (i) The existing perimeter wall is constructed on a mass concrete strip footing which is founded at approximately 650mm below ground level. The approximate size of the strip footing is 500mm wide and 180mm to 200mm deep. Typical details of the foundation can be seen in Photographs 1 and 2 in Appendix A.

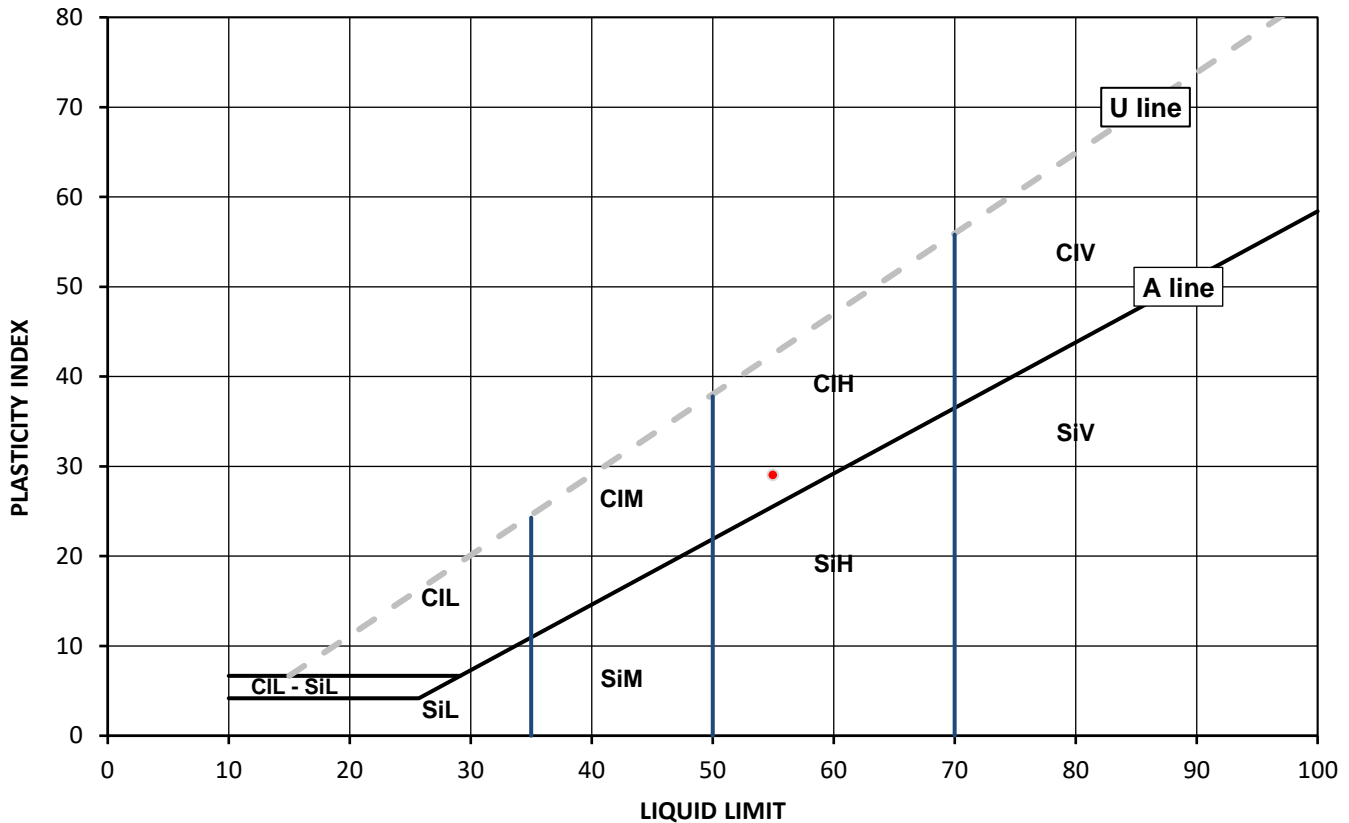
- (ii) The bearing strata was brown slightly sandy, slightly gravelly CLAY. The laboratory testing revealed that the modified Plasticity Index of the clay samples was 27% and 35% which would classify it as a medium shrinkable clay. The Moisture content was 17%. A copy of the laboratory test results can be found in Appendix B of this report.

As Received Water Content [W] %	Liquid Limit [WL] %	Plastic Limit [Wp] %	Plasticity Index [Ip] %	% Passing 425µm BS Test Sieve
16	55	26	29	92

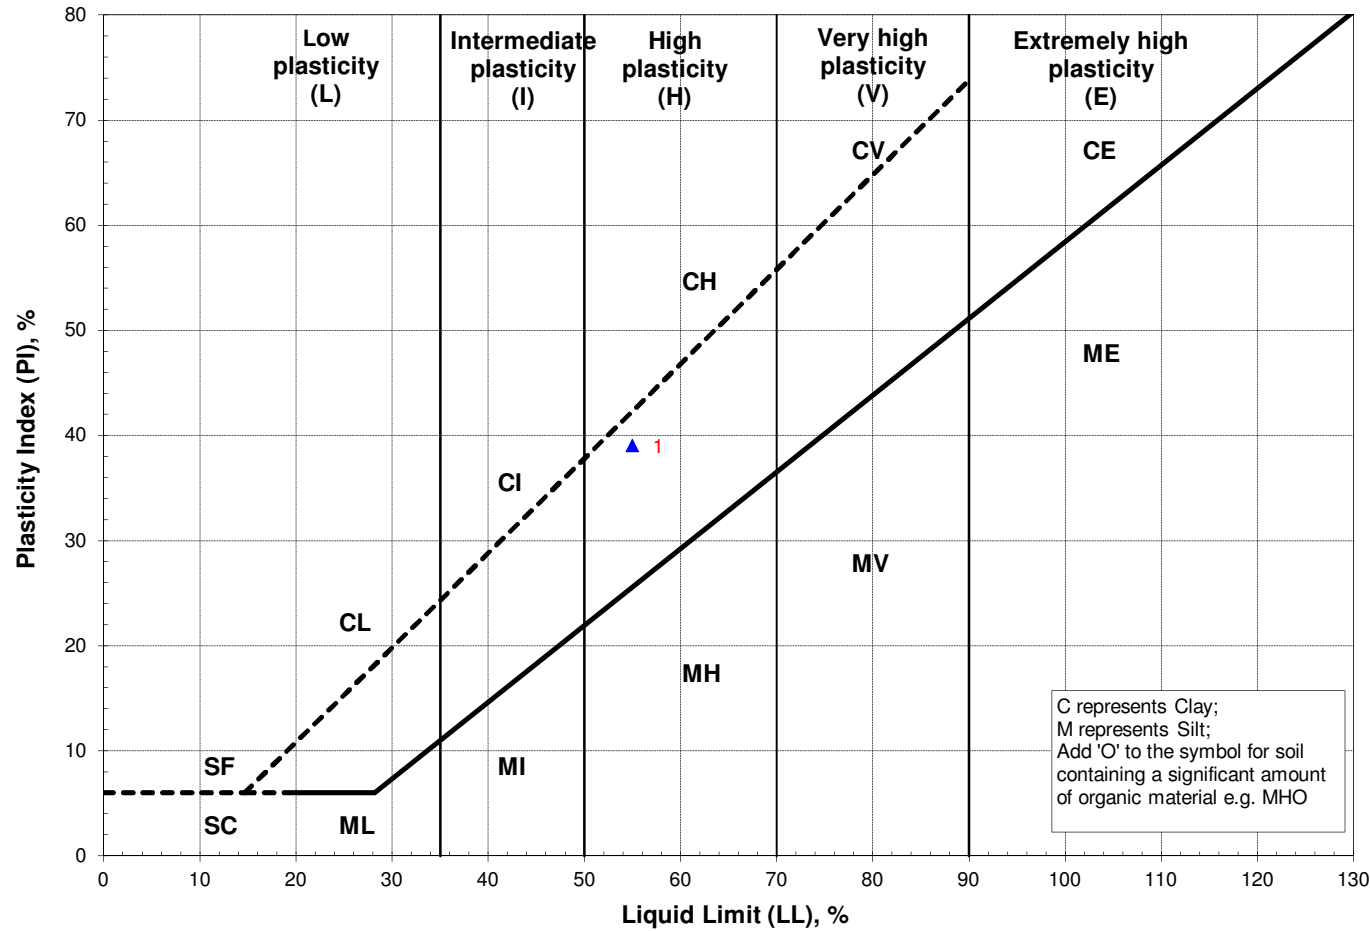
Figure No. 2

Plot No	TH No.	Depth (m)	Moisture Content (%)	Liquid Limit (%)	Plastic Limit (%)	Plasticity Index (%)	Classification	% Passing 425µm (%)	Visual Description
1	TH1	N/A	17.5	55	16	39	CH	91	<i>Brown mottled grey and orange brown slightly sandy slightly gravelly calcareous CLAY. Gravel consists of fine and medium angular to rounded chalk and flint.</i>

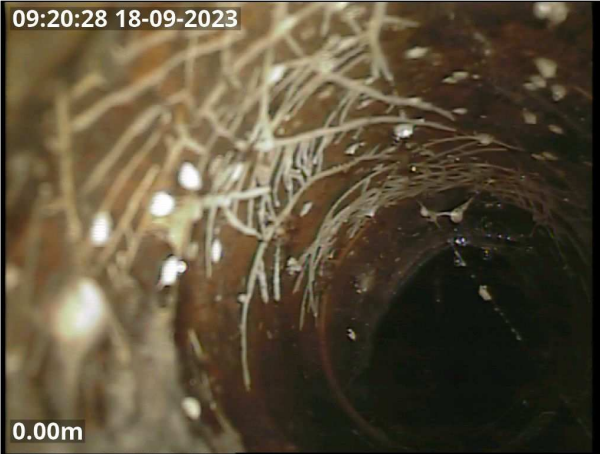
MH	Start node type, manhole, reference number : MH 1		
	0.00	WL	Water level, 0% of the vertical dimension		
	0.00	REM	General remark Remarks: roots round sides of pipe		CCTV 03 pic 1 .jpg
	1.05	MHF	Finish node type, manhole reference number: Lateral 1 Remarks: RWP gully		CCTV 03 pic 2.jpg

Photo: CCTV 03 pic 1.jpg
0m, General remark

In addition to this, the drainage runs should also be jetted out, de-rooted. The pipes should then be relined. Based on the condition of the pipe between Manholes MH1 and MH2, the pipe may need to be replaced.

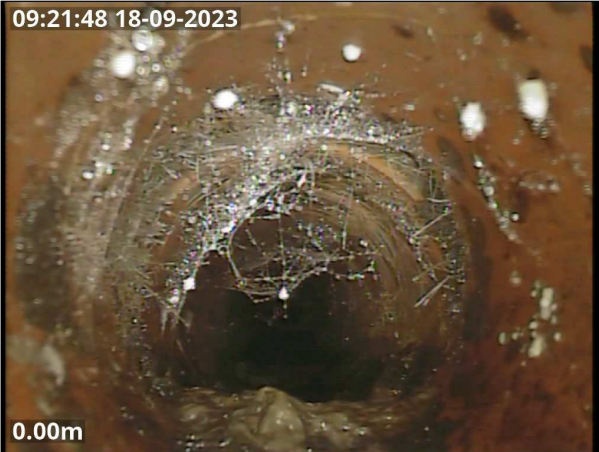
- Root masses in the pipework between Manhole MH1 and MH2.
 - Fine roots along Lateral 1 from Manhole MH1.
 - Settled deposits along Lateral 2 upstream of Manhole MH 1 giving 5% reduction in cross-sectional area.

Photo: CCTV 04 pic 1.jpg
0m, Settled deposits, fine, 5% cross-sectional area loss

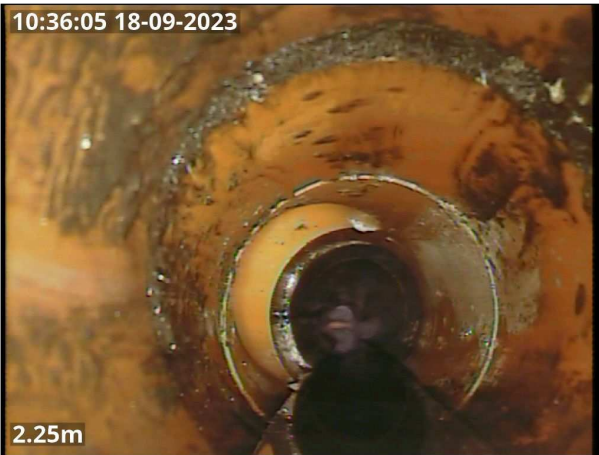
Photo: CCTV 12 pic 1.jpg
2.25m, General remark

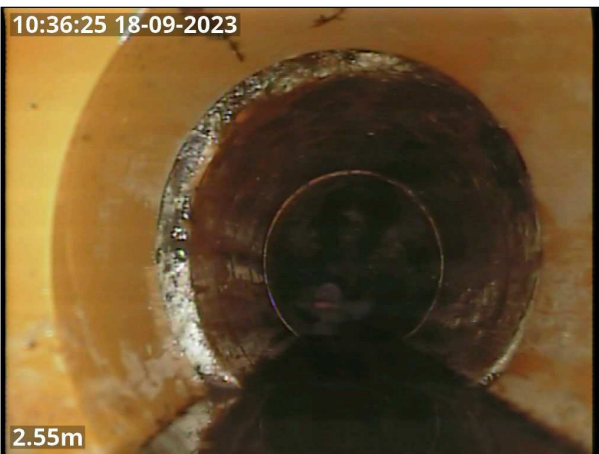
Photo: CCTV 12 pic 3.jpg
2.55m, General remark

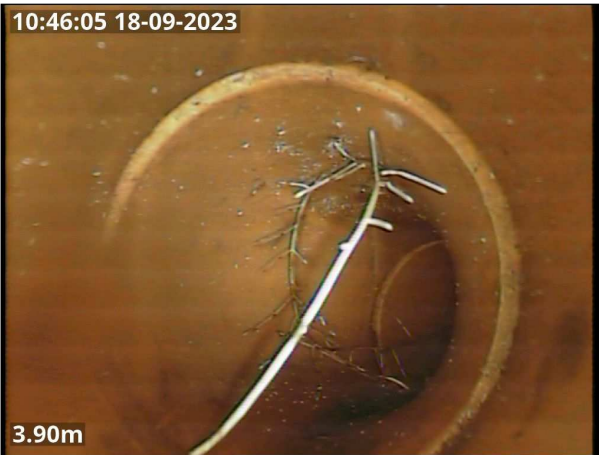
MH	Start node type, manhole, reference number : MH 8		
	0.00	WL	Water level, 0% of the vertical dimension		
	3.90	LR	Line deviates right		
	3.90	RF	Roots, fine		CCTV 14 pic 1.jpg
	4.95	MHF	Finish node type, manhole reference number: Upstream Remarks: at RWP gully, full of roots		CCTV 14 pic 2.jpg

Photo: CCTV 14 pic 1.jpg
3.9m, Roots, fine

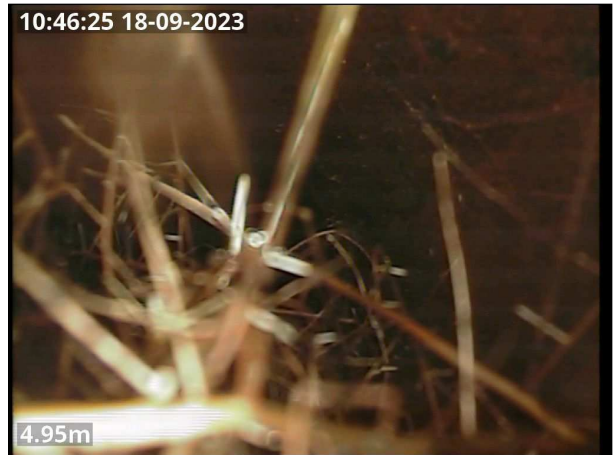
Photo: CCTV 14 pic 2.jpg
4.95m, Finish node type, manhole reference number: Upstream
