## Asbestos Management Building Survey

**Uplands Manor Primary School, Addenbrooke Road, Smethwick, West Midlands, B67 6HT**

**SCOPE:** In Accordance With HSG 264 And SMBC Job No. 2177, Conduct An Asbestos Management Survey To The School Where Safe And Unrestricted Access Permits.

UPLANDS MANOR PRIMARY  
SCHOOL  
ADDENBROOKE ROAD  
SMETHWICK  
WEST MIDLANDS, B67 6HT  
REPORT NUMBER J125739

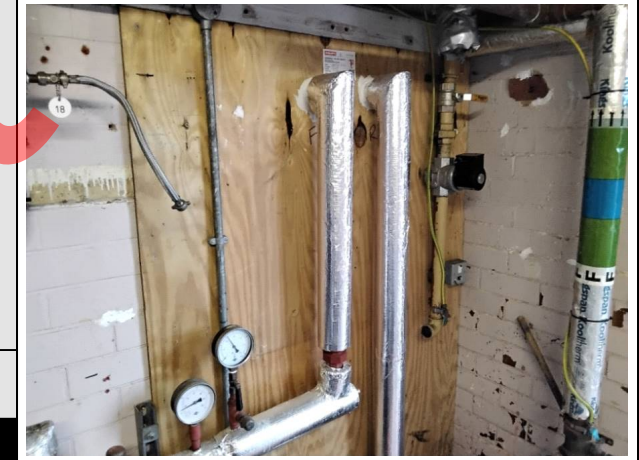
Location: Uplands Manor Primary School – Z-Sub Level 1 – Boiler room 1 –83 Floor Presumed lagging debris below boilers						Survey Date: 15/08/2022 Review Date: N/A	
Level of ID	Sample No.	Quantity	Product	Condition	Surface Treatment	Result	Material Assessment (MA)
P	Visual/225	4m²	3 Thermal Insulation Lagging +	3 High Damage	3 Unsealed lagging and sprays +	3 Crocidolite (or unknown) =	12
Normal Occupancy Activity	Main activity 2	+	Secondary Activity 0	+	–	÷ 2 =	Averages 2
Likelihood of Disturbance	Location 3	+	Accessibility 1	+	Extent / Amount 0	÷ 3 =	+ 2
Human Exposure Potential	Number of Occupants 1	+	Frequency of Use 3	+	Average Time Per Use 0	÷ 3 =	+ 2
Maintenance Activity	Type of Maintenance 0	+	Freq. of Maintenance 0	+	–	÷ 2 =	+ 0
Recommended Action: Inspect prior disturbance			Priority Assessment Sum of averages (PA) =		6		
			Total Risk Score (MA + PA) =		18

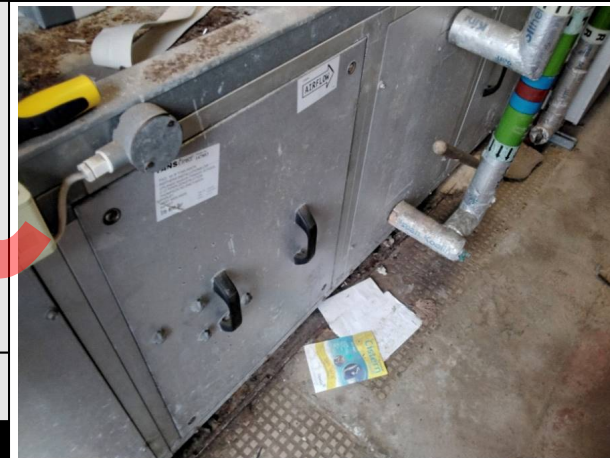
Location: Uplands Manor Primary School – Z-Sub Level 1 – Storage –84 Ceiling						Survey Date: 15/08/2022 Review Date: N/A	
Level of ID	Sample No.	Quantity	Product	Condition	Surface Treatment	Result	Material Assessment (MA)
ID	AT004724/227	2m²	1 Asbestos Cement +	1 Low Damage	1 Surface Sealed +	1 Chrysotile =	4
Normal Occupancy Activity	Main activity 0	+	Secondary Activity 0	+	–	÷ 2 =	Averages 0
Likelihood of Disturbance	Location	+	Accessibility 1	+	Extent / Amount	÷ 3 =	+ 1
Human Exposure Potential	Number of Occupants	+	Frequency of Use	+	Average Time Per Use	÷ 3 =	+ 0
Maintenance Activity	Type of Maintenance	+	Freq. of Maintenance	+	–	÷ 2 =	+ 0
Recommended Action: Consider labelling, and manage in place			Priority Assessment Sum of averages (PA) =		1		
			Total Risk Score (MA + PA) =		5

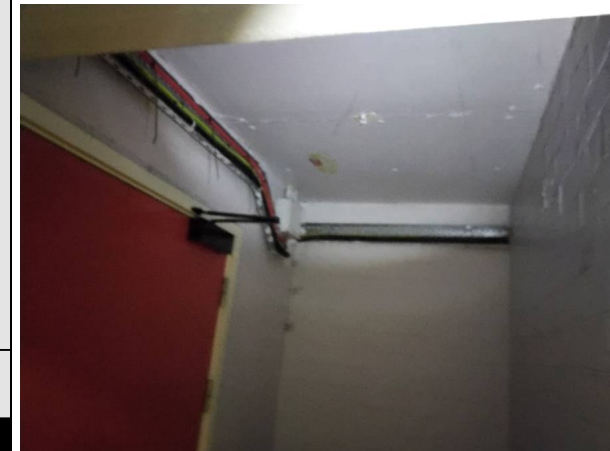
Location: Uplands Manor Primary School – Z-Sub Level 1 – Boiler house –B Ceiling Presumed lagging residue to ceiling							Survey Date: 15/08/2022 Review Date: N/A	
Level of ID P	Sample No. Visual/230	Quantity 10m <sup>2</sup>	Product 3 Thermal Insulation Lagging	Condition 1 Low Damage	Surface Treatment 2 Sealed	Result 3 Crocidolite (or unknown)	Material Assessment (MA) = 9	
Normal Occupancy Activity	Main activity 0	+	Secondary Activity 0	+	–	÷ 2 =	Averages 0	
Likelihood of Disturbance	Location	+	Accessibility 1	+	Extent / Amount	÷ 3 =	+	1
Human Exposure Potential	Number of Occupants	+	Frequency of Use	+	Average Time Per Use	÷ 3 =	+	0
Maintenance Activity	Type of Maintenance	+	Freq. of Maintenance	+	–	÷ 2 =	+	0
Recommended Action: Inspect prior disturbance				Priority Assessment Sum (PA) of averages		=	1	
				Total Risk Score		(MA + PA)=	10

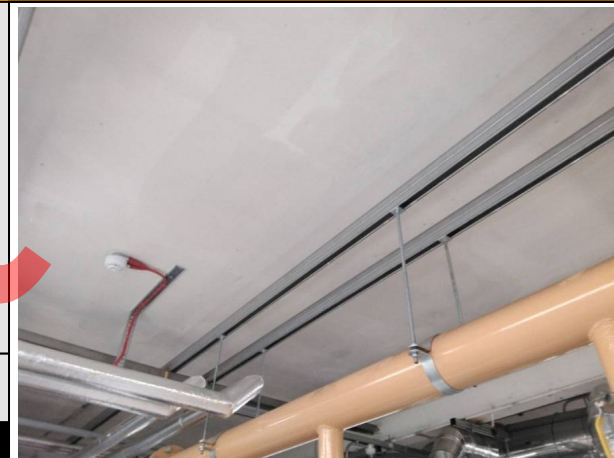
Location: Uplands Manor Primary School – Z-Sub Level 1 – Boiler house –B Wall Presumed lagging residue to walls							Survey Date: 15/08/2022 Review Date: N/A	
Level of ID P	Sample No. Visual/231	Quantity 14m <sup>2</sup>	Product 3 Thermal Insulation Lagging	Condition 1 Low Damage	Surface Treatment 2 Sealed	Result 3 Crocidolite (or unknown)	Material Assessment (MA) = 9	
Normal Occupancy Activity	Main activity 0	+	Secondary Activity 0	+	–	÷ 2 =	Averages 0	
Likelihood of Disturbance	Location	+	Accessibility 1	+	Extent / Amount	÷ 3 =	+	1
Human Exposure Potential	Number of Occupants	+	Frequency of Use	+	Average Time Per Use	÷ 3 =	+	0
Maintenance Activity	Type of Maintenance	+	Freq. of Maintenance	+	–	÷ 2 =	+	0
Recommended Action: Inspect prior disturbance				Priority Assessment Sum (PA) of averages		=	1	
				Total Risk Score		(MA + PA)=	10

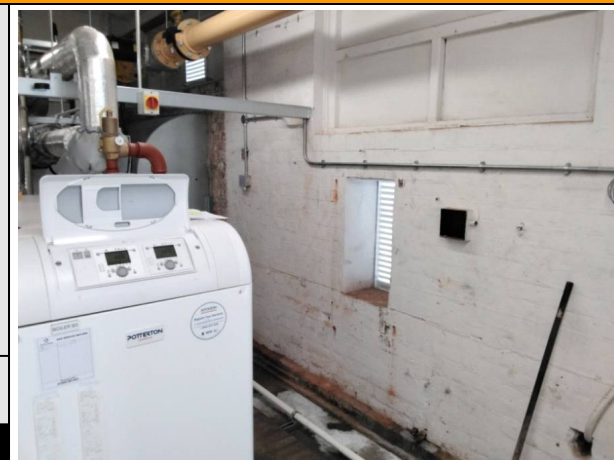
Location: Uplands Manor Primary School – Z-Sub Level 1 – Boiler house –B Tank Room No access within area							Survey Date: 15/08/2022 Review Date: N/A				
Level of ID P	Sample No. Visual/232	Quantity 20m²	Product 3 Asbestos Insulation/Coating	+	Condition 1 Low Damage	+	Surface Treatment 1 Surface Sealed	+	Result 3 Crocidolite (or unknown)	=	Material Assessment (MA) 8
Normal Occupancy Activity	Main activity 0	+	Secondary Activity 0	+	–	÷ 2 =	Averages 0

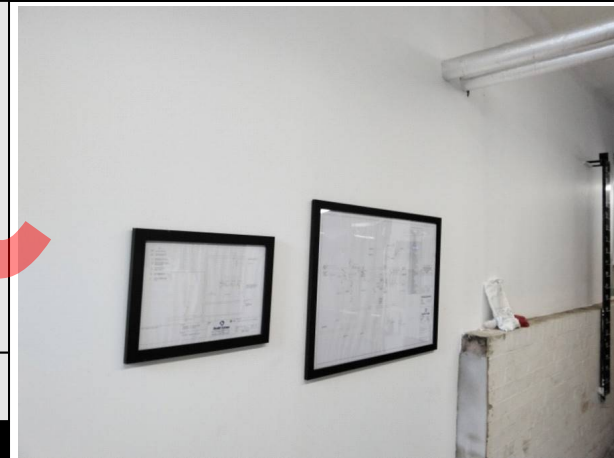
Location: Uplands Manor Primary School – Z-Sub Level 1 – Pump room –B1 Ceiling Lagging residue to ceiling							Survey Date: 15/08/2022 Review Date: N/A		
Level of ID	Sample No.	Quantity	Product	Condition	Surface Treatment	Result	Material Assessment (MA)		
P	Visual/237	18m²	3 Thermal Insulation Lagging	+	1 Low Damage	+	2 Sealed	+	3 Crocidolite (or unknown) = 9
Normal Occupancy Activity	Main activity 0	+	Secondary Activity 0	+	–	÷ 2 =	Averages 0		
Likelihood of Disturbance	Location	+	Accessibility 1	+	Extent / Amount	÷ 3 =	+	1	
Human Exposure Potential	Number of Occupants	+	Frequency of Use	+	Average Time Per Use	÷ 3 =	+	0	
Maintenance Activity	Type of Maintenance	+	Freq. of Maintenance	+	–	÷ 2 =	+	0	
Recommended Action: Inspect prior disturbance				Priority Assessment Sum of averages (PA)		=	1		
				Total Risk Score		(MA + PA)=	10

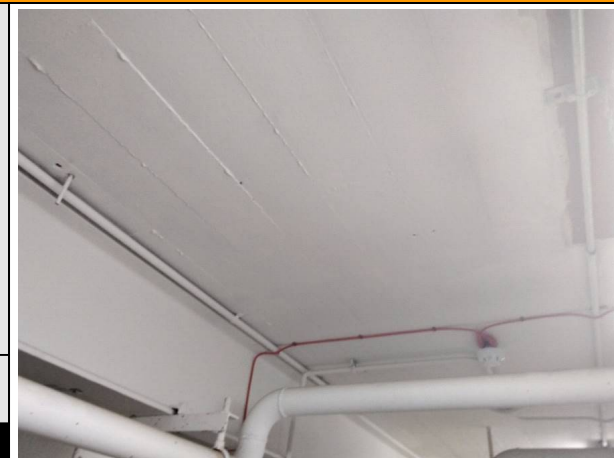
Location: Uplands Manor Primary School – Z-Sub Level 1 – Pump room –B1 Electrical Services - Cable Braiding/Insulation							Survey Date: 15/08/2022 Review Date: N/A	
Level of ID P	Sample No. Visual/242	Quantity 4lm	Product 1 Composite Bitumen	Condition 1 Low Damage	Surface Treatment 0 Completely Sealed	Result 3 Crocidolite (or unknown)	Material Assessment (MA) = 5	
Normal Occupancy Activity	Main activity 0	+	Secondary Activity 0	+	–	÷ 2 =	Averages 0	
Likelihood of Disturbance	Location	+	Accessibility 0	+	Extent / Amount	÷ 3 =	+	0
Human Exposure Potential	Number of Occupants	+	Frequency of Use	+	Average Time Per Use	÷ 3 =	+	0
Maintenance Activity	Type of Maintenance	+	Freq. of Maintenance	+	–	÷ 2 =	+	0
Recommended Action: Inspect prior disturbance				Priority Assessment Sum of averages (PA)		=	0	
				Total Risk Score		(MA + PA)=	5

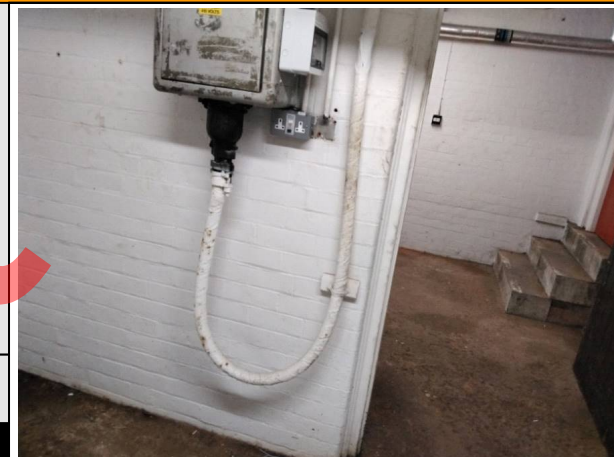
Location: Uplands Manor Primary School – Z-Sub Level 1 – Pump room –B1 Electrical Services							Survey Date: 15/08/2022 Review Date: N/A	
Level of ID P	Sample No. Visual/243	Quantity 1m²	Product 2 Textile Woven/Cloth	Condition 1 Low Damage	Surface Treatment 2 Unsealed	Result 3 Crocidolite (or unknown)	Material Assessment (MA) = 8	
Normal Occupancy Activity	Main activity 0	+	Secondary Activity 0	+	–	÷ 2 =	Averages 0	
Likelihood of Disturbance	Location	+	Accessibility 1	+	Extent / Amount	÷ 3 =	+	1
Human Exposure Potential	Number of Occupants	+	Frequency of Use	+	Average Time Per Use	÷ 3 =	+	0
Maintenance Activity	Type of Maintenance	+	Freq. of Maintenance	+	–	÷ 2 =	+	0
Recommended Action: Inspect prior disturbance				Priority Assessment Sum of averages (PA)		=	1	
				Total Risk Score		(MA + PA)=	9

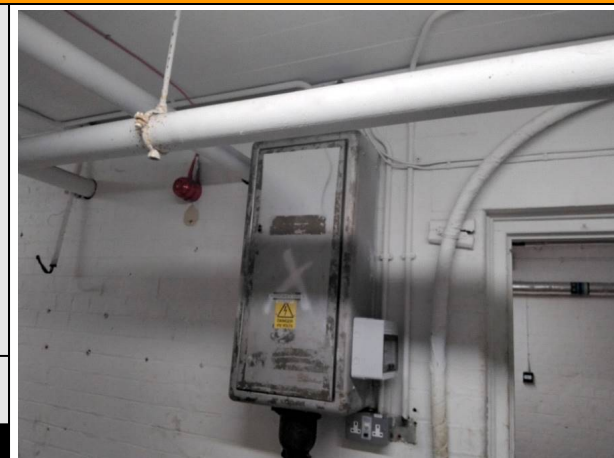
<b>Location:</b> Uplands Manor Primary School – Z-Sub Level 1 – Switch room –86 Electrical Services Presumed flash pads and rope seal to live services							<b>Survey Date:</b> 15/08/2022 <b>Review Date:</b> N/A		
Level of ID	Sample No.	Quantity	Product	Condition	Surface Treatment	Result	Material Assessment (MA)		
P	Visual/245	1m <sup>2</sup>	2 Textile Woven/Cloth	+	1 Low Damage	+	2 Unsealed	+	3 Crocidolite (or unknown) = 8
<b>Normal Occupancy Activity</b>	Main activity 0	+	Secondary Activity 0	+	–	÷ 2 =	Averages 0		
<b>Likelihood of Disturbance</b>	Location	+	Accessibility 1	+	Extent / Amount	÷ 3 =	+	1	
<b>Human Exposure Potential</b>	Number of Occupants	+	Frequency of Use	+	Average Time Per Use	÷ 3 =	+	0	
<b>Maintenance Activity</b>	Type of Maintenance	+	Freq. of Maintenance	+	–	÷ 2 =	+	0	
<b>Recommended Action:</b> Inspect prior disturbance				<b>Priority Assessment Sum of averages</b>		(PA) =	1

<b>Total Risk Score</b>		(MA + PA) =	9

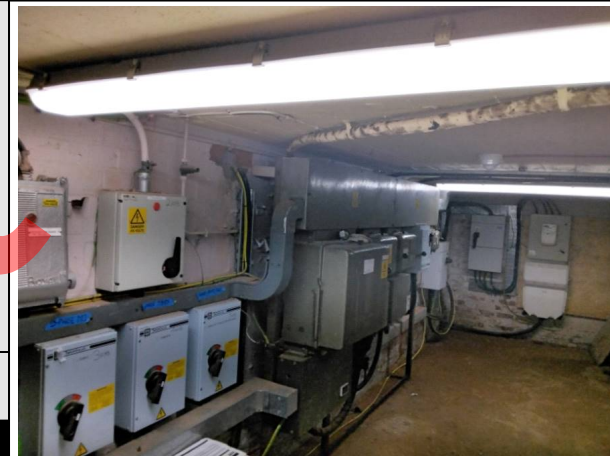
<b>Location:</b> Uplands Manor Primary School – Z-Sub Level 1 – Switch room –86 Fuses Flash guards to old fuses (x6)							<b>Survey Date:</b> 15/08/2022 <b>Review Date:</b> N/A		
Level of ID	Sample No.	Quantity	Product	Condition	Surface Treatment	Result	Material Assessment (MA)		
ID	AT004738/248	1	2 Asbestos Textiles/Paper	+	2 Medium Damage	+	2 Unsealed	+	1 Chrysotile = 7
<b>Normal Occupancy Activity</b>	Main activity 0	+	Secondary Activity 0	+	–	÷ 2 =	Averages 0		
<b>Likelihood of Disturbance</b>	Location	+	Accessibility 1	+	Extent / Amount	÷ 3 =	+	1	
<b>Human Exposure Potential</b>	Number of Occupants	+	Frequency of Use	+	Average Time Per Use	÷ 3 =	+	0	
<b>Maintenance Activity</b>	Type of Maintenance	+	Freq. of Maintenance	+	–	÷ 2 =	+	0	
<b>Recommended Action:</b> Removal by licensed contractor				<b>Priority Assessment Sum of averages</b>		(PA) =	1		
				<b>Total Risk Score</b>		(MA + PA) =	8

Room Code	Room	Floor	Description	Recommended Action
86	Switch room	Z-Sub Level 1	Textile Woven/Cloth Fuses Flash guards to old fuses (x6)	Removal by licensed contractor

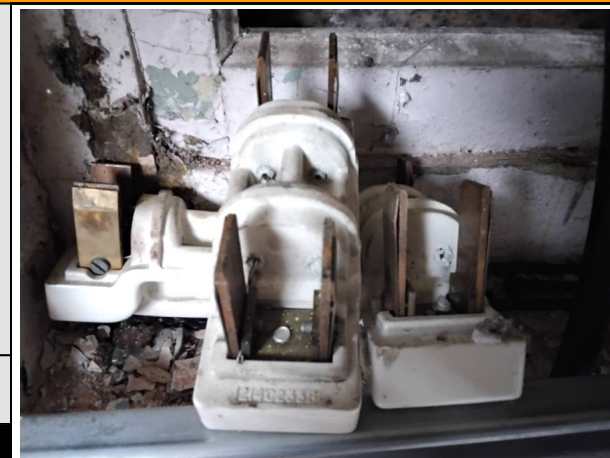
Location: Uplands Manor Primary School – Z-Sub Level 1 – Switch room –86 Electrical Services - Cable Braiding/Insulation							Survey Date: 15/08/2022 Review Date: N/A	
Level of ID P	Sample No. Visual/250	Quantity 6lm	Product 1 Composite Bitumen	Condition 1 Low Damage	Surface Treatment 0 Completely Sealed	Result 3 Crocidolite (or unknown)	Material Assessment (MA) = 5	
Normal Occupancy Activity	Main activity 0	+	Secondary Activity 0	+	–	÷ 2 =	Averages 0	
Likelihood of Disturbance	Location	+	Accessibility 0	+	Extent / Amount	÷ 3 =	+	0
Human Exposure Potential	Number of Occupants	+	Frequency of Use	+	Average Time Per Use	÷ 3 =	+	0
Maintenance Activity	Type of Maintenance	+	Freq. of Maintenance	+	–	÷ 2 =	+	0
Recommended Action: Inspect prior disturbance				Priority Assessment Sum of averages (PA)		=	0	
				Total Risk Score		(MA + PA)=	5

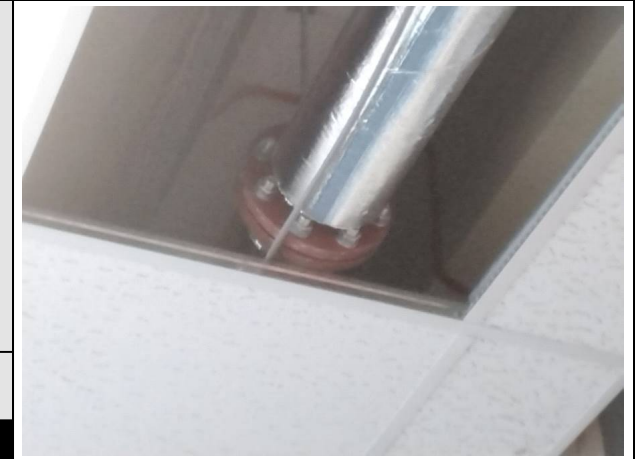
Location: Uplands Manor Primary School – Ground Floor – Corridor 12 –12 Pipework Gasket(s)							Survey Date: 15/08/2022 Review Date: N/A	
Level of ID P	Sample No. Visual/025	Quantity 2m <sup>2</sup>	Product 1 Gasket CAF Joint/Gasket	Condition 1 Low Damage	Surface Treatment 1 Surface Sealed	Result 3 Crocidolite (or unknown)	Material Assessment (MA) = 6	
Normal Occupancy Activity	Main activity 0	+	Secondary Activity 0	+	–	÷ 2 =	Averages 0	
Likelihood of Disturbance	Location	+	Accessibility 1	+	Extent / Amount	÷ 3 =	+	1
Human Exposure Potential	Number of Occupants	+	Frequency of Use	+	Average Time Per Use	÷ 3 =	+	0
Maintenance Activity	Type of Maintenance	+	Freq. of Maintenance	+	–	÷ 2 =	+	0
Recommended Action: Inspect prior disturbance				Priority Assessment Sum of averages (PA)		=	1	
				Total Risk Score (MA + PA)=			7

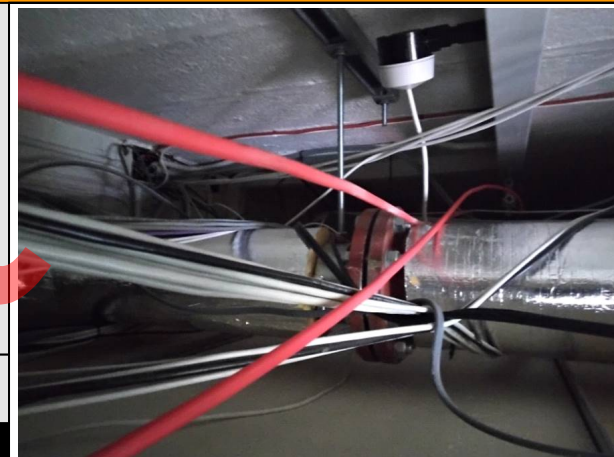
Location: Uplands Manor Primary School – Ground Floor – Corridor –17 Pipework Gasket(s)							Survey Date: 15/08/2022 Review Date: N/A	
Level of ID P	Sample No. Visual/028	Quantity 2m <sup>2</sup>	Product 1 Gasket CAF Joint/Gasket	Condition 1 Low Damage	Surface Treatment 1 Surface Sealed	Result 3 Crocidolite (or unknown)	Material Assessment (MA) = 6	
Normal Occupancy Activity	Main activity 0	+	Secondary Activity 0	+	–	÷ 2 =	Averages 0	
Likelihood of Disturbance	Location	+	Accessibility 1	+	Extent / Amount	÷ 3 =	+	1
Human Exposure Potential	Number of Occupants	+	Frequency of Use	+	Average Time Per Use	÷ 3 =	+	0
Maintenance Activity	Type of Maintenance	+	Freq. of Maintenance	+	–	÷ 2 =	+	0
Recommended Action: Inspect prior disturbance				Priority Assessment Sum of averages (PA)		=	1	
				Total Risk Score (MA + PA)=			7

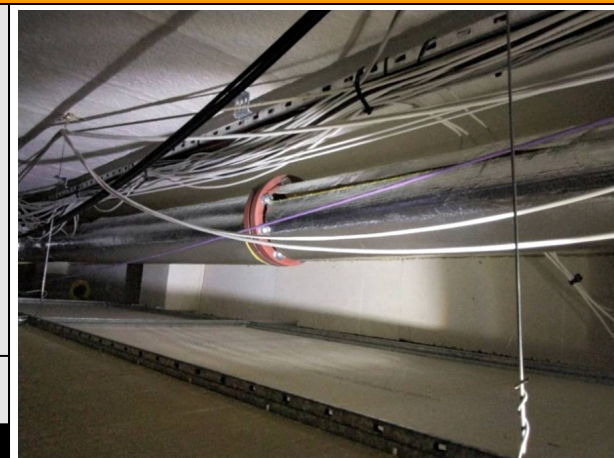
Location: Uplands Manor Primary School – Ground Floor – Corridor –17.1 Pipework Gasket(s)							Survey Date: 15/08/2022 Review Date: N/A	
Level of ID P	Sample No. Visual/041	Quantity 1m <sup>2</sup>	Product 1 Gasket CAF Joint/Gasket	Condition 1 Low Damage	Surface Treatment 1 Surface Sealed	Result 3 Crocidolite (or unknown)	Material Assessment (MA) 6	
Normal Occupancy Activity	Main activity 0	+	Secondary Activity 0	+	–	÷ 2 =	Averages 0	
Likelihood of Disturbance	Location	+	Accessibility 1	+	Extent / Amount	÷ 3 =	+	1
Human Exposure Potential	Number of Occupants	+	Frequency of Use	+	Average Time Per Use	÷ 3 =	+	0
Maintenance Activity	Type of Maintenance	+	Freq. of Maintenance	+	–	÷ 2 =	+	0
Recommended Action: Inspect prior disturbance				Priority Assessment Sum of averages (PA) =		1		
				Total Risk Score (MA + PA)=		7

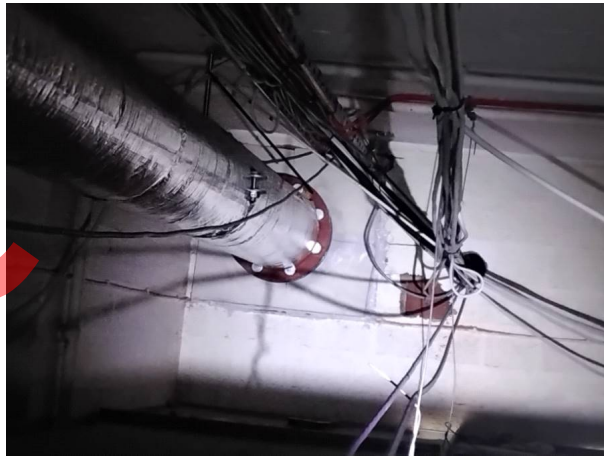
Location: Uplands Manor Primary School – Ground Floor – Duct –Duct Pipework Presumed pipe lagging within floor duct							Survey Date: 15/08/2022 Review Date: N/A	
Level of ID P	Sample No. Visual/096	Quantity >100lm	Product 3 Thermal Insulation Lagging	Condition 1 Low Damage	Surface Treatment 3 Unsealed lagging and sprays	Result 3 Crocidolite (or unknown)	Material Assessment (MA) 10	
Normal Occupancy Activity	Main activity 0	+	Secondary Activity 0	+	–	÷ 2 =	Averages 0	
Likelihood of Disturbance	Location	+	Accessibility 0	+	Extent / Amount	÷ 3 =	+	0
Human Exposure Potential	Number of Occupants	+	Frequency of Use	+	Average Time Per Use	÷ 3 =	+	0
Maintenance Activity	Type of Maintenance	+	Freq. of Maintenance	+	–	÷ 2 =	+	0
Recommended Action: Inspect prior disturbance				Priority Assessment Sum of averages (PA) =		0		
				Total Risk Score (MA + PA)=		10

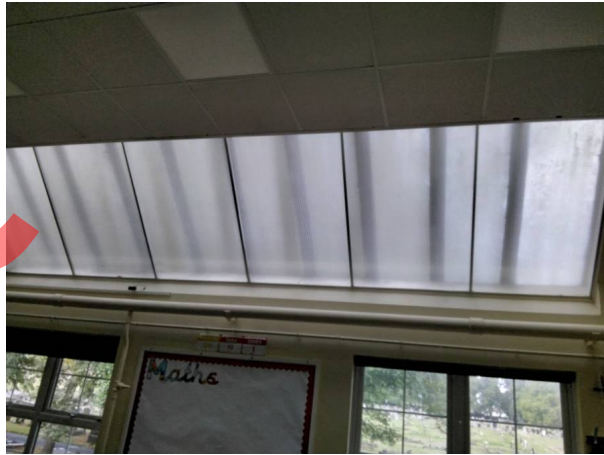
<b>Location:</b> Uplands Manor Primary School – 1st Floor – Classroom 3B –20 Skylight Presumed rope to skylight unable to gain access							<b>Survey Date:</b> 15/08/2022 <b>Review Date:</b> N/A		
Level of ID P	Sample No. Visual/165	Quantity 10lm	Product 2 Textile Rope/String/Yarn	Condition 1 Low Damage	Surface Treatment 2 Unsealed	Result 3 Crocidolite (or unknown)	Material Assessment (MA) 8		
<b>Normal Occupancy Activity</b>	Main activity 0	+	Secondary Activity 0	+	–	÷ 2 =	Averages 0

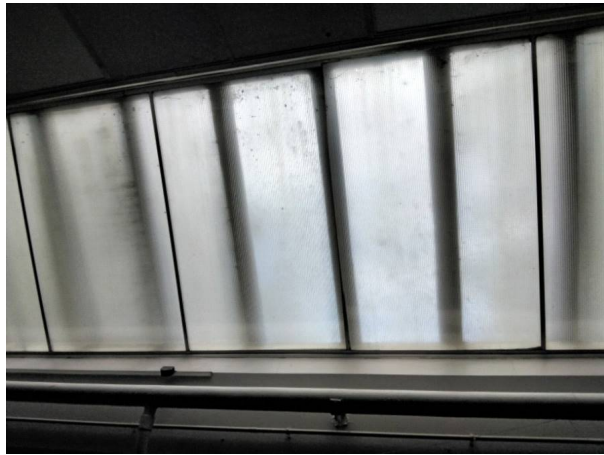
Location: Uplands Manor Primary School – 1st Floor – Classroom 1S –21 Skylight Presumed rope to skylight unable to gain access										Survey Date: 15/08/2022 Review Date: N/A	
Level of ID P	Sample No. Visual/167	Quantity 10lm	Product 2 Textile Rope/String/Yarn	+	Condition 1 Low Damage	+	Surface Treatment 2 Unsealed	+	Result 3 Crocidolite (or unknown)	=	Material Assessment (MA) 8
Normal Occupancy Activity	Main activity 0	+	Secondary Activity 0	+	–	÷ 2 =	Averages 0

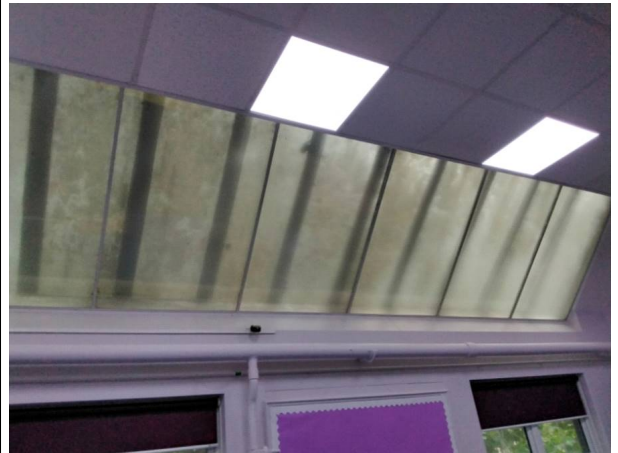
Location: Uplands Manor Primary School – 1st Floor – Classroom 3M –23 Roof - Skylight							Survey Date: 15/08/2022 Review Date: N/A	
Level of ID P	Sample No. Visual/188	Quantity 10lm	Product 2 Textile Rope/String/Yarn +	Condition 1 Low Damage	Surface Treatment + 2 Unsealed	Result + 3 Crocidolite (or unknown)	Material Assessment (MA) = 8	
Normal Occupancy Activity	Main activity 0	+	Secondary Activity 0	+	–	÷ 2 =	Averages 0	
Likelihood of Disturbance	Location	+	Accessibility 1	+	Extent / Amount	÷ 3 =	+	1
Human Exposure Potential	Number of Occupants	+	Frequency of Use	+	Average Time Per Use	÷ 3 =	+	0
Maintenance Activity	Type of Maintenance	+	Freq. of Maintenance	+	–	÷ 2 =	+	0
Recommended Action: Inspect prior disturbance				Priority Assessment Sum (PA) of averages		=	1	
				Total Risk Score		(MA + PA)=	9

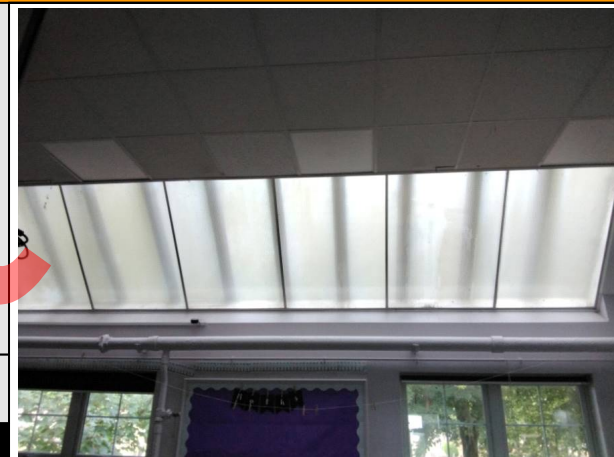
Location: Uplands Manor Primary School – 1st Floor – Classroom 4G –24 Roof - Skylight							Survey Date: 15/08/2022 Review Date: N/A	
Level of ID P	Sample No. Visual/191	Quantity 10lm	Product 2 Textile Rope/String/Yarn +	Condition 1 Low Damage	Surface Treatment + 2 Unsealed	Result + 3 Crocidolite (or unknown)	Material Assessment (MA) = 8	
Normal Occupancy Activity	Main activity 0	+	Secondary Activity 0	+	–	÷ 2 =	Averages 0	
Likelihood of Disturbance	Location	+	Accessibility 1	+	Extent / Amount	÷ 3 =	+	1
Human Exposure Potential	Number of Occupants	+	Frequency of Use	+	Average Time Per Use	÷ 3 =	+	0
Maintenance Activity	Type of Maintenance	+	Freq. of Maintenance	+	–	÷ 2 =	+	0
Recommended Action: Inspect prior disturbance				Priority Assessment Sum (PA) of averages		=	1	
				Total Risk Score		(MA + PA)=	9
