Asbestos Survey Report

Refurbishment & Demolition Survey

HM Coastguard (Crosby)
MCA Liverpool/RS/Crosby CRS
Hall Road
Liverpool
L23 8SY

Project Number: N-69442
Issue Date: 3rd November 2017
Issue No: 1

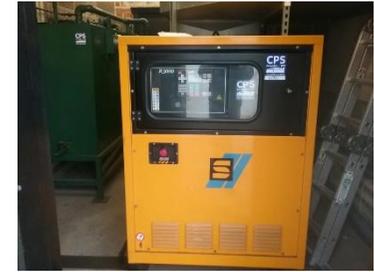
Surveyor		Andrew Stringer		Room / Area		001 - Generator Room		
Survey Date		19 October 2017		Level of Identification		Inspected Area		
Next Inspection				Sample No				
Building		Generator Building		Item		Generator		
Floor		0		Amount				
A - Product Type		B - Extent of Damage		C - Surface Treatment		D - Asbestos Type		Accessibility
No Suspect Materials Seen						No Asbestos Detected		
Material Ass' Score = (A+B+C+D):		0		Risk Coding				Recommendation:
Further Information:		Area visually inspected. No suspect materials seen. Generator and associated equipment found to be of modern age

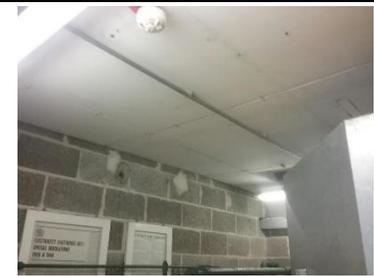
Surveyor		Andrew Stringer		Room / Area		001 - Generator Room		
Survey Date		19 October 2017		Level of Identification		Sampled		
Next Inspection				Sample No		0001		
Building		Generator Building		Item		Ceiling Boards		
Floor		0		Amount				
A - Product Type		B - Extent of Damage		C - Surface Treatment		D - Asbestos Type		Accessibility
Insulating Board						No Asbestos Detected		0
Material Ass' Score = (A+B+C+D):		0		Risk Coding				Recommendation: No recommendation required
Further Information:		Includes roof space hatch

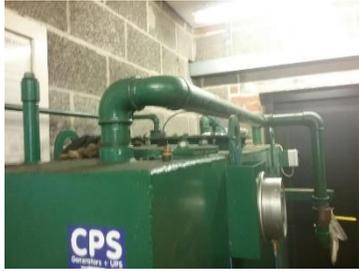
Surveyor		Andrew Stringer		Room / Area		001 - Generator Room

Survey Date		19 October 2017		Level of Identification		Sampled		
Next Inspection				Sample No		0002		
Building		Generator Building		Item		Gaskets To Top Of Oil Tank		
Floor		0		Amount				
A - Product Type		B - Extent of Damage		C - Surface Treatment		D - Asbestos Type		
Gasket						No Asbestos Detected		0
Material Ass' Score = (A+B+C+D):		0		Risk Coding		Recommendation: No recommendation required		
Further Information:

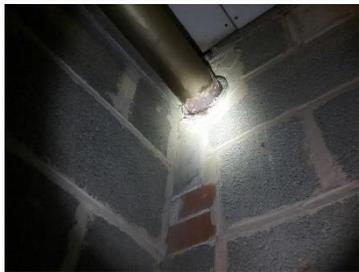
Surveyor		Andrew Stringer		Room / Area		001 - Generator Room

Survey Date		19 October 2017		Level of Identification		Sampled		
Next Inspection				Sample No		0003		
Building		Generator Building		Item		Rope To Generator Exhaust Where It Exits Wall		
Floor		0		Amount				
A - Product Type		B - Extent of Damage		C - Surface Treatment		D - Asbestos Type		
Textile Rope & Yarn						No Asbestos Detected		0
Material Ass' Score = (A+B+C+D):		0		Risk Coding		Recommendation: No recommendation required		
Further Information:

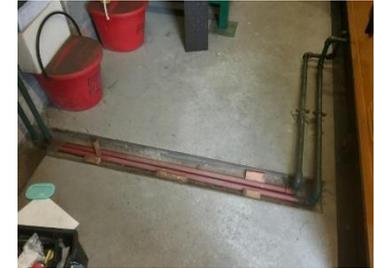
Surveyor		Andrew Stringer		Room / Area		001 - Generator Room		
Survey Date		19 October 2017		Level of Identification		Sampled		
Next Inspection				Sample No		0004		
Building		Generator Building		Item		Dust / Debris Within Floor Channel		
Floor		0		Amount				
A - Product Type		B - Extent of Damage		C - Surface Treatment		D - Asbestos Type		Accessibility
Debris						No Asbestos Detected		0
Material Ass' Score = (A+B+C+D):		0		Risk Coding		Recommendation:		No recommendation required
Further Information:

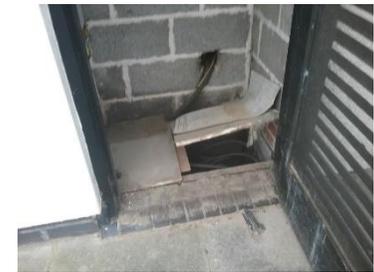
Surveyor		Andrew Stringer		Room / Area		002 - Electrical Intake Store		
Survey Date		19 October 2017		Level of Identification		Inspected Area		
Next Inspection				Sample No				
Building		Generator Building		Item		Below Timber Floor Panels		
Floor		0		Amount				
A - Product Type		B - Extent of Damage		C - Surface Treatment		D - Asbestos Type		Accessibility
No Suspect Materials Seen						No Asbestos Detected		
Material Ass' Score = (A+B+C+D):		0		Risk Coding		Recommendation:		
Further Information: Area visually inspected. No suspect materials seen. Void below contains modern rubber coated intake cable which exits via cast iron pipe

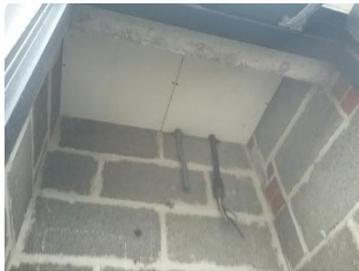
Surveyor		Andrew Stringer		Room / Area		002 - Electrical Intake Store

Survey Date		19 October 2017		Level of Identification		Strong Presumed (X)		
Next Inspection				Sample No		As 0001		
Building		Generator Building		Item		Ceiling Board		
Floor		0		Amount				
A - Product Type		B - Extent of Damage		C - Surface Treatment		D - Asbestos Type		
Insulating Board						No Asbestos Detected		0
Material Ass' Score = (A+B+C+D):		0		Risk Coding		Recommendation:		No recommendation required
Further Information:		Visually consistent with sample number 0001.

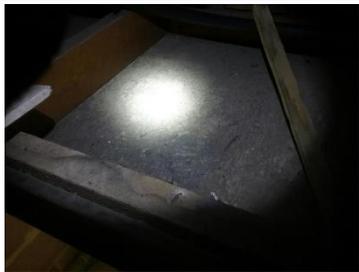
Surveyor		Andrew Stringer		Room / Area		003 - Roof Space

Survey Date		19 October 2017		Level of Identification		Sampled		
Next Inspection				Sample No		0005		
Building		Generator Building		Item		Debris On Top Of Ceiling Boards		
Floor		0		Amount				
A - Product Type		B - Extent of Damage		C - Surface Treatment		D - Asbestos Type		
Insulating Board						No Asbestos Detected		0
Material Ass' Score = (A+B+C+D):		0		Risk Coding		Recommendation:		No recommendation required
Further Information:

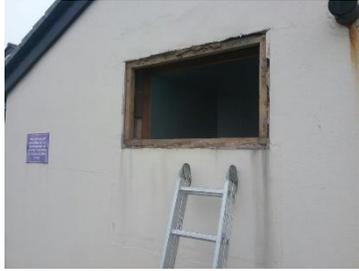
Surveyor		Andrew Stringer		Room / Area		004 - External

Survey Date		19 October 2017		Level of Identification		Inspected Area		
Next Inspection				Sample No				
Building		Generator Building		Item		Wall Vent Cover		
Floor		External		Amount				
A - Product Type		B - Extent of Damage		C - Surface Treatment		D - Asbestos Type		
No Suspect Materials Seen						No Asbestos Detected		
Material Ass' Score = (A+B+C+D):		0		Risk Coding		Recommendation:		
Further Information:		Area visually inspected. No suspect materials seen. Timber frame with natural slate packers. No suspect materials observed in wall cavity surrounding vent

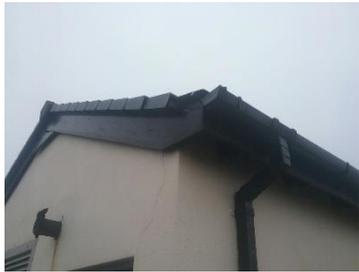
Surveyor		Andrew Stringer		Room / Area		004 - External

Survey Date		19 October 2017		Level of Identification		Inspected Area		
Next Inspection				Sample No				
Building		Generator Building		Item		Behind Plastic Verge Capping		
Floor		External		Amount				
A - Product Type		B - Extent of Damage		C - Surface Treatment		D - Asbestos Type		
No Suspect Materials Seen						No Asbestos Detected		
Material Ass' Score = (A+B+C+D):		0		Risk Coding		Recommendation:		
Further Information:		Area visually inspected. No suspect materials seen.

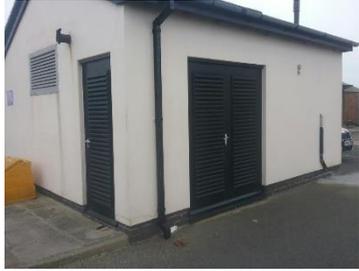
Surveyor		Andrew Stringer		Room / Area		004 - External

Survey Date		19 October 2017		Level of Identification		Inspected Area		
Next Inspection				Sample No				
Building		Generator Building		Item		Doors		
Floor		External		Amount				
A - Product Type		B - Extent of Damage		C - Surface Treatment		D - Asbestos Type		
No Suspect Materials Seen						No Asbestos Detected		
Material Ass' Score = (A+B+C+D):		0		Risk Coding		Recommendation:		
Further Information:		Area visually inspected. No suspect materials seen. No suspect seals or packers observed to all doors

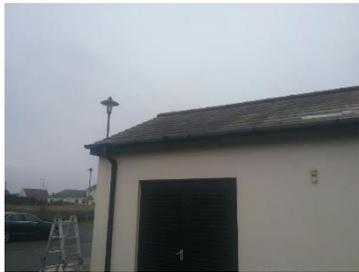
Surveyor		Andrew Stringer		Room / Area		004 - External

Survey Date		19 October 2017		Level of Identification		Sampled		
Next Inspection				Sample No		0006		
Building		Generator Building		Item		Roof Tiles		
Floor		External		Amount				
A - Product Type		B - Extent of Damage		C - Surface Treatment		D - Asbestos Type		
Cement Products						No Asbestos Detected		0
Material Ass' Score = (A+B+C+D):		0		Risk Coding		Recommendation:		No recommendation required
Further Information:

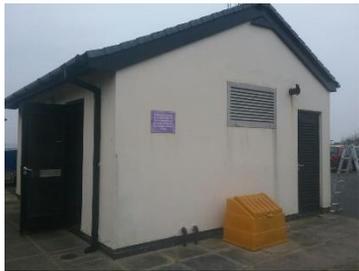
Surveyor		Andrew Stringer		Room / Area		004 - External

Survey Date		19 October 2017		Level of Identification		Sampled		
Next Inspection				Sample No		0007		
Building		Generator Building		Item		Wall Render		
Floor		External		Amount				
A - Product Type		B - Extent of Damage		C - Surface Treatment		D - Asbestos Type		
Plaster						No Asbestos Detected		0
Material Ass' Score = (A+B+C+D):		0		Risk Coding		Recommendation: No recommendation required		
Further Information:

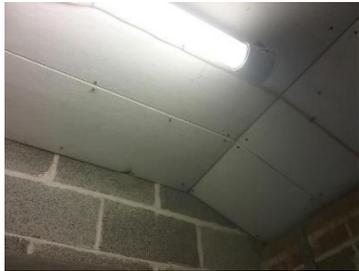
Surveyor		Andrew Stringer		Room / Area		005 - Store

Survey Date		19 October 2017		Level of Identification		Sampled		
Next Inspection				Sample No		0008		
Building		Quarantine Building		Item		Ceiling Boards		
Floor		0		Amount				
A - Product Type		B - Extent of Damage		C - Surface Treatment		D - Asbestos Type		
Insulating Board						No Asbestos Detected		0
Material Ass' Score = (A+B+C+D):		0		Risk Coding		Recommendation: No recommendation required		
Further Information:

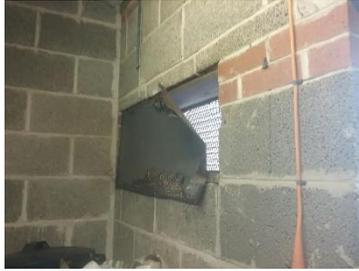
Surveyor		Andrew Stringer		Room / Area		006 - Store

Survey Date		19 October 2017		Level of Identification		Inspected Area		
Next Inspection				Sample No				
Building		Quarantine Building		Item		Wall Vent		
Floor		0		Amount				
A - Product Type		B - Extent of Damage		C - Surface Treatment		D - Asbestos Type		
No Suspect Materials Seen						No Asbestos Detected		
Material Ass' Score = (A+B+C+D):		0		Risk Coding		Recommendation:		
Further Information:		Area visually inspected. No suspect materials seen.

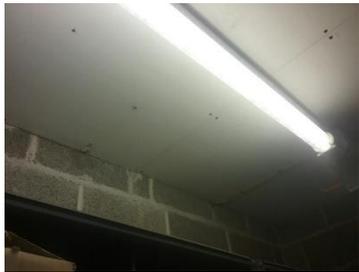
Surveyor		Andrew Stringer		Room / Area		006 - Store

Survey Date		19 October 2017		Level of Identification		Sampled		
Next Inspection				Sample No		0009		
Building		Quarantine Building		Item		Ceiling Boards		
Floor		0		Amount				
A - Product Type		B - Extent of Damage		C - Surface Treatment		D - Asbestos Type		
Insulating Board						No Asbestos Detected		0
Material Ass' Score = (A+B+C+D):		0		Risk Coding		Recommendation: No recommendation required		
Further Information:

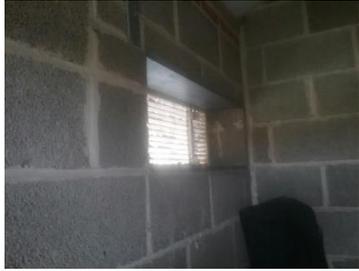
Surveyor		Andrew Stringer		Room / Area		007 - Store

Survey Date		19 October 2017		Level of Identification		Inspected Area		
Next Inspection				Sample No				
Building		Quarantine Building		Item		Wall Vent		
Floor		0		Amount				
A - Product Type		B - Extent of Damage		C - Surface Treatment		D - Asbestos Type		
No Suspect Materials Seen						No Asbestos Detected		
Material Ass' Score = (A+B+C+D):		0		Risk Coding		Recommendation:		
Further Information:		Area visually inspected. No suspect materials seen.

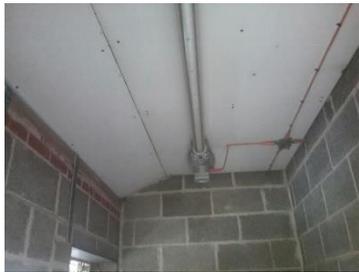
Surveyor		Andrew Stringer		Room / Area		007 - Store

Survey Date		19 October 2017		Level of Identification		Strong Presumed (X)		
Next Inspection				Sample No		As 0009		
Building		Quarantine Building		Item		Ceiling Boards		
Floor		0		Amount				
A - Product Type		B - Extent of Damage		C - Surface Treatment		D - Asbestos Type		
Insulating Board						No Asbestos Detected		0
Material Ass' Score = (A+B+C+D):		0		Risk Coding		Recommendation:		No recommendation required
Further Information:		Visually consistent with sample number 0009.

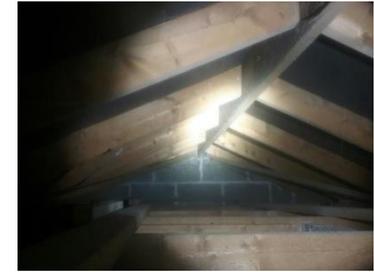
Surveyor		Andrew Stringer		Room / Area		008 - Roof Space		
Survey Date		19 October 2017		Level of Identification		Inspected Area		
Next Inspection				Sample No				
Building		Quarantine Building		Item		All Areas		
Floor		0		Amount				
A - Product Type		B - Extent of Damage		C – Surface Treatment		D – Asbestos Type		Accessibility
No Suspect Materials Seen						No Asbestos Detected		
Material Ass' Score = (A+B+C+D):		0		Risk Coding		Recommendation:		
Further Information:		Area visually inspected. No suspect materials seen.

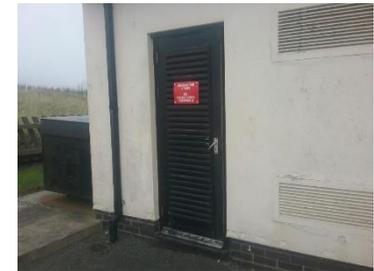
Surveyor		Andrew Stringer		Room / Area		009 - External		
Survey Date		19 October 2017		Level of Identification		Inspected Area		
Next Inspection				Sample No				
Building		Quarantine Building		Item		Doors		
Floor		External		Amount				
A - Product Type		B - Extent of Damage		C – Surface Treatment		D – Asbestos Type		Accessibility
No Suspect Materials Seen						No Asbestos Detected		
Material Ass' Score = (A+B+C+D):		0		Risk Coding		Recommendation:		
Further Information:		Area visually inspected. No suspect materials seen. No suspect seals or packers observed to all doors

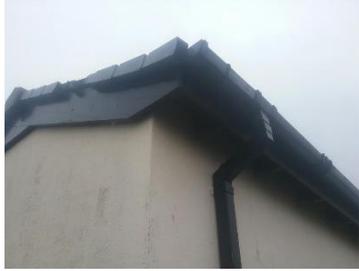
Surveyor		Andrew Stringer		Room / Area		009 - External

Survey Date		19 October 2017		Level of Identification		Inspected Area		
Next Inspection				Sample No				
Building		Quarantine Building		Item		Soffits And Fascias		
Floor		External		Amount				
A - Product Type		B - Extent of Damage		C - Surface Treatment		D - Asbestos Type		
No Suspect Materials Seen						No Asbestos Detected		
Material Ass' Score = (A+B+C+D):		0		Risk Coding		Recommendation:		
Further Information:		Area visually inspected. No suspect materials seen.

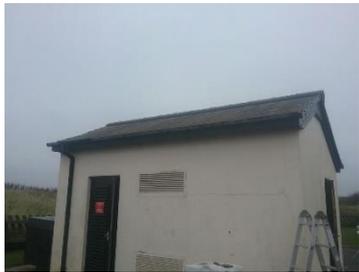
Surveyor		Andrew Stringer		Room / Area		009 - External

Survey Date		19 October 2017		Level of Identification		Sampled		
Next Inspection				Sample No		0010		
Building		Quarantine Building		Item		Roof Tiles		
Floor		External		Amount				
A - Product Type		B - Extent of Damage		C - Surface Treatment		D - Asbestos Type		
Cement Products						No Asbestos Detected		0
Material Ass' Score = (A+B+C+D):		0		Risk Coding		Recommendation:		No recommendation required
Further Information:

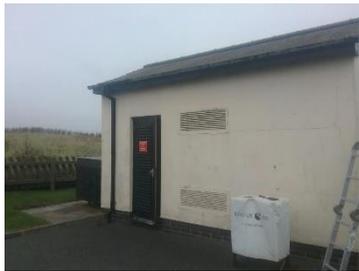
Surveyor		Andrew Stringer		Room / Area		009 - External

Survey Date		19 October 2017		Level of Identification		Sampled		
Next Inspection				Sample No		0011		
Building		Quarantine Building		Item		Wall Render		
Floor		External		Amount				
A - Product Type		B - Extent of Damage		C - Surface Treatment		D - Asbestos Type		
Plaster						No Asbestos Detected		0
Material Ass' Score = (A+B+C+D):		0		Risk Coding		Recommendation:		No recommendation required
Further Information:
