Survey of  
Asbestos Materials  
at

HELLESDON  
COMMUNITY CENTRE  
Norwich

Survey completed on : 08 April 2016

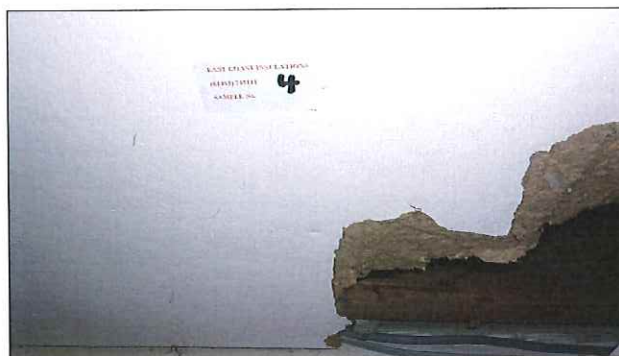
| <b>Photograph No:-</b><br><b>04</b> | | | | | <b>Sample No:-</b><br><b>HCC-04</b> | | | | |

| <b>Front corridor, old fibreboard ceiling above ceiling tiles</b> | A.I.B. | 4 | <input checked="" type="checkbox"/><br>Management | <input type="checkbox"/><br>Refurbishment/<br>Demolition | |

| <b>Damaged</b> | NO<br>0 | | MINOR<br>2 | | SEVERE<br>4 | | | | <input checked="" type="checkbox"/> |
| <b>General Condition</b> | GOOD<br>0 | | FAIR<br>2 | | POOR<br>4 | | <b>Laboratory Results</b><br><b>Fibreboard</b> | | |

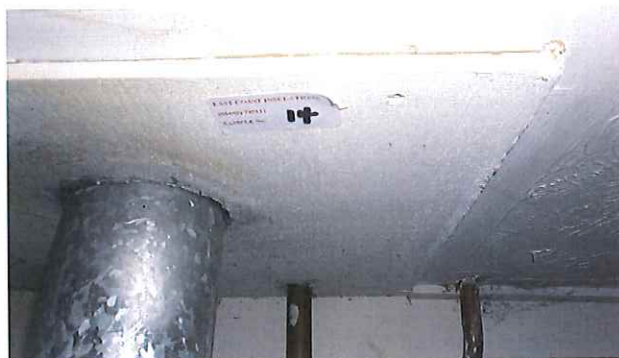
| <b>Photograph No:-</b><br><b>14</b> | | | <b>Sample No:-</b><br><b>HCC-14</b> | | | |

| <b>Damaged</b> | NO<br>0 | MINOR<br>2 | SEVERE<br>4 | | | <input checked="" type="checkbox"/> |
| <b>General Condition</b> | GOOD<br>0 | FAIR<br>2 | POOR<br>4 | <b>Laboratory Results</b><br><b>Insulating board</b> | | |
