STRUCTURAL REPORT 17 POPLAR CLOSE, LEEDS, LS13 4UQ

Client: Leeds Federated Housing Association
Project Name: 17 Poplar Close
Report Title: Retaining Wall Survey
Report Author: TH
Document ref: 00.21166-ACE-ZZ-ZZ-RP-S-0001
Date: 16/07/2021

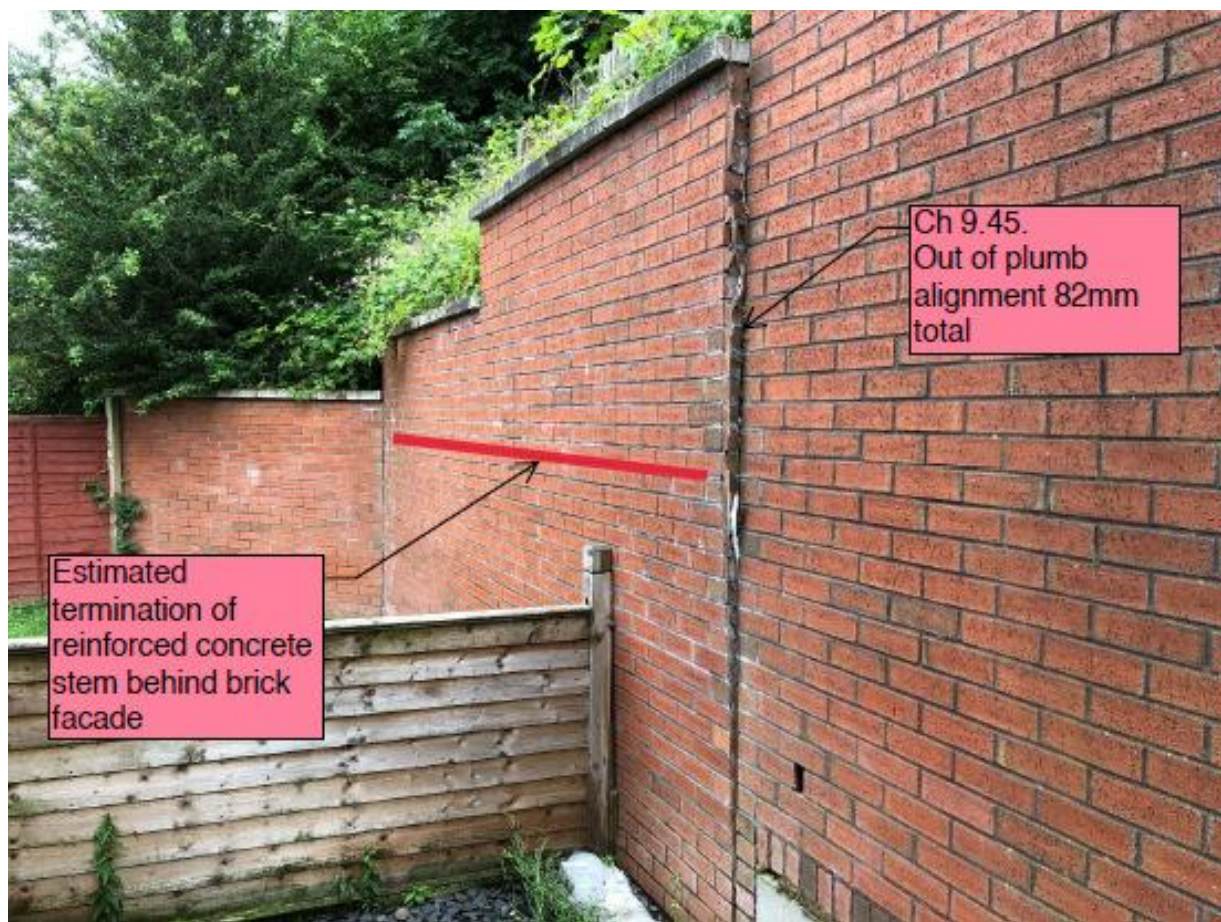
- 4.2. There appeared to be no movement at the base of the walls during inspection so it can be assumed that the movement is not down to overturning, sliding or bearing pressure failures.
- 4.3. The table shows that the section of the wall between CH 9.45 and CH 14.95 has displayed significant movement in the stem. The vertical alignment for the rest of the wall observed was within an acceptable limit.
- 4.4. From the results above it is apparent that the retaining wall is deflecting at an unacceptable level and that further investigation, and remedial works are required.

Photo 2 – Section wall showing movement

- 5.1. It is recommended that the brick outer leaf is removed for the area of wall that has shown movement to the stem ch 9.45m to 14.95m. The actual reinforced concrete stem can then be surveyed to establish the extent of damage and the possible causes of the failure. The backfill behind the wall would need to be removed prior to the removal of the brickwork to ensure the wall is not under load during the works.
- 5.2. Trial pits should be undertaken on the retained side to investigate the side of the wall that was not able to be observed during the inspection.
- 5.3. Trial pits will also need to be undertaken within the garden area of the property on the lower side to uncover the extent of the foundations of the wall.

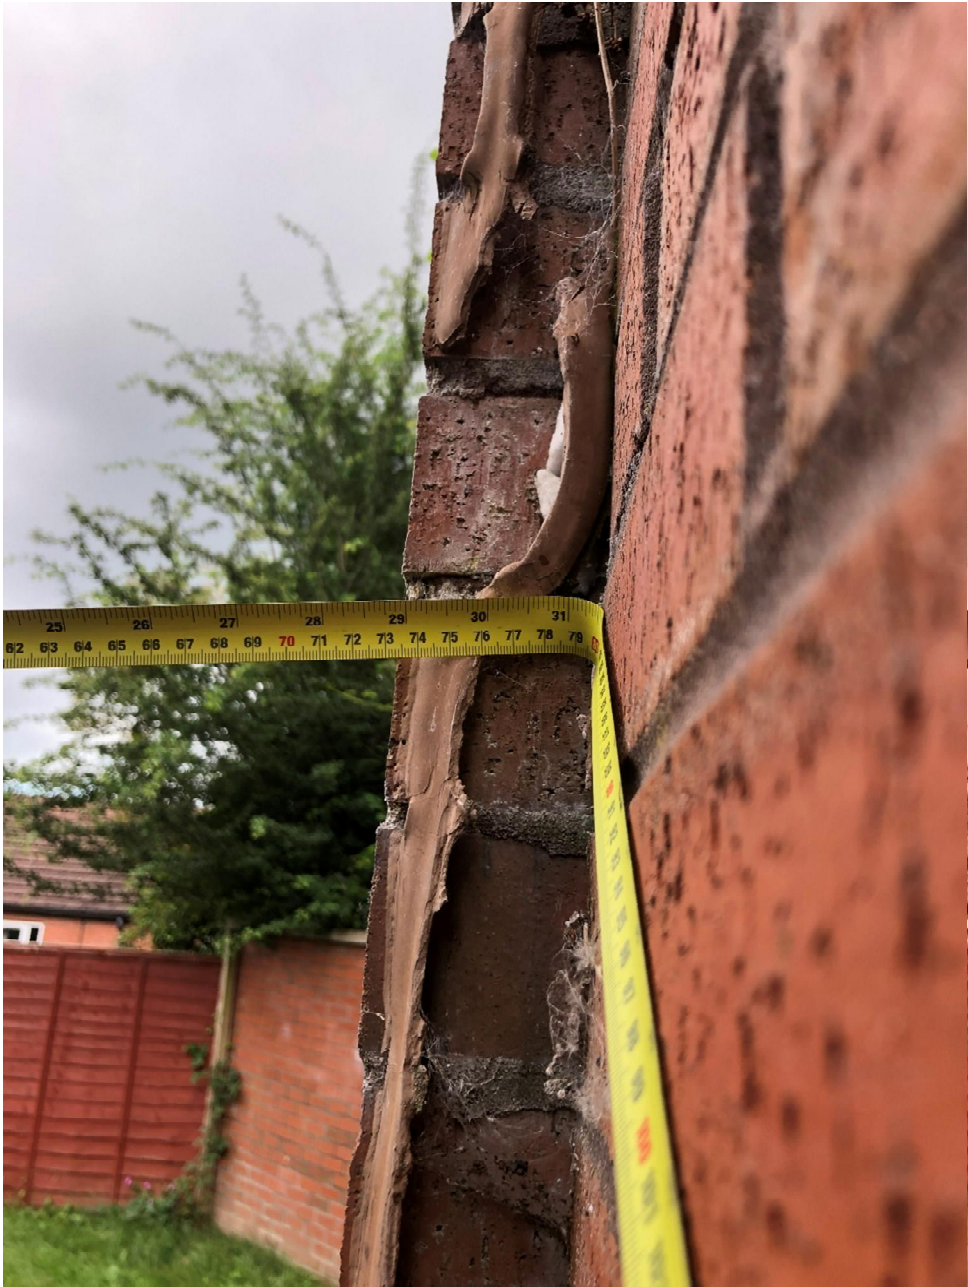
Photo 3 – extent of movement

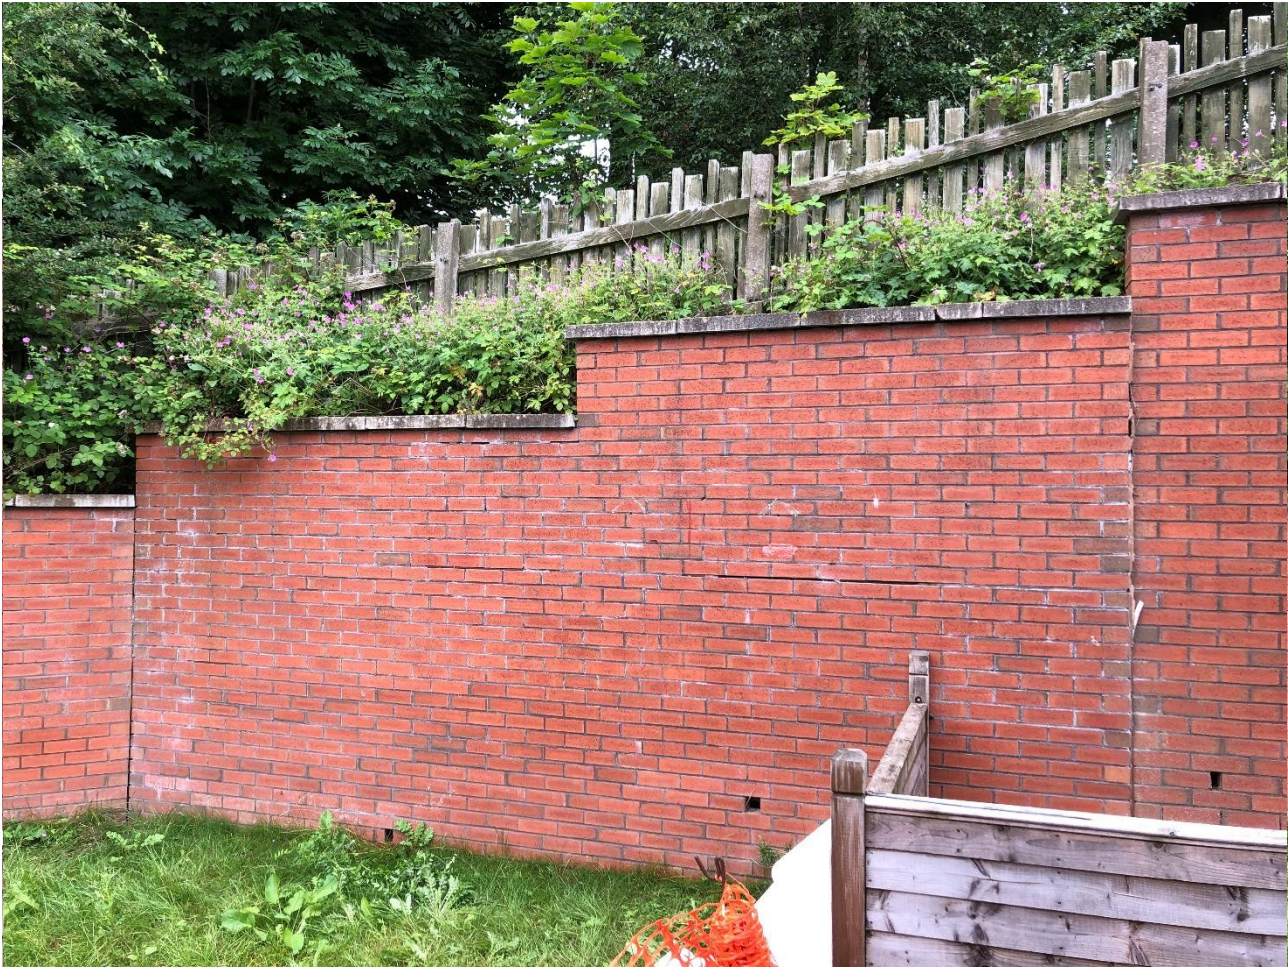
Photo 4 – Elevation of section under movement

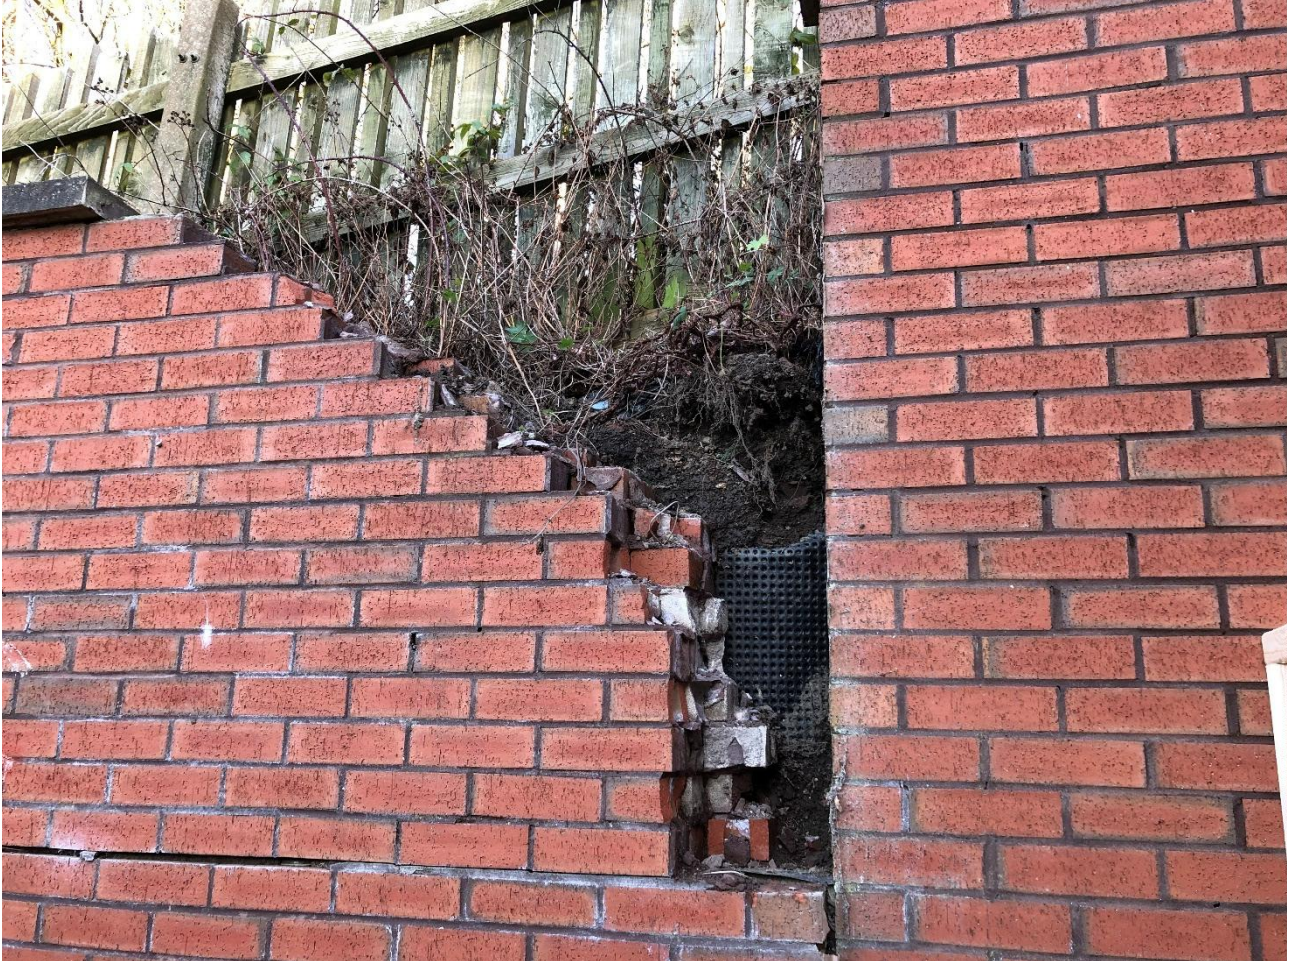
- 3.8. The masonry façade was removed to the level of the top of the concrete stem at ch 9.45m (see photo 8). The bricks were removed from the top of the wall to the top of the concrete stem (recorded at approx 1.525m above ground level).
- 3.9. In addition to the exposure of the stem, 2No. trial pits were dug at CH 9.45 and Ch 12.05 to investigate the extent and stability of the foundations.

Photo 8 – Level of the top of concrete stem

- 5.4. It is recommended that the brick leaf between CH 9.45 and 14.95 be taken down and rebuilt. Refer to appendix B for sketch detail. Provide a 150mm thick concrete stem from the top of the existing concrete stem, reinforced with 1No. layer A393 mesh.
- 5.5. The proposed concrete stem is to be dowelled into the existing concrete stem with B10 bars at 200mm centres. The embedment (in both existing and proposed concrete) should be min. 200mm.
- 5.6. The brick face is to be taken down (to ground level) and rebuilt to the top of the wall. Tie back to concrete stem using Ancon 36/8 wall extension system or similar.

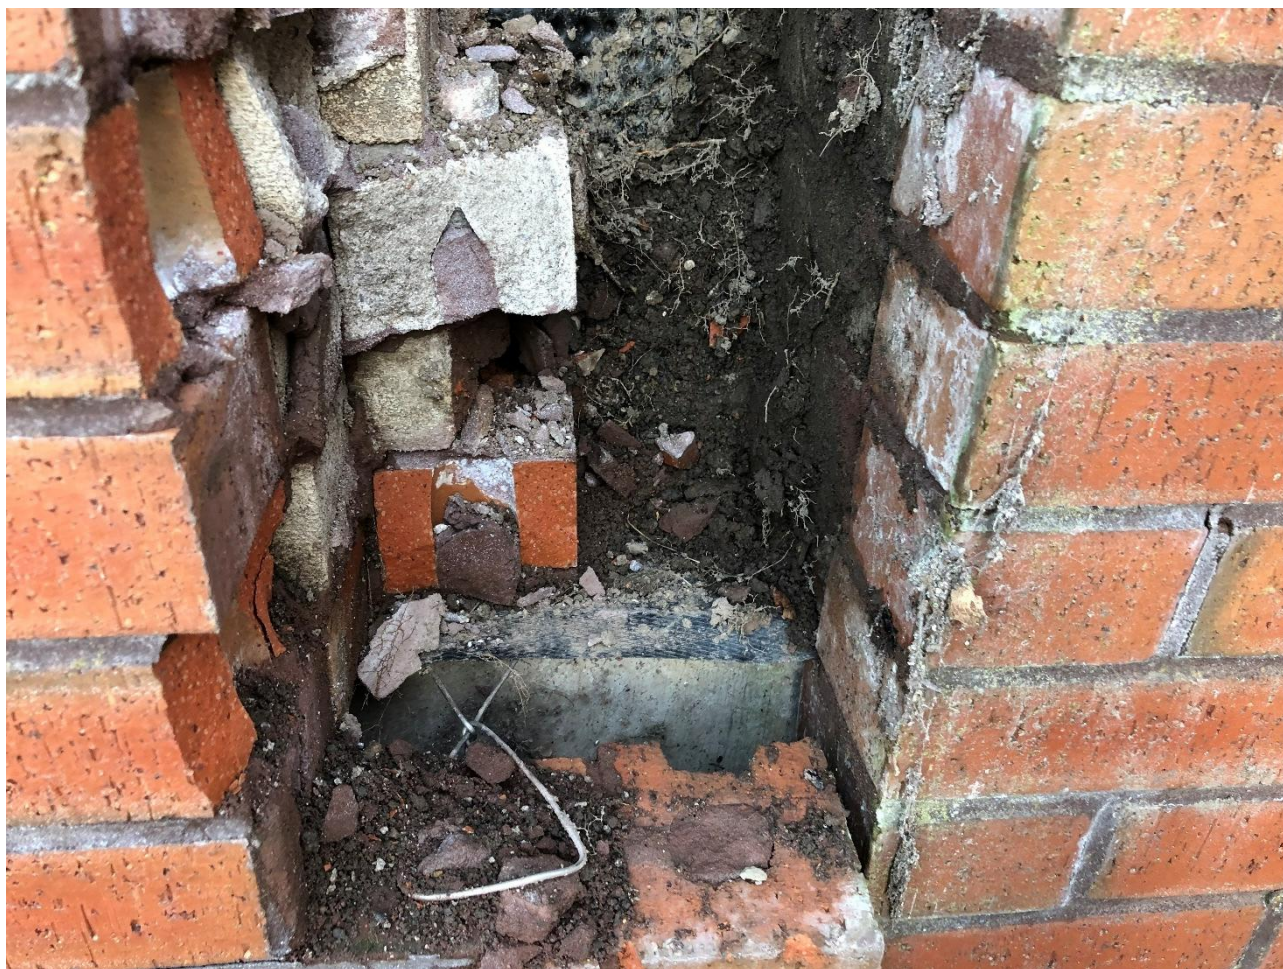
- 4.5. The exposed concrete stem behind the brick façade appeared to be in the original position from when it was constructed. The brick façade only had been observed to have bowed away from the retaining structure, moving independently from the stem.
- 4.6. The trial pits revealed the foundations at the front of the retaining structure (the foundations at the back were inaccessible due to the dense vegetation on the steep slope of the retained side).
- 4.7. The foundations were in good condition when observed. The concrete footing was found to extend approx 620mm from the edge of the brick leaf.

Photo 9 – Close up of exposed concrete stem

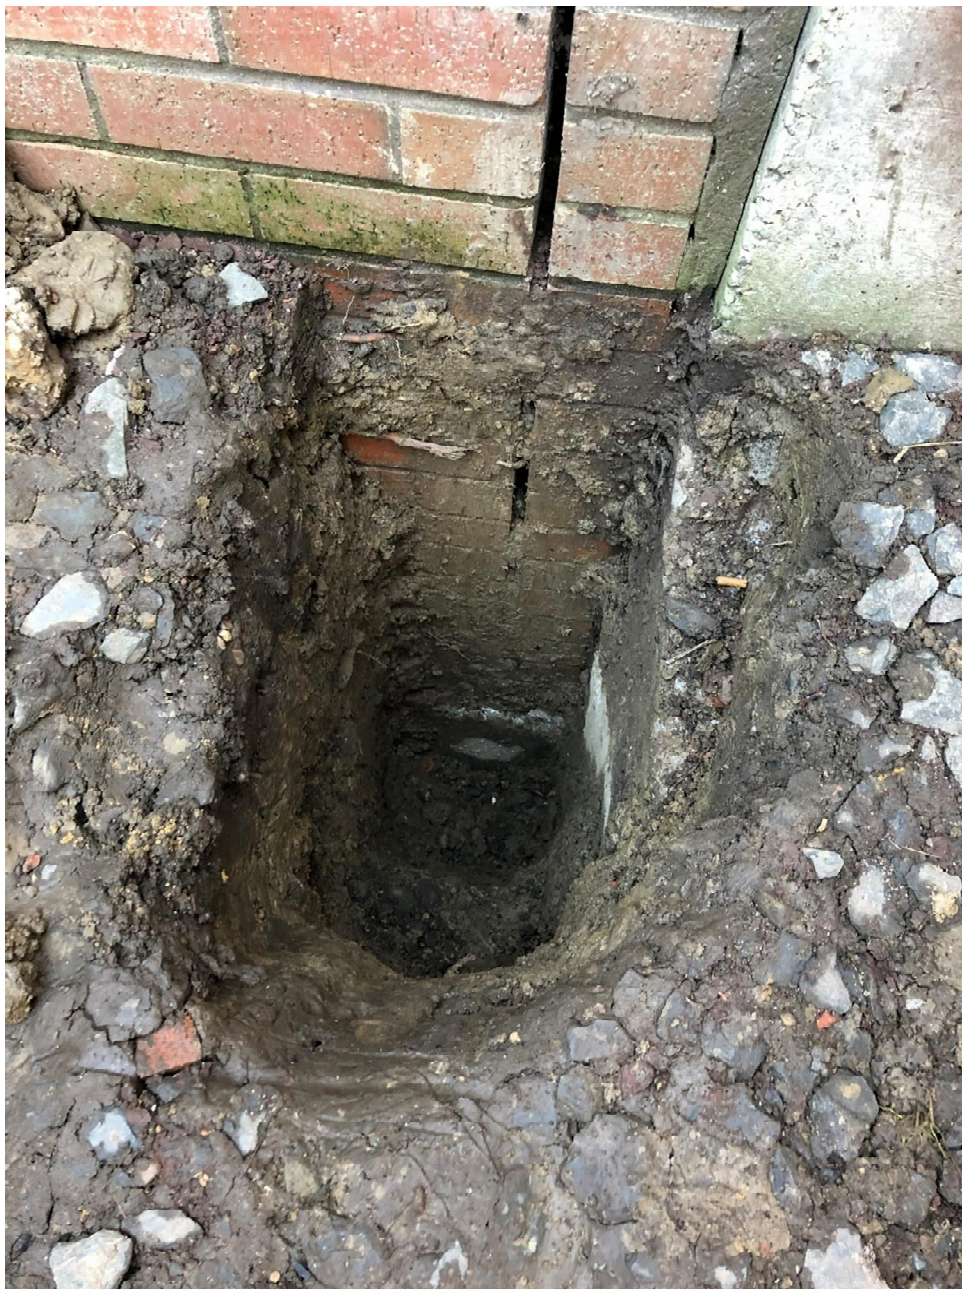
Photo 10 – Trial Hole at CH 9.45

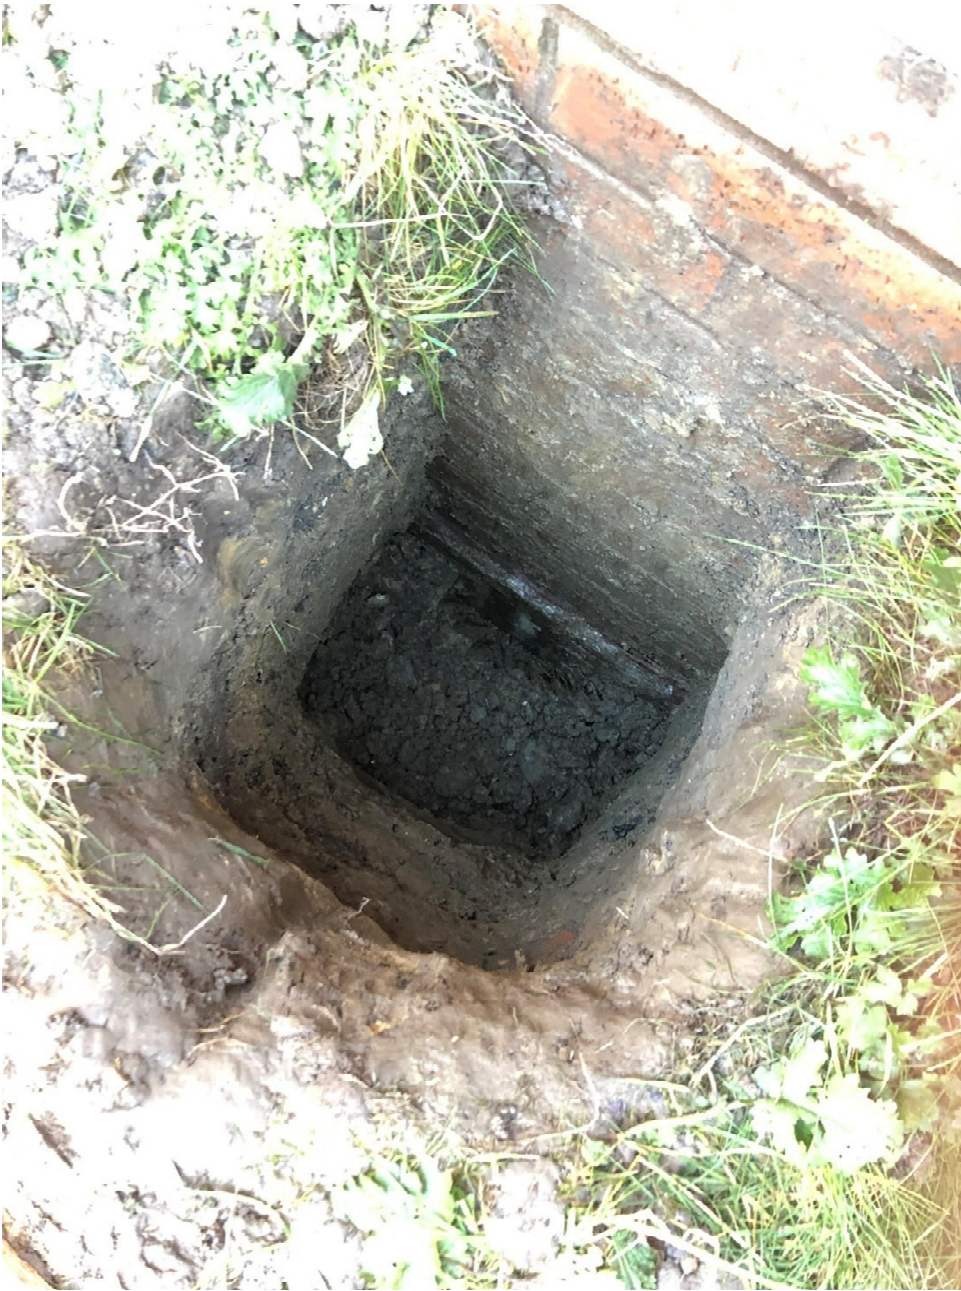
Photo 11 – Trial Hole at CH 12.05
