Asbestos Survey & Report

Bat And Ball Station

No: 473

Railtrack - Southern Asbestos Survey on

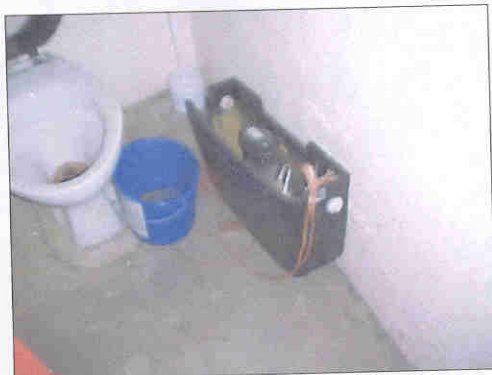
Platform, Platform Level, Toilets

General		Sample Details	
Component:	Cistern	Ref. No:	473/01a
Survey Date:	17/03/99	Asbestos?	NO
Survey/Inspection:	Survey	Type:	No asbestos
Surveyor:	TH	Analysis:	N/A

Condition:	Good	Access:	Maintenance
Friability:	Low	Exposure:	Maintenance
Sealant:	Fully sealed	Approximate amount:	1 m ²
Position:	Internal	RISK:	NONE

Cistern in disused toilets in station

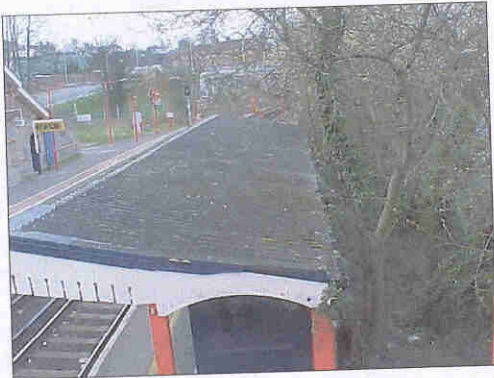
Platform 1, Platform Level, Shelter#1

General		Sample Details	
Component:	Roof	Ref. No:	473/02a
Survey Date:	17/03/99	Asbestos?	YES
Survey/Inspection:	Survey	Type:	Chrysotile
Surveyor:	TH	Analysis:	Significant (2-50%)

Condition:	Fair	Access:	Maintenance
Friability:	Low	Exposure:	Public
Sealant:	None	Approximate amount:	60 m ²
Position:	External	RISK:	LOW

cement roofing sheets to platform 1 shelter

SHELTER: AC roof sheets
Recommendation: label and inspect

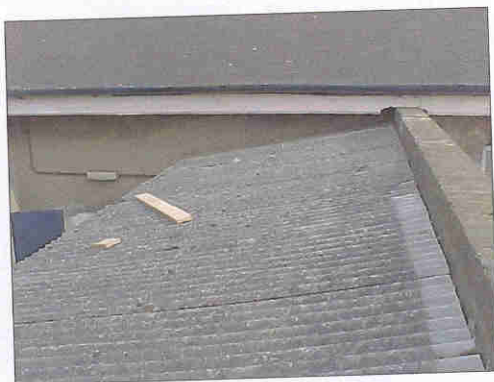
Platform 1, Platform Level, Disused gents toilets

General		Sample Details	
Component:	Roof	Ref. No:	473/03a
Survey Date:	17/03/99	Asbestos?	NO
Survey/Inspection:	Survey	Type:	No asbestos
Surveyor:	TH	Analysis:	N/A

Condition:	Fair	Access:	Maintenance
Friability:	Low	Exposure:	Maintenance
Sealant:	None	Approximate amount:	10 m ²
Position:	External	RISK:	NONE

Cement roof sheets toilets in disused gents toilets

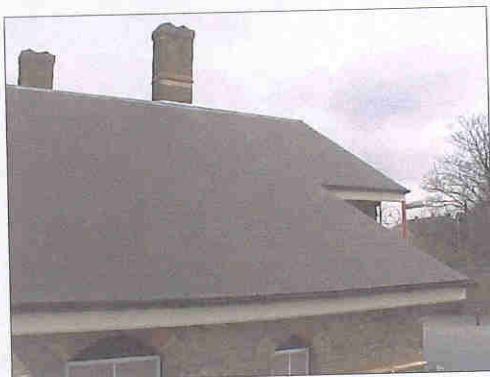
Roof, Roof, Station Building

General		Sample Details	
Component:	Roof Slates	Ref. No:	473/04a
Survey Date:	17/03/99	Asbestos?	YES
Survey/Inspection:	Survey	Type:	Chrysotile
Surveyor:	TH	Analysis:	Significant (2-50%)

Condition:	Good	Access:	Maintenance
Friability:	Low	Exposure:	Maintenance
Sealant:	None	Approximate amount:	300 m ²
Position:	External	RISK:	LOW

Cement roof slates to station building

STATION BUILDING: AC roof slates
Recommendation: label and inspect
