Condition Survey of Significant Fabric

Radford House (Former Ramsgate Fire Station),
18 – 20 Effingham Street, Ramsgate CT11 9AT

For Ramsgate Town Council

May 2020

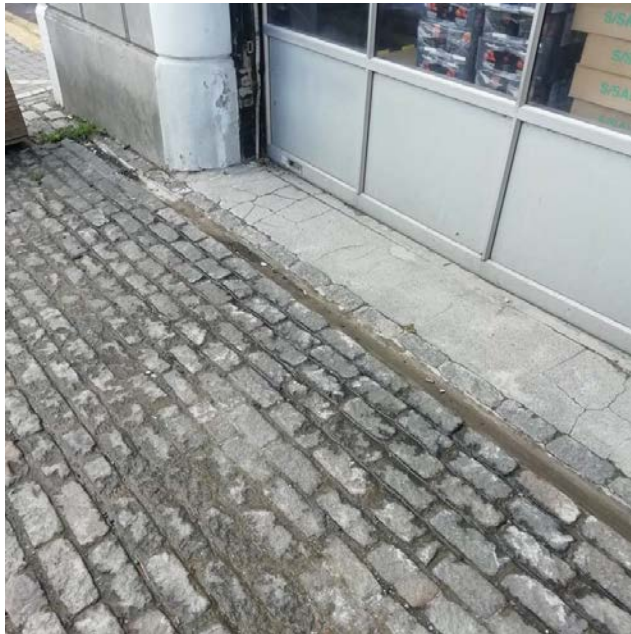
The front forecourt of the Radford House has granite setts, they appear to be original and are evidenced in the historic record photograph of the fire station shortly after its opening in 1905. The front threshold appears to be later concrete; it has many cracks from use and should be repaired on a 'like for like' basis.

Figure 1 - Front forecourt entrance paving and condition of threshold.

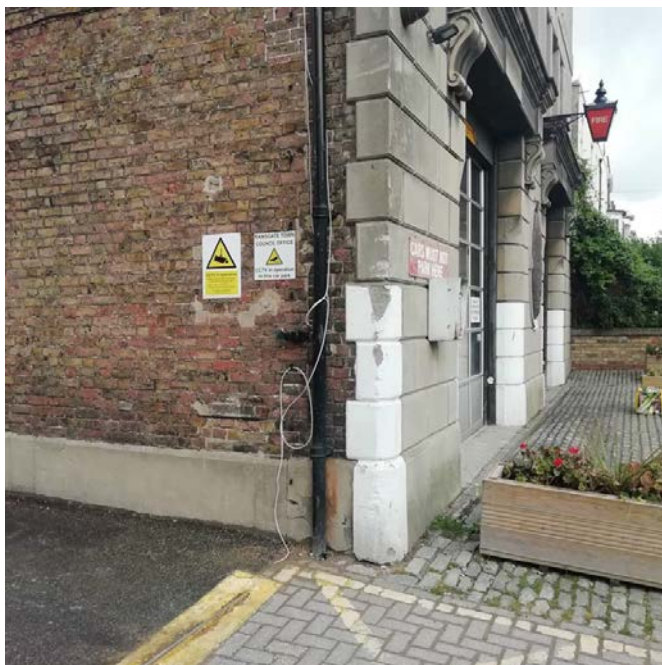
Figure 2 - South east facing elevation damage to render arris

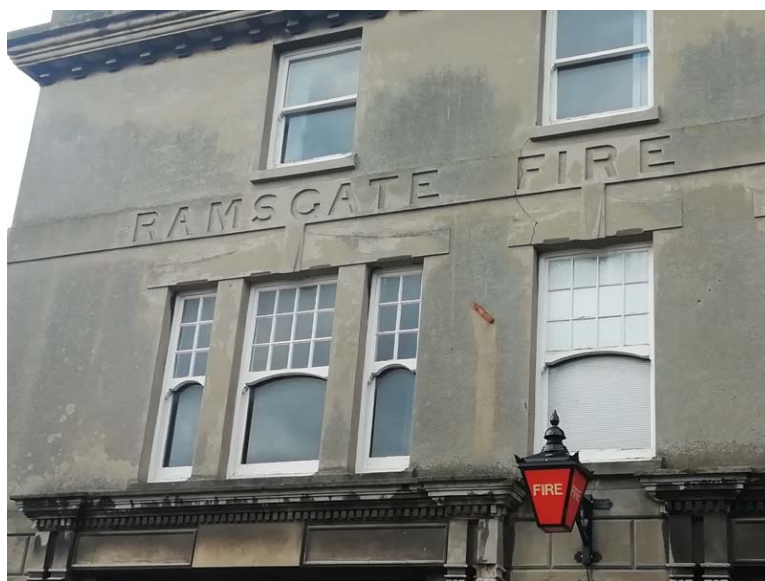
The render to the front façade is likely to conceal the original brickwork of the 18th century house and the fenestration pattern of that period. The render has what appears to be a significant crack to the front façade (below the plat band with the incised lettering). There are other isolated cracks to the front elevation render and to the render and moulding details at the rear bay, cills and areas of damage noted from general wear and tear. Some areas of run render detail to the rear bay window have failed and the solid masonry mullions have lateral cracking and loss. The render is quite heavily stained to the cornices above the two entrance doors to the appliance bay/engine house; this would benefit from a light clean as identified in the Executive Summary in Section 2.

Figure 3 - Typical façade cracks to render to front facade

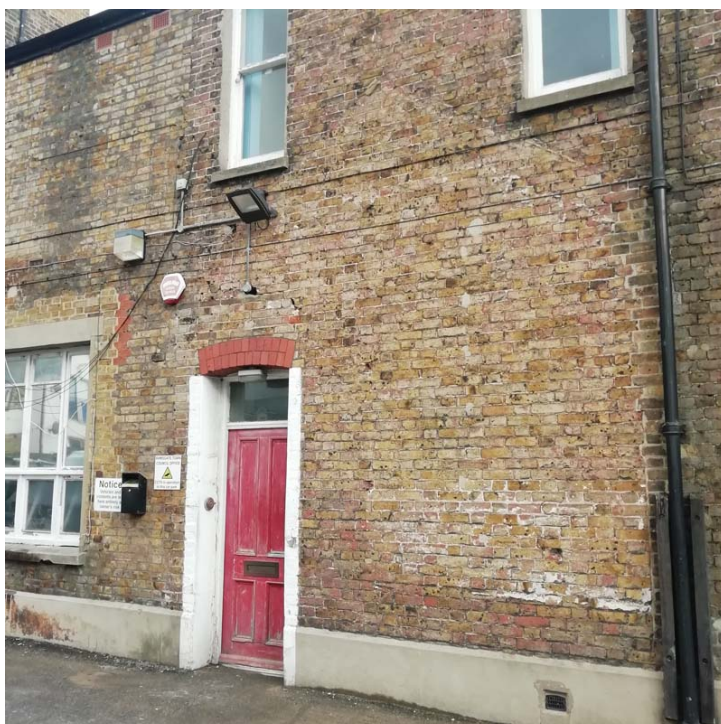
Figure 4 - Scar of former annexe, modern services and areas of re-pointing and light cleaning required to south east facing elevation

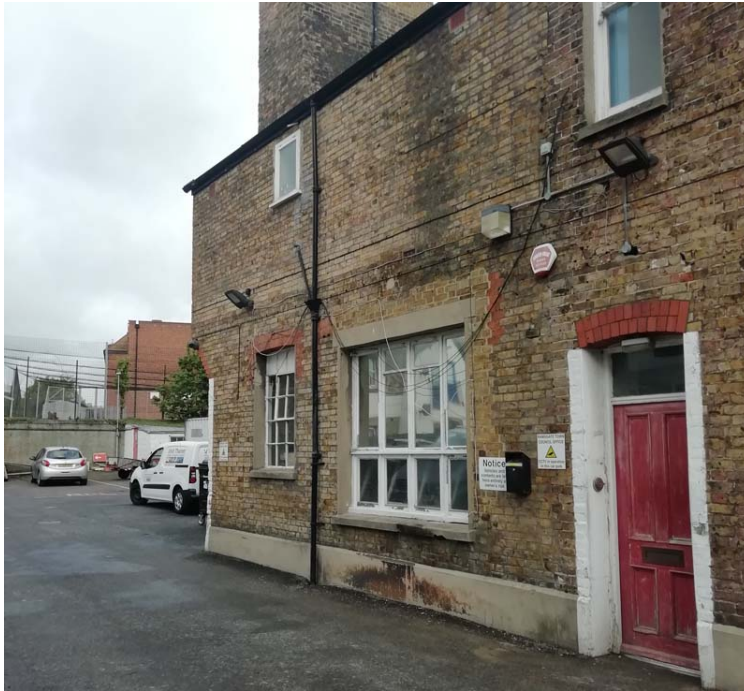
Figure 5 - Typical of areas requiring a light clean to the façade brickwork to south east facing elevation

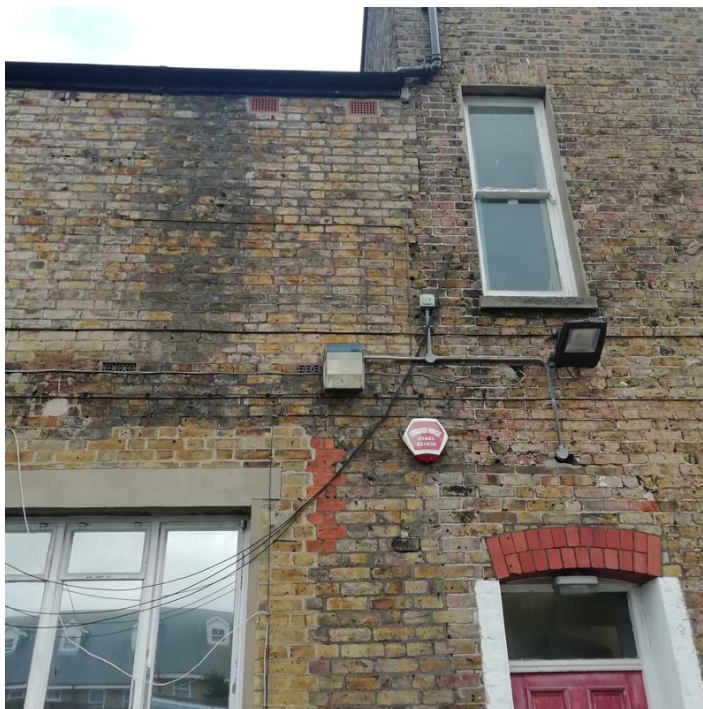
Figure 6 – Evidence of additional storey to rear wing and brickwork requiring re-pointing to south east facing elevation

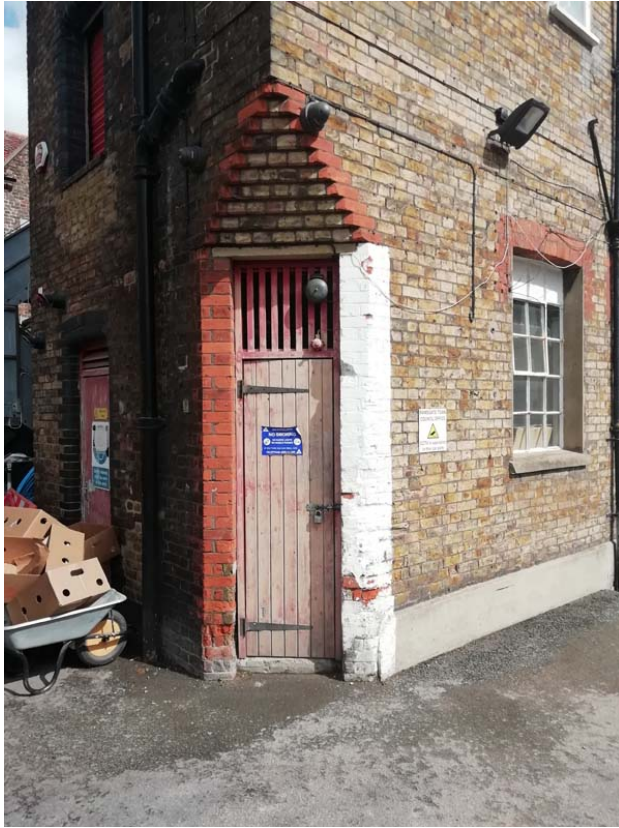
Figure 7 – Typical damage to brickwork adjacent to doorway

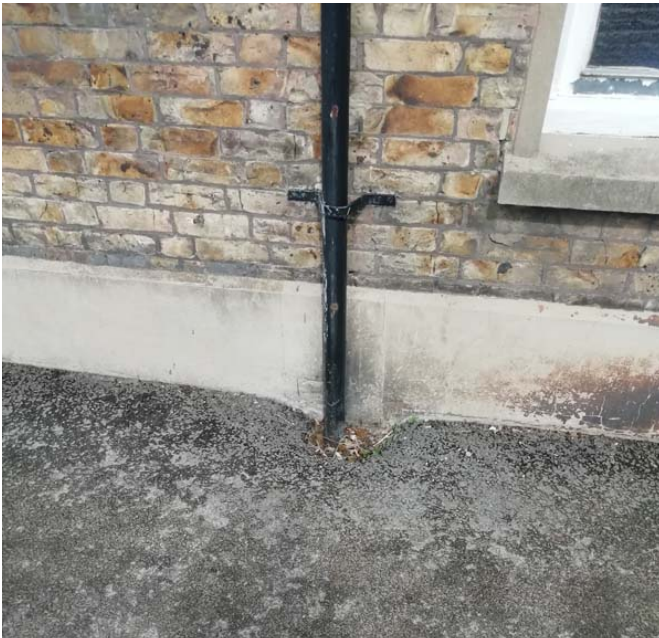
Figure 8 – Typical example of gully to south east facing façade requiring regular maintenance to keep clear of debris

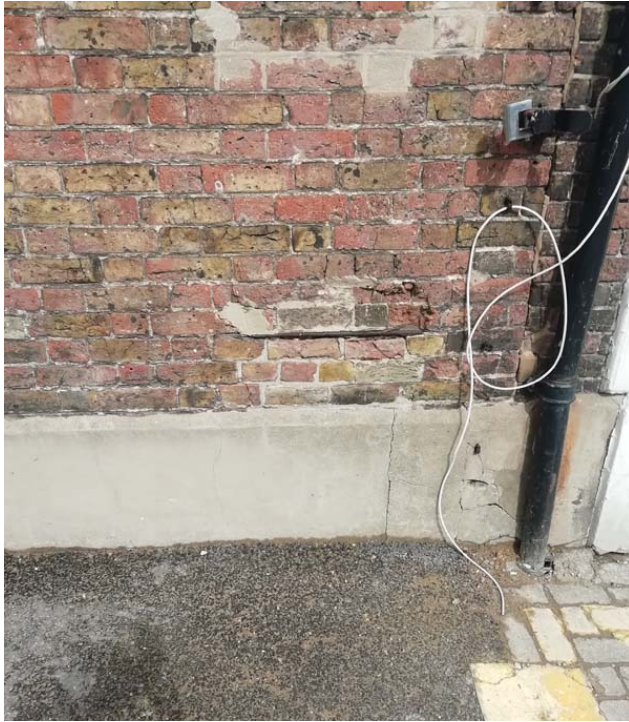
Figure 9 – Typical repairs required to brickwork and render to south east facing elevation

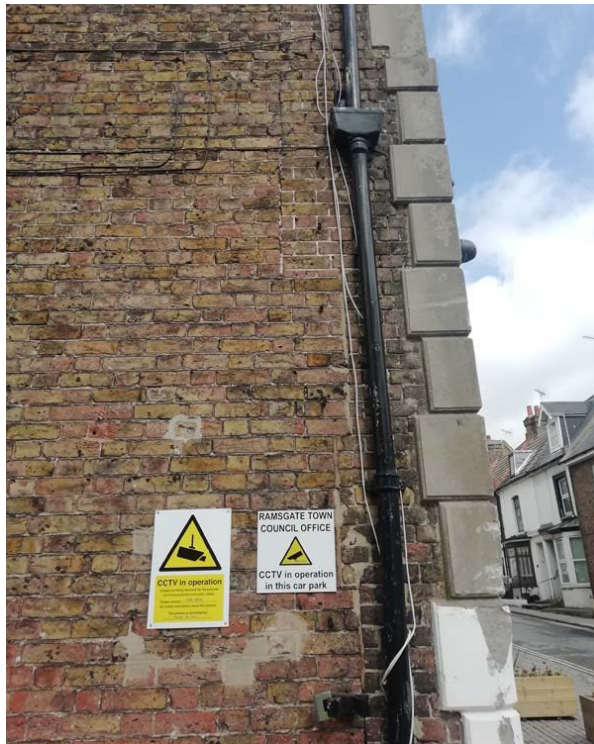
Figure 10 – Evidence of historic work to the façade, modern services and typical condition of rainwater goods to south east facing elevation

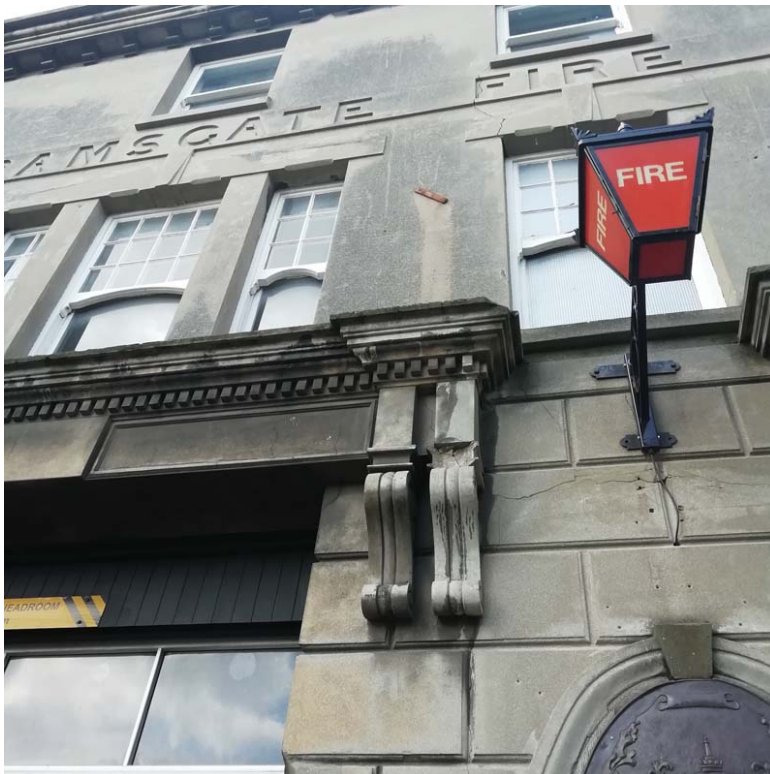
Figure 12 – Typical damage to cornice and light cleaning required to front elevation and replica light fitting. Crack to façade render.

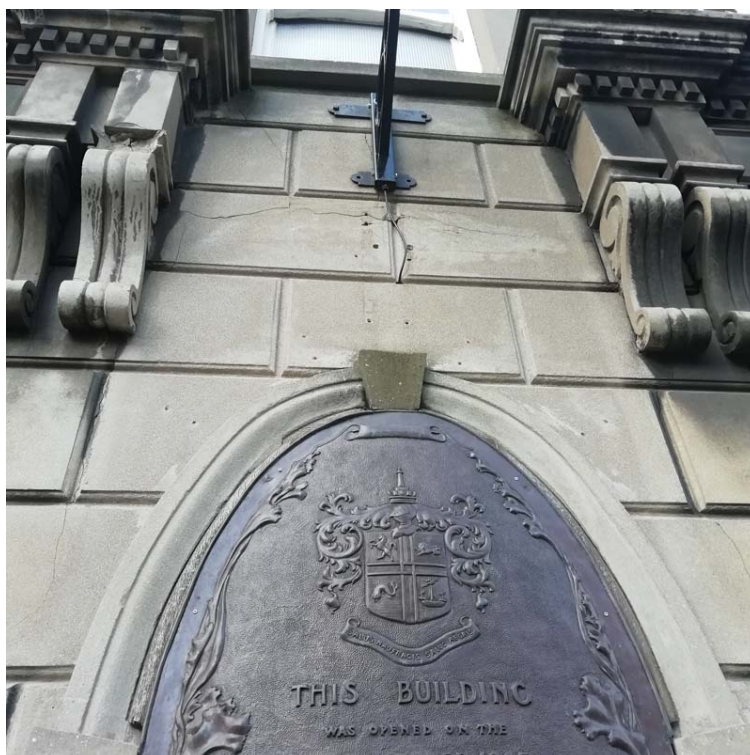
Figure 13 – Former fixing holes to lantern and isolated repairs to replica plaque to front facade

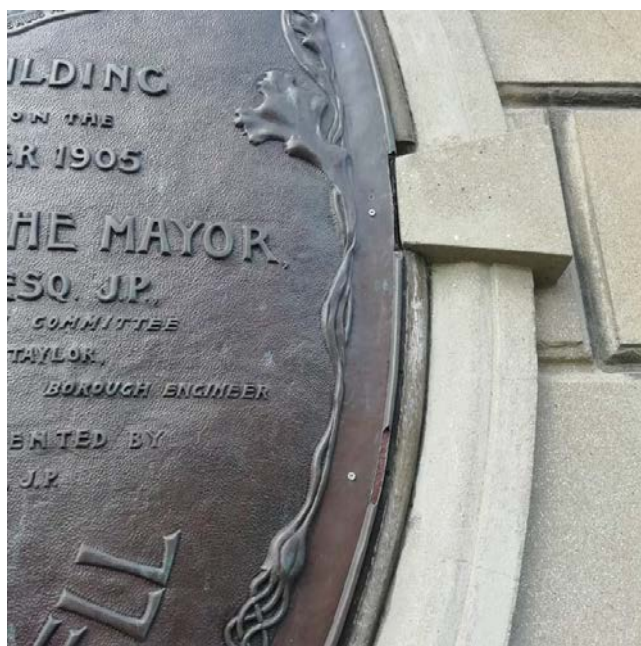
The existing replica plaque externally, is in reasonably good condition although the timber surround should be monitored as it has some open joints and is unfinished. The bronze cartouche has some localised loss of detail to the surround moulding of the cartouche.

Figure 14 – Typical example of localised damage to replica plaque

and condition of timber surround bead to front façade.

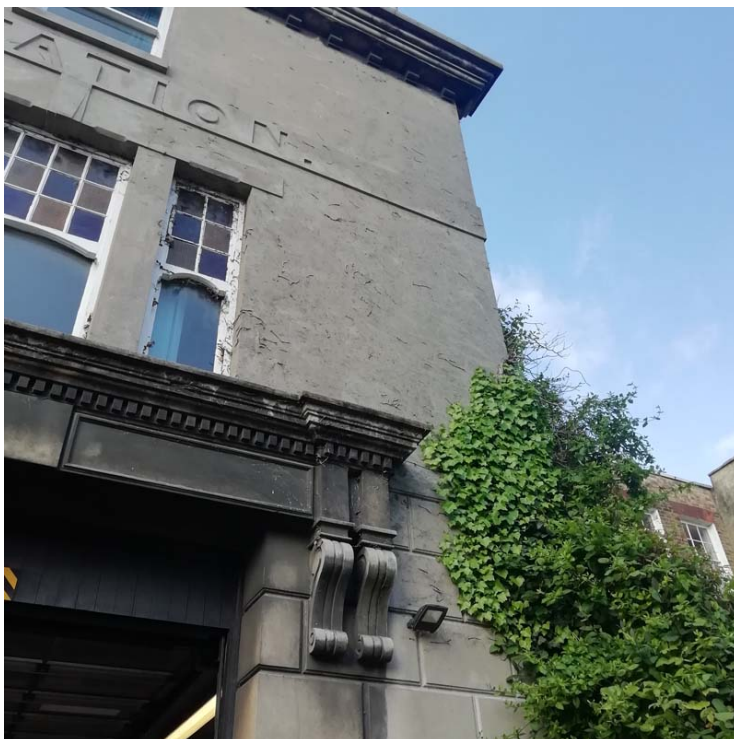
Figure 15 – Typical example of remaining vegetation and new growth to front façade

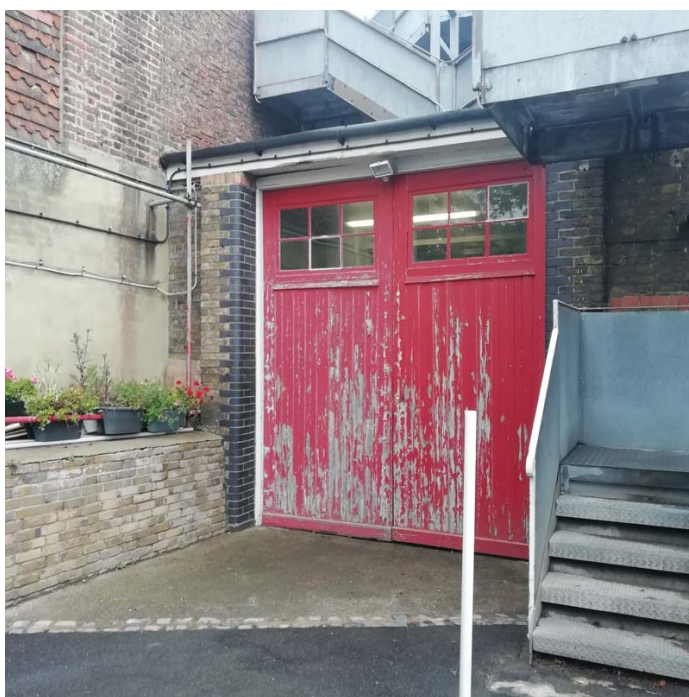
Figure 16 – External condition of rear doors

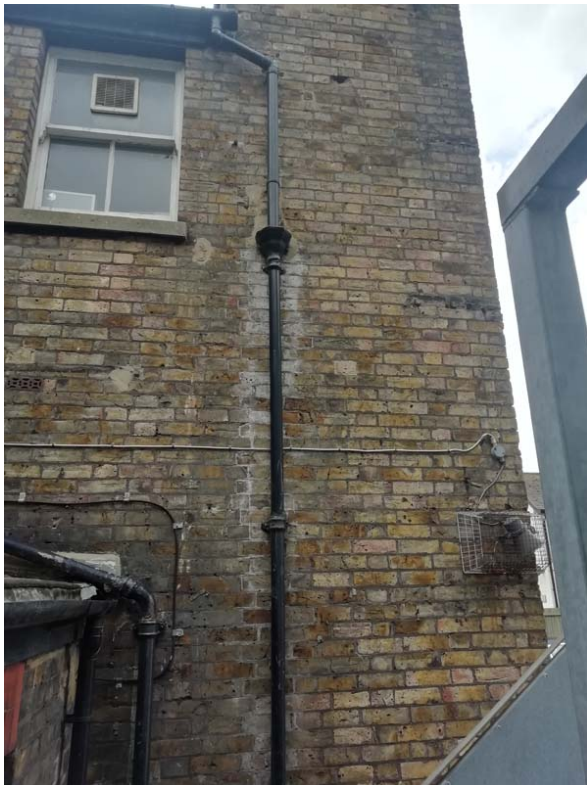
Figure 18 – Typical example of modern vent to window and efflorescence to north west facing façade brickwork

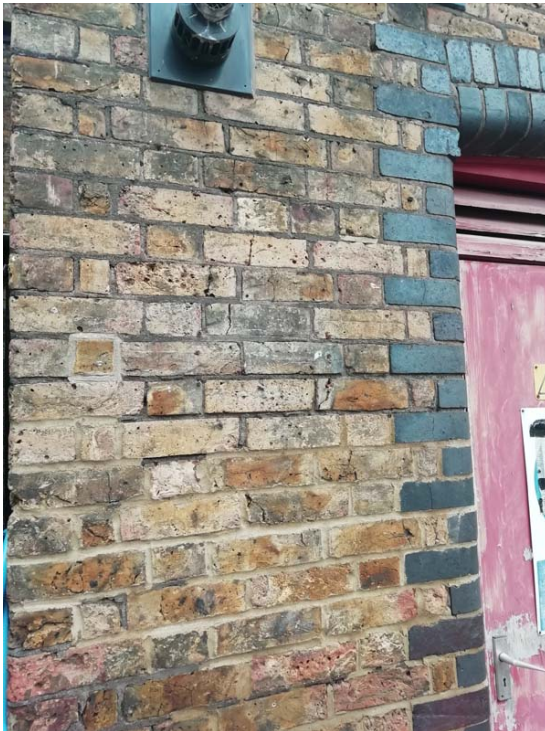
Figure 19 – Typical example of cracked bricks, modern re-pointing and 'hungry' mortar joints to rear south west facing elevation.

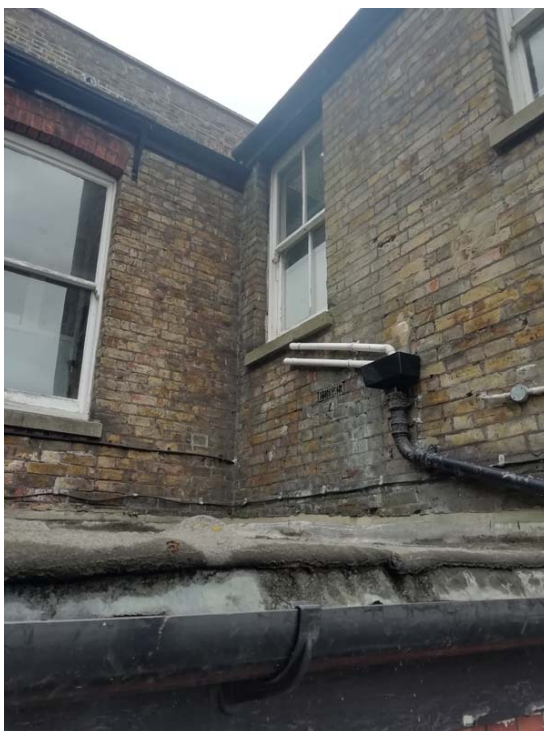
Figure 20 – Typical example of efflorescence and existing condition of asphalt roofs to modern additions at rear.

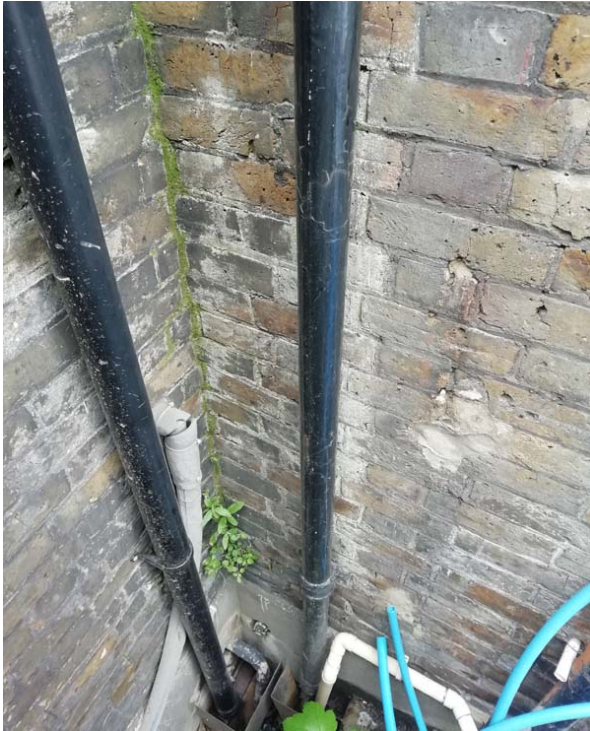
Figure 21 – Typical example of localised vegetation and condition of external gullies at the rear

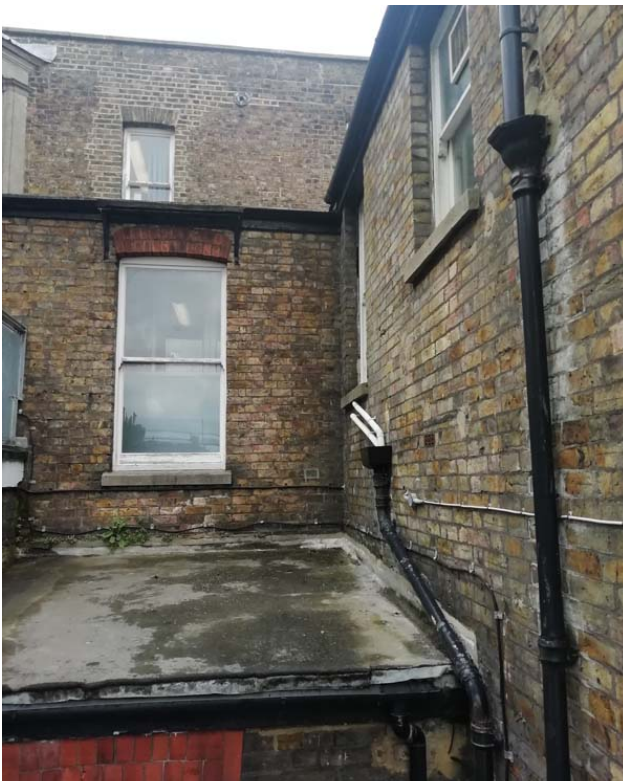
Figure 22 – Hood detail to existing rear window suggesting gutter is inefficient

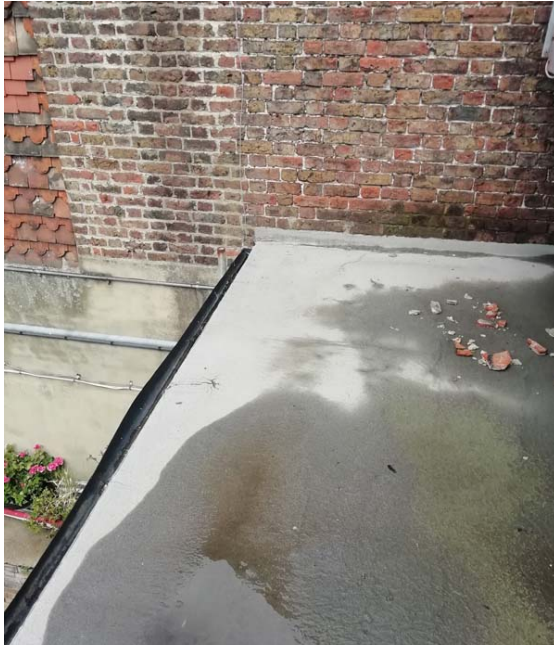
The lower single storey annexes to the rear are generally asphalt and this looks to be in reasonably condition but with larger areas of ponding which are a concern and may cause leaks to occur if not

remedied or replaced with new coverings. The verge at the gutter shows signs that the asphalt has crept towards the gutter line and this can also cause issues with regards to efficient draining of surface water from the roof.

Figure 23 – Typical condition of modern asphalt roofs with ponding and debris from damaged part wall with No.22

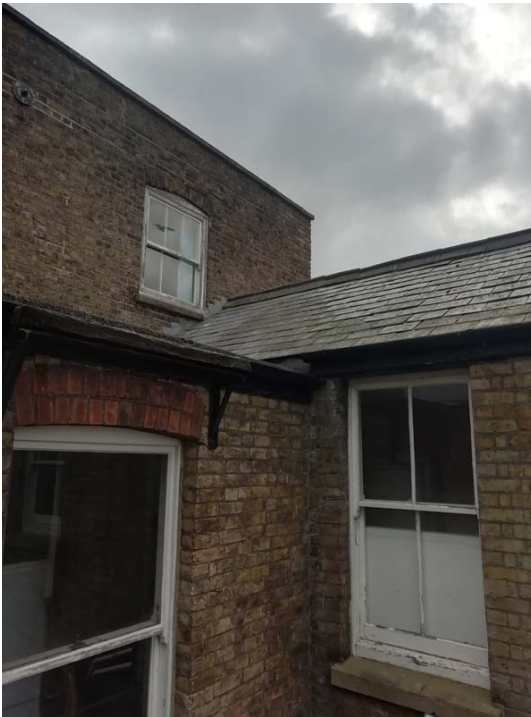
Figure 24 – Typical examples of existing condition to painted timber windows

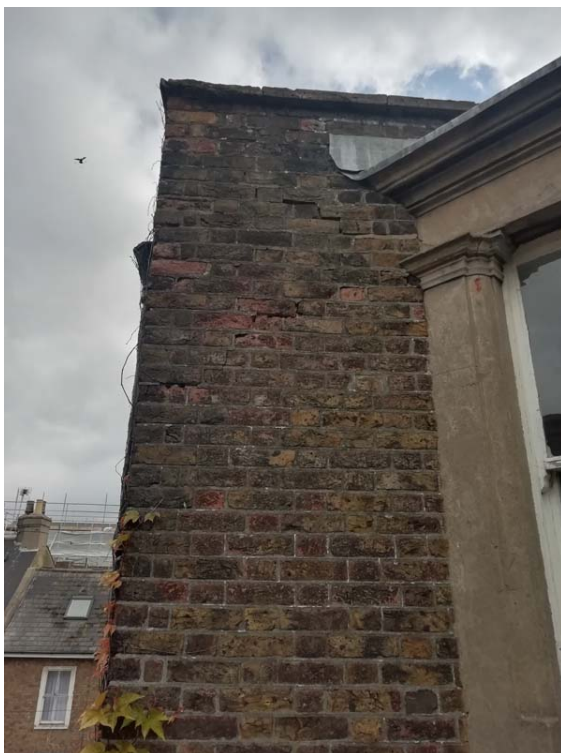
Figure 25 – Typical condition of brickwork with extant tuck pointing and coping with Virginia Creeper re-establishing to rear south west facing elevation

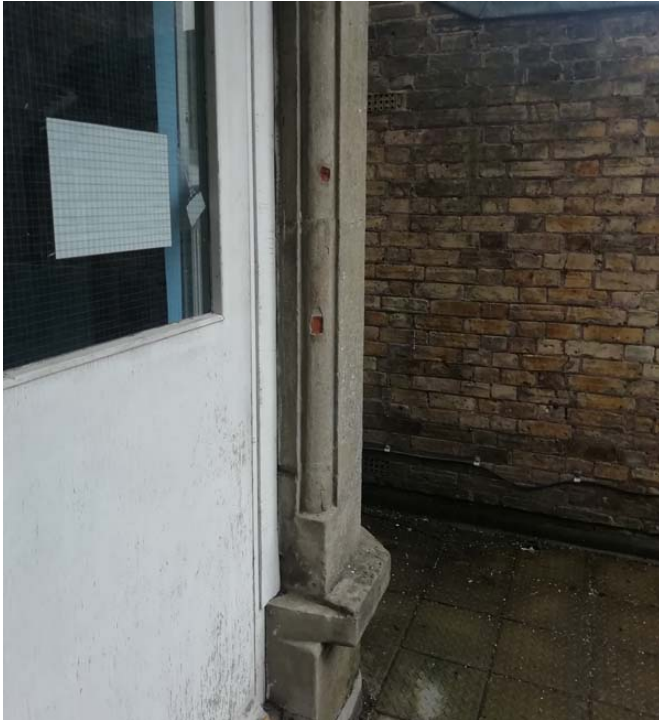
Figure 27– Typical example of repairs required to render of rear bay window details indicating underlying red brick at first floor

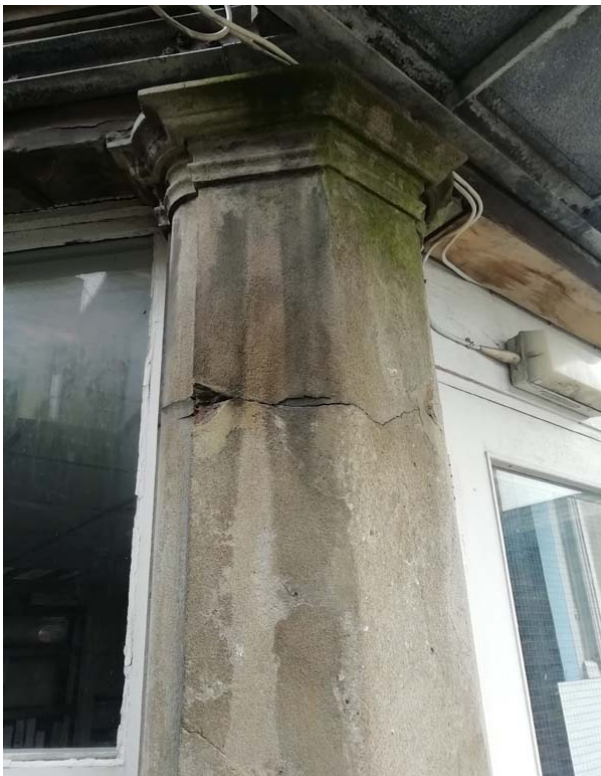
Figure 28 – Typical cracks to render details of rear bay window at first floor

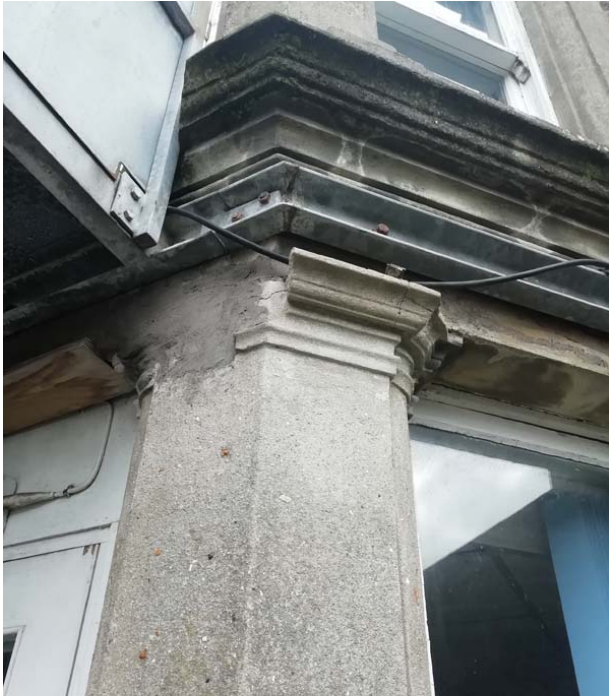
Figure 29 – Typical loss of render cornice detail to rear bay window at first floor

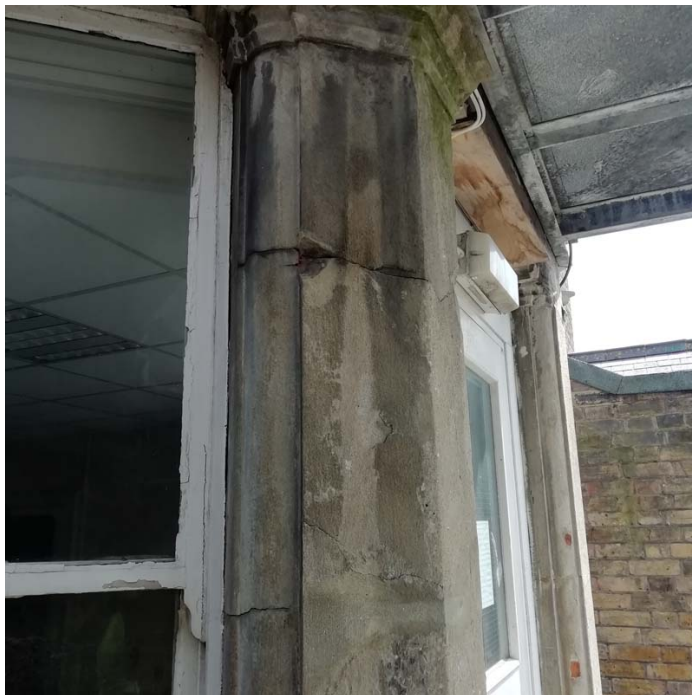
Figure 30 – Typical detail of cracks to rear bay window render at first floor

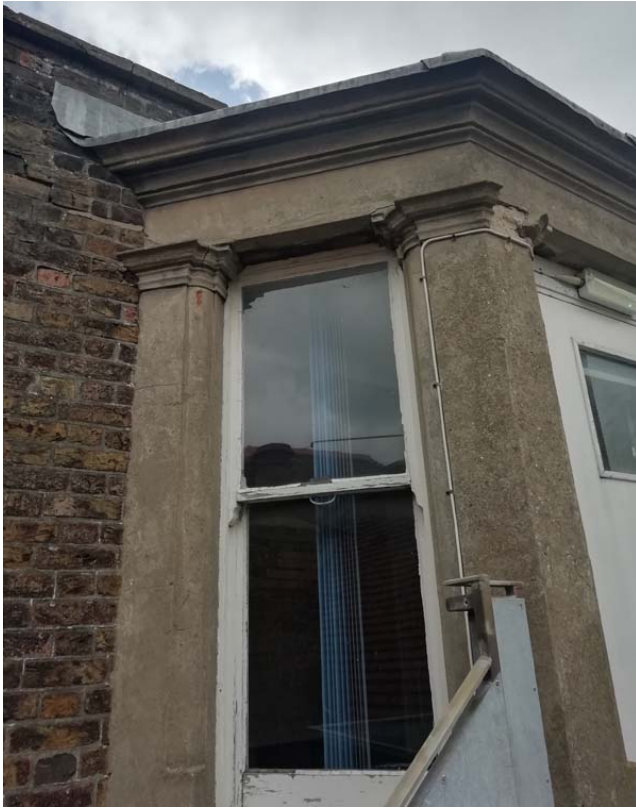
Figure 31 – Typical condition of rear bay windows and loss to detail of render to second floor

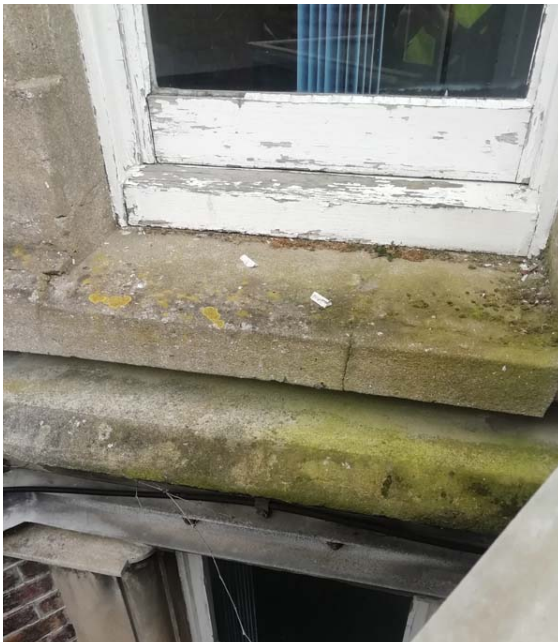
Figure 32 – Typical crack to rear bay window cill to second floor

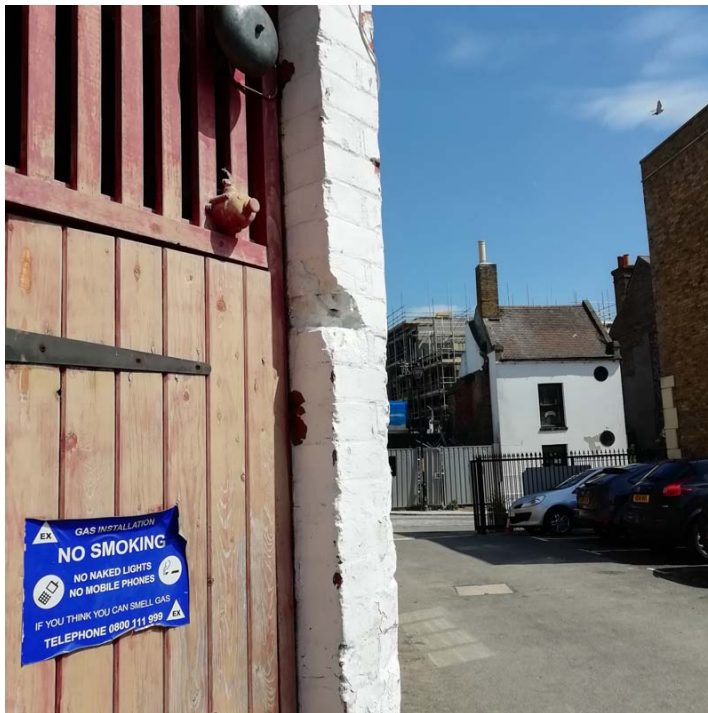
Figure 34 – Typical example of damage to brickwork to south east facing elevation

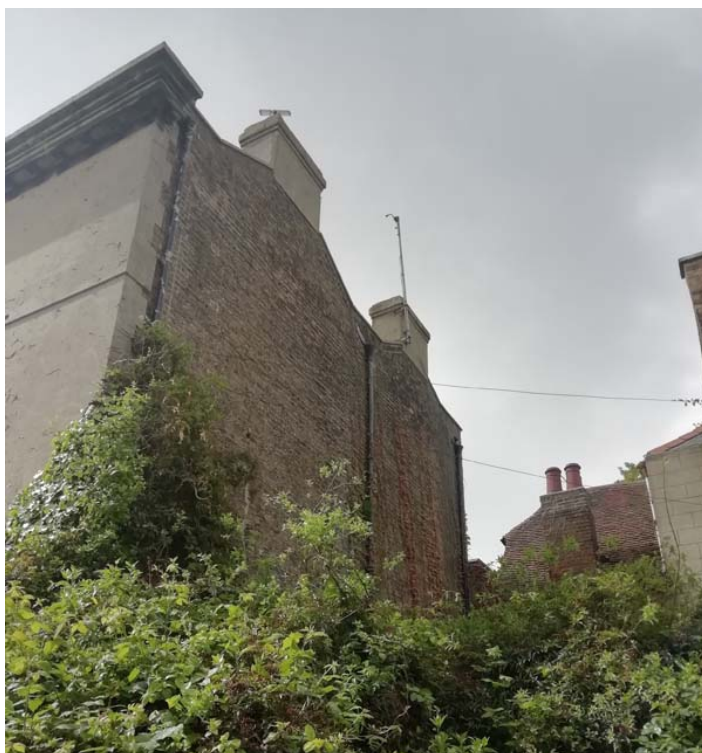
Figure 36 – North west facing façade with Virginia Creeper re-establishing, condition of rainwater goods and the lower section not currently visible to establish its condition. Loss of chimney pots.

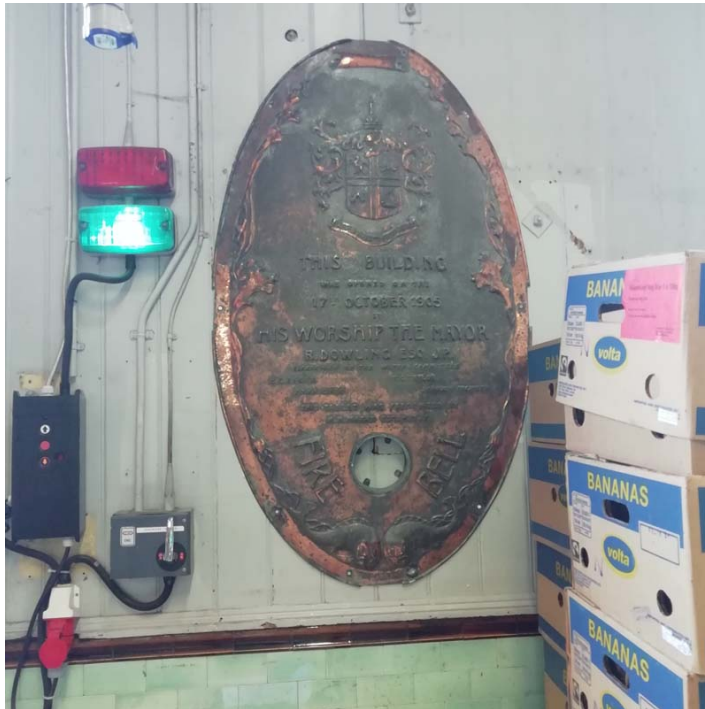
Author
Figure 37 – Condition of the original plaque to Ground floor 00-01

The original plaque is located on the inner face of the external wall of the main façade. It needs to be cleaned and properly assessed by a suitably qualified and experienced metal conservator and a decision made as to how it will be best retained within the building and on display; without its condition deteriorating further.

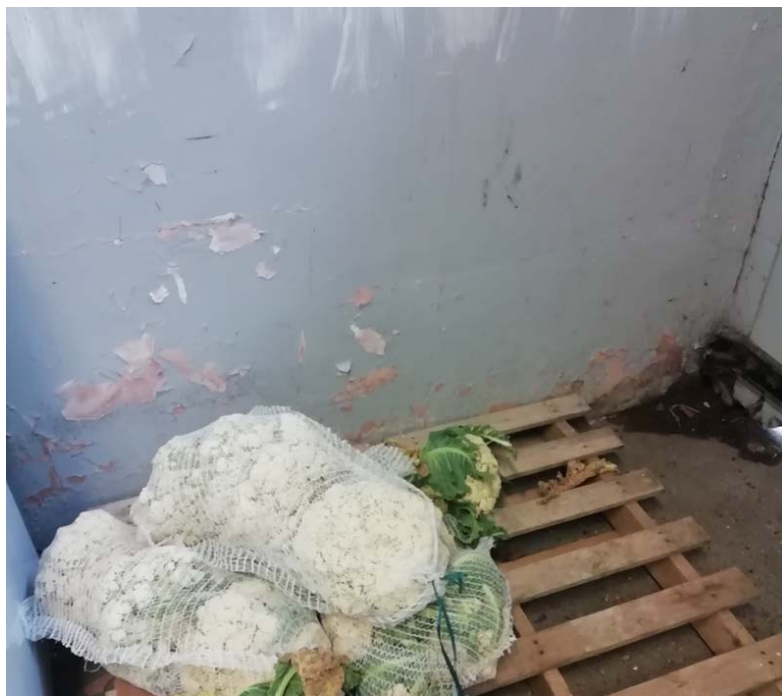
Figure 44 – Typical example of hygroscopic salts to base of wall with modern gypsum plaster – Ground Floor 00-01

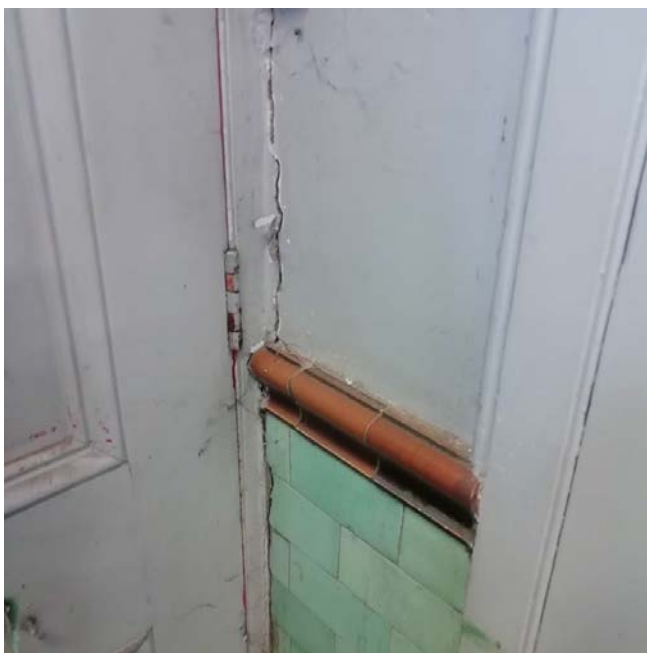
Figure 45 – Typical cracks at inner reveal to external door – Ground Floor 00-01

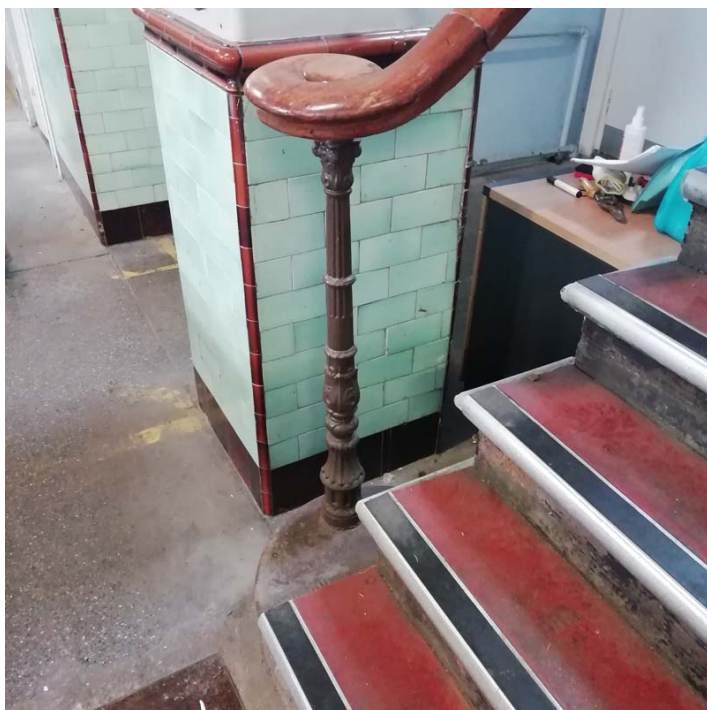
Figure 46 – Typical view of existing staircase curtail with missing balusters and modern covering to the stone treads 00-01

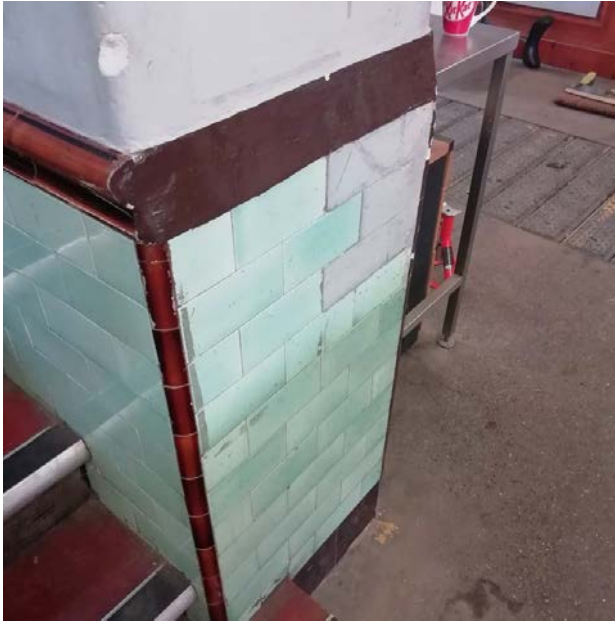
Figure 47 – Typical example of loss to existing glazed bricks and dado band – Ground Floor 00-01

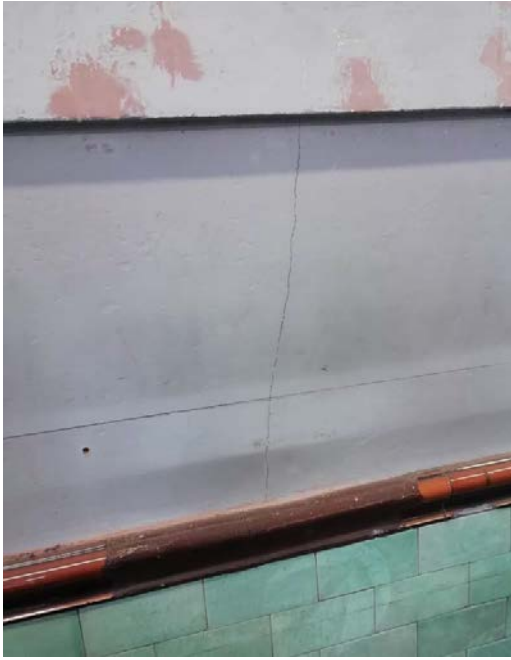
Figure 49 – Typical cracks to inner face of external wall – Ground Floor 00-01

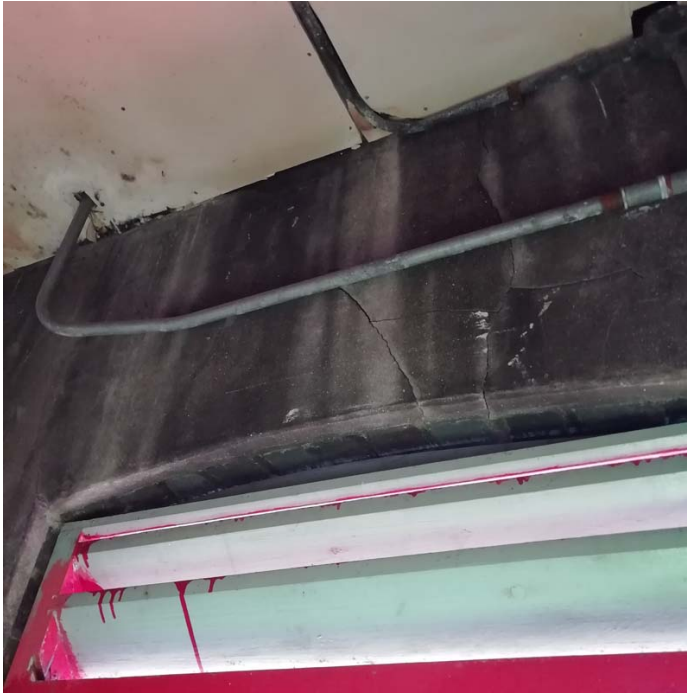
Figure 51 – Example of crack to render in rear plant room – Ground Floor 00-08

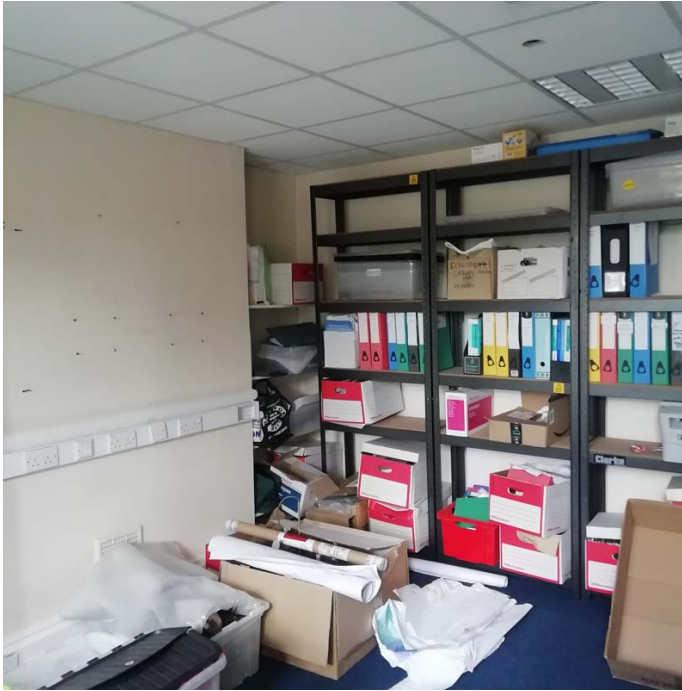
Figure 53 – Typical example of lost detail to chimney breast – vented with modern services conduit attached – First floor 01-09

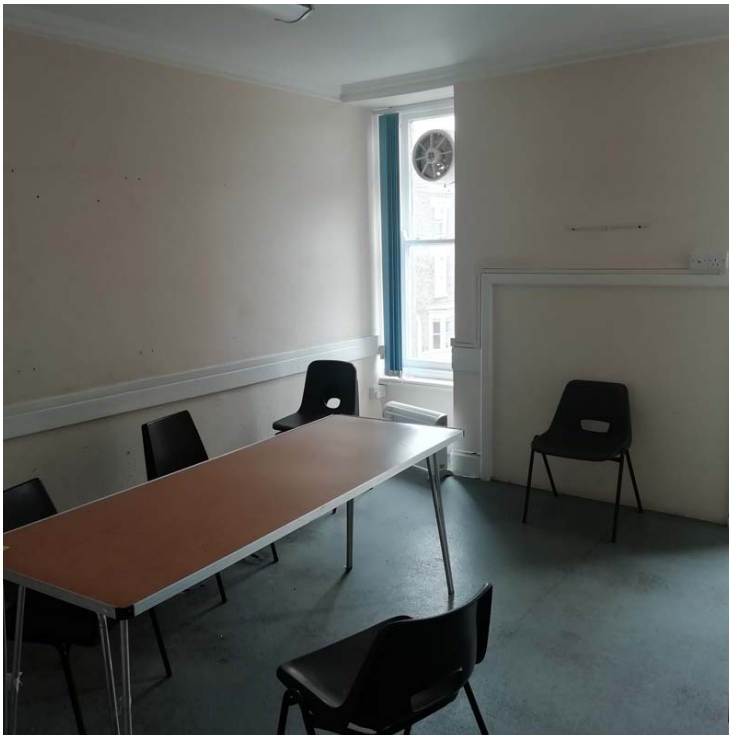
Figure 54 - Typical lost detail to chimney breast – currently blocked – First floor 01-05

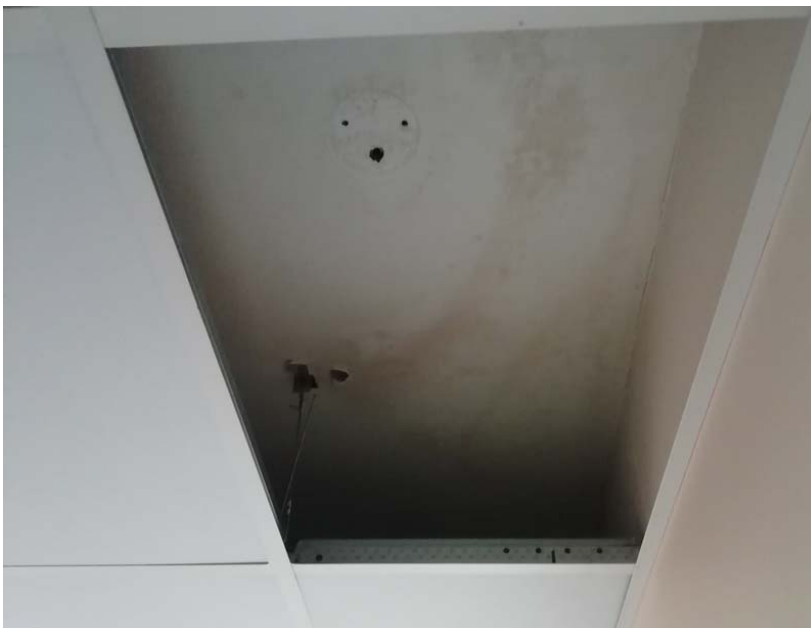
Figure 56 – Typical example of evidence of leaks to annexe – First floor 01-06

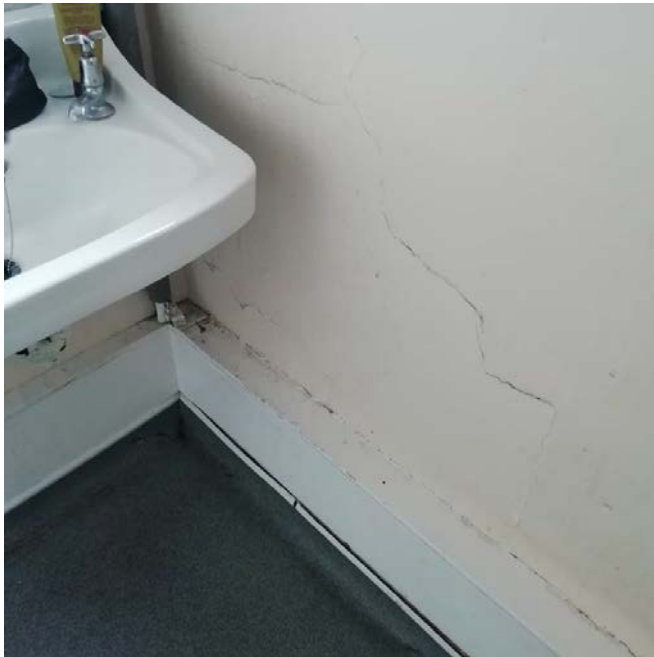
Figure 57 – Typical example of cracks to rear annexe – First Floor 01-07

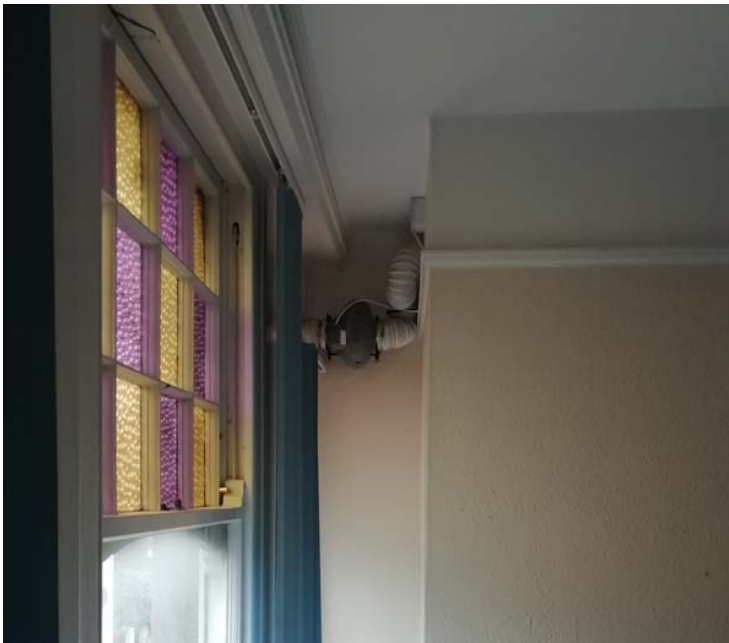
Figure 60 – Typical example of inappropriate intervention with modern services penetrating the front façade and insertion of new partitions to sub divide the original plan form – First floor 01-01

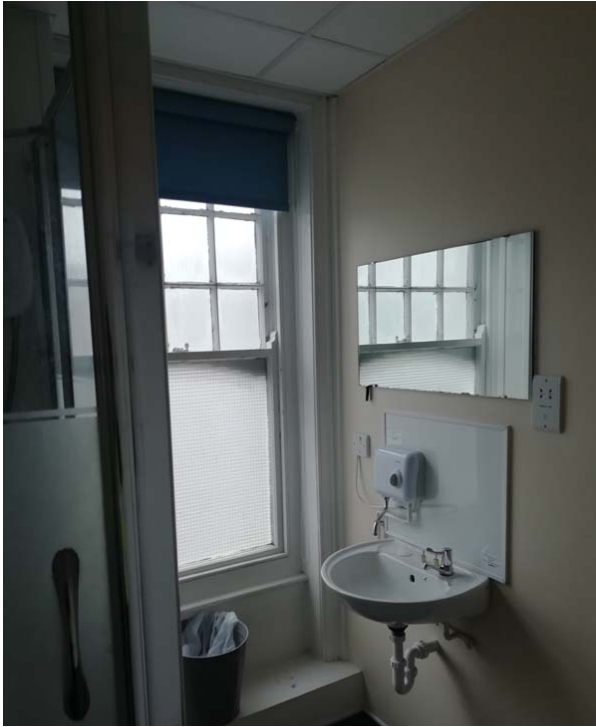
Figure 63 – Typical example of an inappropriate intention with lower sash glazed with obscured glass 01-03

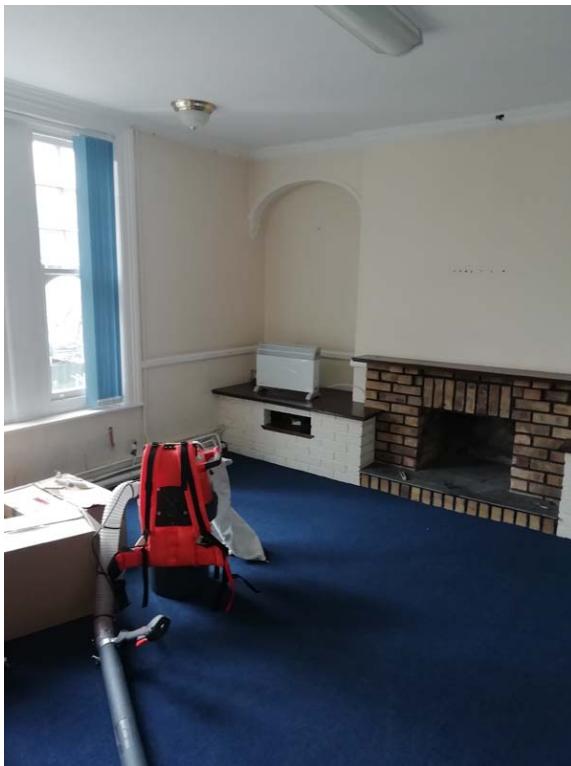
Figure 64 – Typical example of inappropriate modern fireplace surround 01-04

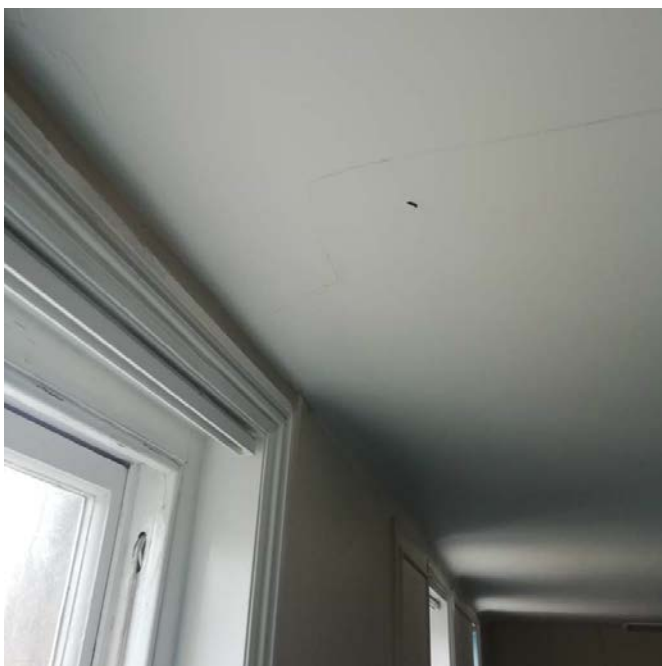
Figure 68 – Evidence of cracking which may relate to an original partition line (now lost) – Second floor 02-01
