Condition Survey of Significant Fabric

Radford House (Former Ramsgate Fire Station),
18 – 20 Effingham Street, Ramsgate CT11 9AT

For Ramsgate Town Council

May 2020

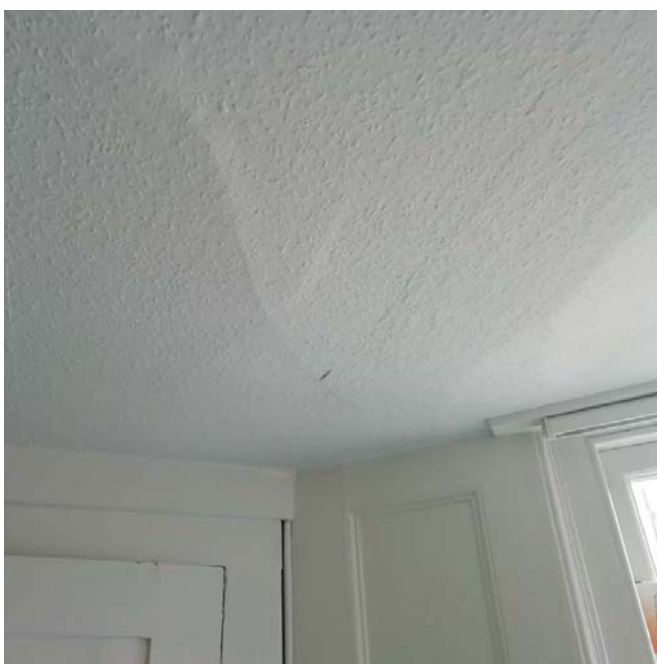
Figure 70 – Typical 'dip' in the ceiling of the bay – Second floor 02-04
