Refurbishment & Demolition Survey Report

Site Address: Council Offices
Pine Grove
Crowborough
East Sussex
TN6 1DH

Client Name: Crowborough Town Council

Survey Date: 11th December 2024

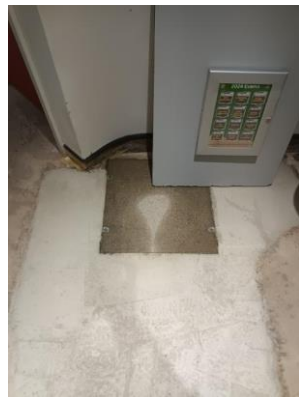
No access has been gained within the following locations:					
Building	Floor	Room No.	Room Description	Comment	Image
Council Offices	Ground	06	Male Toilet	There was no access within the floor drainage duct. The duct could not be opened.
