## Refurbishment Asbestos Survey

**The Old Priory  
Leominster  
HR6 8EQ**

**Leominster Town Council**

Refurbishment Asbestos Survey  
 The Old Priory  
 Leominster  
 HR6 8EQ  
 Leominster Town Council

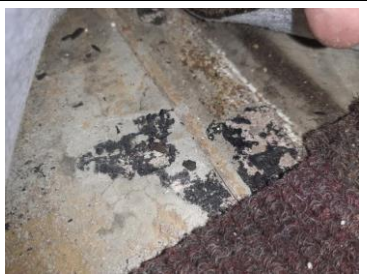
<p>Ground Floor, Reception, 045</p> <p>Bitumen Residue - Bitumen</p> <p>Below carpet and screed.</p>

E-44446/VS013	N	18 m <sup>2</sup>	Difficult	1	0	0	Chrysotile 1	2 Very Low	Including porch section. <b>Manage</b>
<p>Ground Floor, Boiler Room, 046</p> <p>Pump - Gaskets (compressed)</p>

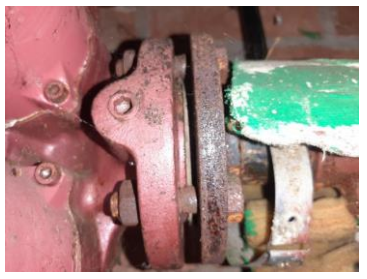
E-44446/S015	N	2 no	Easy	2	0	1	Chrysotile 1	4 Very Low	<b>Remove</b>
<p>Ground Floor, Boiler Room, 046</p> <p>Valve - Gaskets (compressed)</p>

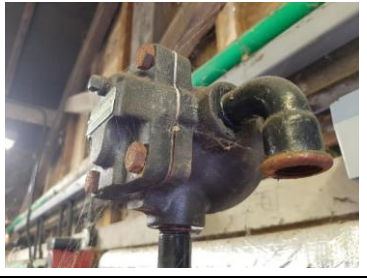
E-44446/S016	N	3 no	Easy	2	0	1	Chrysotile 1	4 Very Low	<b>Remove</b>
<p>Ground Floor, Boiler Room, 046</p> <p>Boiler - Rope Debris.</p>

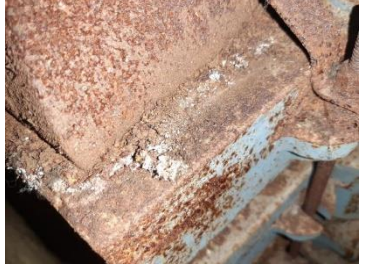
E-44446/S019	N	Small Amount	Easy	2	3	1	Chrysotile 1	7 Medium	<b>Remove</b>

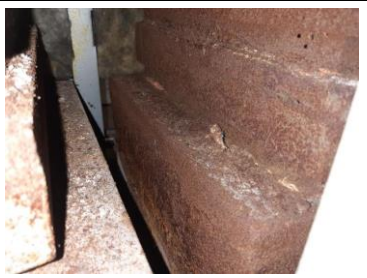
<p>Ground Floor, Boiler Room, 046 Boiler - Rope</p>

<p>E-44446/S020</p>	<p>N</p>	<p>2 boilers no</p>	<p>Easy</p>	<p>2</p>	<p>1</p>	<p>1</p>	<p>Chrysotile 1</p>	<p>5 Low</p>	<p><b>Remove</b></p>
<p>Ground Floor, Garage, 047 Partition - Cement</p>

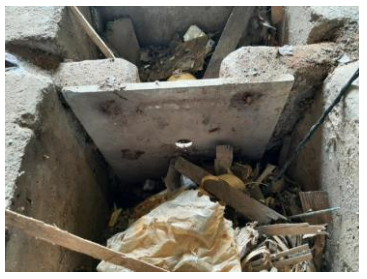
<p>E-44446/S023</p>	<p>N</p>	<p>1 no</p>	<p>Easy</p>	<p>1</p>	<p>0</p>	<p>1</p>	<p>Chrysotile 1</p>	<p>3 Very Low</p>	<p>In pit. <b>Manage</b></p>
<p>Ground Floor, Store, 080 Floor Tiles - Vinyl Floor Tile Brown tiles.</p>

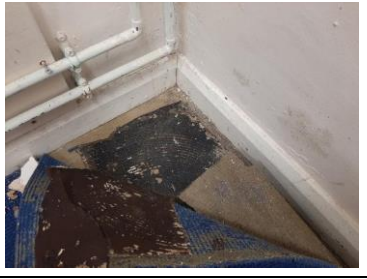
<p>E-44446/S027</p>	<p>N</p>	<p>8 m<sup>2</sup></p>	<p>Medium</p>	<p>1</p>	<p>0</p>	<p>0</p>	<p>Chrysotile 1</p>	<p>2 Very Low</p>	<p>Below carpet. <b>Manage</b></p>
<p>Ground Floor, Store, 080 Bitumen Adhesive - Bitumen To brown tiles.</p>

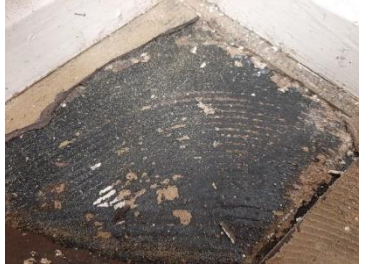
<p>E-44446/S028</p>	<p>N</p>	<p>8 m<sup>2</sup></p>	<p>Difficult</p>	<p>1</p>	<p>0</p>	<p>0</p>	<p>Chrysotile 1</p>	<p>2 Very Low</p>	<p>Below carpet. <b>Manage</b></p>

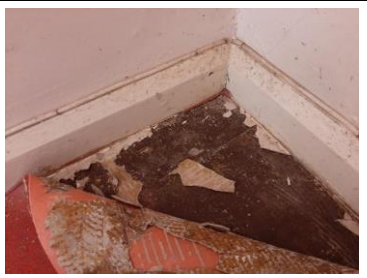
<p>Ground Floor, Side Porch, 081</p> <p>Floor Tiles - Vinyl Floor Tile</p> <p>Brown tiles.</p>

<p>E-44446/VS027</p>	<p>N</p>	<p>3 m<sup>2</sup></p>	<p>Difficult</p>	<p>1</p>	<p>0</p>	<p>0</p>	<p>Chrysotile 1</p>	<p>2 Very Low</p>	<p>Below modern lino. <b>Manage</b></p>
<p>Ground Floor, Side Porch, 081</p> <p>Bitumen Adhesive - Bitumen</p> <p>To brown tiles.</p>

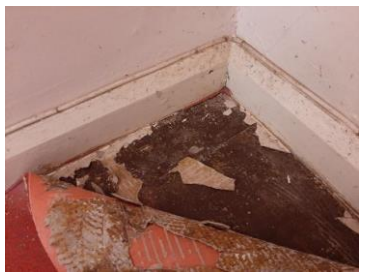
<p>E-44446/VS028</p>	<p>N</p>	<p>3 m<sup>2</sup></p>	<p>Difficult</p>	<p>1</p>	<p>0</p>	<p>0</p>	<p>Chrysotile 1</p>	<p>2 Very Low</p>	<p>Below modern lino. <b>Manage</b></p>
<p>Ground Floor, Office, 082</p> <p>Floor Tiles - Vinyl Floor Tile</p> <p>Brown tiles.</p>

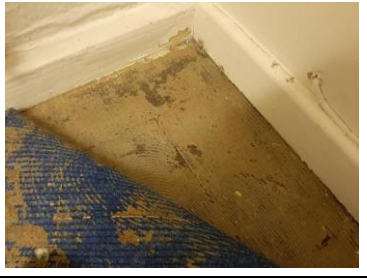
<p>E-44446/VS027</p>	<p>N</p>	<p>20 m<sup>2</sup></p>	<p>Difficult</p>	<p>1</p>	<p>0</p>	<p>0</p>	<p>Chrysotile 1</p>	<p>2 Very Low</p>	<p>Below carpet. <b>Manage</b></p>
<p>Ground Floor, Office, 082</p> <p>Bitumen Adhesive - Bitumen</p> <p>To brown tiles.</p>

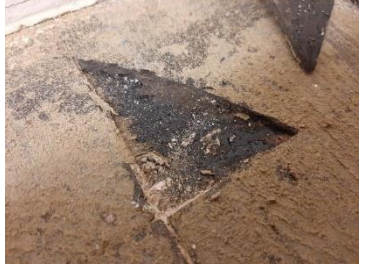
<p>E-44446/VS028</p>	<p>N</p>	<p>20 m<sup>2</sup></p>	<p>Difficult</p>	<p>1</p>	<p>0</p>	<p>0</p>	<p>Chrysotile 1</p>	<p>2 Very Low</p>	<p>Below carpet. <b>Manage</b></p>

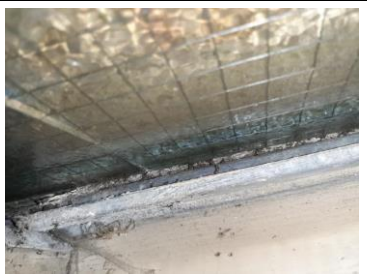
<p>Ground Floor, Office, 084 Skylights - Rope</p>

<p>E-44446/S029</p>	<p>N</p>	<p>3 no</p>	<p>Difficult</p>	<p>2</p>	<p>1</p>	<p>1</p>	<p>Chrysotile 1</p>	<p>5 Low</p>	<p>If the material is to be disturbed during the refurbishment, removal is recommended.  <b>Manage</b></p>
<p>Ground Floor, Entrance, 085 Bitumen Residue - Bitumen Below lino and screed.</p>

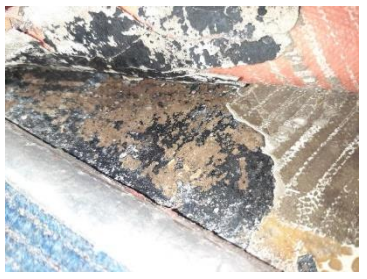
<p>E-44446/PSE-12645/003</p>	<p>N</p>	<p>13 m<sup>2</sup></p>	<p>Difficult</p>	<p>1</p>	<p>0</p>	<p>0</p>	<p>Chrysotile 1</p>	<p>2 Very Low</p>	<p><b>Manage</b></p>
<p>Ground Floor, WC, 086 Bitumen Residue - Bitumen Below lino and screed.</p>

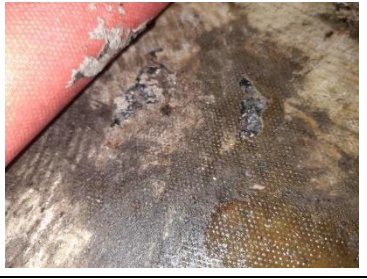
<p>E-44446/PSE-12645/003</p>	<p>N</p>	<p>6 m<sup>2</sup></p>	<p>Difficult</p>	<p>1</p>	<p>0</p>	<p>0</p>	<p>Chrysotile 1</p>	<p>2 Very Low</p>	<p><b>Manage</b></p>
<p>Ground Floor, Kitchen &amp; Cupboard, 087 Bitumen Residue - Bitumen Below lino and screed.</p>

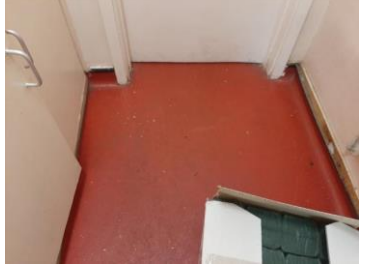
<p>E-44446/PSE-12645/003</p>	<p>N</p>	<p>6 m<sup>2</sup></p>	<p>Difficult</p>	<p>1</p>	<p>0</p>	<p>0</p>	<p>Chrysotile 1</p>	<p>2 Very Low</p>	<p><b>Manage</b></p>

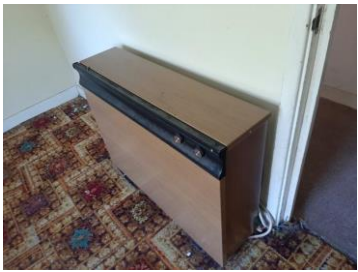
<p>2nd Floor, Bedroom, 012</p> <p>Storage Heater - Insulating Board</p>

E-44446/VS006	Y	4 no	Easy	2	1	2	Chrysotile 1	6 Low	Heat Pads on feet of unit. <b>Remove</b>
<p>External, 143</p> <p>Gas Meter - Gaskets (compressed)</p> <p>Back of old mortuary.</p>

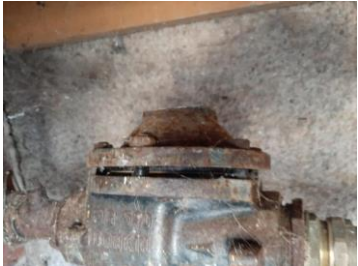
E-44446/P	N	Small Amount	Difficult	2	0	1	Presumed Asbestos 3	6 Low	<b>Manage</b>
<p>External, 143</p> <p>Window Frame - Putty</p> <p>Installation putty between frame and wall of flat roof extension</p>		E-44446/PSE- 12645/007	N	Small Amount	Easy	1	0	0	Chrysotile 1	2 Very Low	<b>Manage</b>
<p>External, 143</p> <p>Soffits - Cement Sheet (Flat)</p>

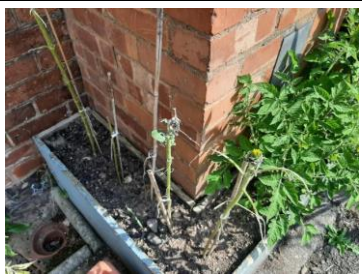
<p>External, 143 Damp Proof Course - Bitumen felt</p>

<p>E-44446/PSEMS 6502/036</p>	<p>N</p>	<p>1 lin m</p>	<p>Difficult</p>	<p>1</p>	<p>0</p>	<p>0</p>	<p>Chrysotile 1</p>	<p>2 Very Low</p>	<p>In Courtyard 2. <b>Manage</b></p>
<p>External, 143 Roof Tiles - Imitation Slate Tile</p>

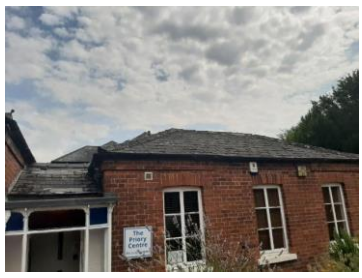
<p>E-44446/PSWSS</p>	<p>N</p>	<p>60 m<sup>2</sup></p>	<p>Medium</p>	<p>1</p>	<p>1</p>	<p>1</p>	<p>Chrysotile 1</p>	<p>4 Very Low</p>	<p><b>Remove</b></p>
<p>External, 143 Roof Tiles - Imitation Slate Tile</p>

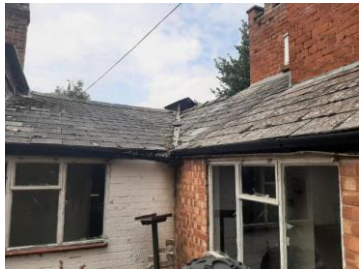
<p>E-44446/PSWSS</p>	<p>N</p>	<p>60 m<sup>2</sup></p>	<p>Medium</p>	<p>1</p>	<p>1</p>	<p>1</p>	<p>Chrysotile 1</p>	<p>4 Very Low</p>	<p><b>Remove</b></p>
