Site Investigation

Pendeen Community Cemetery

04 July 2018

Ref: SI19452

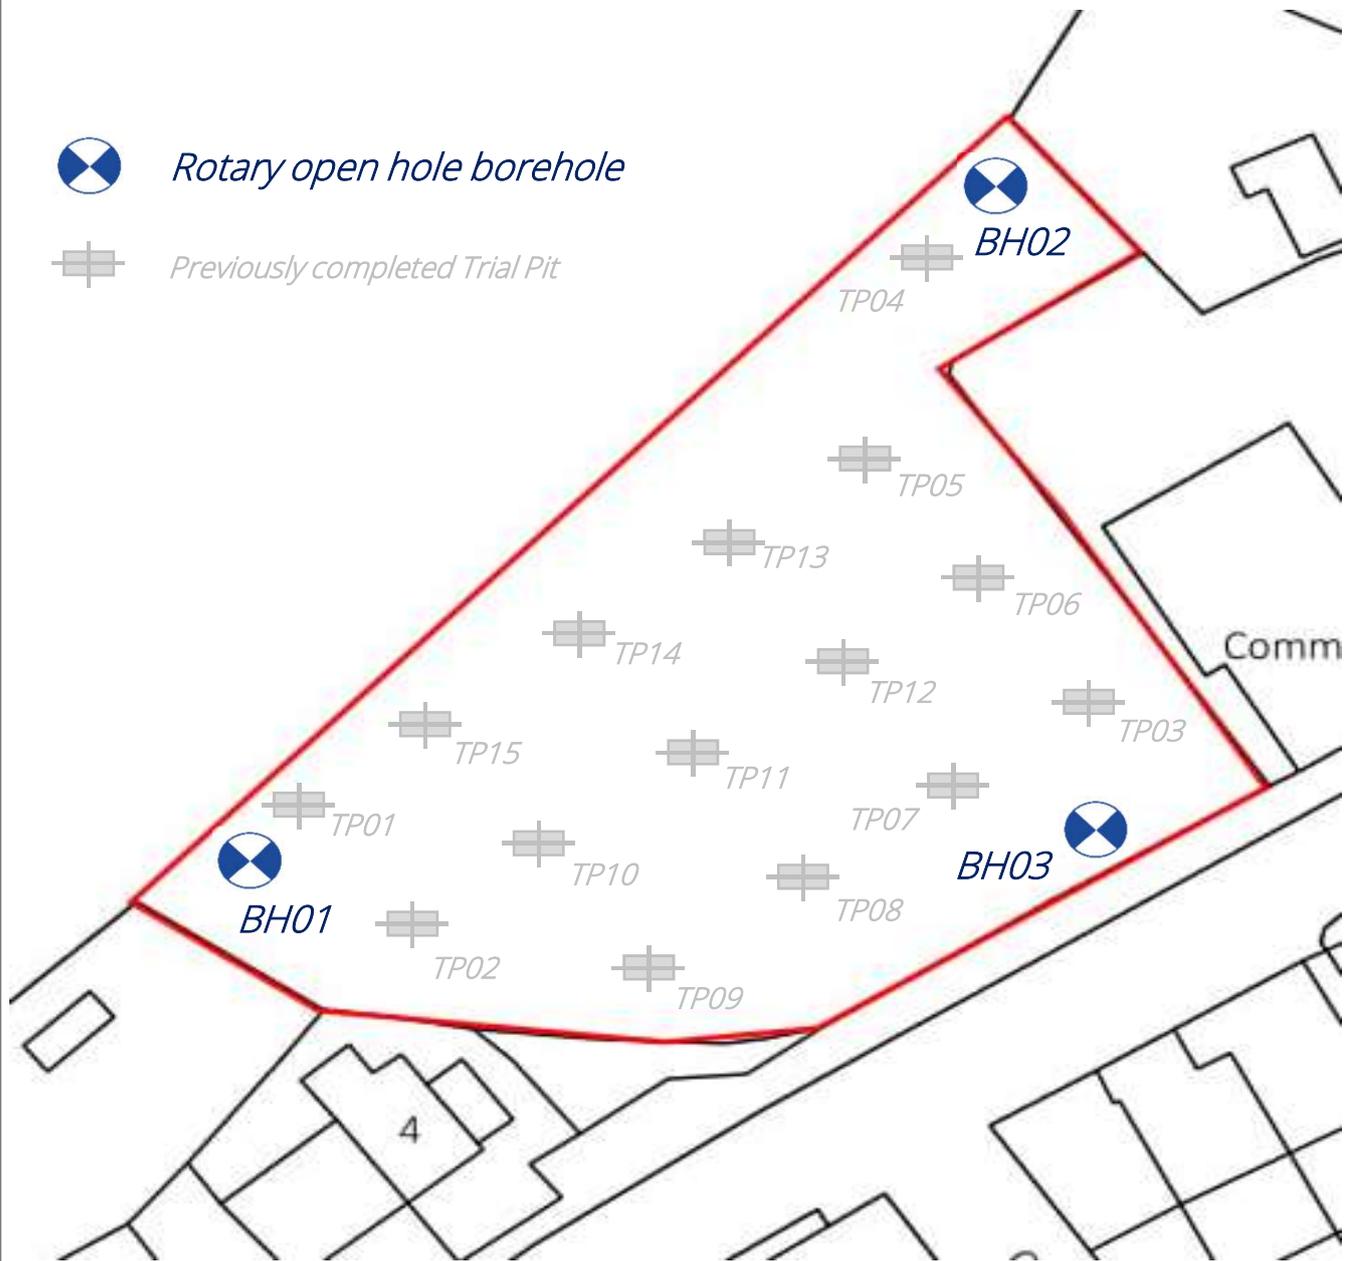
Fig 3.1

3.1.1 A site Investigation was conducted on Tuesday 3rd July 2018. The investigation was overseen by a geotechnical engineer from Wheal Jane Consultancy. An exploratory hole location plan is presented as Figure 3.1.

3.1.3 3nr rotary open hole boreholes, designated BH01 to BH03 were drilled to depths of 10.0mbgl using a Commachio 205 rotary drilling rig on the 3rd July 2018. Rotary open hole drilling does not return core samples, rather it rapidly bores through rock using a tungston studded drill bit which returns ‘chippings’ to the surface via an air flush.
