ASBESTOS REFURBISHMENT & DEMOLITION SURVEY REPORT
FOR
KING GEORGES CAR PARK PUBLIC TOILET BLOCK
SWANAGE

AUGUST 2017

Address:	King Georges Car Park, Swanage, Dorset BH19 1PG
Property Description	
A circa 1950's Public toilet block of Stone construction under a bitumen felt flat roof.	
Block A:	Public Toilet Block

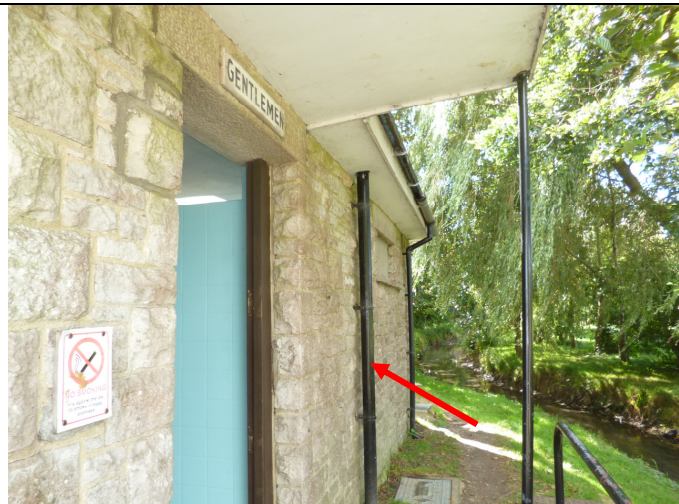
Site Ref	Lab Ref	Description	Analysis Result	Classification
310817APP2	BS077440	King Georges WC female toilets - Ceiling panel	No Asbestos Detected	Not Applicable
310817APP3	BS077441	King Georges WC female toilets - Skylight lining panel	No Asbestos Detected	Not Applicable
310817APP4	BS077442	King Georges WC external - Cement vent pipe	Chrysotile + Crocidolite	Asbestos Cement

Asbestos cement soil vent pipe.

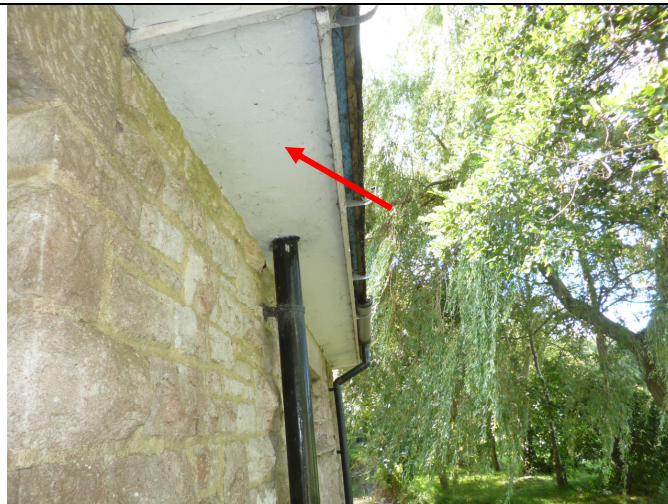
Site Ref	Lab Ref	Description	Analysis Result	Classification
310817APP5	BS077443	King Georges WC external - Soffit	Chrysotile	Asbestos Cement
310817APP6	BS077444	King Georges WC - External bitumen roofing felt	No Asbestos Detected	Not Applicable

Asbestos cement soffit panels.

Building Location Information					Material Information			Comments & Risk Information	
Block	Room	Sample Ref No	Description	Hazard Status	Hazard Location	Material	Sub Type	Recommendations/Comments	RA
A	0001	310817APP2	Female WC	Hazard Not Detected	Ceiling Panel			No asbestos detected in sample	
A	0001	310817APP3	Female WC	Hazard Not Detected	Skight lining panels			No asbestos detected in sample	
A	0002		Central store room	Hazard Not Detected				No asbestos containing materials detected.	
A	0003		Electrical Cupboard	Hazard Confirmed	Electrical Switch gear	Paper/rope	Textiles	Inspect when a qualified electrician is available to isolate and internally access the equipment.	D
A	0003		Male WC	Hazard Not Detected				No asbestos containing materials detected.	
A	Ext	310817APP4	External	Hazard Confirmed	Soil vent pipe	Cement	Cement Products	Inspect on a regular basis.	C
A	Ext	310817APP5	External	Hazard Confirmed	Soffit	Cement	Cement Products	Inspect on a regular basis.	D

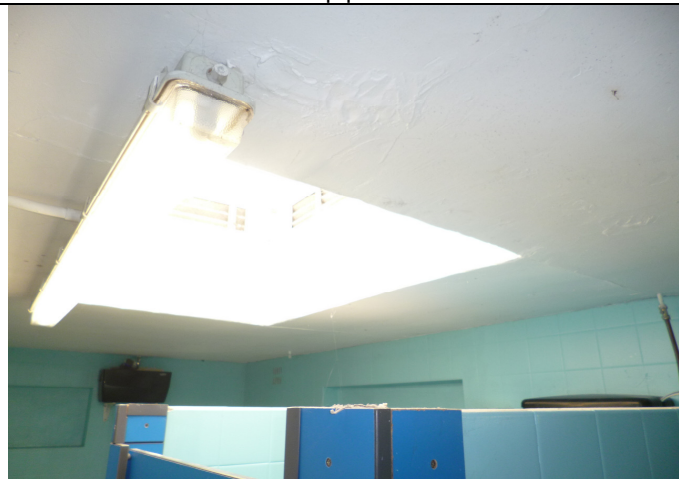
Non-asbestos ceiling panels and skylight linings.

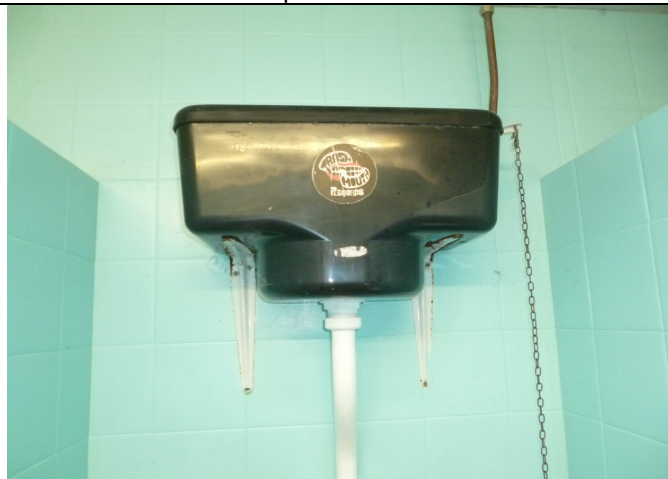
Plastic wc cisterns.

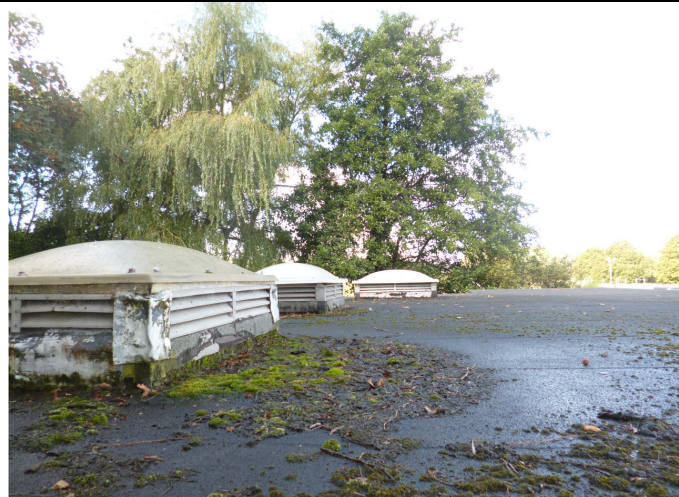
Non-asbestos bitumen felt roof sheet.

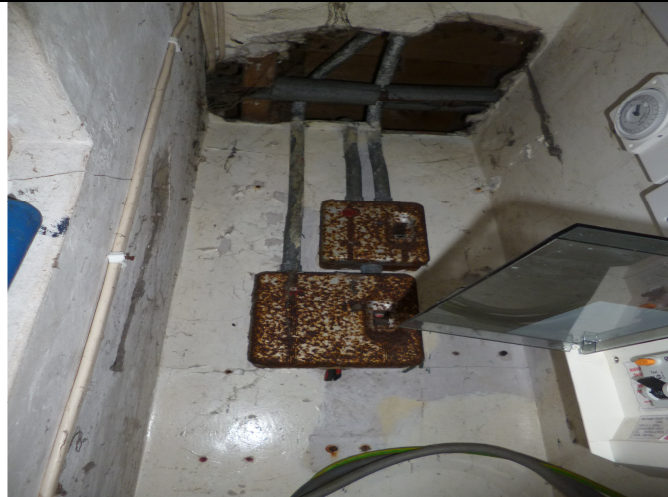
Old electrical switch gear in electrical in store requires further internal inspection once isolated by a qualified electrician.
