# **Swanage Seafront**

**Client: Swanage Town Council**  
**Surveyor: Design Base**

## **PRELIMINARY GEO-ENVIRONMENTAL AND GEOTECHNICAL ASSESSMENT**

**Report No. 5951**  
**April 2014**  
**Version 1**

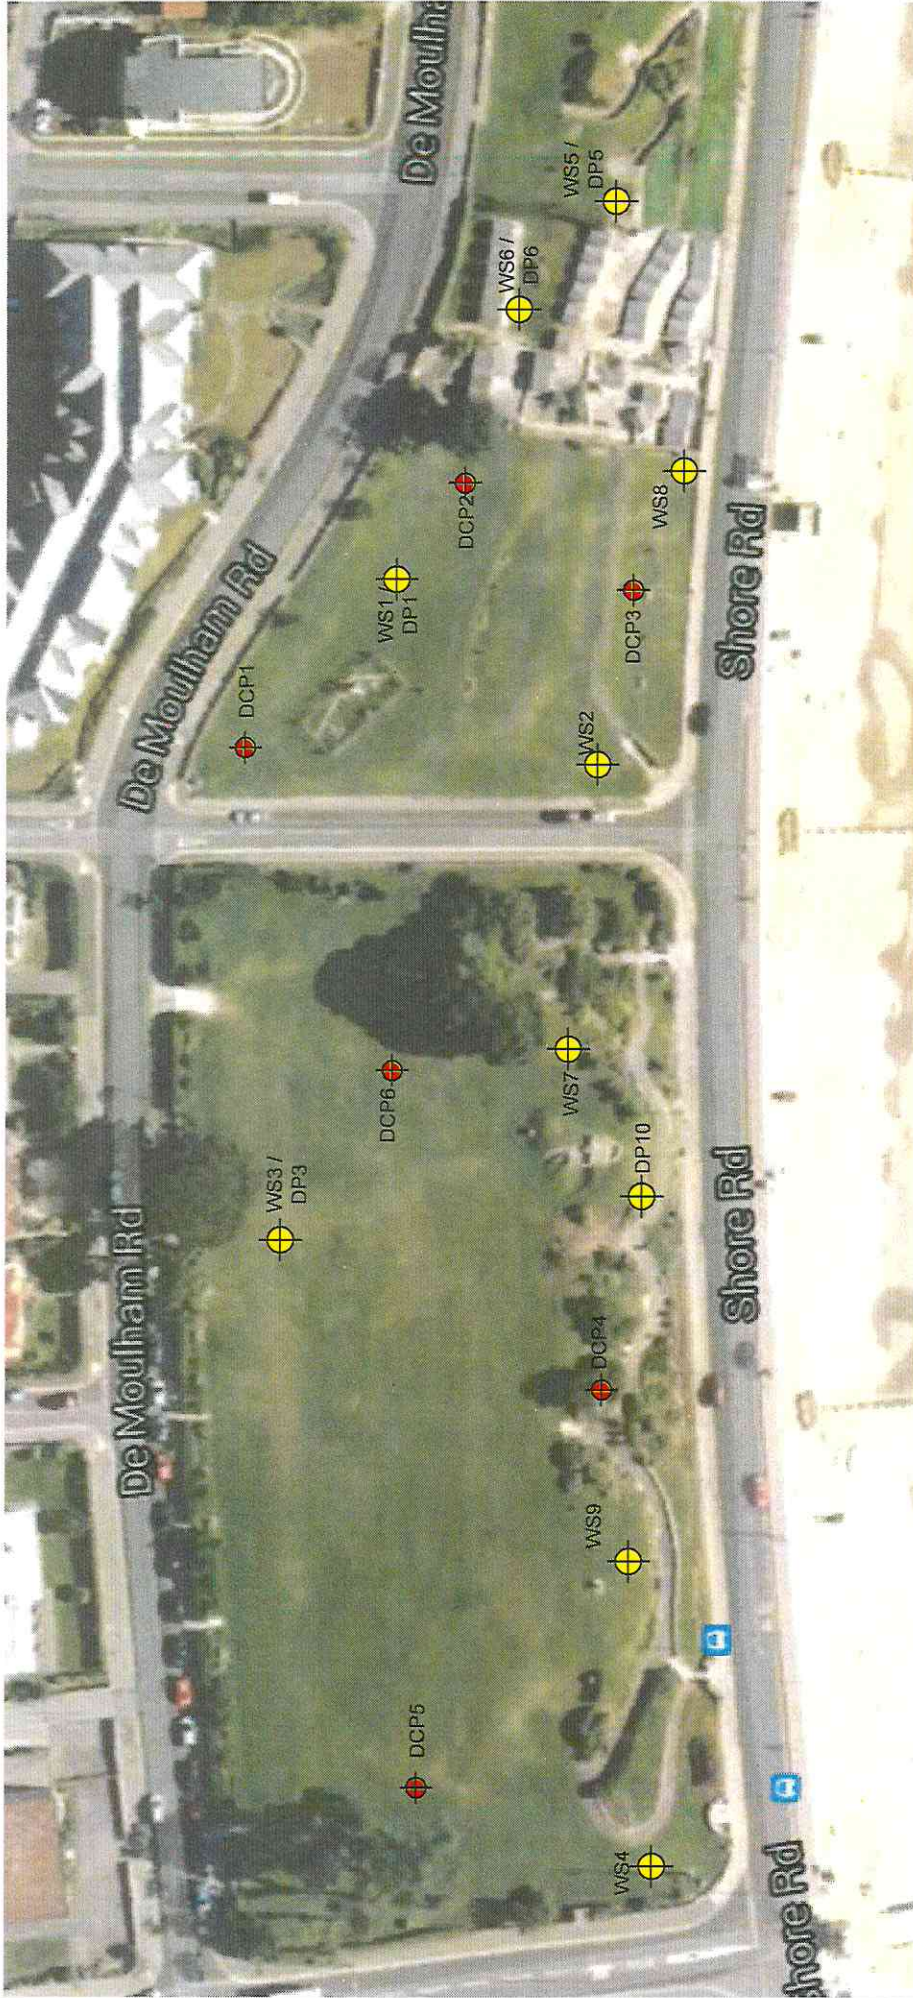
### Site Plan / Exploratory Hole Location Plan

The existing site layout is presented as Figure 2; this also forms the exploratory hole location plan. Photographs showing the sites current condition are presented as Appendix G.

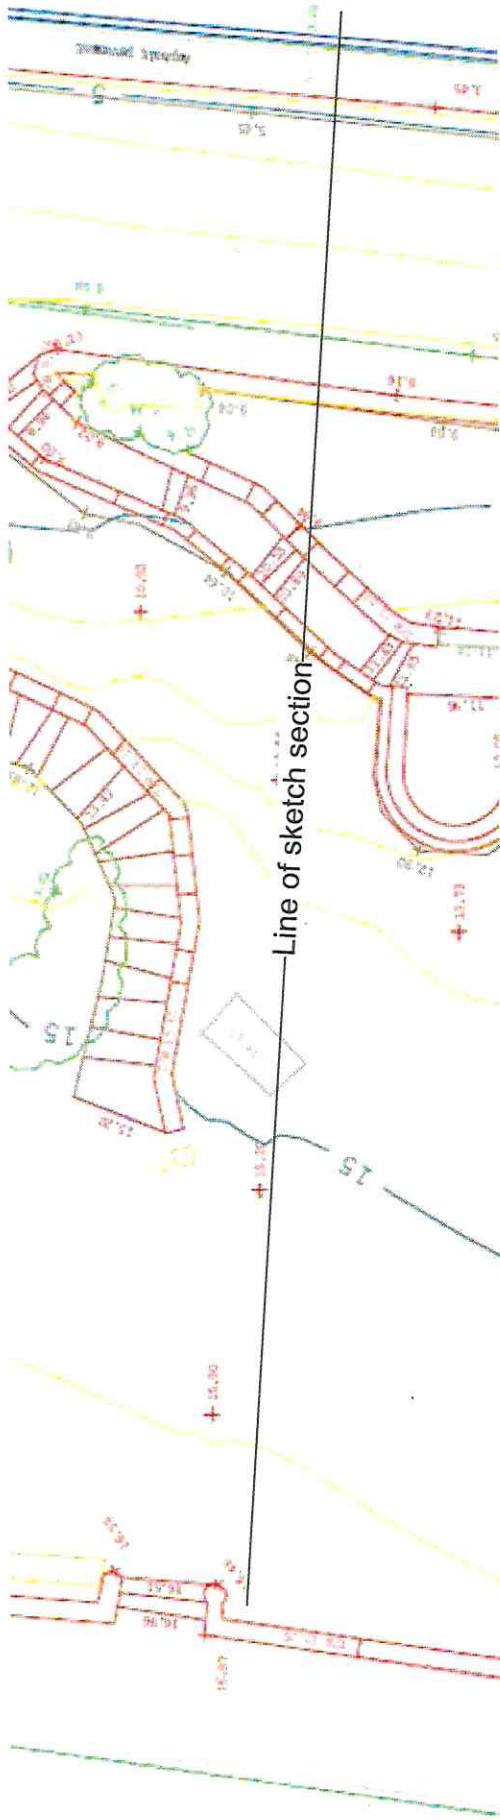
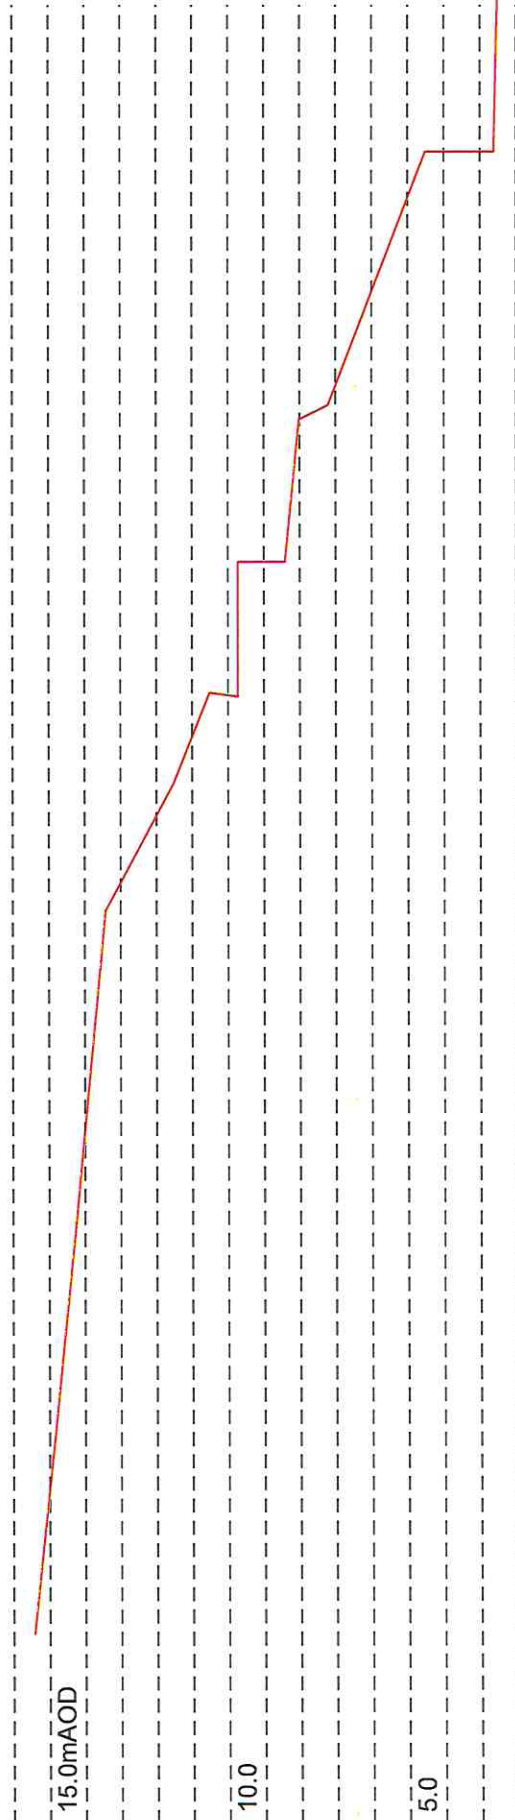
### Northern Section

Finally, the northern most section comprises a gently then steeply sloping grass area (again, down to the east from the west) with a combination of steps and retaining walls which work their way down to Shore Road below. Similarly to the previous section to the south, the entire slope showed signs of instability, including cracking and displacement of retaining walls, extensional cracking in paths, tilting hand rails and leaning telegraph poles.

The overall slope angle of the eastern bank in the northern section is around 27 degrees, measured from crest to toe, and it is around 11m high. A typical section is shown as Figure 4.
