## Gloucester Place, Boundary Wall

Birch Road, Barnard Castle, DL12 8JA

July 2015

*Prepared By*  
Billinghurst George & Partners

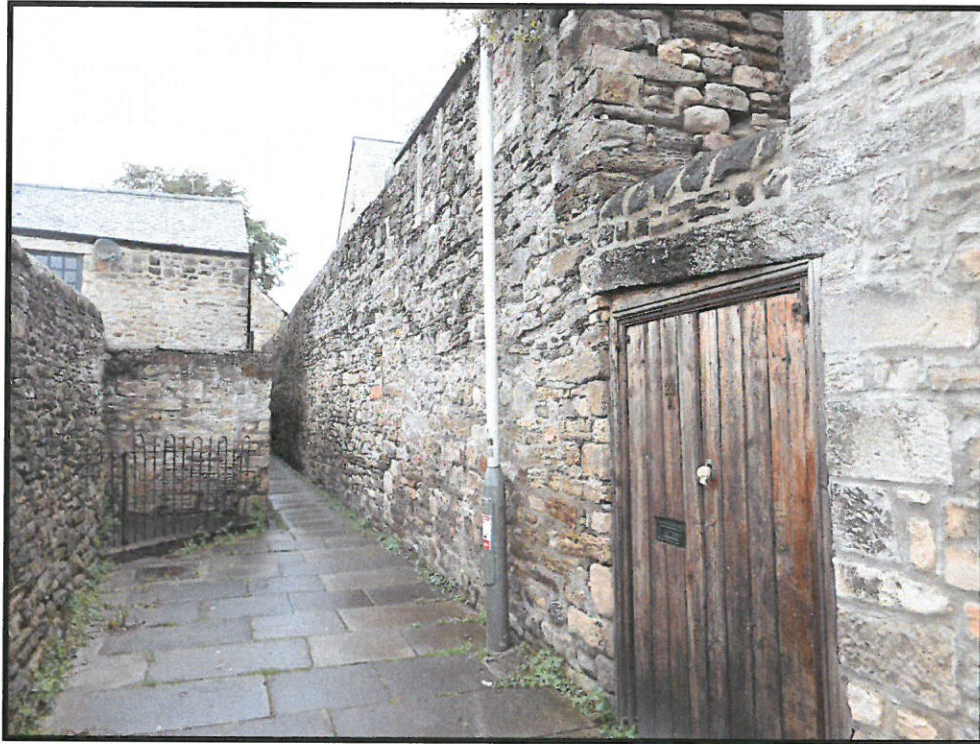
**Photograph 01 Showing a general view of the outer face of the boundary wall**

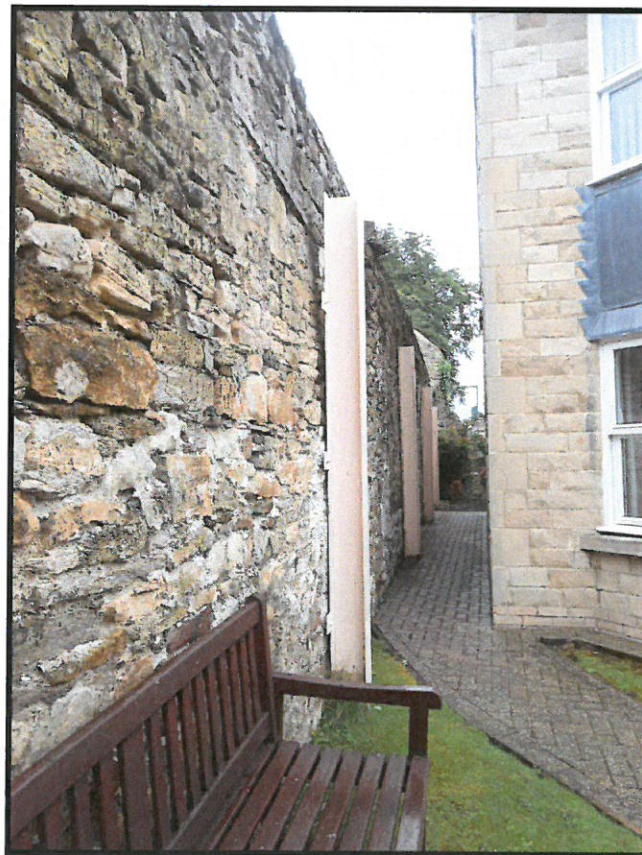
The western boundary wall is constructed in random stone, which is generally in the region of 4000mm high from path level, and is approximately 500mm thick. The inner face of the wall has been provided with a number of 205mm x 205mm steel universal columns, which are secured to it, as a means of lateral restraint. There is a 500mm thick stone buttress to the inner face, near to the southern corner. It is clear, that the wall previously formed part of a building, that has long since been demolished, which is evident by stone dressings to window openings.

**Photograph 02 Showing a general view of the inner face of the boundary wall**

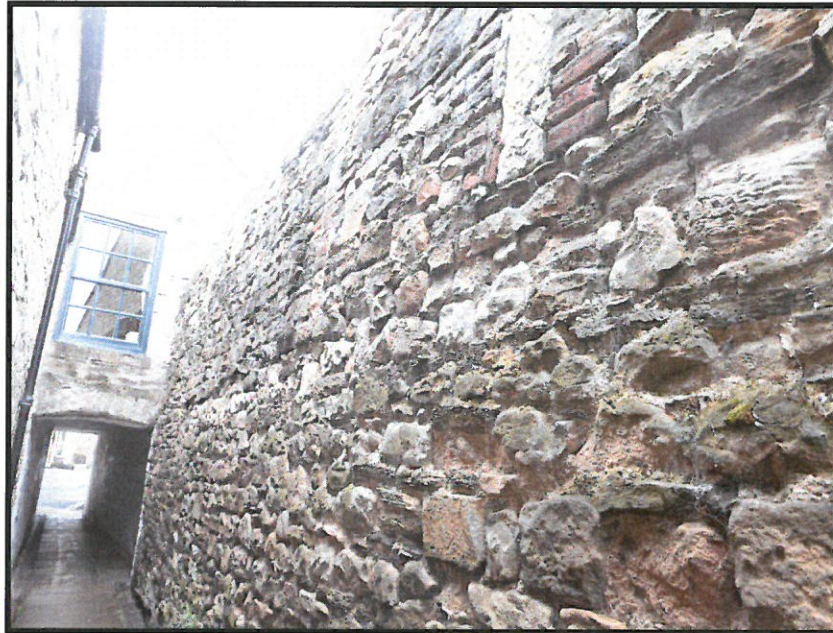
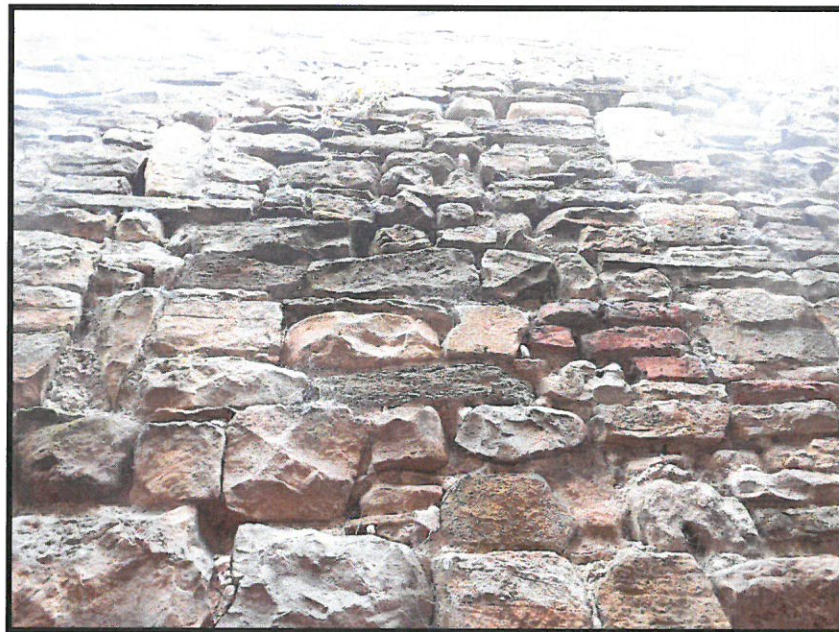
The stone masonry is generally in a fair to reasonable condition, bearing in mind the period of time it has been exposed to the elements, and the standard of repair to which it has been subjected. Erosion of masonry and joints, unsympathetic repairs, and re-pointing in inappropriate materials and styles are the principal defects.

**Photographs 03 & 04 Showing eroded stone & typical deterioration of mortar joints**

- Carefully taking down and rebuilding the upper sections of the wall as necessary. Include for consolidating the core.
- Replacement of decayed embedded timbers with new sections of stone to match existing.
- Repair of cracking to stone buttress. Rake out mortar to cracking, slate pack and repoint.
- Replacement of deteriorated stone as required.
- Rake out and repoint areas of walling as necessary

In respect of the mortar pointing, we are of the opinion that a lime based mortar be used. This should be an NHL 3.5, and coarse sand, 1:3 mix.

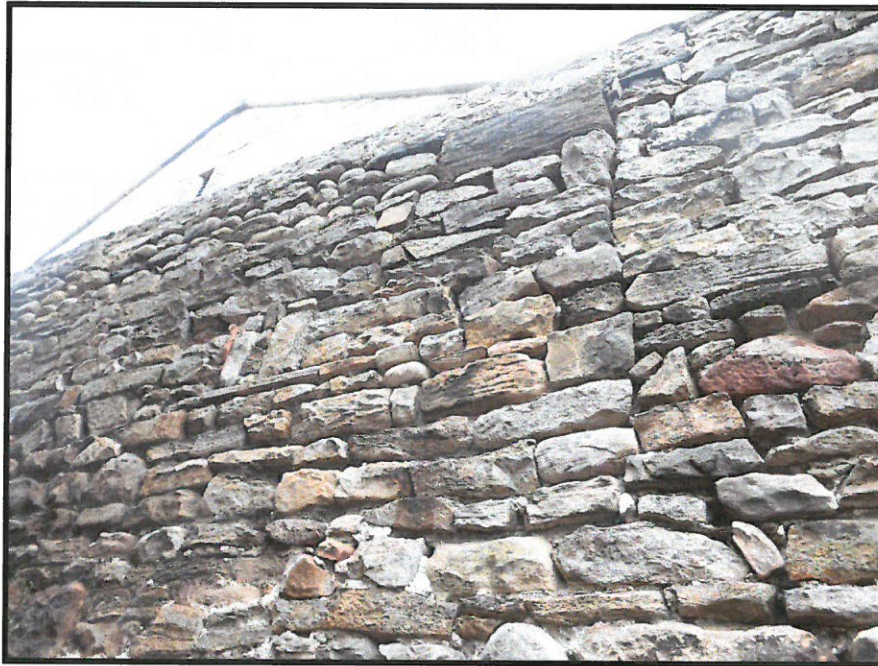
The most significant area of deterioration to the mortar joints, occurs mostly along the upper 1000mm section of the wall. Deterioration was also noted to most sections of the wall, where previous openings have been infilled.

**Photographs 05 Showing typical deterioration of mortar joints to infill sections**

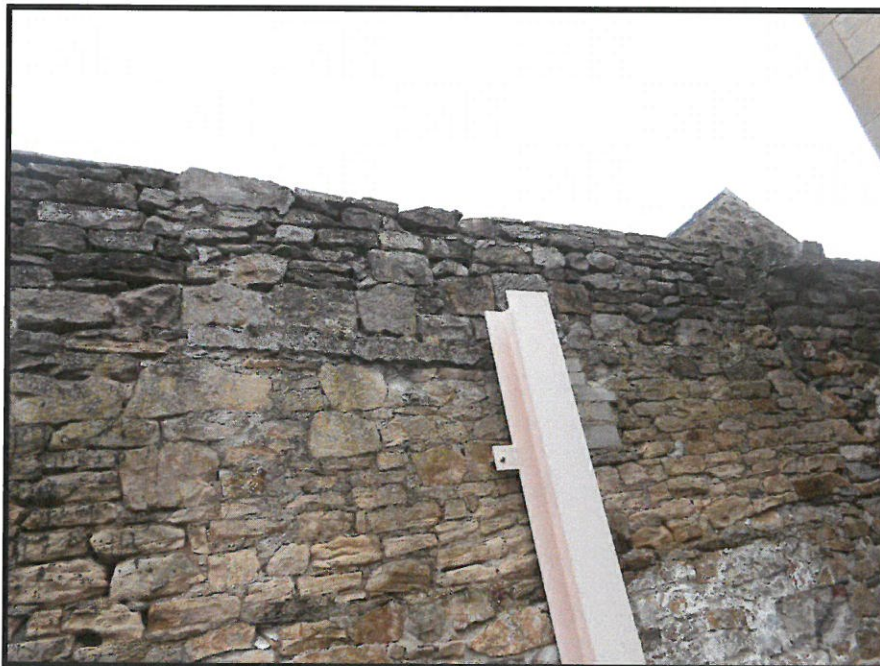
As seen from the garden area, sections of coping were either missing or displaced, which will no doubt have allowed moisture to penetrate and cause deterioration of the inner core material of the wall.

**Photograph 06 Showing deterioration of mortar joints to upper wall section**

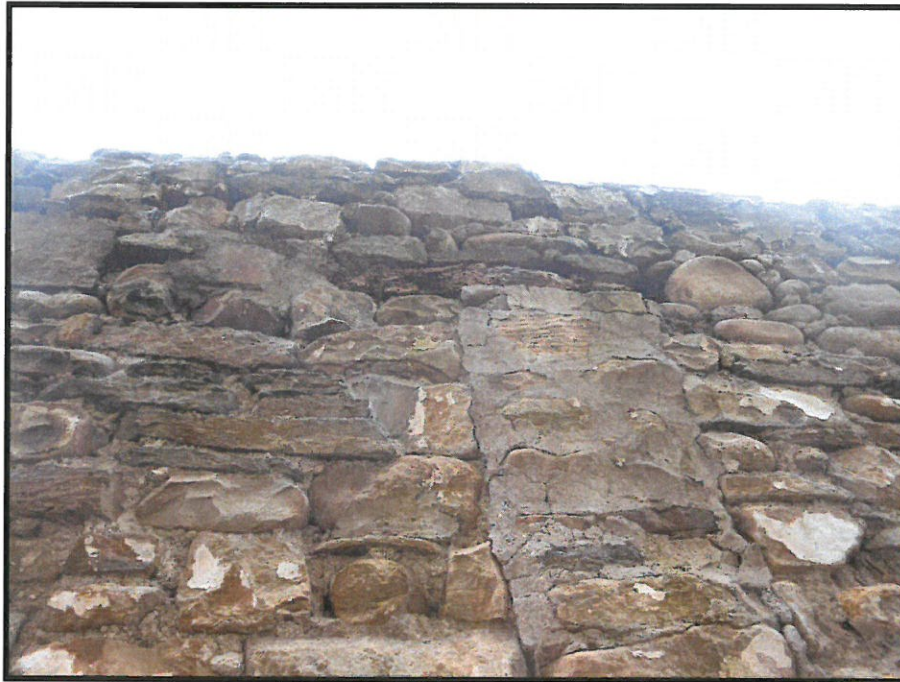
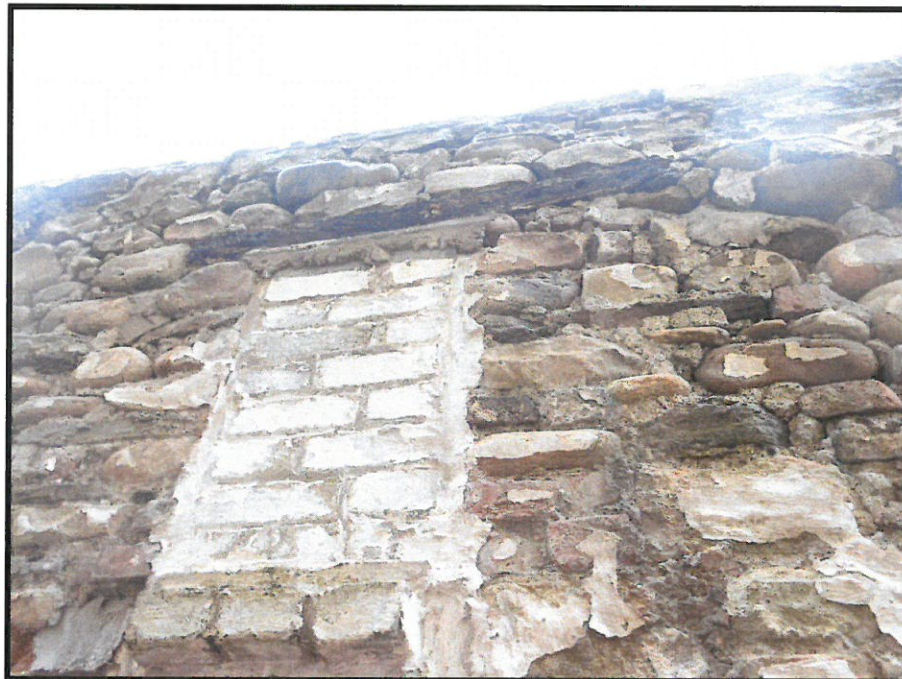
Within the inner section of the wall, there are embedded timbers, which were presumably installed as lintels over previous window openings. These were noted to have decayed, resulting in some disruption of the support masonry above.

**Photographs 07 & 08 Showing deterioration of embedded timbers and disruption of supported masonry**

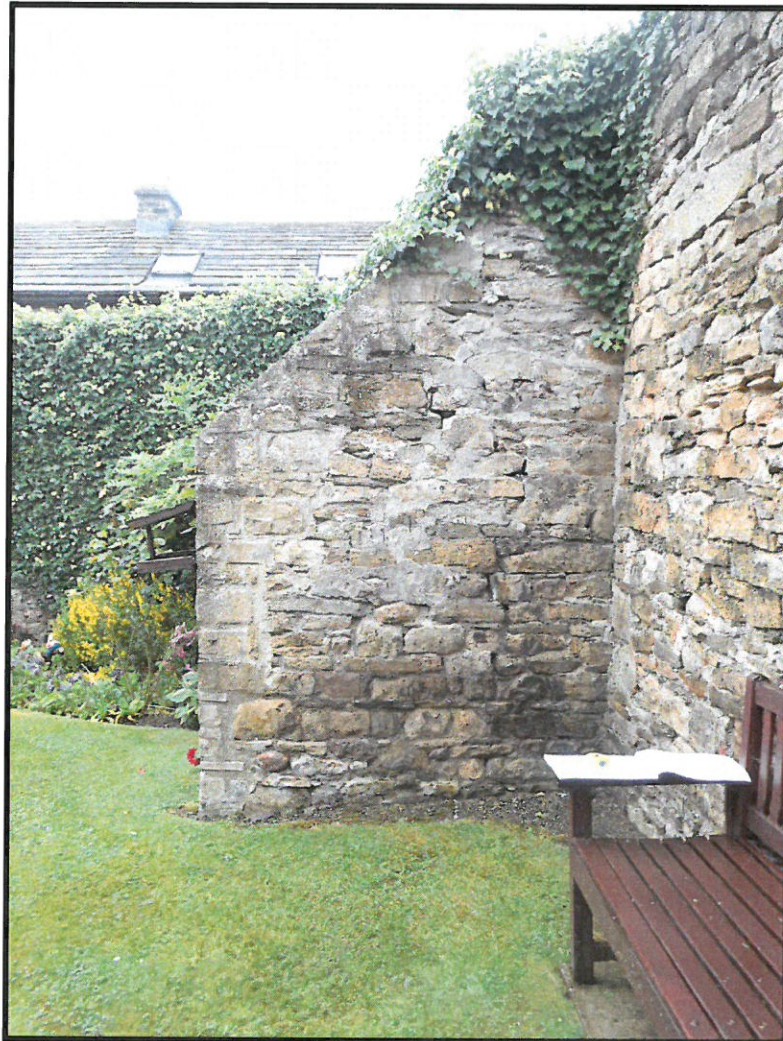
There is evidence of some slight movement to the outer section of the stone buttress, as evident by the diagonal cracking to the central section. However, we are of the opinion that this is most likely historic in nature, and unlikely to be progressive. Localised repair and repointing is all that is deemed necessary.

**Photograph 09 Showing deterioration cracking to stone buttress**
