Jubilee Hall  
Stadon Road  
Anstey

**Site Investigation  
For  
Anstey Parish Council**

**GeoDyne Limited**  
Clarendon House, Clarendon Park,  
Clumber Avenue, Nottingham NG5 1AH  
Tel: 0115 962 0001 email: [info@geodyne.co.uk](mailto:info@geodyne.co.uk)

Project No: 42116		Date: 29 <sup>th</sup> June 2022	
Issue/revision	Prepared by	Checked By	Approved By
	Amy Newman BSc (Hons) MRes MIEnvSc <b>Principal</b>	Jason Hollands BSc (Hons) MSc MIEnvSc CGeol FGS <b>Director</b>	Jason Hollands BSc (Hons) MSc MIEnvSc CGeol FGS <b>Director</b>

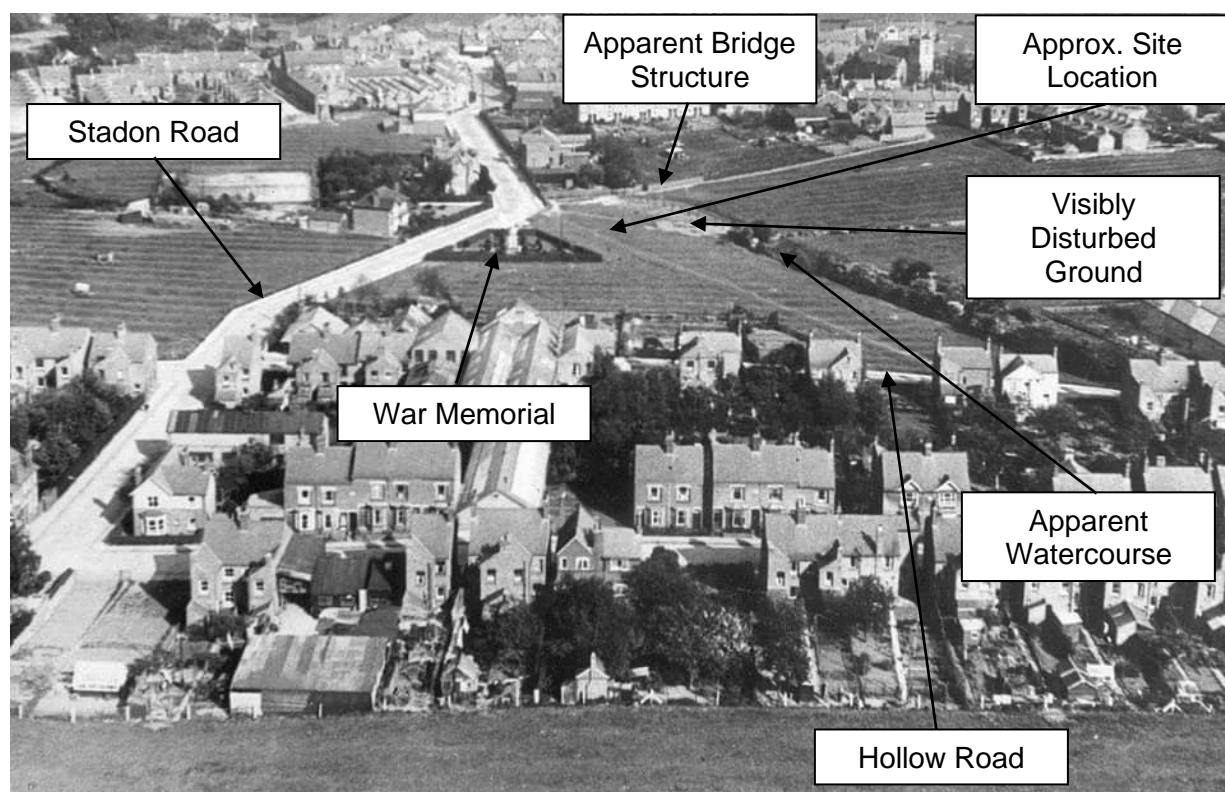
**Figure 1: Historical Aerial Photograph of the Site Looking East (Date Unknown)**

During the site investigation works, anecdotal information about the history of the site was gathered from a Council employee at the site. It appears that historically there may have been an open watercourse which ran west to east possibly just beyond the southern boundary of the site and under a bridge structure on the lane (which is now known as Paper Mill Close). An old aerial photograph (date unknown) was provided to us and shown in Figure 1 below and has been annotated to indicate various features:

As mentioned previously, during the services clearance works a manhole cover was observed in the eastern part of the site which when lifted was noted to comprise a deep chamber and a possible deep drain / culvert which was not shown on any of the supplied plans and was unable to be properly traced with the equipment on site at the time. It is considered possible that the manhole cover identified could be associated with the possible culverting / piping of this historical watercourse. It is therefore recommended that further works are undertaken by the Client to ascertain more detailed information regarding services at the site and including this features, exact route, dimensions and depths etc (such as by a CCTV survey for example) and what easements may be associated with it.

As mentioned previously, during the services clearance works a manhole cover was observed in the eastern part of the site which when lifted was noted to comprise a deep chamber and a possible deep drain / culvert which was not shown on any of the supplied plans and was unable to be properly traced with the equipment on site at the time. It is considered possible that the manhole cover identified could be associated with the possible culverting / piping of this historical watercourse. It is therefore recommended that further works are undertaken by the Client to ascertain more detailed information on this feature including its exact route, dimensions and depths etc (such as by a CCTV survey for example) and what easements may be associated with it.

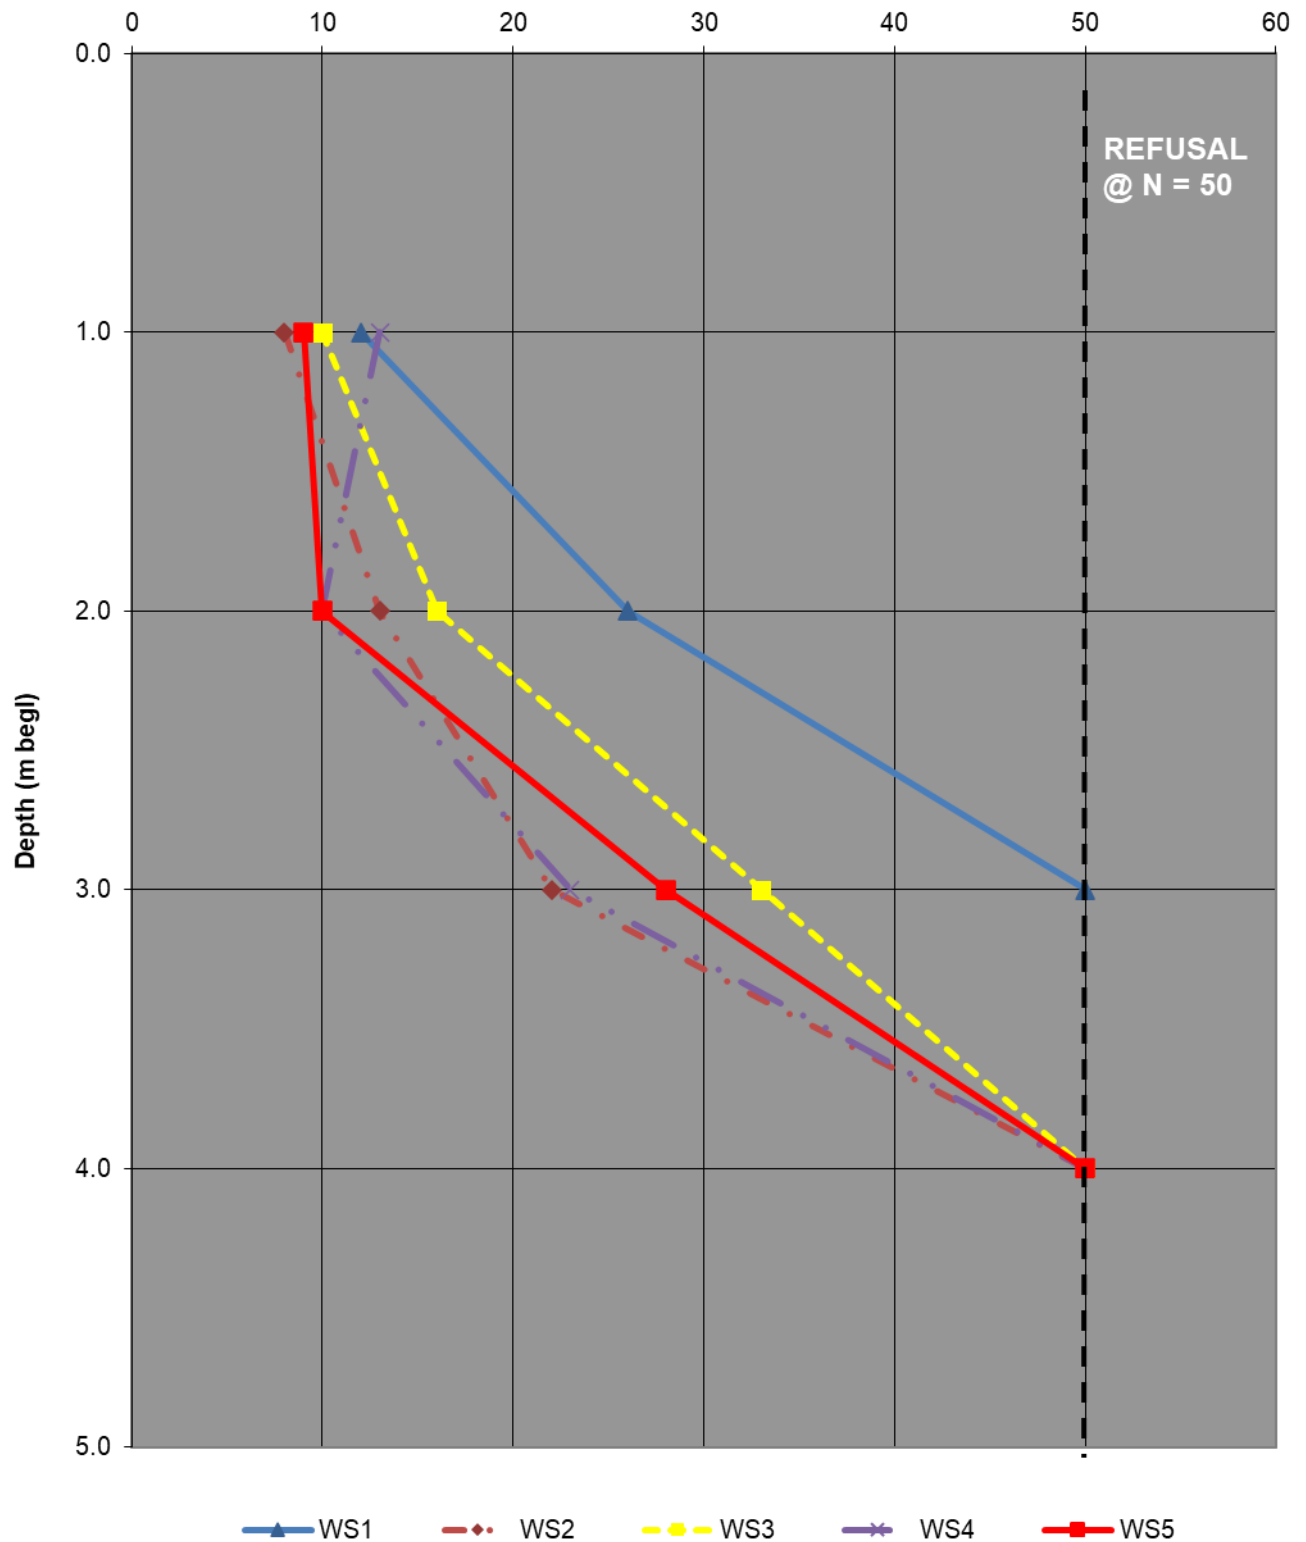
**Chart 42116/01**  
**Jubilee Hall, Anstey**  
 SPT N Values Vs Depth (m begl)  
 SPT N (Uncorrected)

An SPT Vs Depth Chart of the data obtained from the boreholes advanced at the site is shown on the chart on the following page. The SPT results are also included on the borehole logs presented in Appendix VI.

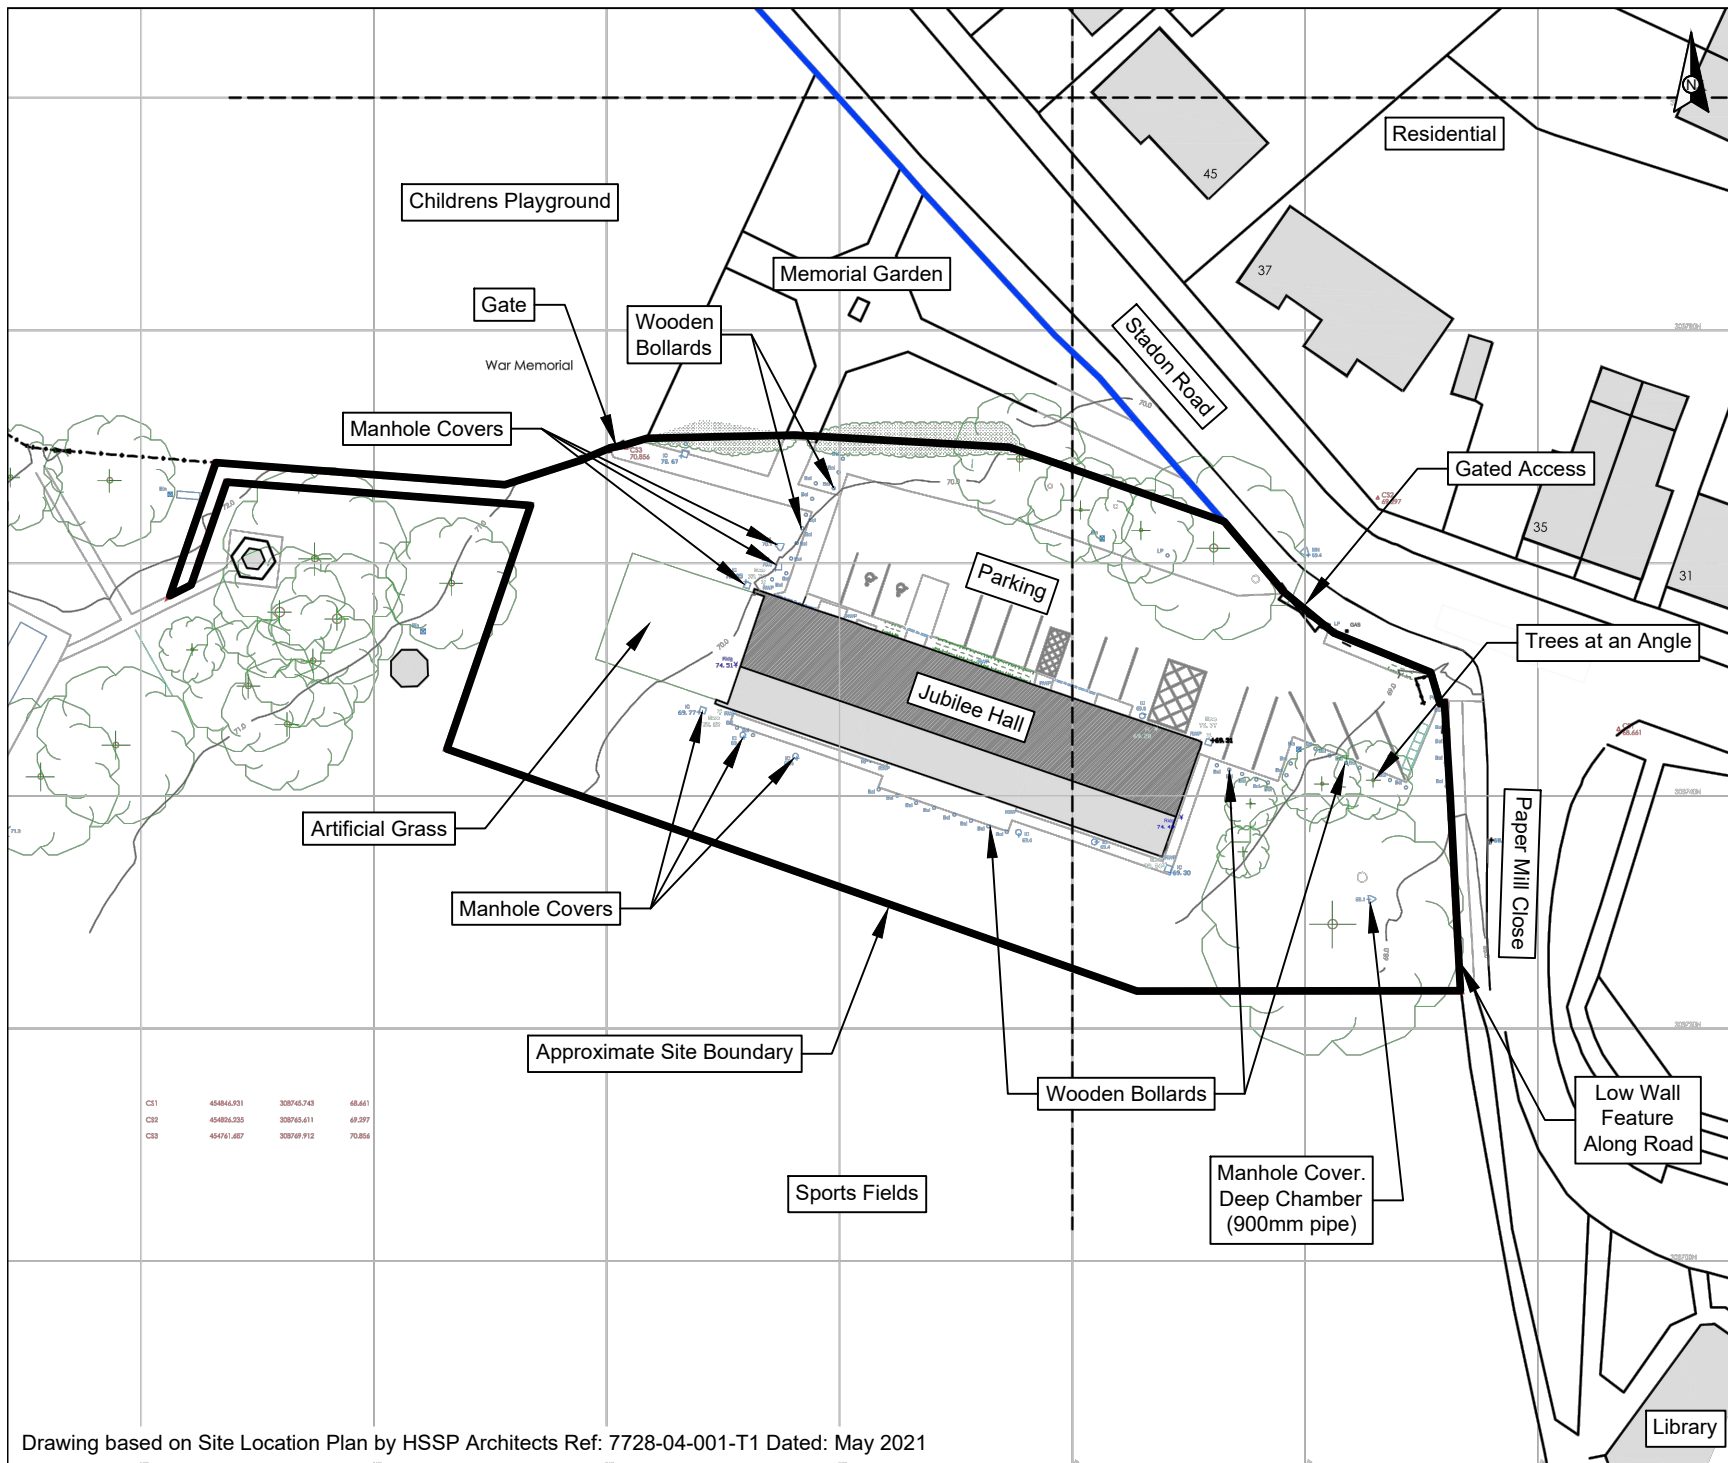
**Annotated Plan  
(Figure No. 42116/02)**

An annotated site plan (Figure No. 42116/02) is presented in Appendix III. Plans showing views of the site (Figure Nos 42116/03 and 42116/06) are presented in Appendix IV.

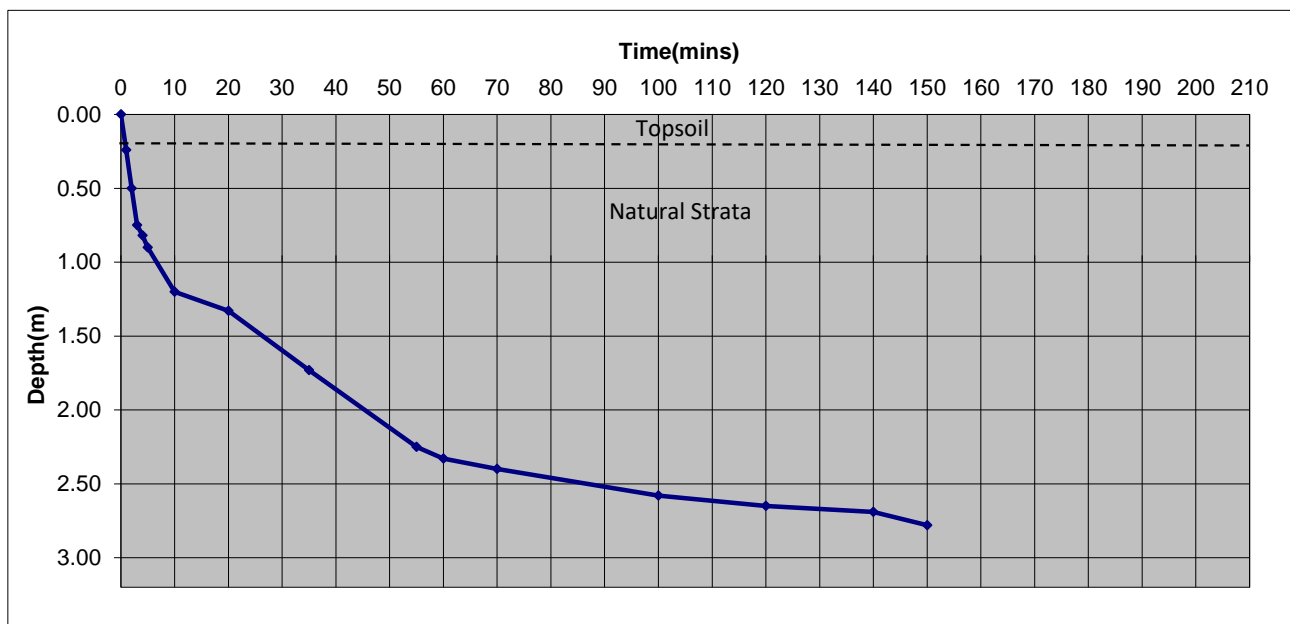
It is noted that the ground conditions between WS1 and WS2 differed in that WS1 comprised natural mainly granular materials below the topsoil, whilst WS2 comprised Made Ground sandy silty gravelly clays. WS1 was completed until the borehole was nearly emptied of water (depth of borehole was 3.00m), WS2 was stopped at 0.26m depth due to silting up of the base of the borehole and time constraints (testing was undertaken over two hours).

Infiltration Rate,  $F$  = 8.56E-06 m/s

Initial falling head testing has been undertaken at the site as discussed above. The use of soakaways to dispose of surface water from the proposed development may be possible in selected areas of the site (such as around WS1). Should soakaways be proposed at the site then appropriate infiltration testing to BRE365 may be required.

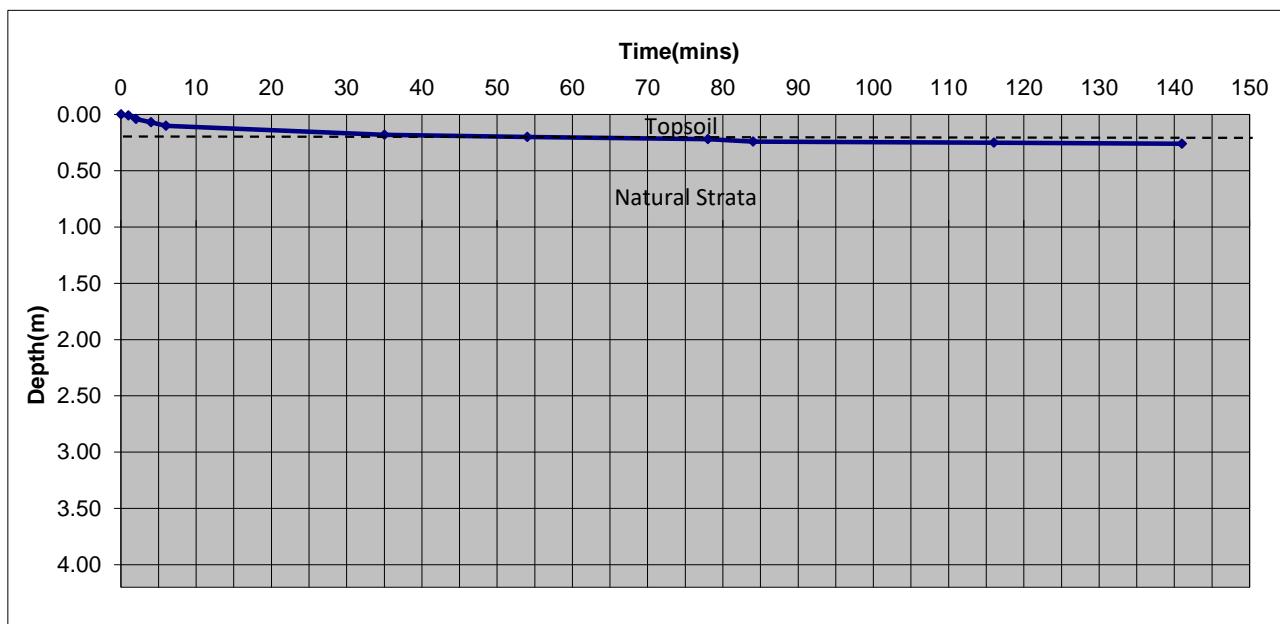
Infiltration Rate,  $F$  = 5.24E-07 m/s
