The Manor House

Report on a Structural

Inspection of cracking present to the Property

May 2016

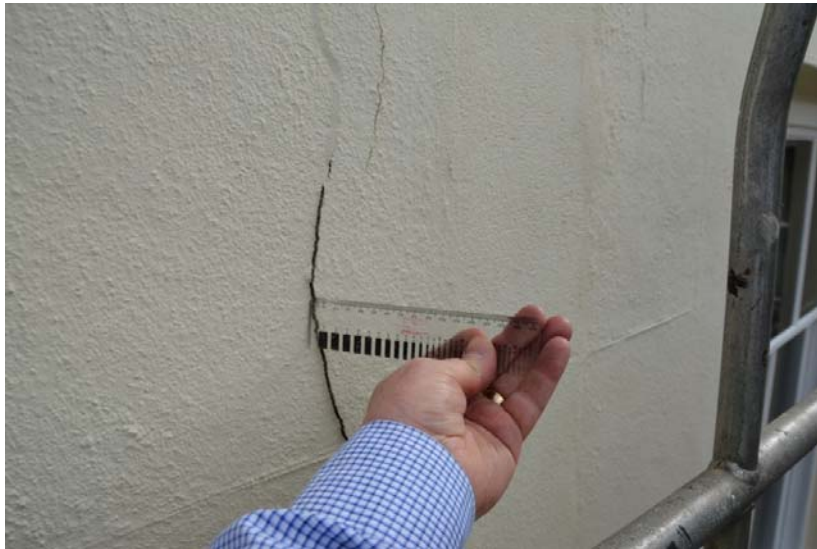
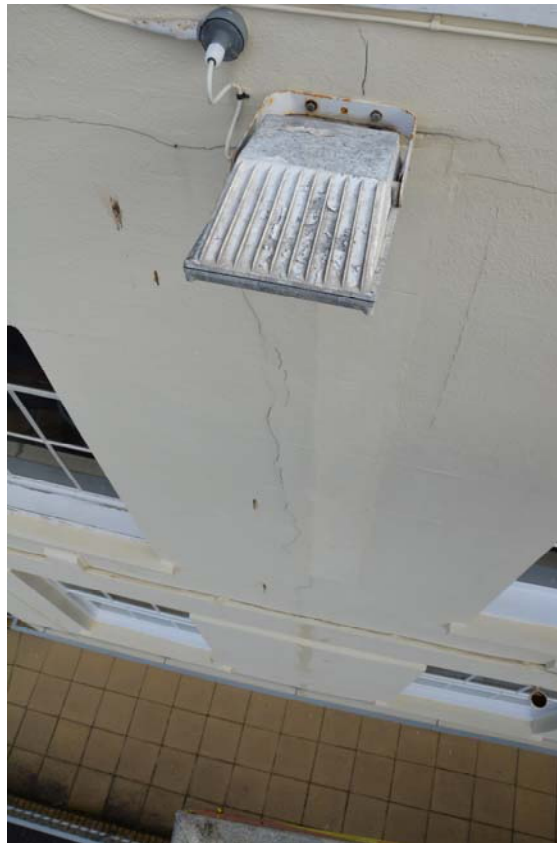
It was evident that the vertical crack between the two windows at first floor was the most extensive one with outward displacements being in the order of 1.5mm to 3mm.

Cracking to centre of first floor windows

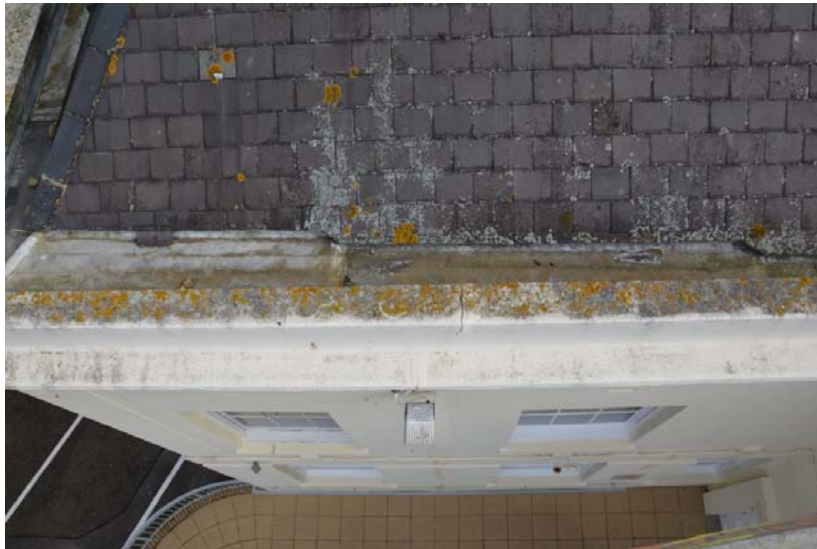
It was noted that the cracking also extended through the parapet with horizontal cracking also evident within the parapet feature.

Cracking to parapet

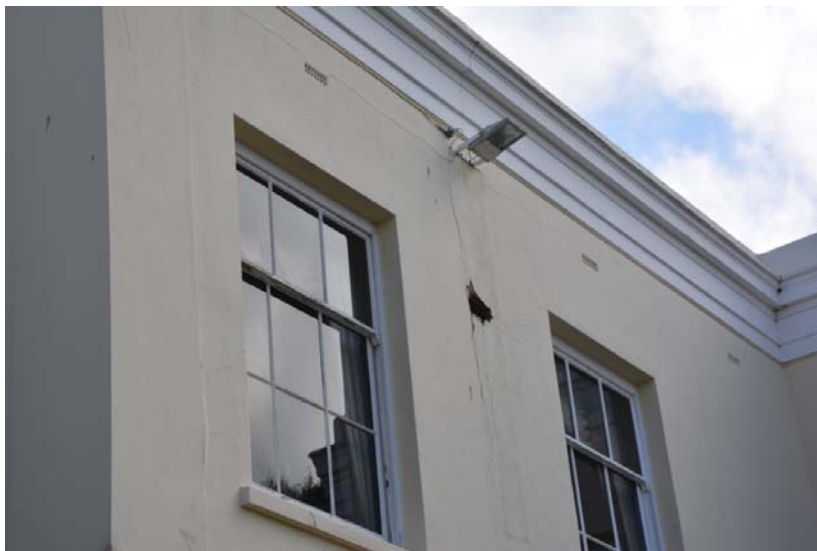
Horizontal Cracking

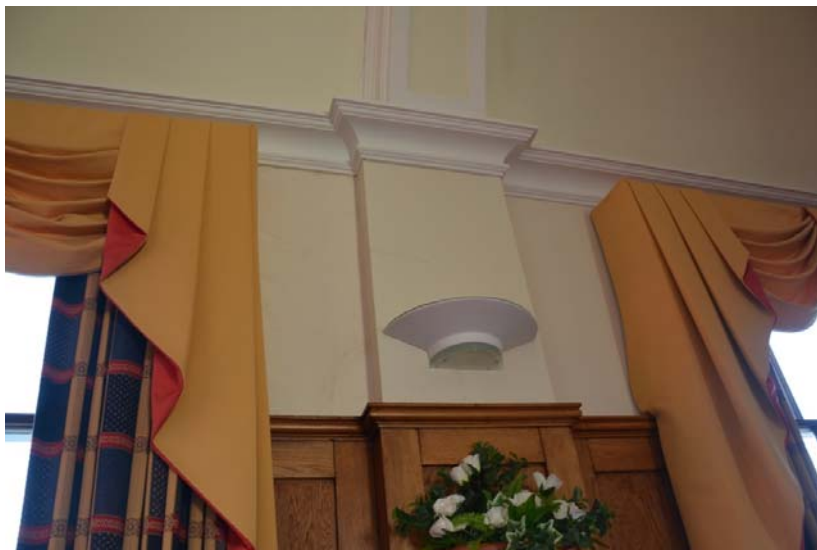
Local to the pier features evidence of minor cracking to the plaster was present together evidence of water leakage.

Minor cracking to plasterwork

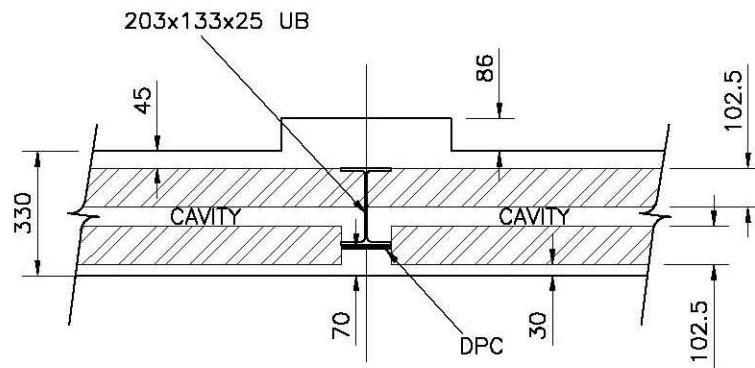
Existing arrangement

Breaking out revealed the wall construction generally to comprise of 30mm of render over a brickwork outer skin with a 50mm cavity and a brickwork inner skin. Within the area of the vertical cracking a steel “I” section column was present with its outer face being some 70mm back from the face of the render.

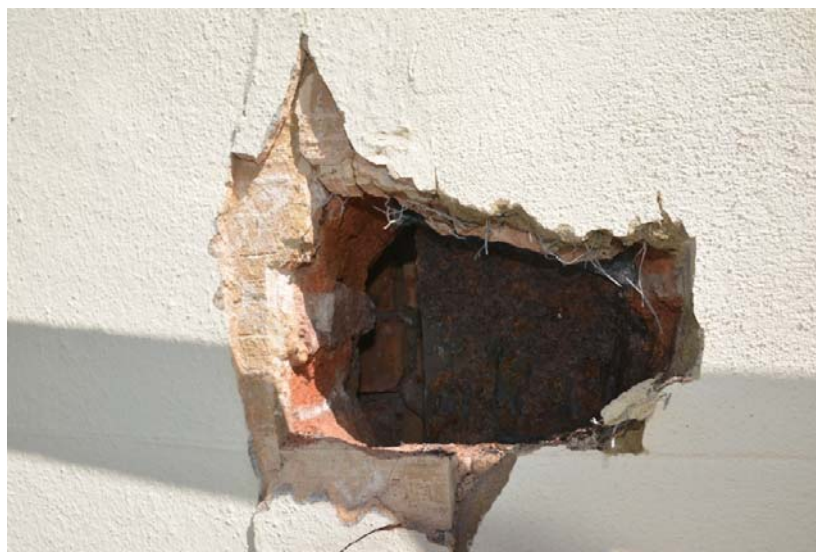
Extensive corrosion was present to the steelwork affecting the outer flange and the web section within the outer masonry leaf.

Steelwork column within wall

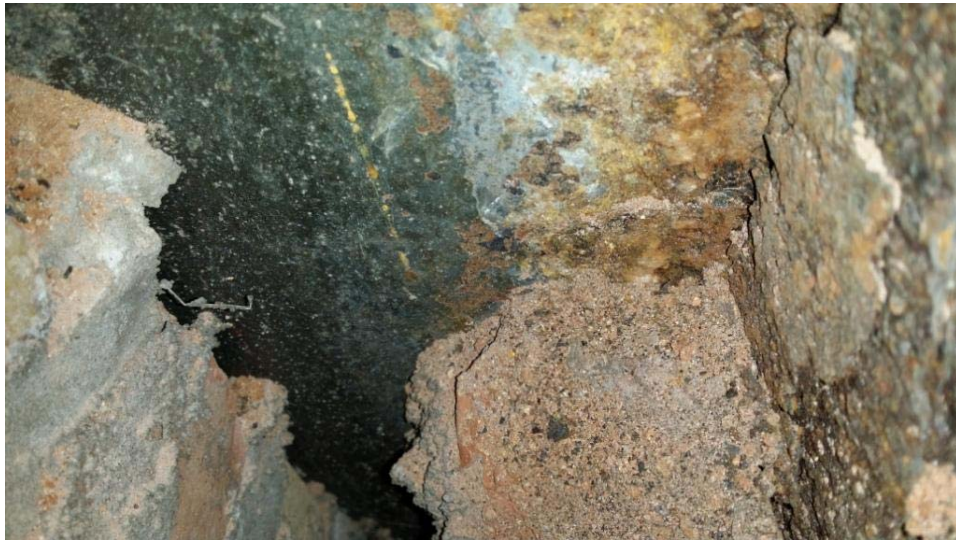
View of steel column within cavity

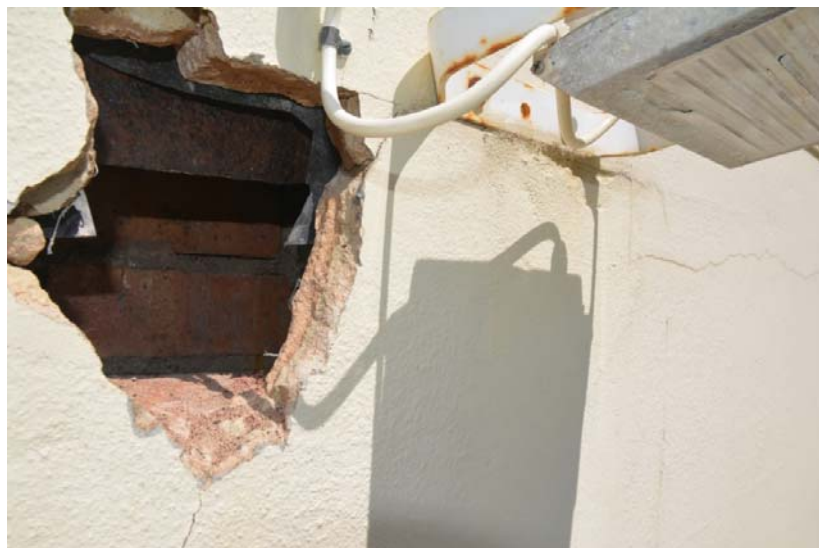
The breaking out revealed a similar cavity wall construction with a rolled steel angle section running horizontally connecting to the column.

Again extensive corrosion was present with again a section of pvc type dpc present to its front surface.

View of horizontal steel angle section

11. That the corroded horizontal angle section below parapet level be replaced with a similar primed 100x100x12mm rolled steel angle section (support of the brickwork above will be required)
12. That the whole of the steelwork be painted as detailed below.
13. Following the above 30mm Kooltherm K5 external wall board shall be installed as indicated.
14. The brickwork pockets and areas of broken out masonry shall then be made good with class B semi engineering brickwork using mortar designation (iii) and the render made good utilizing light mesh reinforcement and painted all to match the existing and the temporary support works and scaffolding removed.

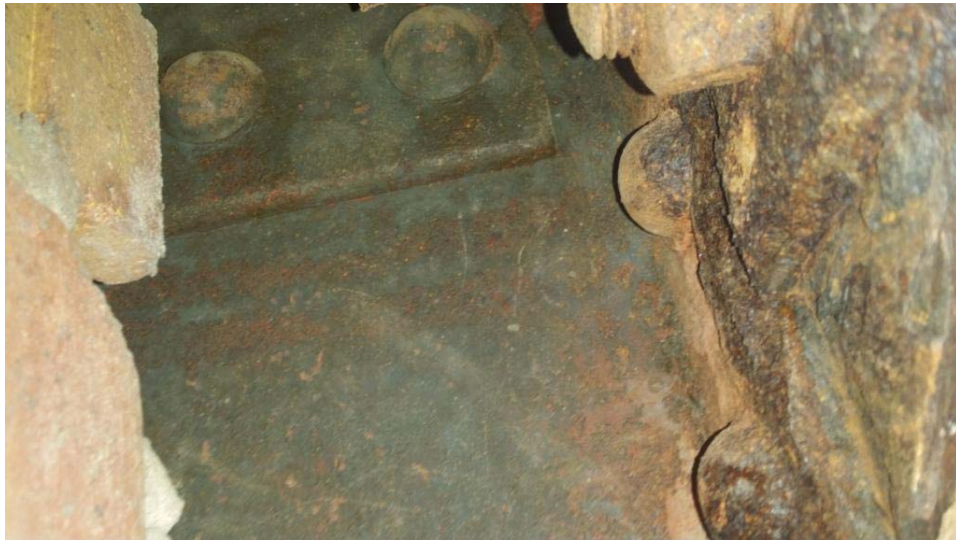
Viewing of the cavity revealed rivets to be present to the steel column connecting what would appear to be a connection plate possibly relating to the roof beams with a bolted connection between the column and the rolled steel angle noted.

Rivets present to column and angle bolt connection
