Refurbishment Survey

Survey Reference Number: X-01076RV1

32 Sally Port
St Marys
Isles of Scilly
TR21 0JE

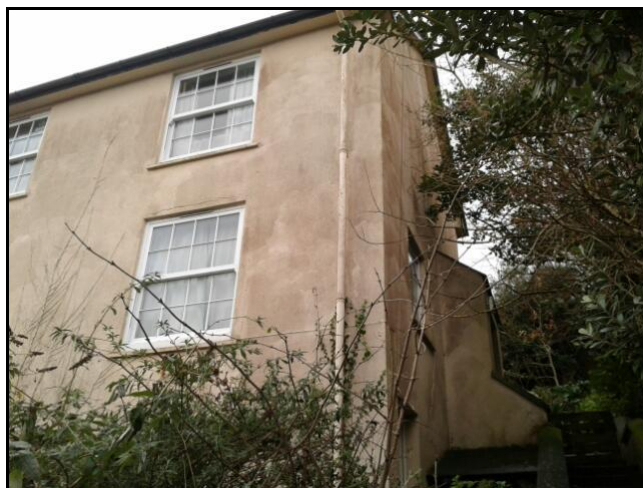
- 1980's 3 storey block built semi-detached house with a man-made tiled pitched roof.
