| Project | C2 STATS | |

**ANNEXE 3 - ASBESTOS ACTION PLAN (AAP)**  
(Format as required by Annex 3 of IAN 63/05 Rev 01)

**Asset Name:** South of Carminow to North of Callywith

**ASSET NAME** [South of Carminow to North of Callywith]  
**ASSET REFERENCE NO(S)** [Mile Post: 94/0 – 99/0]  
**LOCATION** [A30]  
**OTHER DEFINING REFERENCE/NAME** []  
**BRIEF DESCRIPTION OF ASSET** [5km Section]

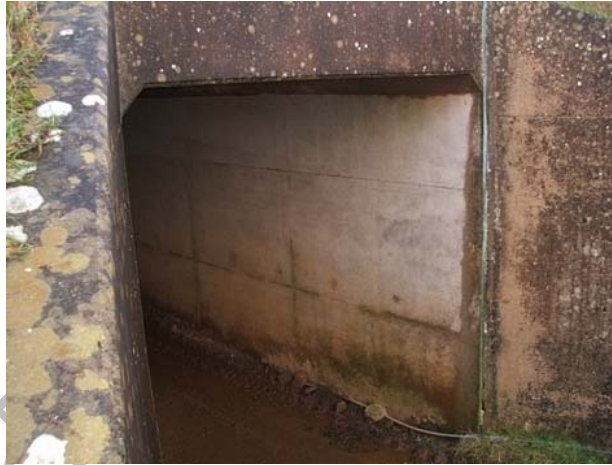
Mil Post: 94/5, 95/2, 98/5 - Road underpass. Reinforced concrete structure with rubber expansion joints.

The waterproof membranes system to the bridge deck (located above the road underpasses MP: 94/5/ 95/2, 98/5) is presumed to contain asbestos. Sample prior to maintenance.
