Refurbishment Survey Report

Asbestos was located
Highest Priority ACM Recommendation = H - Manage
2 Consort Terrace

Order Placed By: Paul Ainsley
Project Number: MCP-1189H-426

Survey Date: 19/12/2013

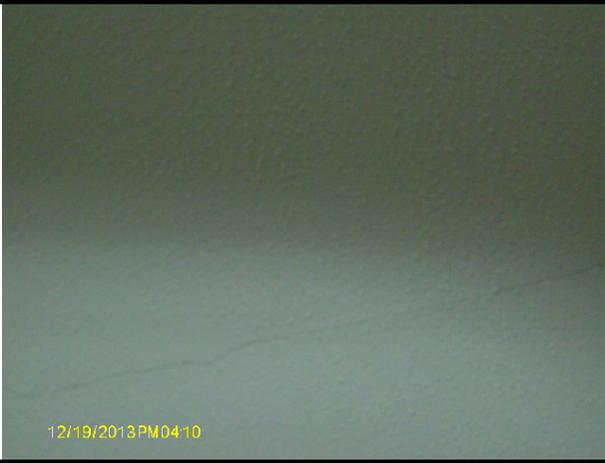
<p>12/19/2013 PM 04:24</p>
<p>Ph09 Sample 01 – Textured coating to ceiling – Communal Entrance Hall Asbestos detected</p>	<p>Ph10 Sample 02 – Textured coating to ceiling – Flat 2B Kitchen Asbestos detected</p>

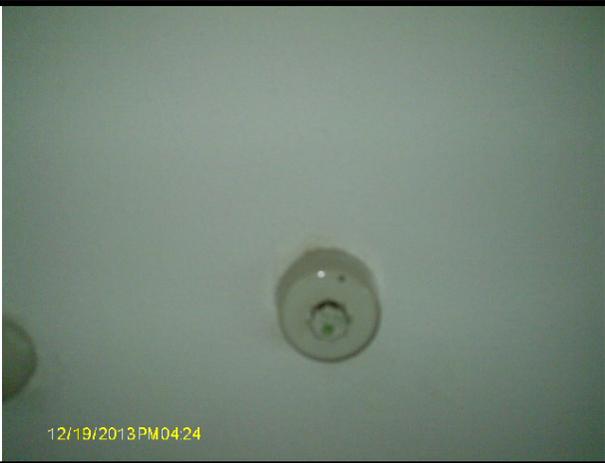
<p>12/19/2013 PM 04:25</p>
<p>Ph11 Sample 03 – Textured coating to ceiling – Flat 2B Lounge Asbestos detected</p>	<p>Ph12 Sample 04 – Textured coating to ceiling – Flat 2B Bedroom 01 Asbestos detected</p>

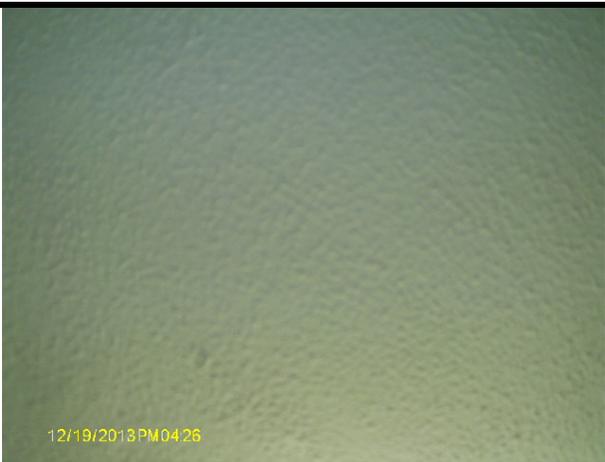
<p>12/19/2013 PM04:26</p>
<p>Ph13 Sample 05 – Textured coating to ceiling – Flat 2B Bathroom Asbestos detected</p>	<p>Ph14 Sample 06 – Textured coating to ceiling – Flat 2B Hall, Stairs & Landing Asbestos detected</p>

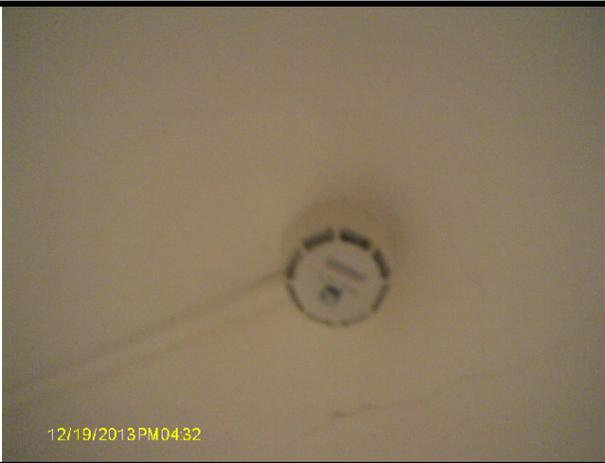
<p>12/19/2013 PM04:33</p>
<p>Ph15 Sample 07 – Textured coating to ceiling – Flat 2B Bedroom 02 Asbestos detected</p>	<p>Ph16 Sample 08 – Textured coating to ceiling – Flat 2B Bedroom 03 No Asbestos detected</p>

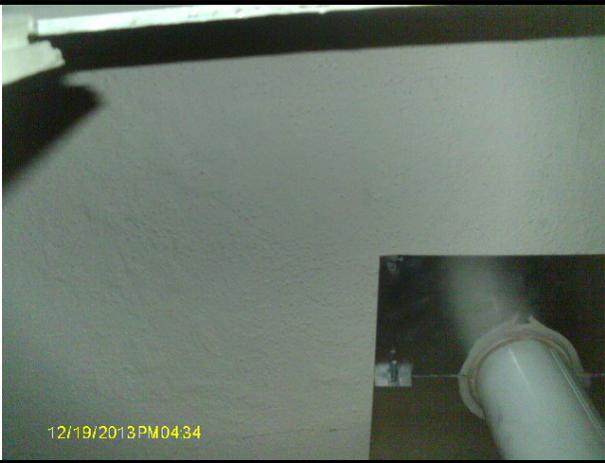
<p>Ph17 Sample 09 – Textured coating to ceiling – Flat 2B Boiler Store Asbestos detected</p>
