Fleet Air Museum

Project Ref: 8920

Digital Image Record (Site Visit 15th October 2015)

Digital Image Record (Site Visit 22nd November 2017)

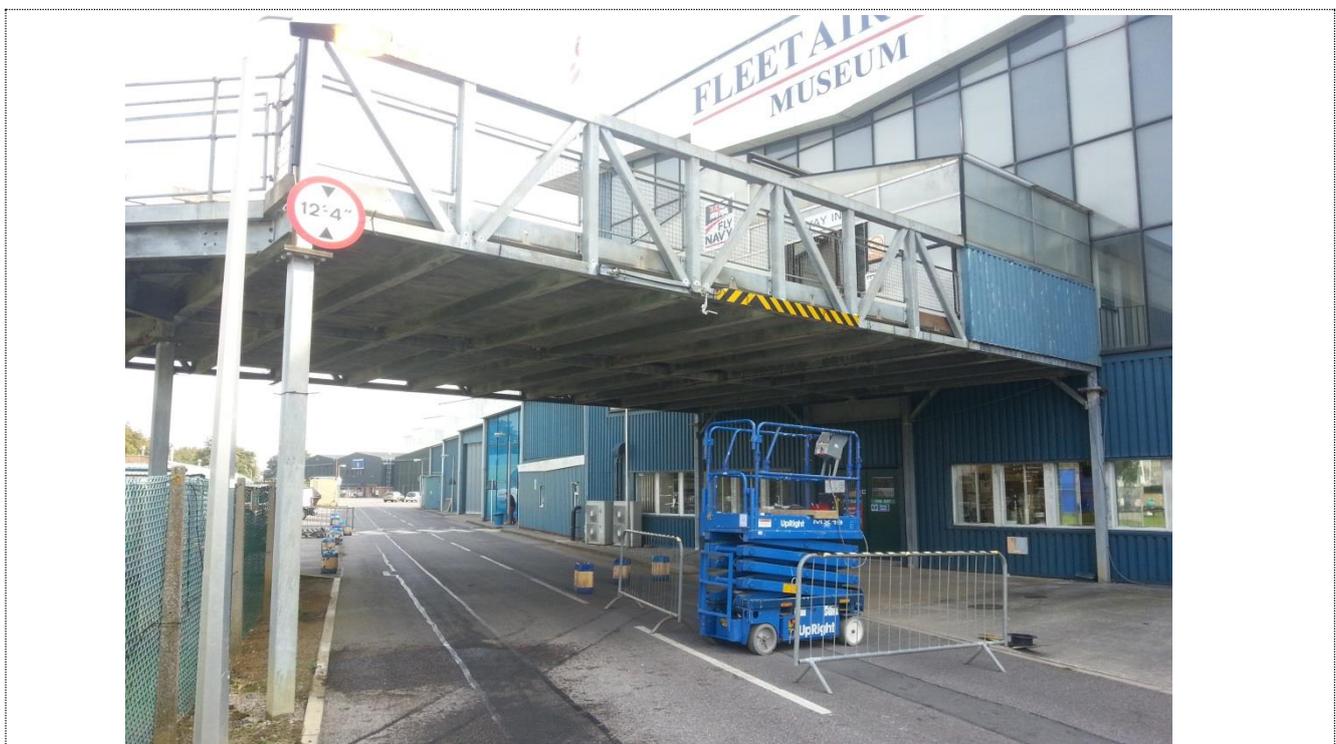
P01 – General view of existing bridge deck structure and entrance canopy over.

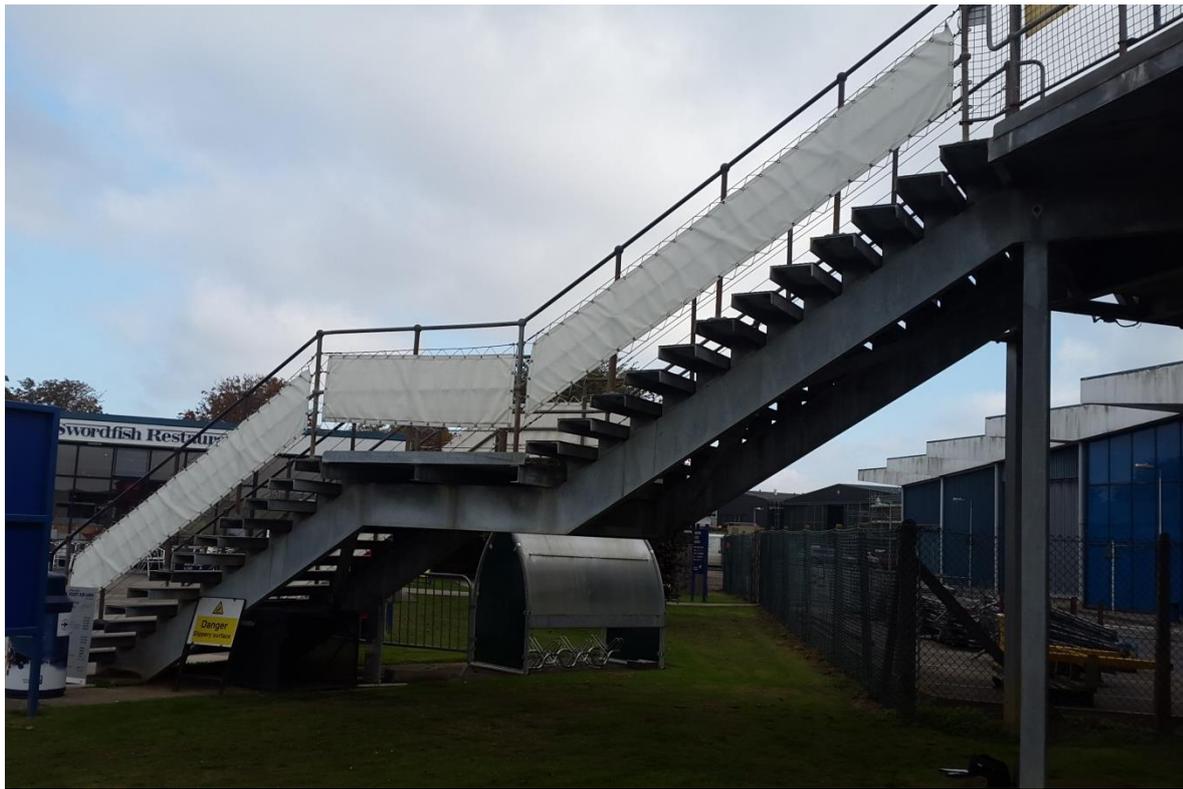
P02 – General view of existing staircase structure.

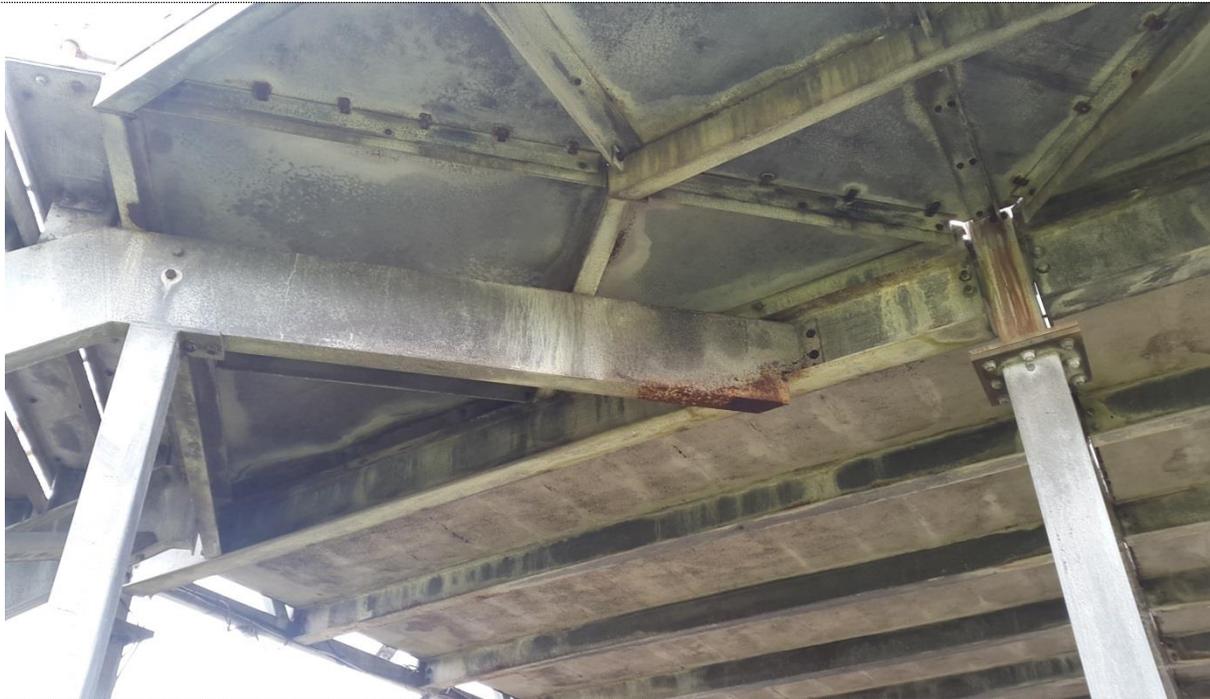
P03 – General view under cantilevering deck adjacent to staircase structure. Note moderate surface corrosion to fixings and locally to member surfaces.

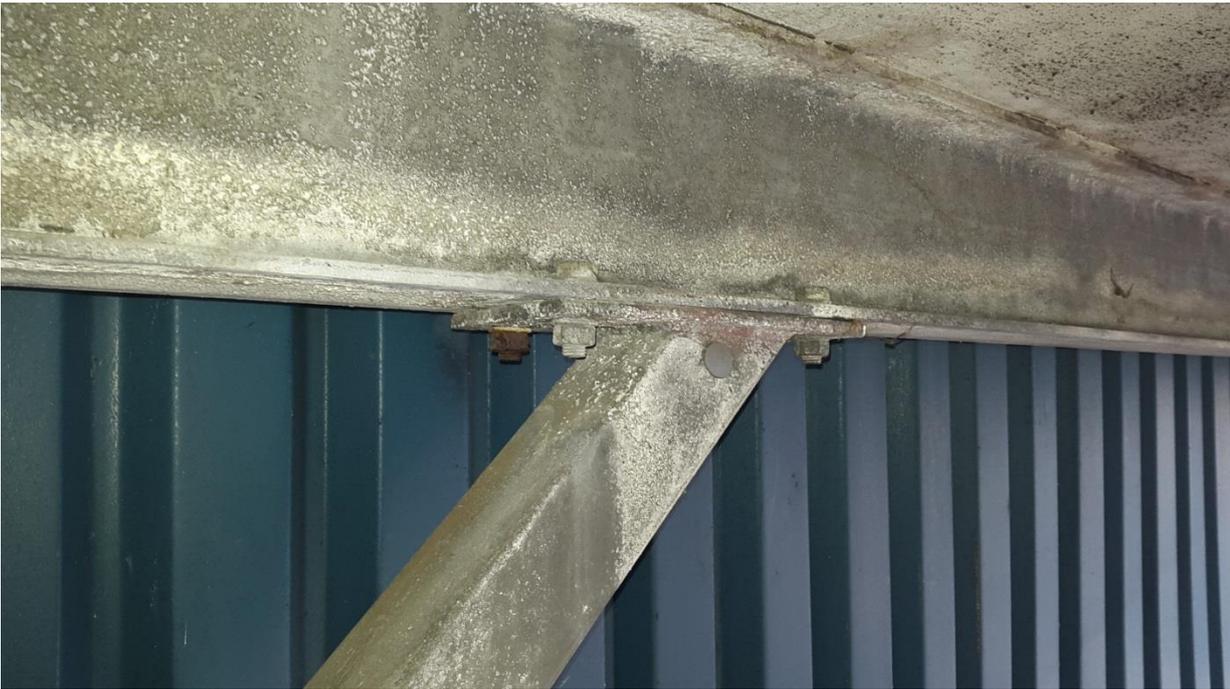
P04 – Typical detail to frame over door opening in adjacent building. Note, moderate corrosion to bolted fixing.

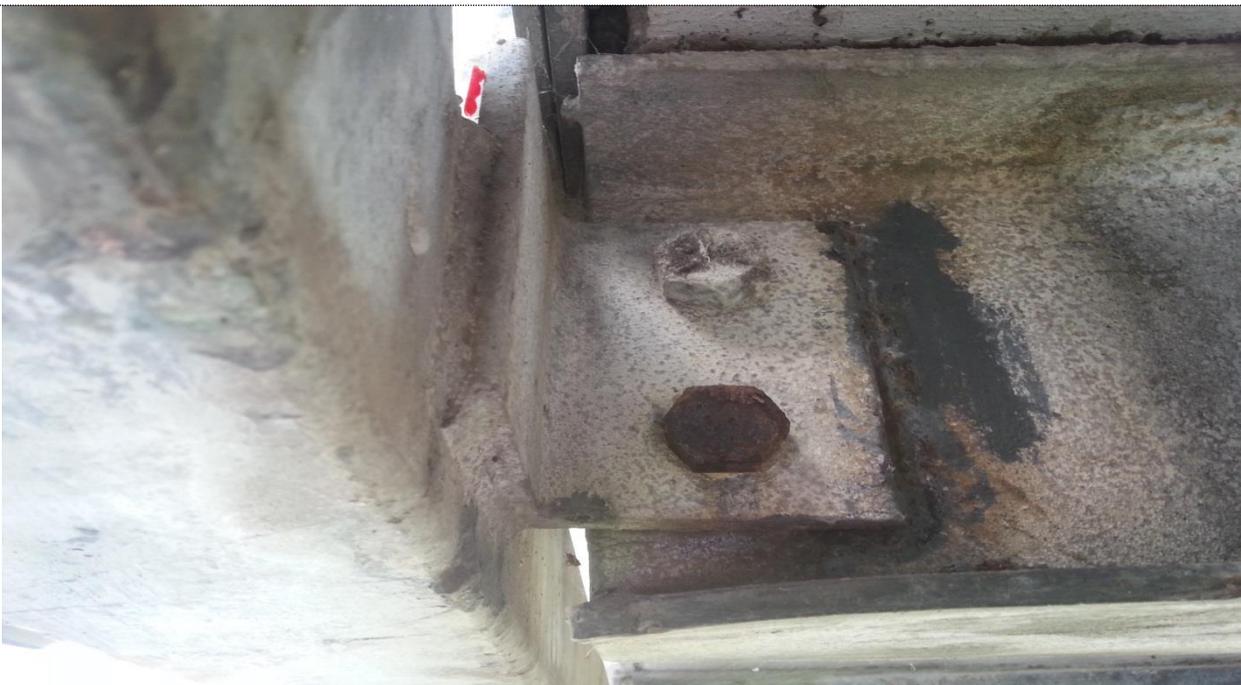
P05 – Typical moderate surfaces corrosion to bolt head securing deck beam to principal truss.

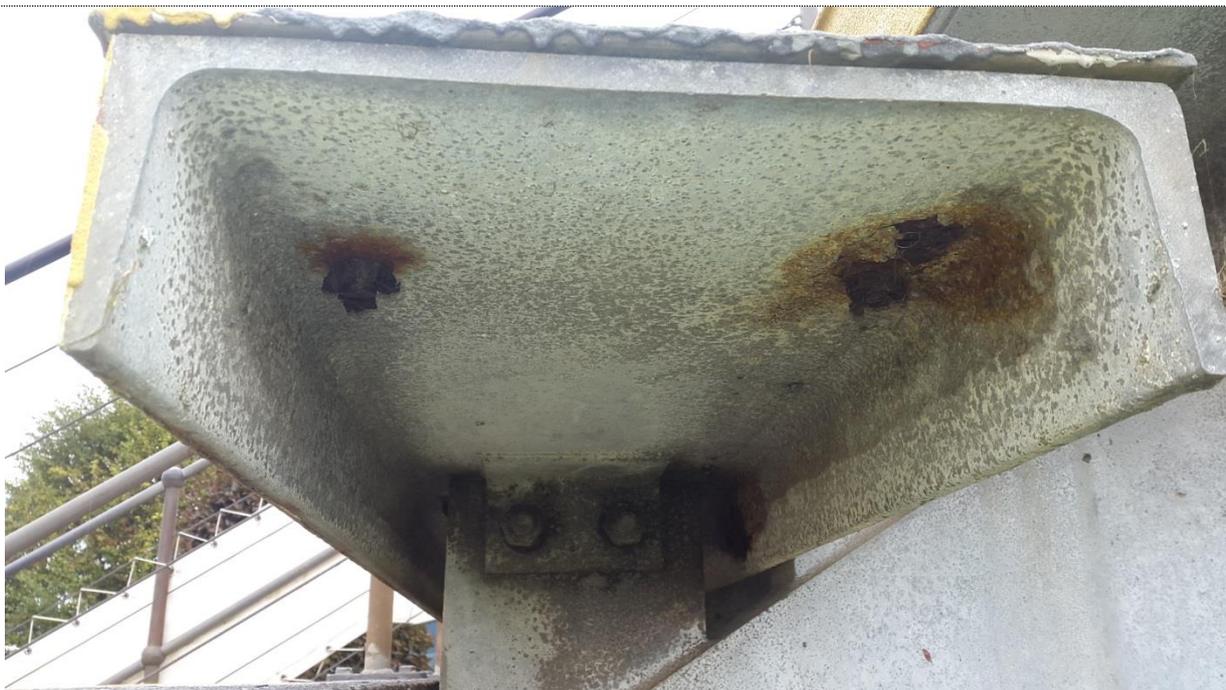
P06 – Moderate corrosion to nuts securing staircase members and locally on surfaces of staircase members.

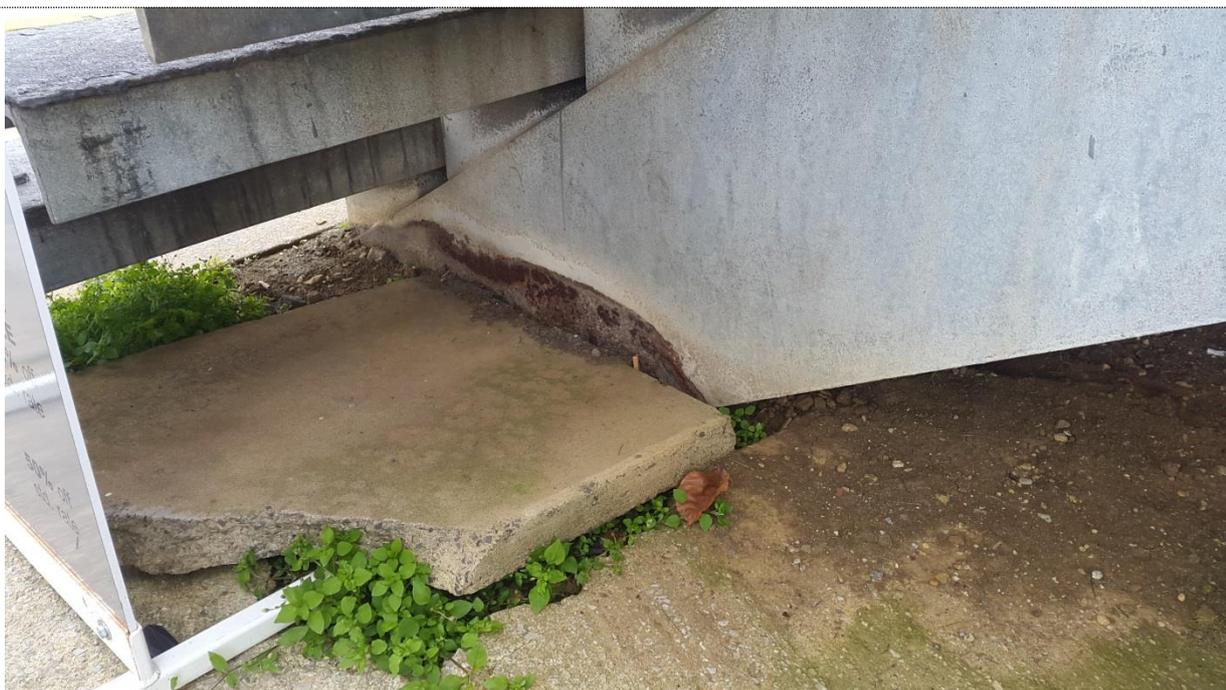
P07 – Significant corrosion to staircase stringers at interface with ground surface.

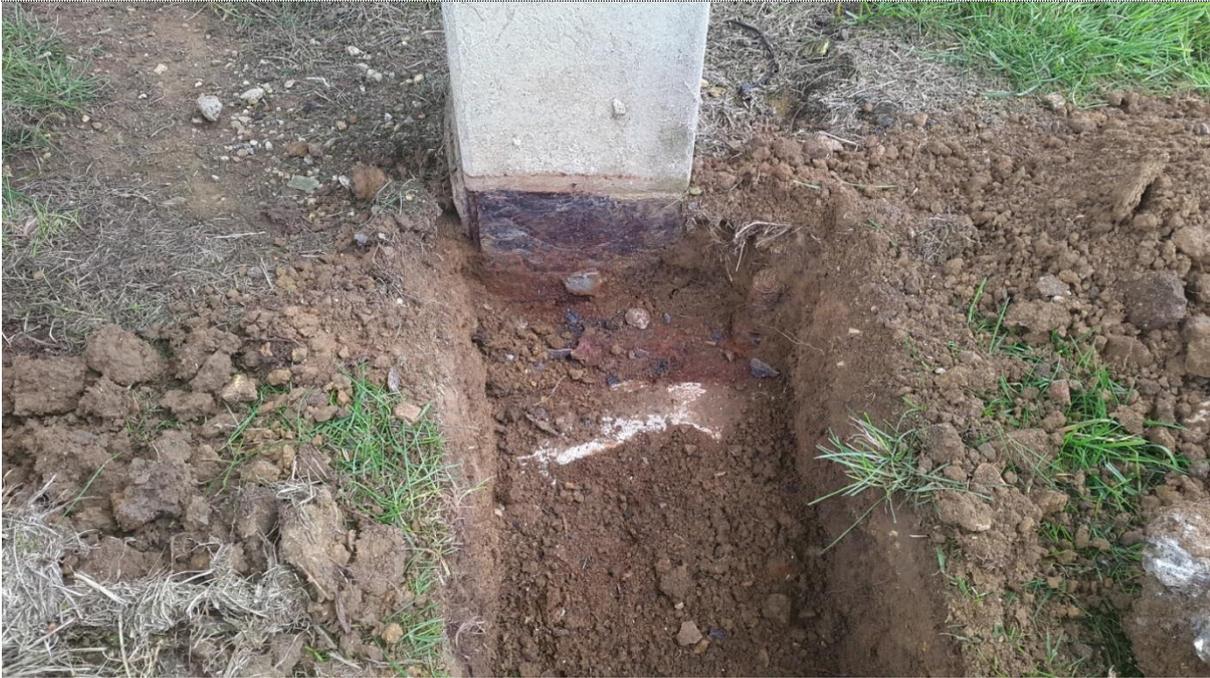
P08 – Significant corrosion and surface delamination of buried steel support structure.

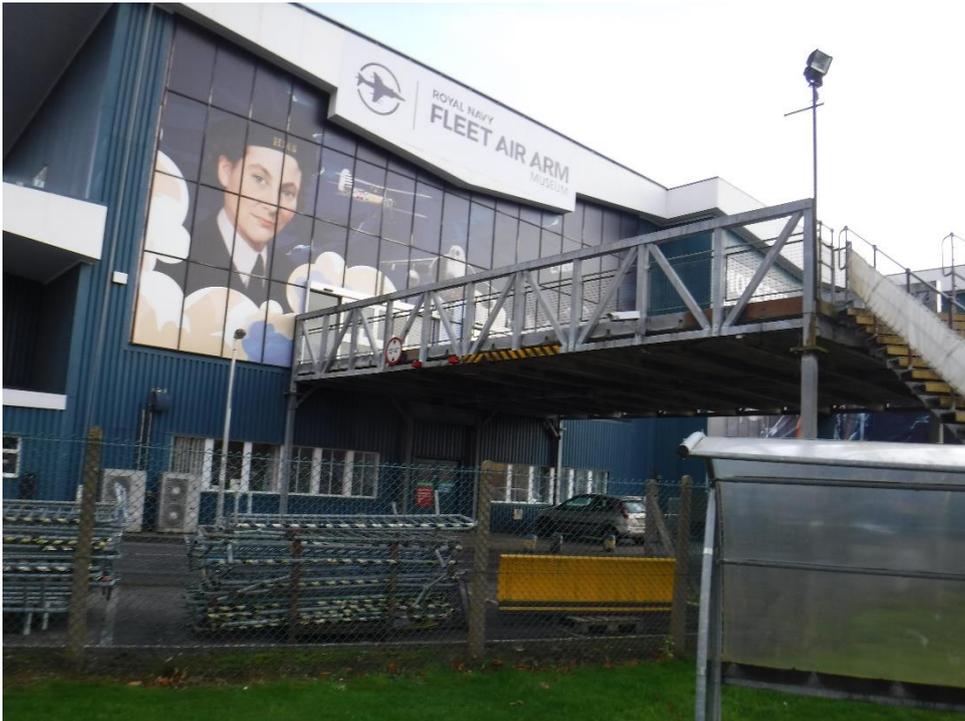
P09 – General view of existing bridge deck structure.

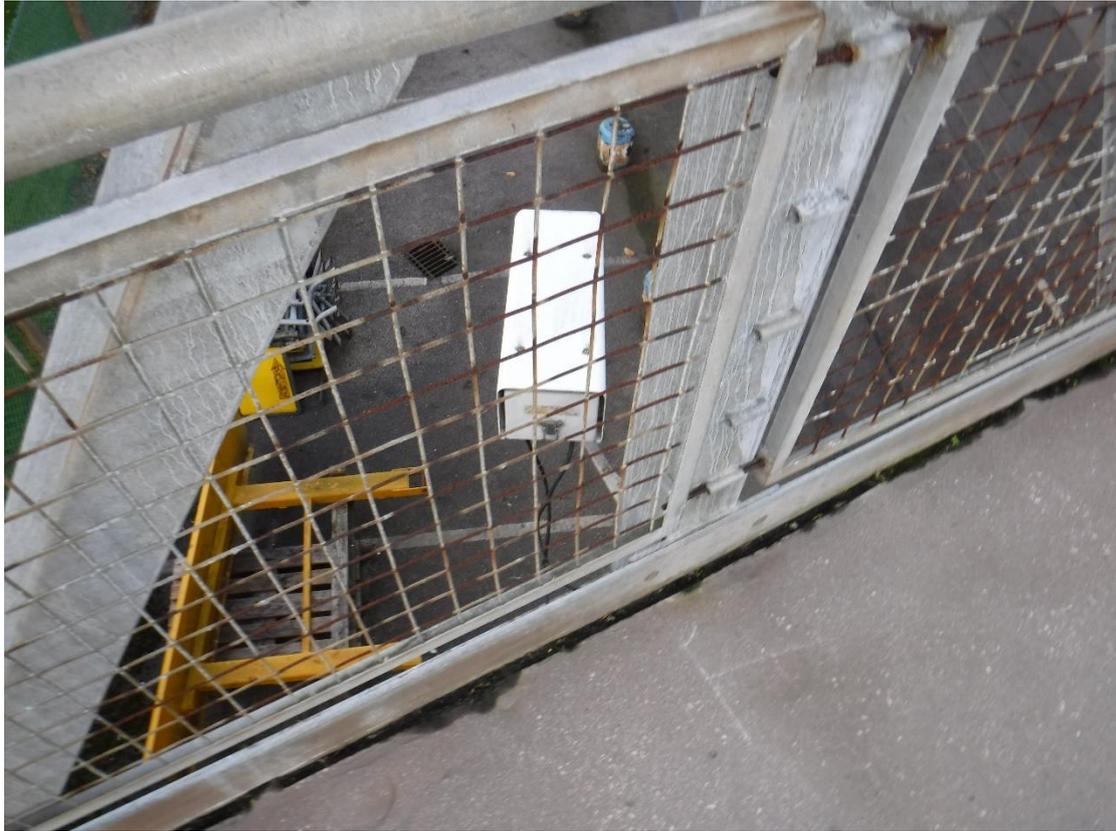
P10 –General view of CCTV system

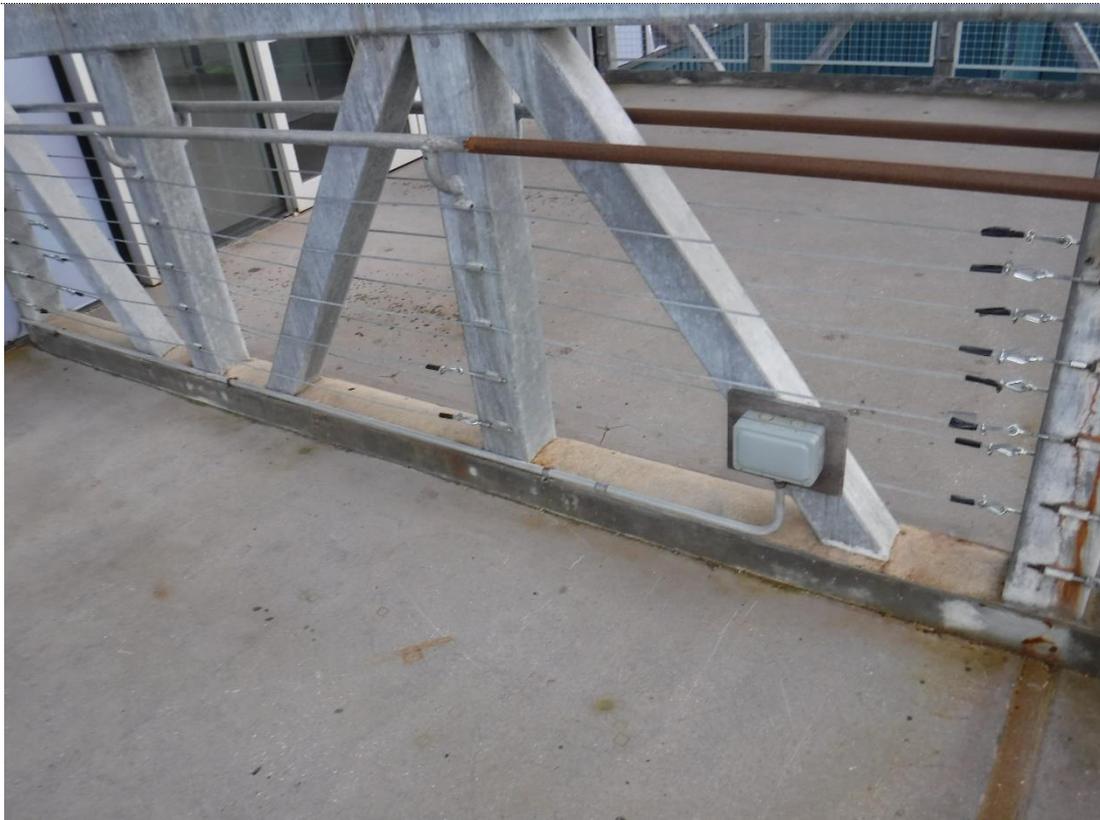
P11 –General view of electrical fitting

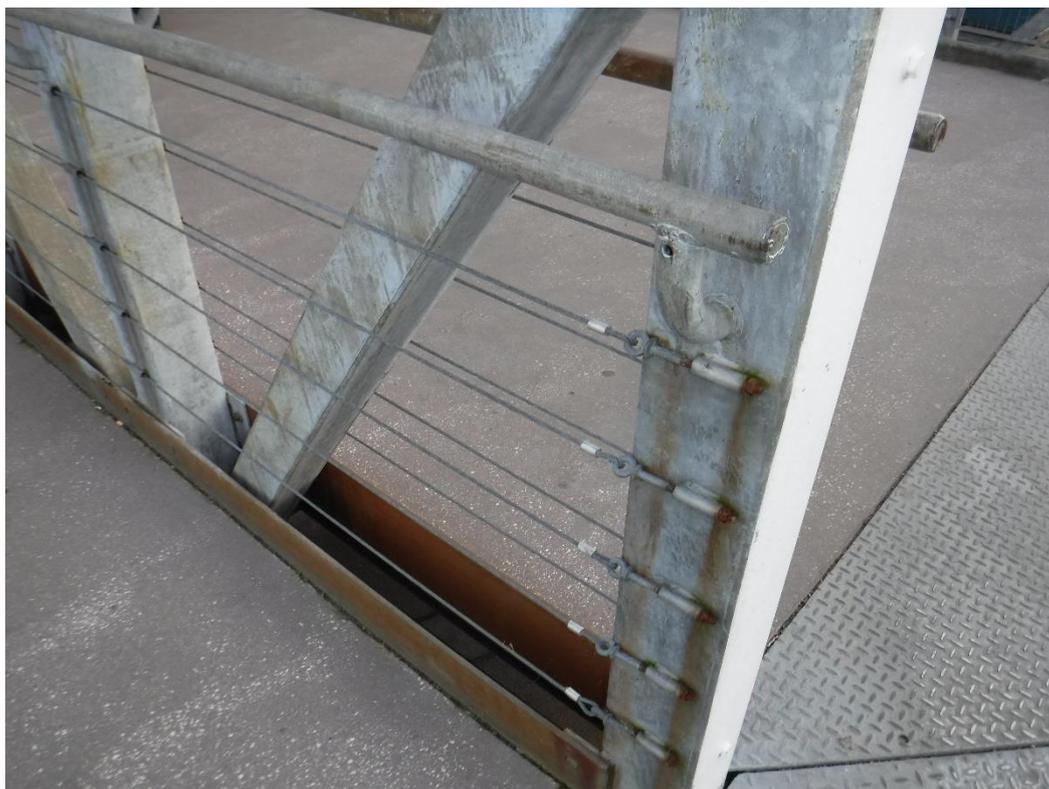
P12 –General view of stainless steel handrail panel

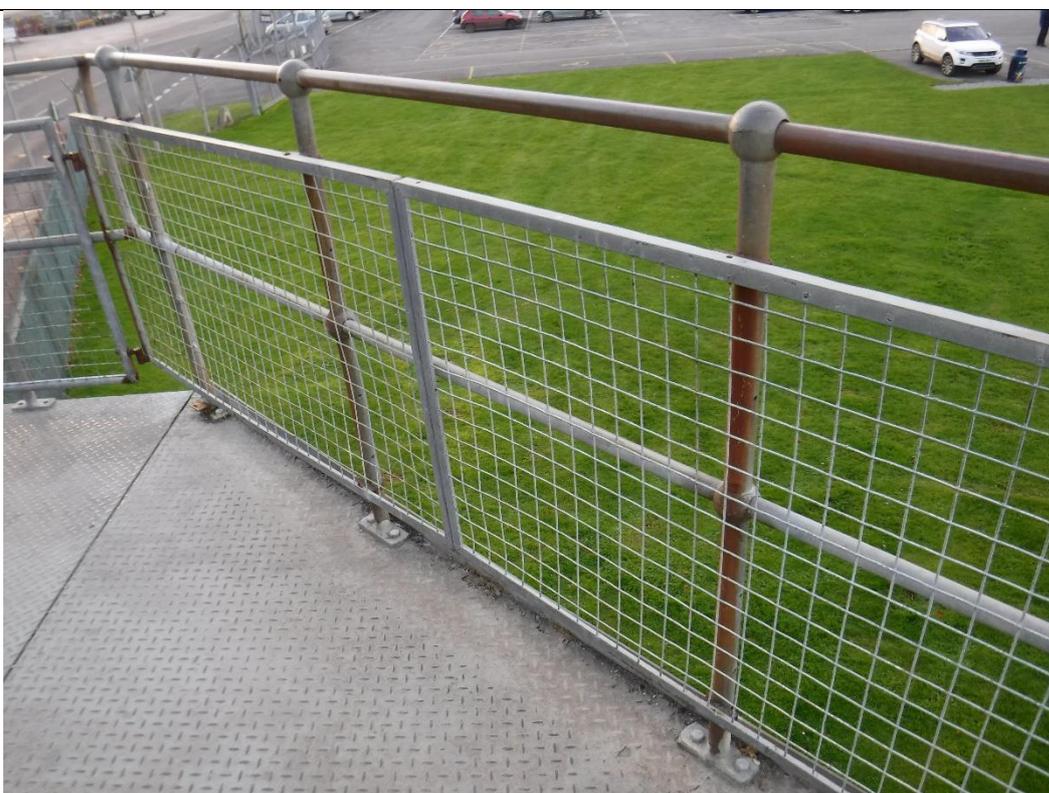
P13 –General view of mesh infill panel

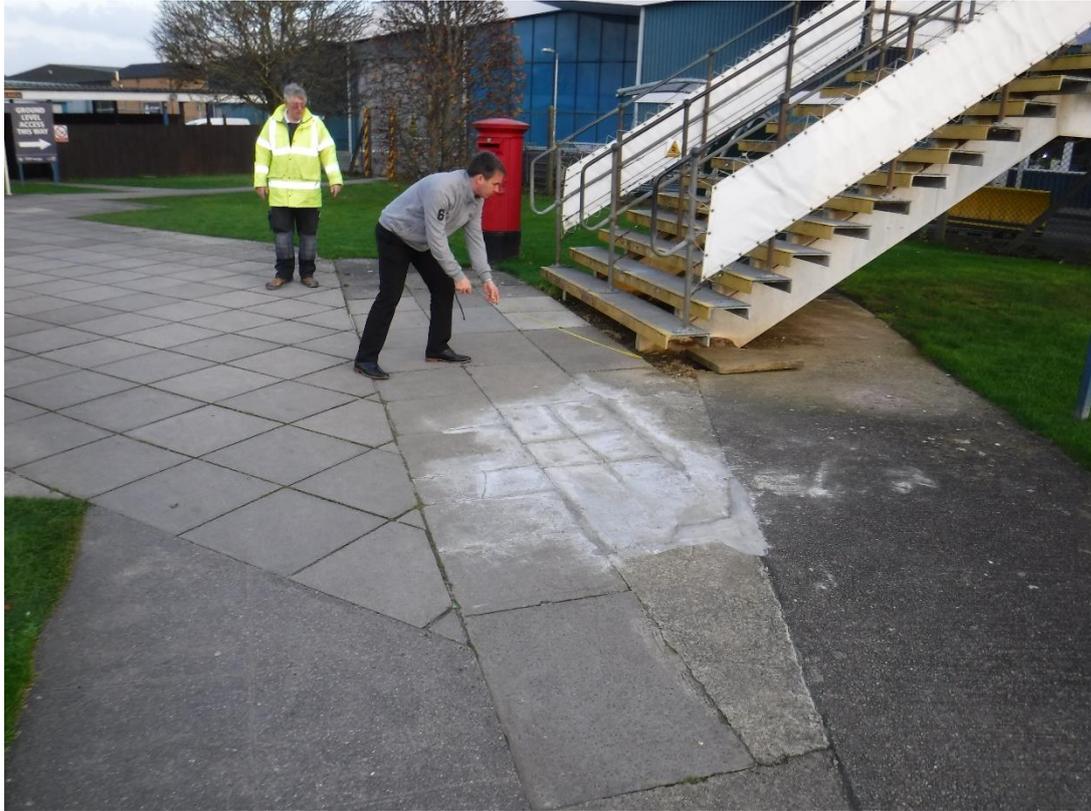
P14 –General view of paving slabs at base of stairs

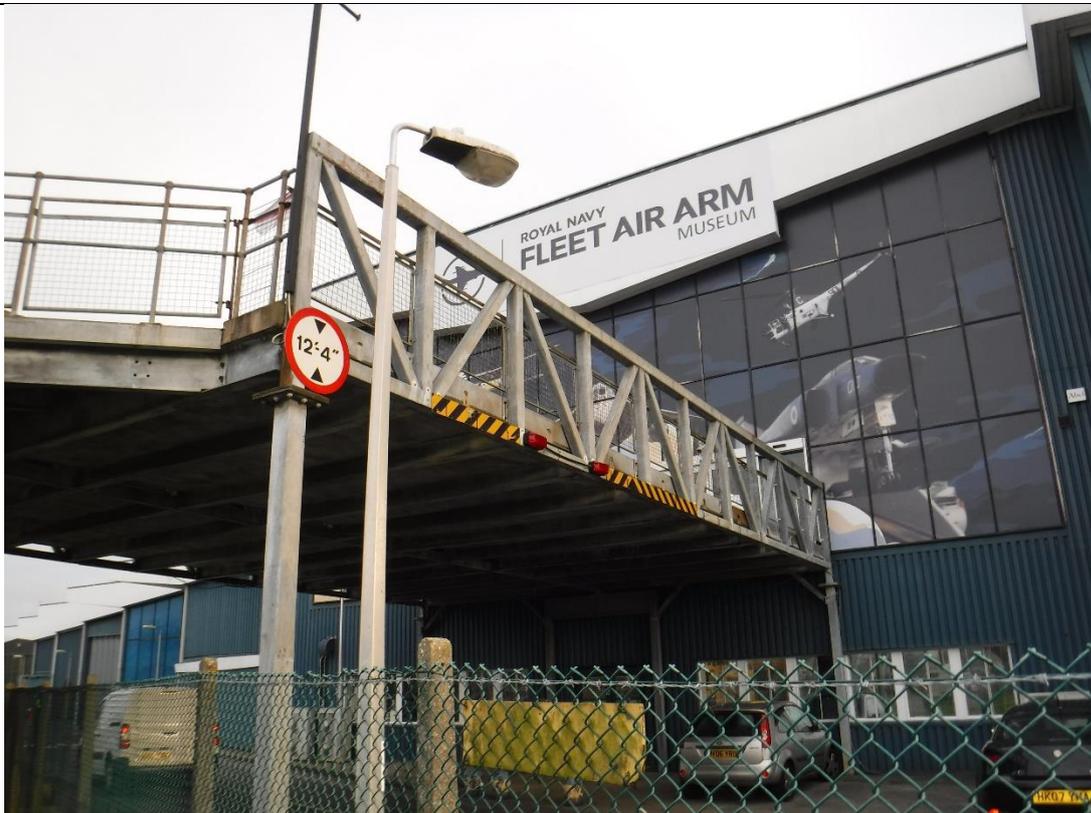
P15 –General view of bridge and entrance to museum
