AIR CONDITIONING PROBLEM AND DIAGNOSIS

Tuesday, 30 June 2020

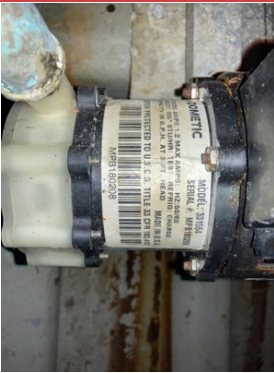
LOWER DECK SW PUMP DETAILS

Pump is working correctly but in poor condition and quite rusty would recommend replacement for long term reliability.

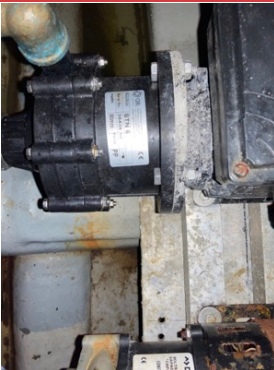
UPPER DECK SW PUMP DETAILS

This pump has been replaced but external influences has also prematurely aged this pump

The inlet of this pump had a small air leak which although not a big one could have long term issues of pump taking in air.

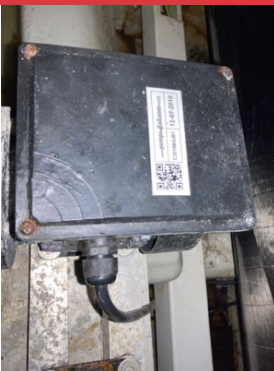
UPPER DECK PUMP DETAILS.

This Pump has a date on showing replacement with a non Dometic pump manufactured in 2018.

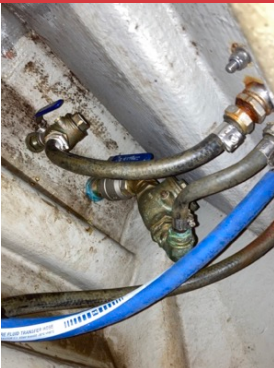
ONE WAY VALVE.

This one way valve on skin fitting wasn't functioning correctly removed and 'freed' up in workshop and replaced
