HENLEY TOWN COUNCIL

A feasibility study for the proposed natural turf pitch improvement works at Jubilee Park, 357 Reading Road, Henley-on-Thames, RG9 4HA.

13th November 2023 [Revision 3, 23rd February 2024]

TGMS1315.2 [ABRIDGED VERSION]

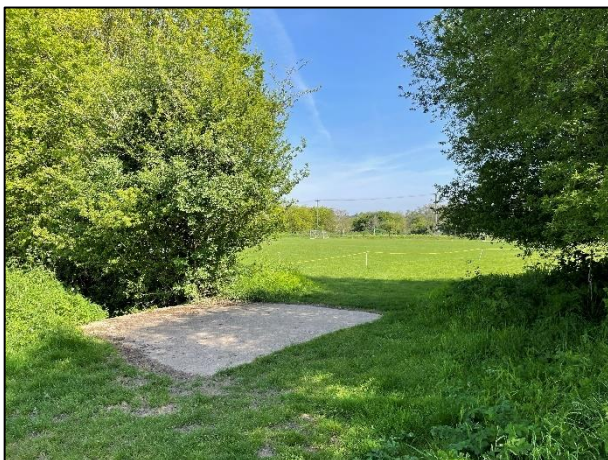
Figure 10. Concrete bridge over a ditch that runs along the south-eastern boundary.

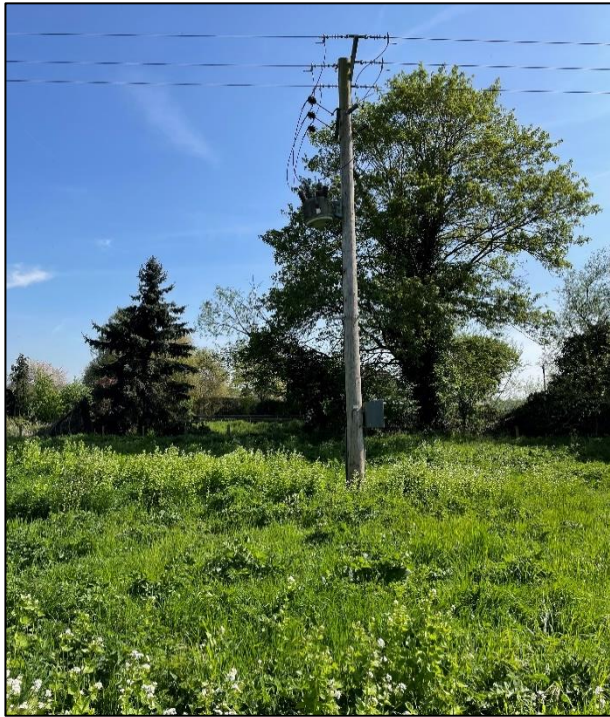
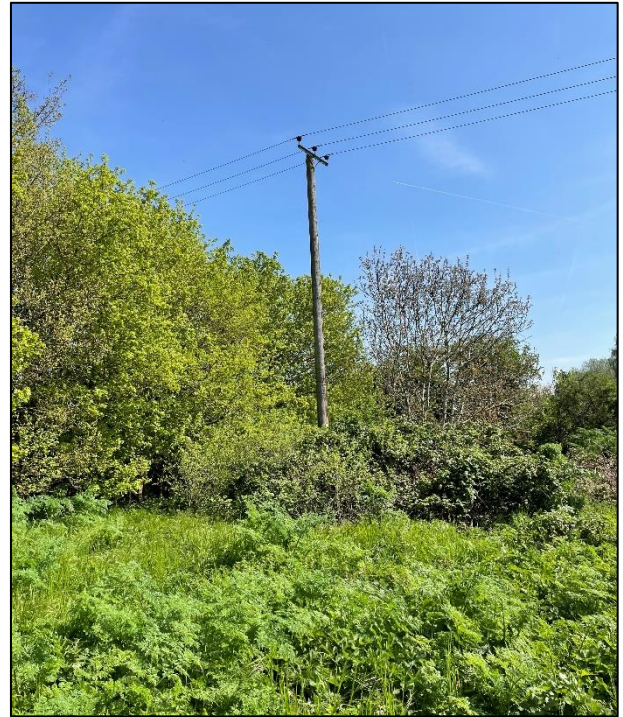
Figure 18. Overhead power lines in the fallow triangular area.

Figure 19. Overhead power lines in the fallow triangular area..

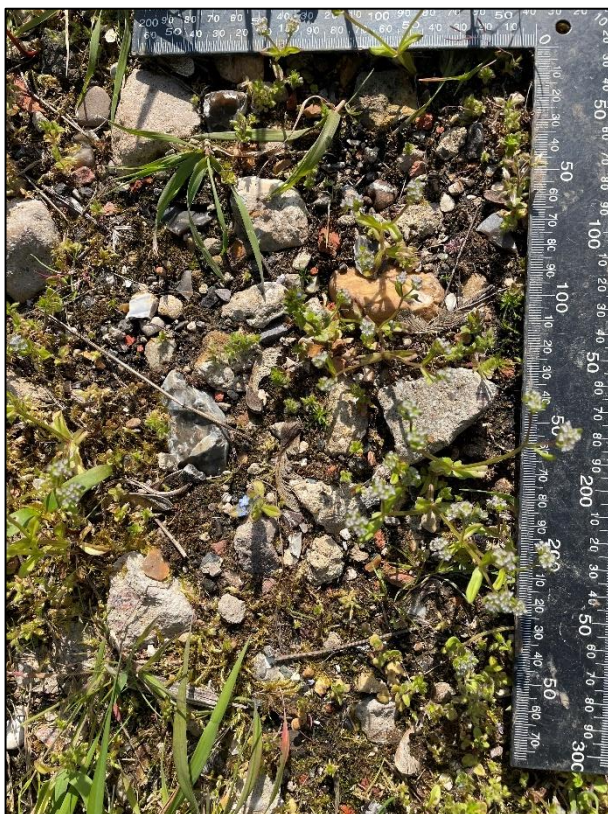
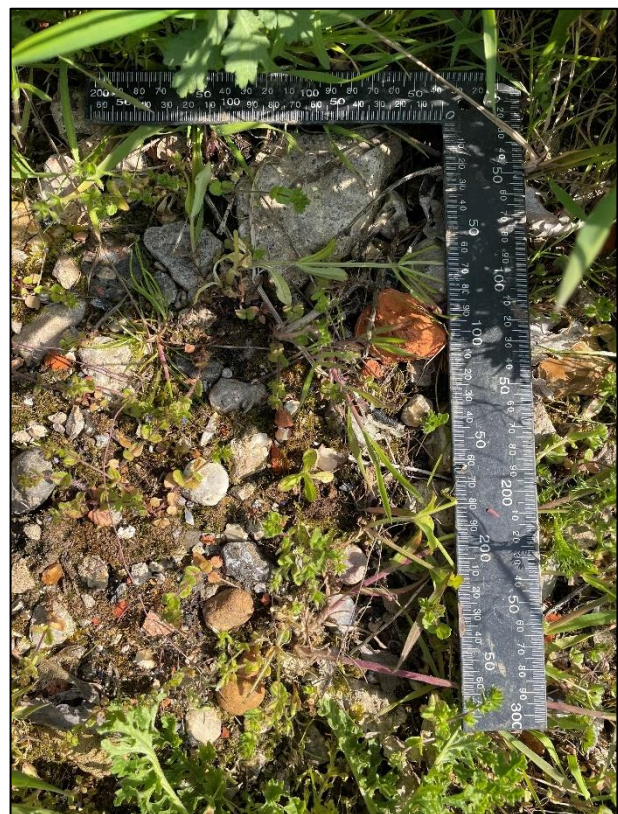
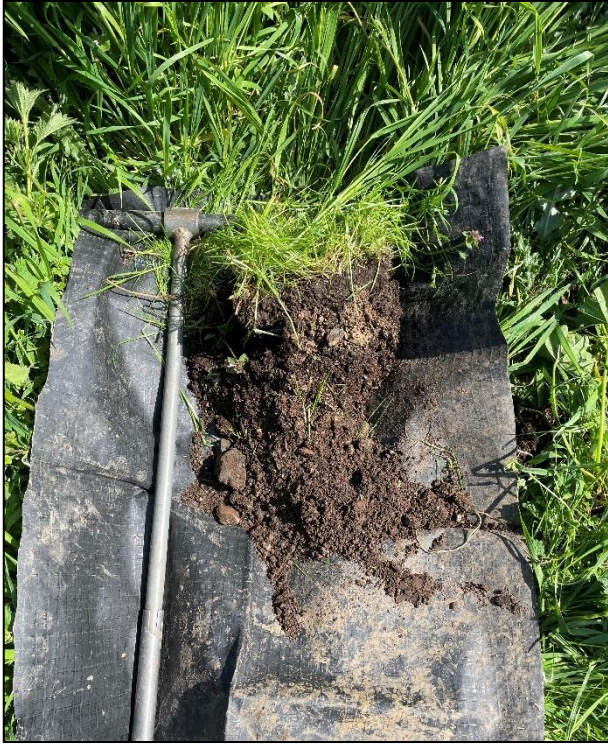
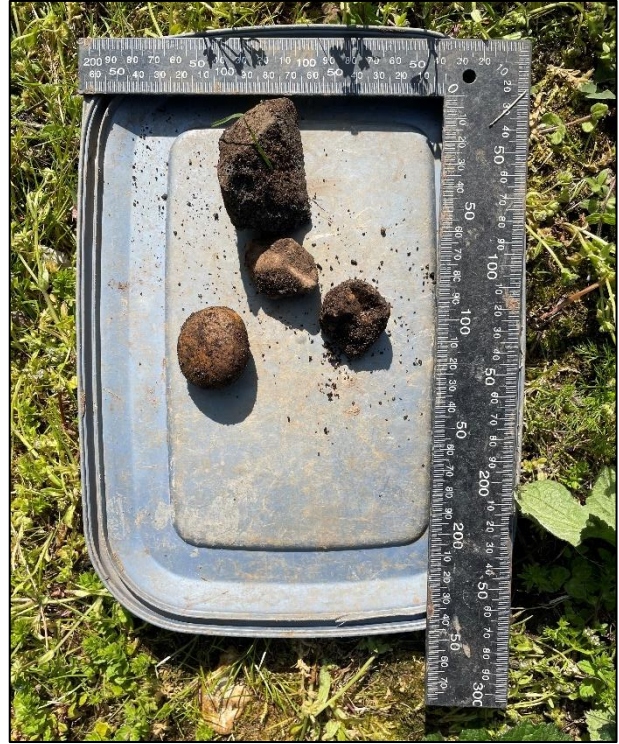
TP1 was located towards the centre of the fallow area near the overhead power lines. A lot of stone and fragments of building materials were evident on the surface (Figures 36 and 37), and the soil profile was found to comprise a mix of SANDY LOAM topsoil, stones and made ground, which extended beyond the maximum excavation depth of 0.40 m (Figures 38 and 39).

Figure 36. TP1 – Stones and fragments of building materials on the surface.

Figure 37. TP1 – Stones and fragments of building materials on the surface.

Figure 38. TP1 – Sandy loam topsoil mixed with stones and made ground.

Figure 39. TP1 – High stone content.

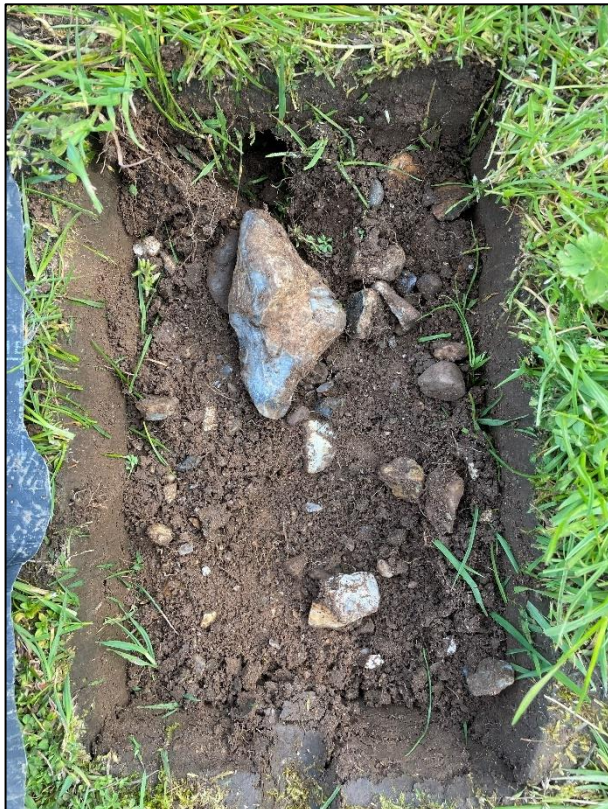
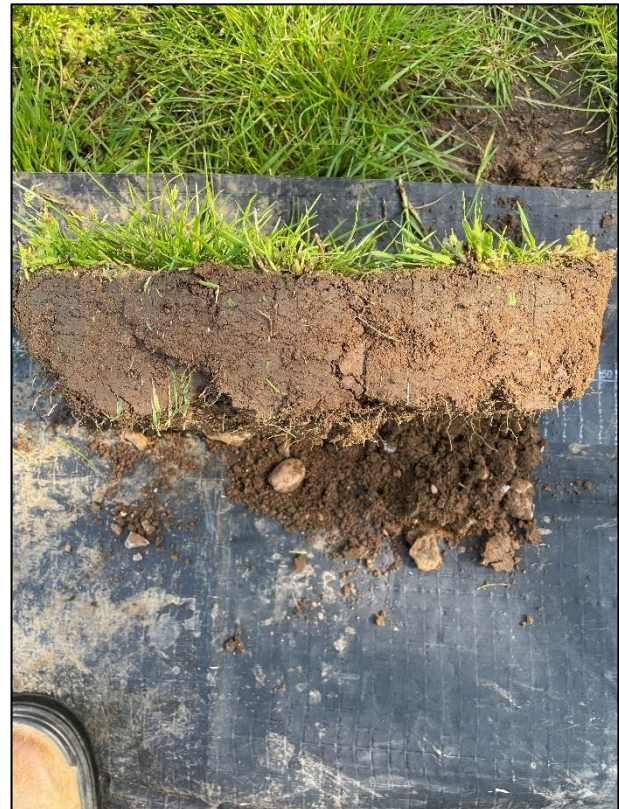
TP2 was located towards halfway along an old track immediately adjacent to a neighbouring tennis court (Figure 3). The soil profile was found to comprise 100 mm of SANDY LOAM topsoil over very stony SANDY LOAM subsoil. The stones were predominantly flints of up to 100 mm in their longest axis, and the excavation was aborted at 200 mm depth (Figures 40 and 41).

Figure 40. TP2 – Sandy loam topsoil with a high stone content.

Figure 41. TP2 – Sandy loam topsoil.

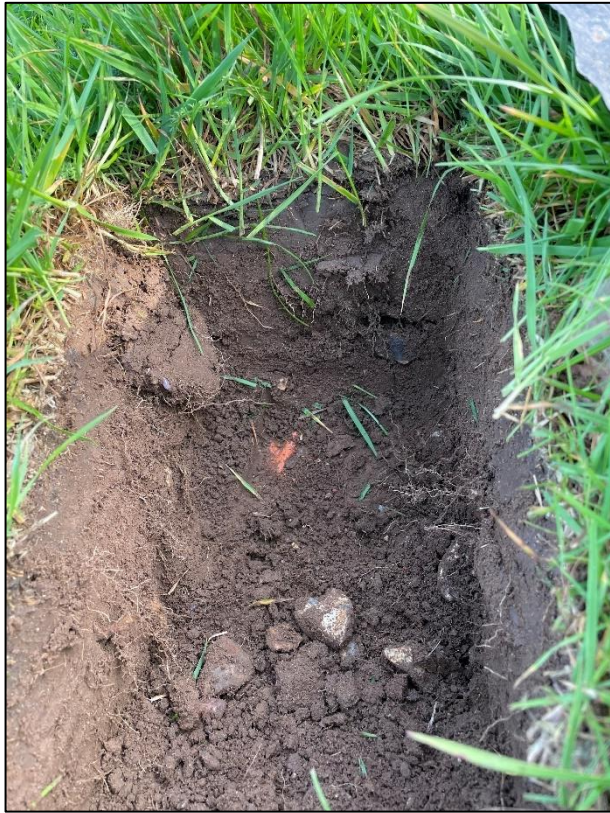
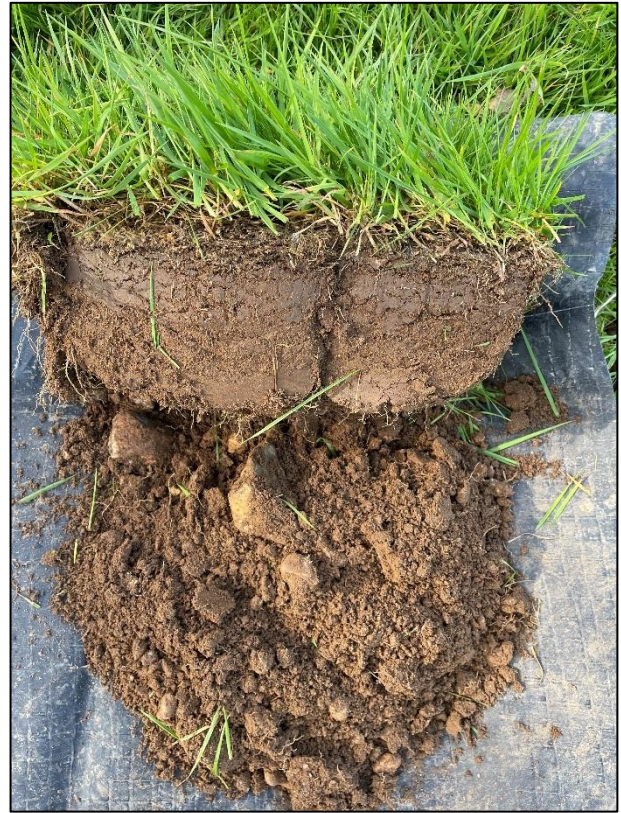
TP3 was located on the batter slope near the site entrance off Reading Road (Figure 3). The soil profile was found to comprise 25 mm of thatch (organic material) over 0.10 m of brown SANDY LOAM topsoil, over very stony SANDY LOAM subsoil, which extended beyond the maximum excavation depth of 0.30 m (Figures 42 and 43).

Figure 42. TP3 – Sandy loam topsoil.

Figure 43. TP3 – Sandy loam topsoil over very stony sandy loam subsoil.

Indices of 2 and above indicate that there is sufficient supply of a particular nutrient. With reference to Table 3, the topsoil is generally in good order aside from a deficiency in the macro nutrient Potassium in the vicinity of TP3, and so it is recommended that, following pitch construction, the fertiliser programme be amended to address this deficiency. Soil pH of 8.1 (near the overhead power lines) is above (alkaline) the recommended range for the cultivation of Perennial ryegrass species (5.5 to 7.5). An alkaline environment will reduce the availability of certain nutrients - particularly P, K, B, Co, Cu, Fe, Mn and Zn. An elevated pH will also impact on beneficial soil fungal populations and activity. In other areas, soil pH of 5.6 to 6.0 is at the lower end (acidic) of the recommended range for the cultivation of Perennial ryegrass species (5.5 to 7.5). An acidic environment will reduce soil nutrient availability and the efficiency of any applied fertilisers or organic materials. A sub optimum pH will also impact on soil microbial populations and rates of activity. It is therefore recommended that a granulated form of carbonate of lime is applied during pitch construction to increase the pH to a more neutral reaction.

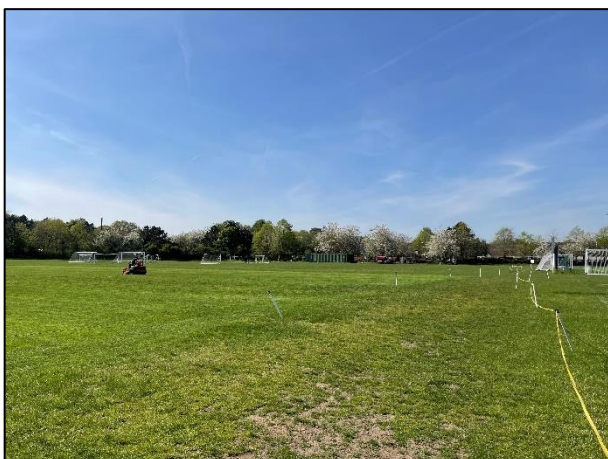
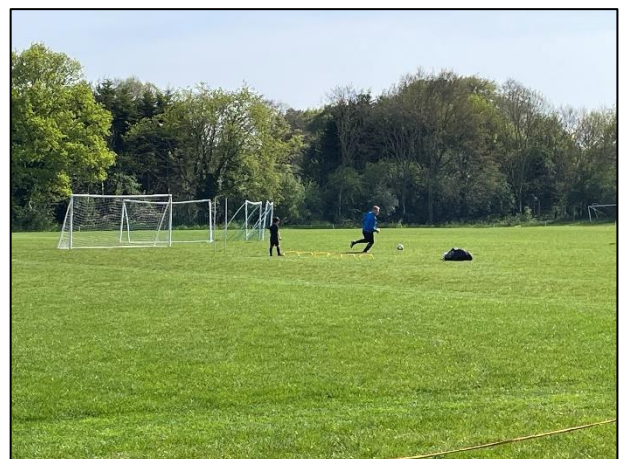
There are numerous minor surface depressions across the site, and ~25 mm of surface thatch, and so areas outside of the proposed 3G pitch and car park development works would benefit from enhanced agronomic maintenance and overseeding using a sports-specific ryegrass-dominated seed mix (Figures 45 and 46).

Figure 45. Surface depressions.

Figure 46. Rolling surface.

17. **Agronomic condition:** There are numerous minor surface depressions across the site, and ~25 mm of surface thatch, and so areas outside of the proposed 3G pitch and car park development works would benefit from enhanced agronomic maintenance and overseeding with a suitable grass sward using a sports-specific ryegrass-dominated seed mix. The area in the vicinity of the overhead power lines has been fallow for some time and is now covered with ~0.50 m of volunteer vegetation. There will be a need to remove this vegetation prior to soil importation and pitch construction works and the establishment of a suitable grass sward using a sports-specific ryegrass-dominated seed mix. If this area were to be extended into the paddock to the south-east that could potentially be for sale, there will be a need to arrange for two trees (a sycamore and blue spruce) to be removed.

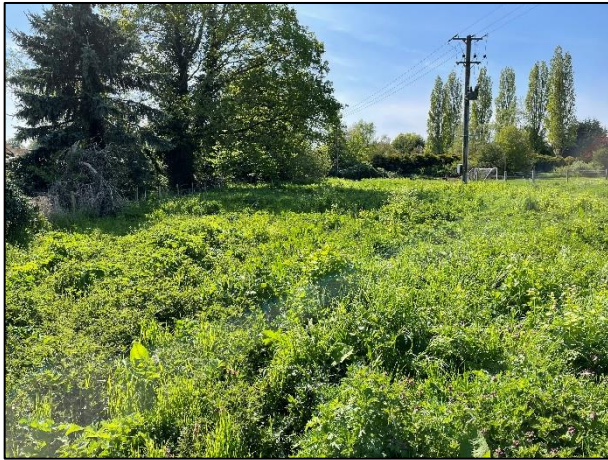
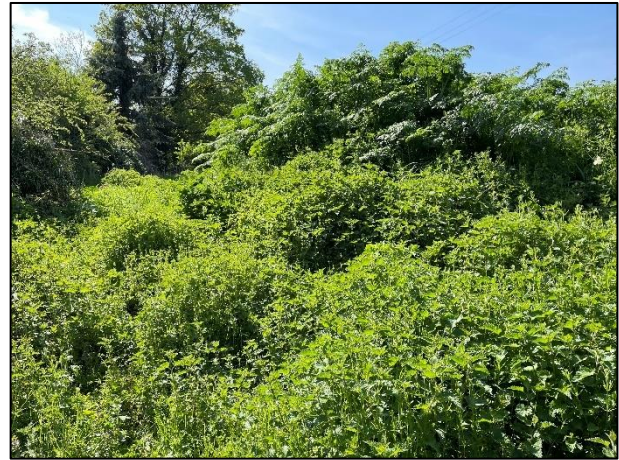
The area in the vicinity of the overhead power lines has been fallow for some time and is now covered with ~0.50 m of volunteer vegetation (Figures 47 and 48), which will require removal prior to any works.

Figure 47. Volunteer vegetation.

Figure 48. Volunteer vegetation.

There will be a need to remove this vegetation prior to soil importation and pitch construction works and the establishment of a suitable grass sward using a sports-specific ryegrass-dominated seed mix. If this area were to be extended into the paddock to the south-east that could potentially be for sale, there will be a need to arrange for two trees (a sycamore and blue spruce) to be removed (Figures 49 and 50).

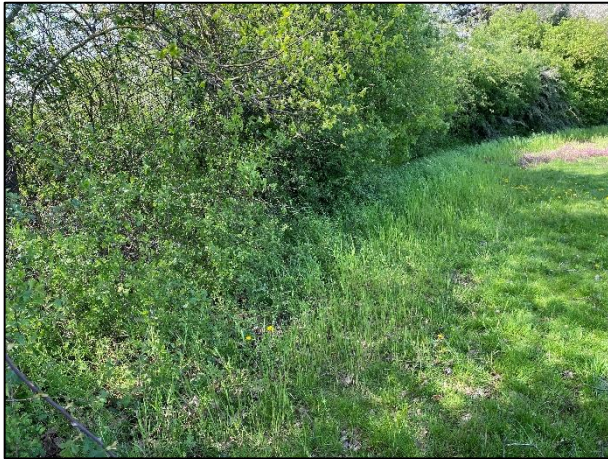
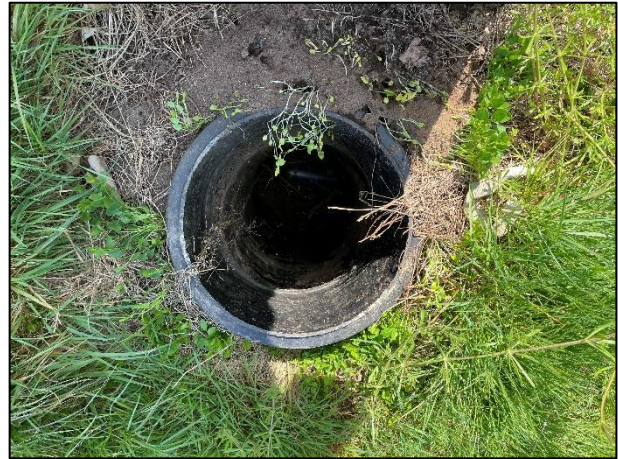
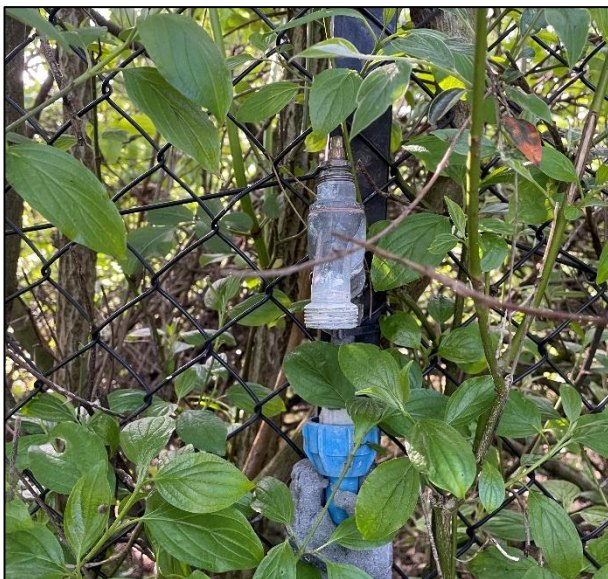
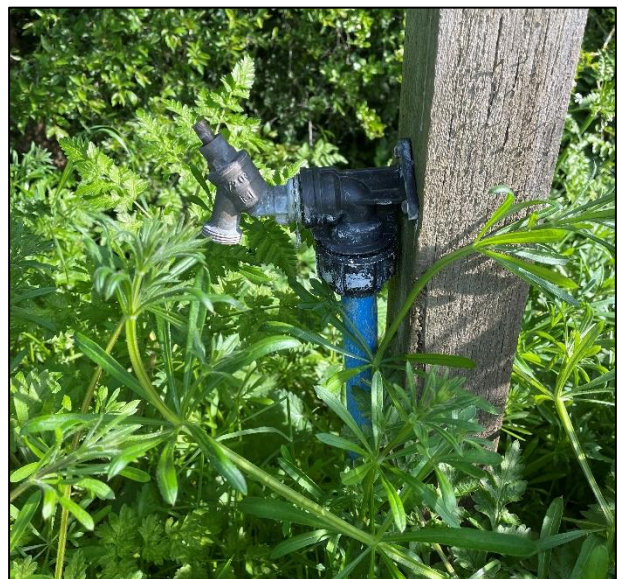
With reference to Figure 2, a standpipe is located towards the north-western corner in the treeline, with a nearby stop-cock which isolates a supply to another standpipe located near the culvert under the concrete bridge (Figures 53 and 56).

Figure 53. Approximate location of the north-western standpipe and stop-cock.

Figure 54. The stop-cock.

Figure 55. The north-western standpipe.

Figure 56. The southern standpipe.
