## **ASBESTOS SURVEY REPORT**

**UERN Ref No: E1124**

**Northminster Car Park  
Northminster  
Peterborough  
PE1 1TW**

### **Asbestos Management Survey**

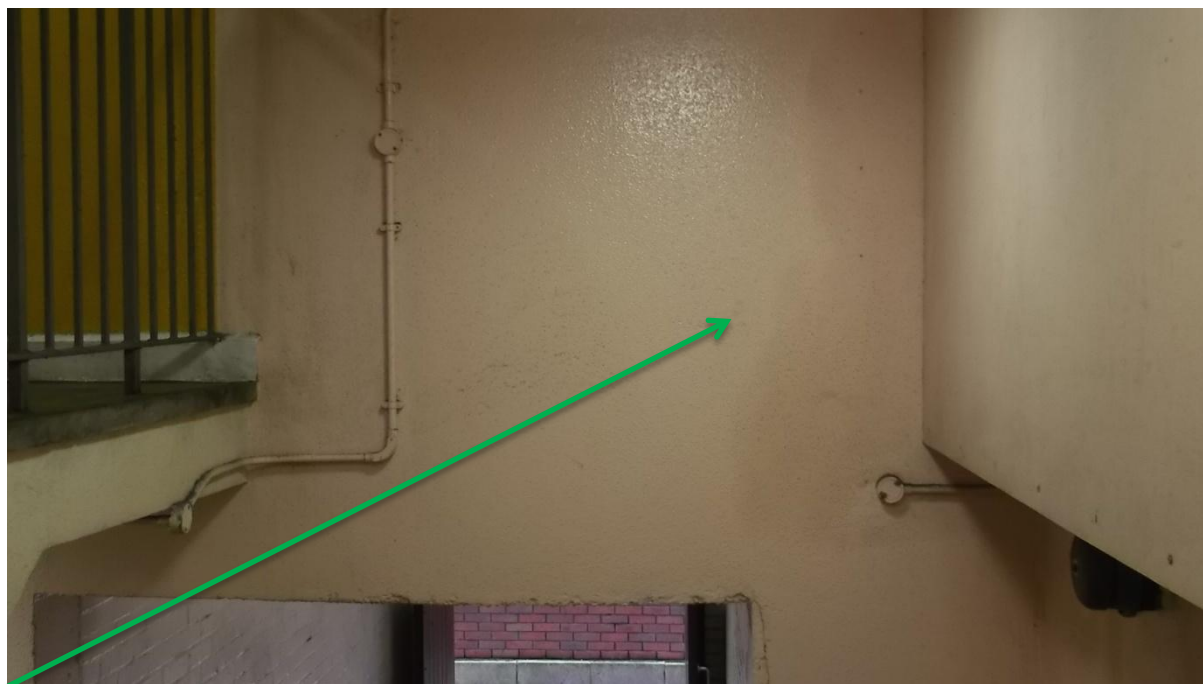
| COMBINED MATERIAL & PRIORITY RISK ASSESSMENT SCORE | | | N/A = (MS + PS) |
|---|---|---|---|
| Photo no | 1703 | Area | Stairwells |

| COMBINED MATERIAL & PRIORITY RISK ASSESSMENT SCORE | | | N/A = (MS + PS) |
|---|---|---|---|
| Location | Walls | Sample no | N01 |
| Material type | Textured Coating | Description | Decorative Finish |
| Type (TY) | NAD | | |
| Area (extent & unit) | 800 m <sup>2</sup> | Material Score | Not Applicable |

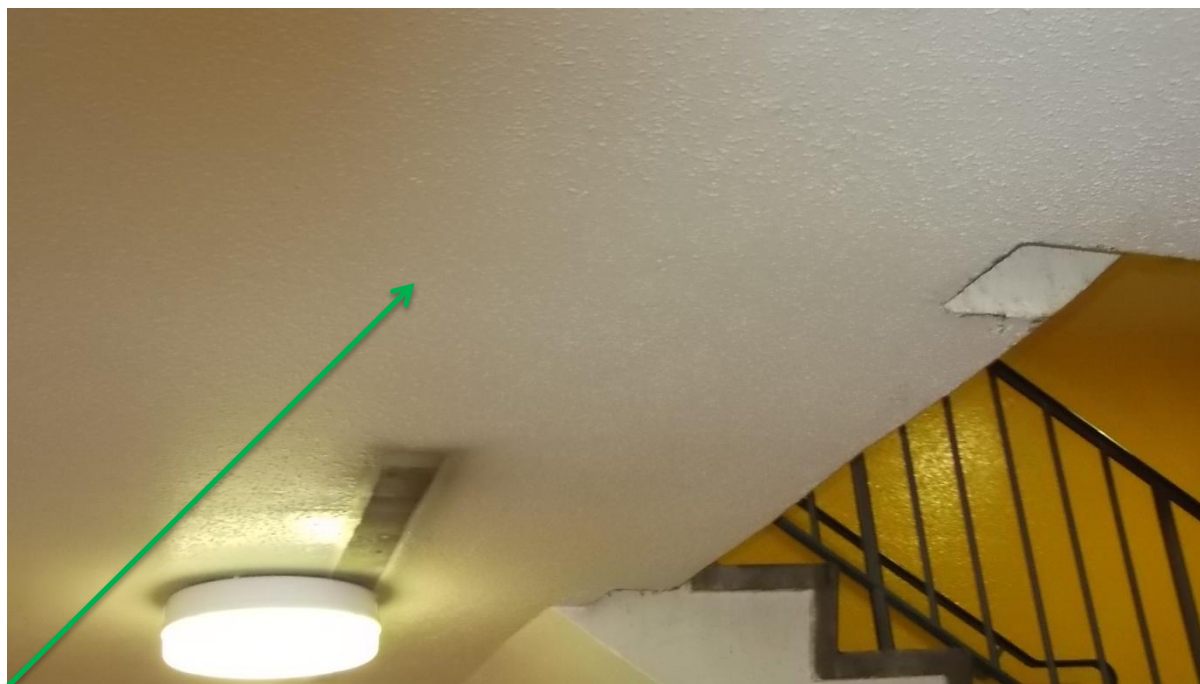
| COMBINED MATERIAL & PRIORITY RISK ASSESSMENT SCORE | | | N/A = (MS + PS) |
|---|---|---|---|
| Photo no | 1702 | Area | Stairwells |

| COMBINED MATERIAL & PRIORITY RISK ASSESSMENT SCORE | | | N/A = (MS + PS) |
|---|---|---|---|
| Location | Ceilings | Sample no | N02 |
| Material type | Textured Coating | Description | Decorative Finish |
| Type (TY) | NAD | | |
| Area (extent & unit) | 300 m <sup>2</sup> | Material Score | Not Applicable |

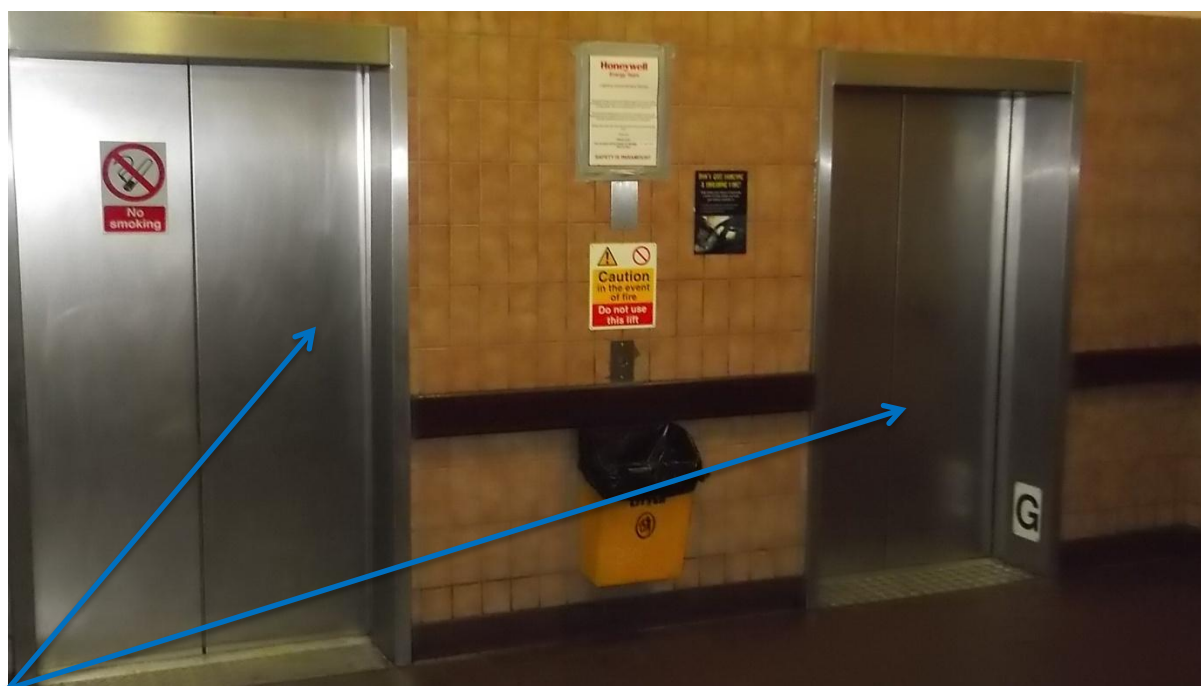
| COMBINED MATERIAL & PRIORITY RISK ASSESSMENT SCORE | | | Presumed 15 = (MS + PS) |
|---|---|---|---|
| Photo no | 1708 | Area | Stairwells |

| COMBINED MATERIAL & PRIORITY RISK ASSESSMENT SCORE | | | Presumed 15 = (MS + PS) |
|---|---|---|---|
| Location | Lifts | Sample no | No Access |
| Material type | Presumed AIB | Description | Panels |
| Type (TY) | Presumed Amosite | | |
| Area (extent & unit) | 3 Lifts | Material Score | 7 |
| Priority Score | 8 | Combined Score | 15 |

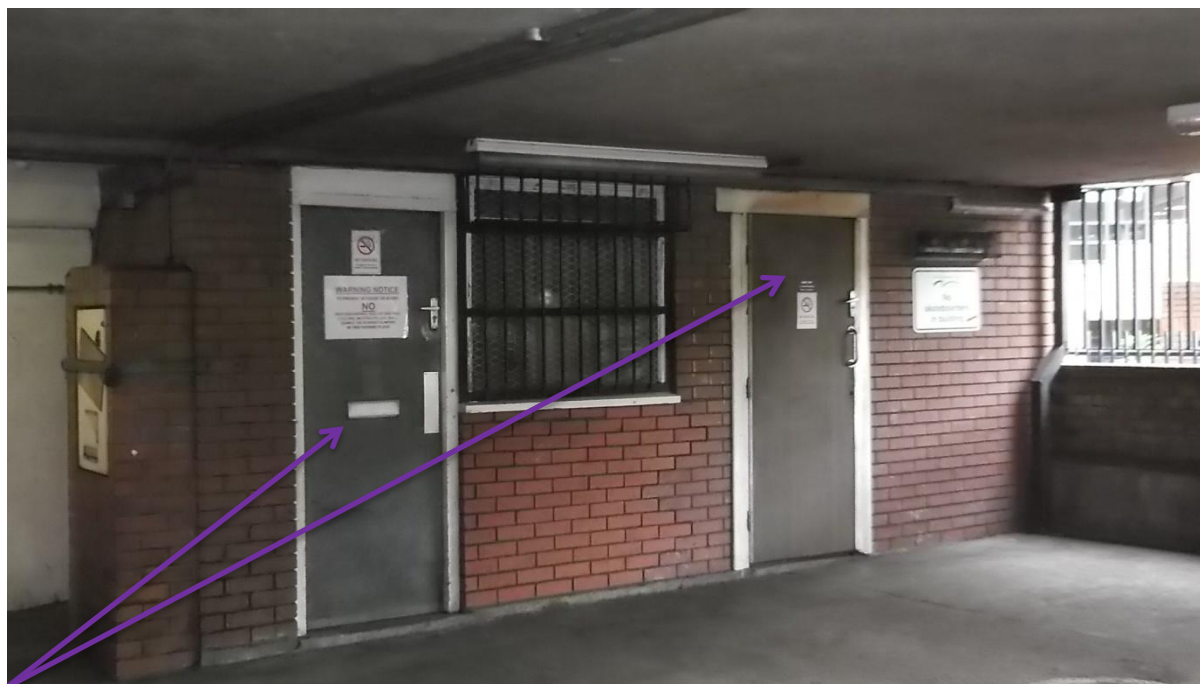
| <b>COMBINED MATERIAL &amp; PRIORITY RISK ASSESSMENT SCORE</b> | | | <b>Presumed = (MS + PS)</b> |
|---|---|---|---|
| <b>Photo no</b> | 1707 | <b>Area</b> | 1 <sup>st</sup> Floor |

| <b>COMBINED MATERIAL &amp; PRIORITY RISK ASSESSMENT SCORE</b> | | | <b>Presumed = (MS + PS)</b> |
|---|---|---|---|
| <b>Location</b> | Office | <b>Sample no</b> | No Access |
| <b>Material type</b> | Unknown | <b>Description</b> | Unknown |
| <b>Type (TY)</b> | Presumed to Contain Asbestos | | |
| <b>Area (extent &amp; unit)</b> | 12 m <sup>2</sup> | <b>Material Score</b> | Unknown |
| <b>Priority Score</b> | Unknown | <b>Combined Score</b> | Unknown |

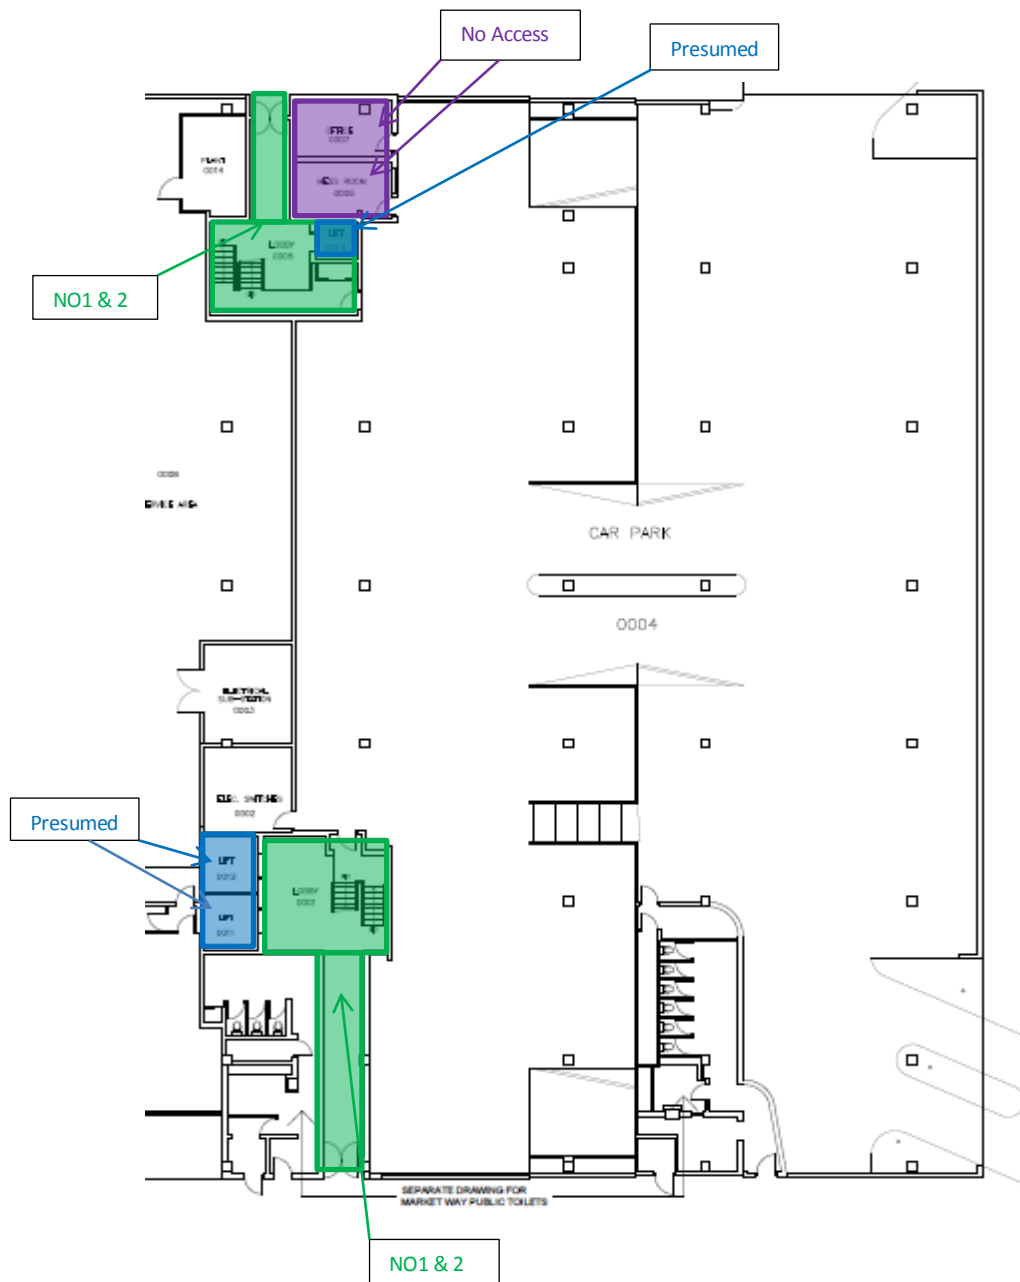
Drawing No:02062014  
Eurn No:E1124

N01 & N02 applies to all Stairwells.  
Presumed to all Lift Shafts
