Beverley Town Council New Town Hall Project Manager

TENDER PACK

Beverley Town Council New Town Hall

Condition Report

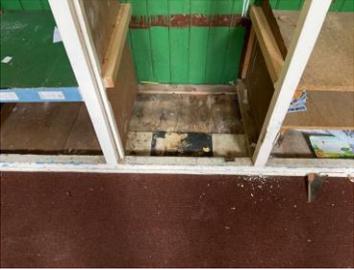
Inspection Date	Surveyor	Survey Type	Floor	Analysis	
	11/11/2022	Robin Walker	Refurbishment	Ground Floor	Chrysotile	
	Building	Room	Description	Extent		
	St Johns Ambulance	Store 010	Floor	Small amounts m ²		
	Sample No / Inspection Ref	Product Type	Surface Treatment	Damage Extent	Material Risk Score	Priority Total
	A-20386 / S006 203512	Vinyl floor tiles	Composite	Good	3	N/A
	Normal Occupant Activity	Likelihood of Disturbance	Human Exposure Potential	Maintenance Activity	Risk Rating	Total Assessment Score
	N/A	N/A	N/A	N/A	Very Low	3
Recommendations / Actions	Non notifiable product - Remove under strict accordance with current and relevant legislation notes.					
Surveyor Comments	Mixed black and white vinyl floor tiles to floor			Review Date	N/A

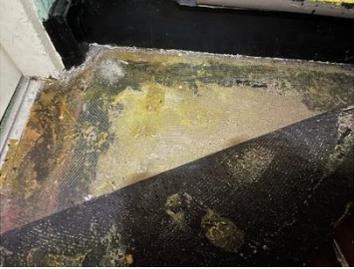
Inspection Date	Surveyor	Survey Type	Floor	Analysis	
	11/11/2022	Robin Walker	Refurbishment	Ground Floor	Chrysotile	
	Building	Room	Description	Extent		
	St Johns Ambulance	Entrance lobby 013	Floor	4 m ²		
	Sample No / Inspection Ref	Product Type	Surface Treatment	Damage Extent	Material Risk Score	Priority Total
	A-20386 / S007 204835	Bituminous Product	Composite	Good	3	N/A
	Normal Occupant Activity	Likelihood of Disturbance	Human Exposure Potential	Maintenance Activity	Risk Rating	Total Assessment Score
	N/A	N/A	N/A	N/A	Very Low	3
Recommendations / Actions	Non notifiable product - Remove under strict accordance with current and relevant legislation notes.					
Surveyor Comments	Bitumen adhesive to floor			Review Date	N/A

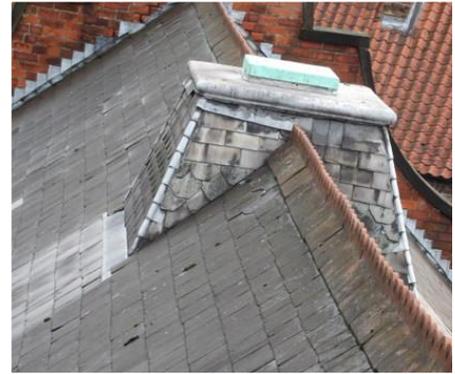
Cupola flashings slipped and missing. Cupola capped with copper.

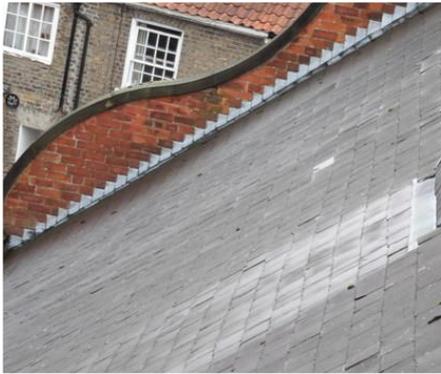
Missing/slipped slates to all slopes.

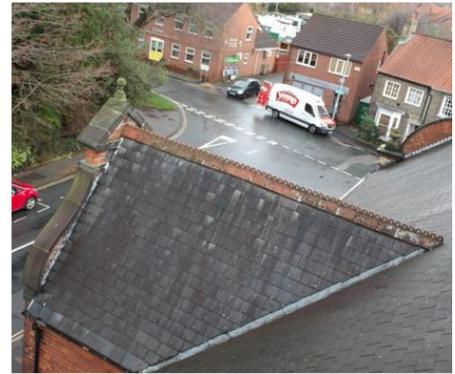
Entrance roof.

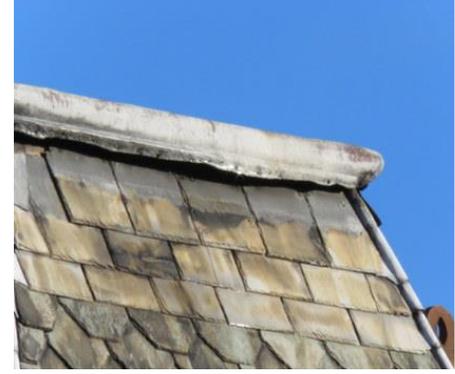
Missing flashing to cupola.

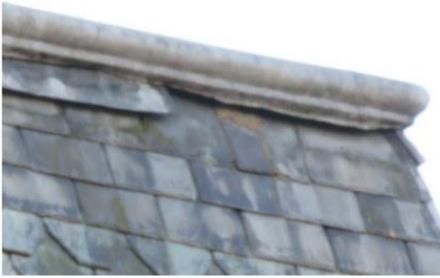
Missing flashing to cupola.

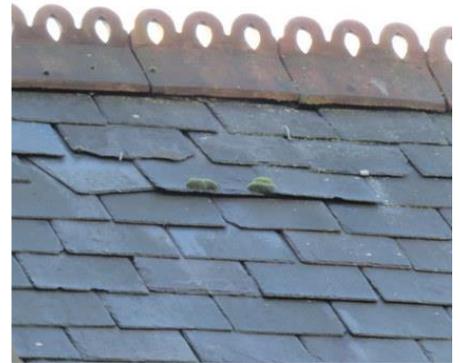
Pointing generally to ridge missing. Tangles in place in various locations.

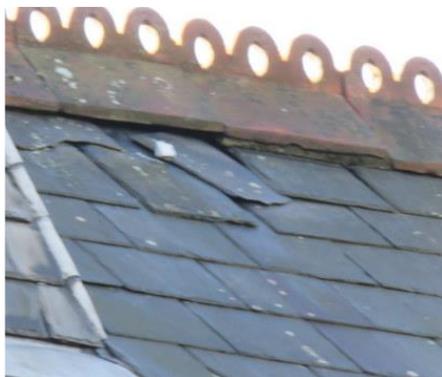
Slipped/missing slates to Morton Lane slope.

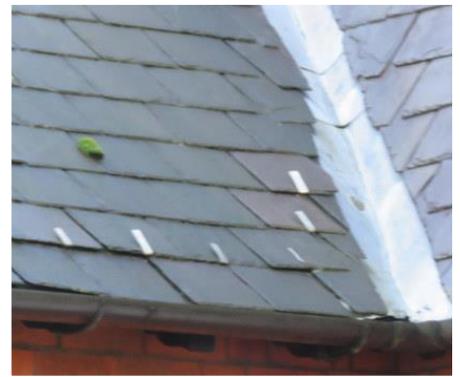
Tangles evident to entrance roof.

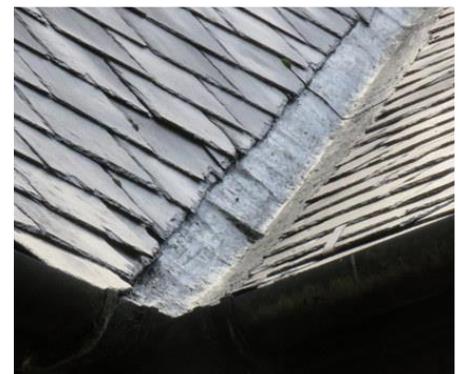
Liquid repair to valley gutter.

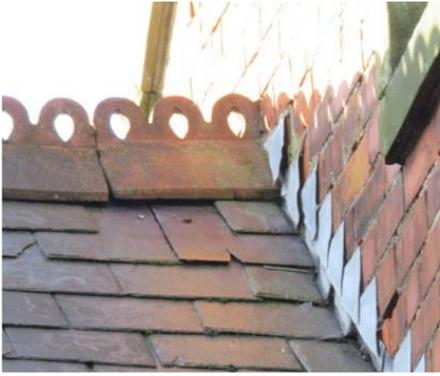
Poor flashings to gables.
Slipped/missing slate.

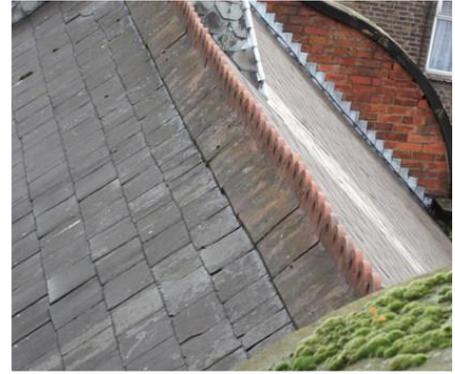
Deflection to main roof ridge.

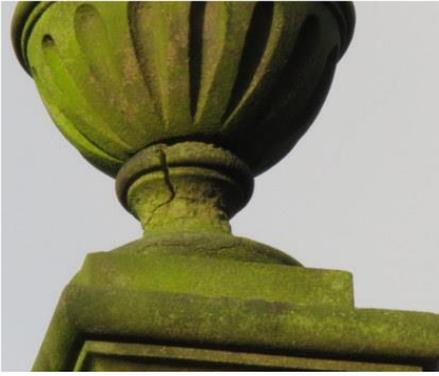
Cracking to stone support on finial on Wilbert lane gable.

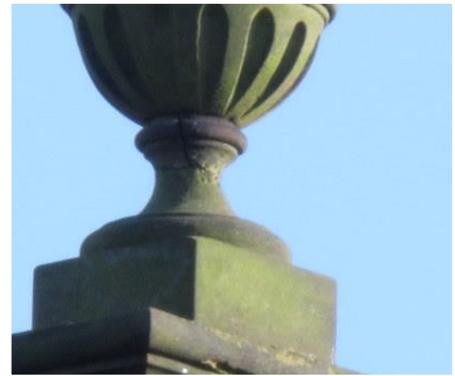
Cracking to stone support on finial on Wilbert lane gable.

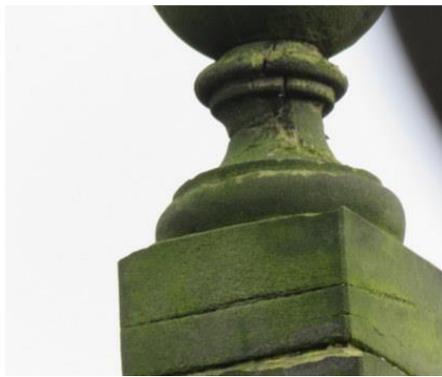
Cracking to stone support on finial on Morton lane gable.

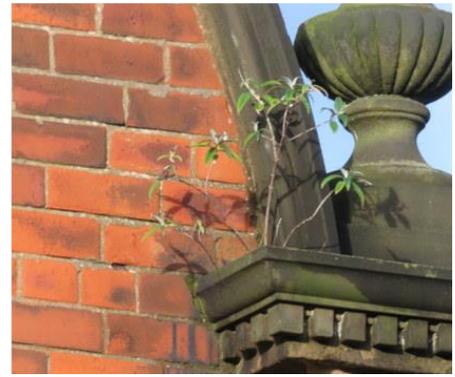
Plant growth to stone details on Wilbert Lane gable.

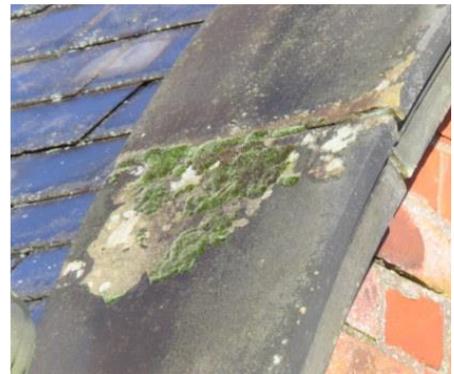
Stone starting to spall to parapet cappings.

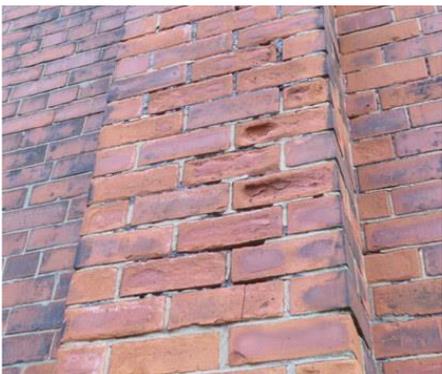
The chimney brickwork is generally spalled and with open brickwork joints, particularly near the top of the chimney and requires comprehensively overhauling.

Spalled bricks and open joints to chimney.

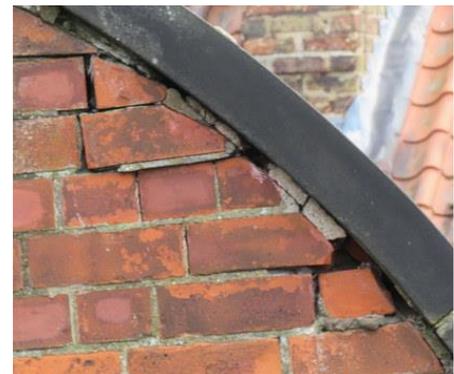
Loose brickwork and open joints to gable beneath capping stones.

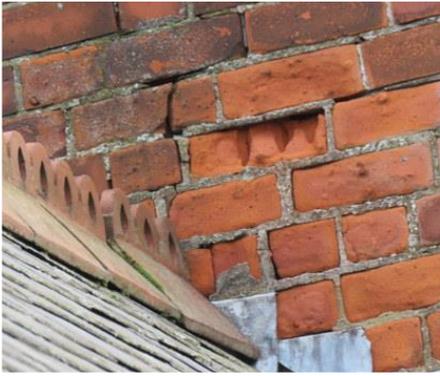
Spalled bricks, poor pointing to rear of Wilbert lane gable.

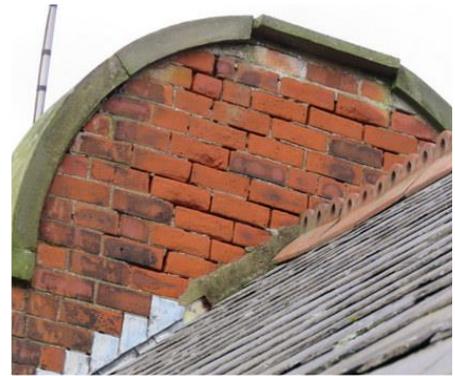
Poor pointing to rear of Morton Lane gable. Section of flashing replaced with sand cement.

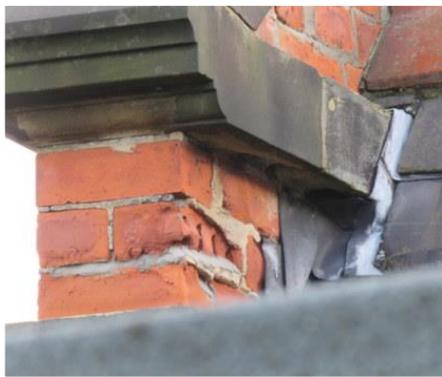
Spalled bricks/poor pointing behind Morton Lane entrance parapet.

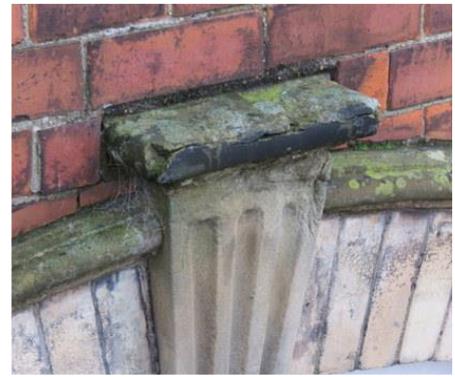
Stone details above windows spalling/cracked.

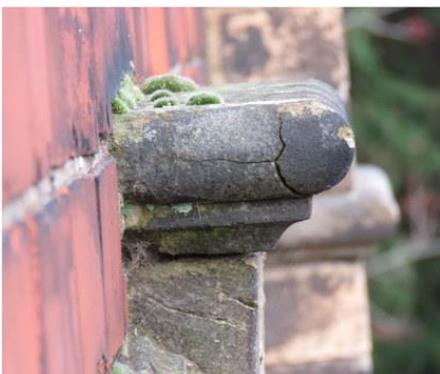
Stone details above windows spalling/cracked.

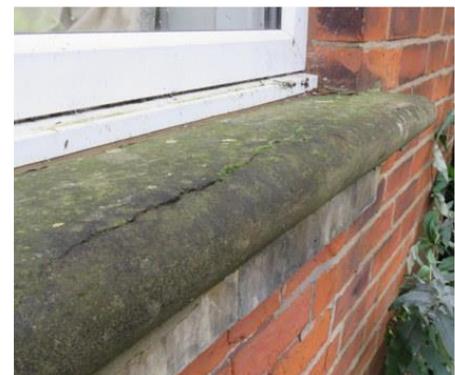
Stone cills cracking in various locations.

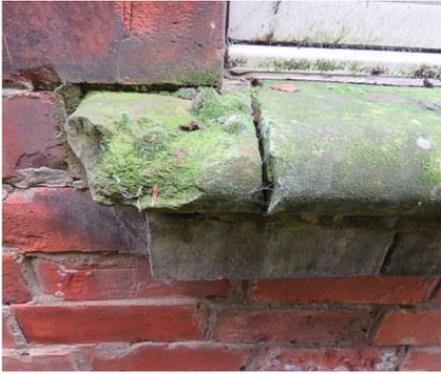
Damaged/cracked stone cills to a number of windows.

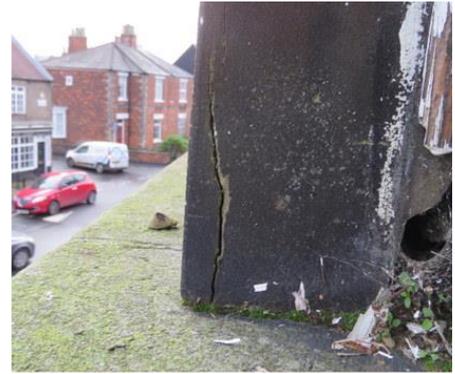
Cracking to face of stone column between Wilbert Lane gable window.

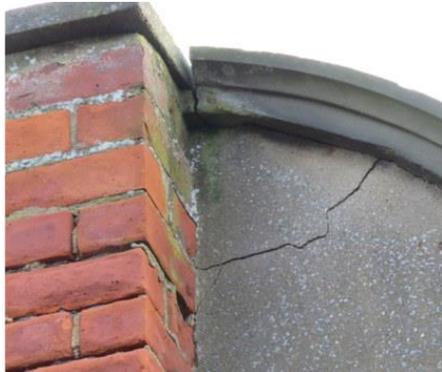
Cracking to high level render to chimney.

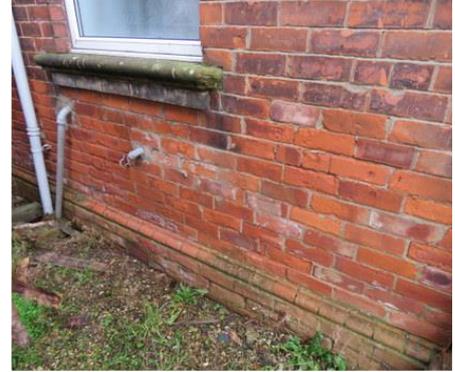
Poor pointing/spalled brick faces to a number of locations.

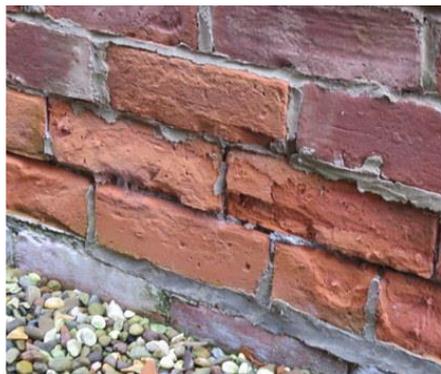
Low level brickwork spalled and pointing poor.

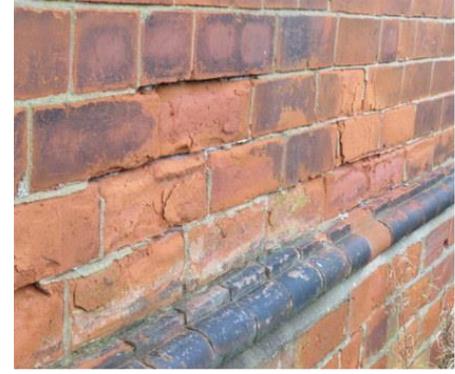
Poor pointing/spalled brick faces to a number of locations.

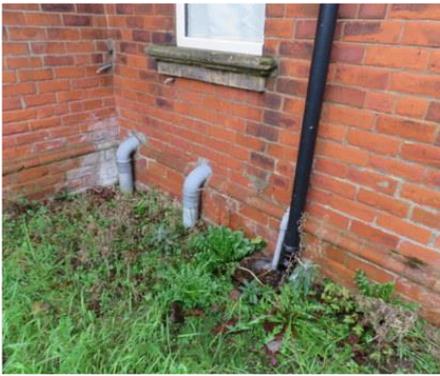
Foul drainage from W.C.'s.

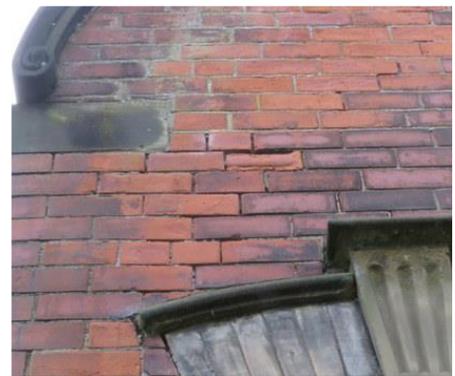
Stepped cracking above Morton Lane entrance.

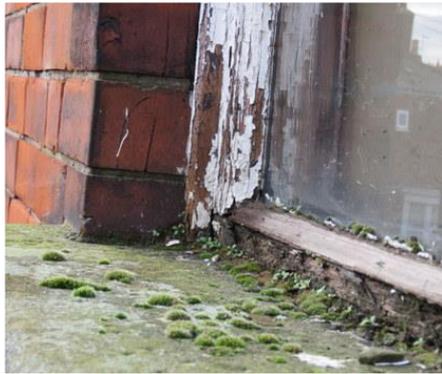
Decay to remaining timber windows.

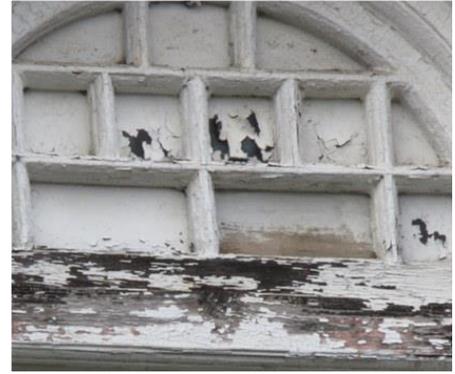
Decay to remaining timber windows.

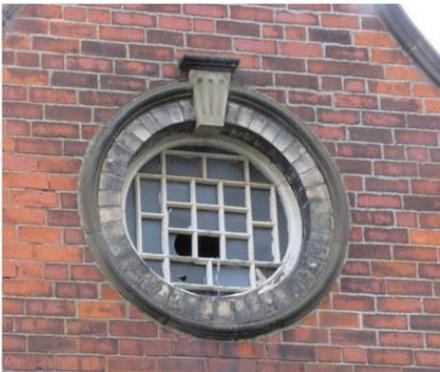
There is missing glazing to the circular window above the male WC window which requires replacing to prevent weather ingress and birds etc.

Broken glass to round window above Morton Lane entrance.

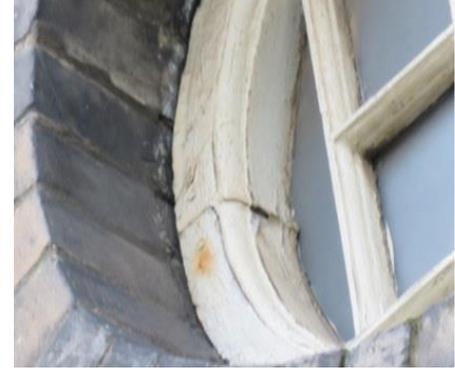
Seal around wooden windows have perished.

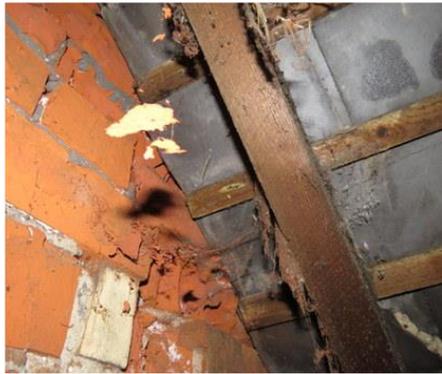
Spalled bricks to Wilbert lane gable.

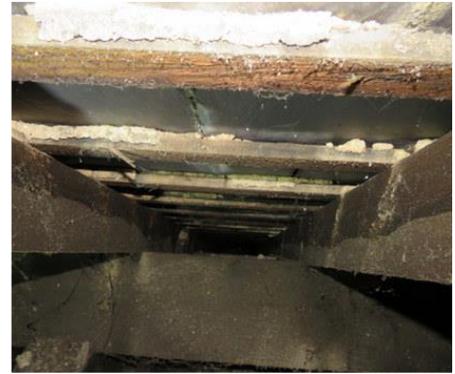
Void between roof and eaves paring loose and missing in various locations.

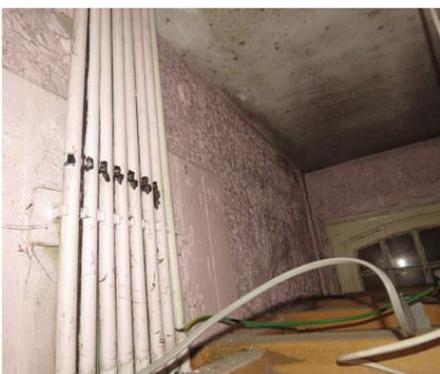
Ceiling void above entrance.

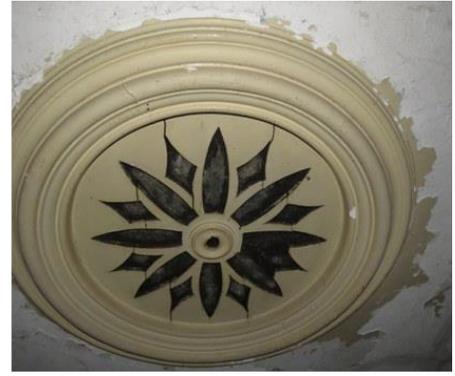
Damage to ceiling vents.

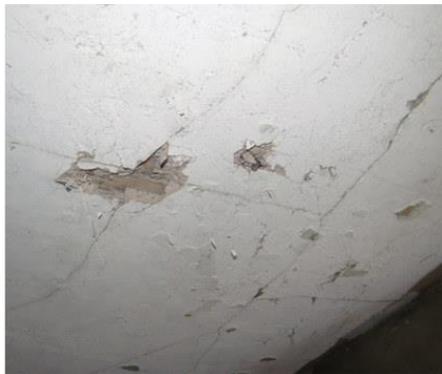
Delaminated sections of plaster lath throughout first floor areas.

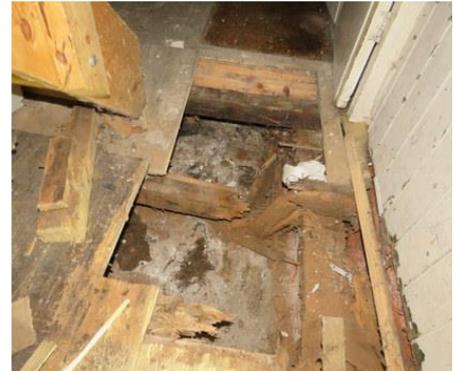
In the front entrance lobby the suspended timber floor has partially collapsed near the bottom of the staircase which may be due to rising dampness causing timber decay to the floor. We also observed woodworm to the floorboards in the front entrance lobby.

Timber decay and beetle activity to rotten floor beneath stairs.

We strongly advise that a specialist in dampness and timber, who is preferably a member of the Property Care Association, is requested to provide a quotation for, and advise as to the extent of the remedial work necessary to address the dampness in the walls which we anticipate will involve the installation of a remedial DPC and the re-plastering of walls to affected areas up to 1000mm high. We recommend that a 25 year insurance backed warranty is obtained from the specialist which is transferable to a third party.

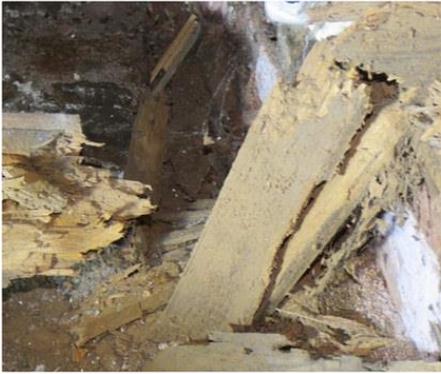
Timber decay to stairs floor void.

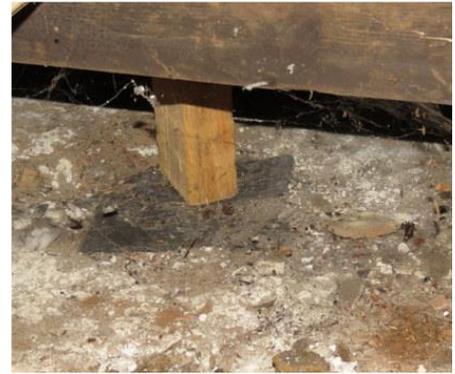
Additional supports fitted beneath damp joists to floor at Wilbert lane entrance.

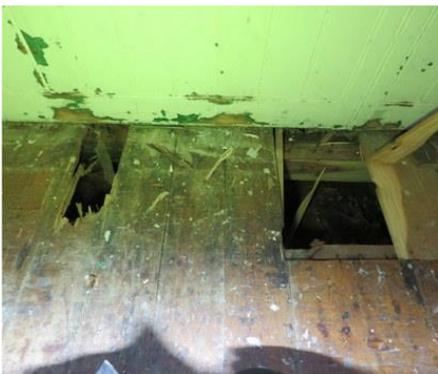
Rot to floor structure in main hall.

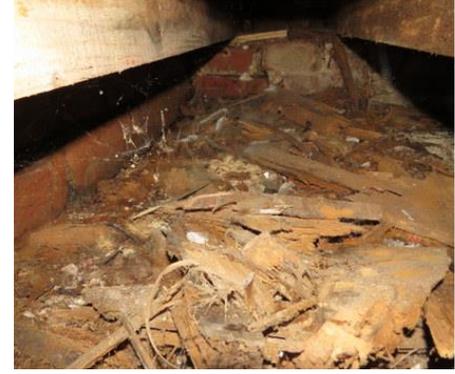
Debris and signs of wet rot to hall floor.

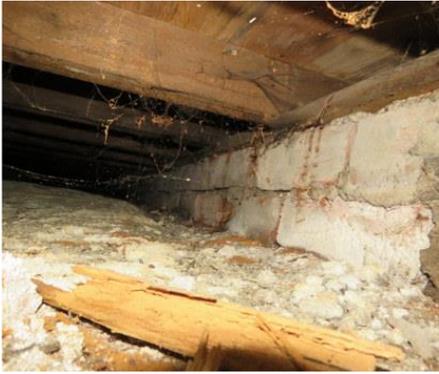
Mycellium evident below hall floor.

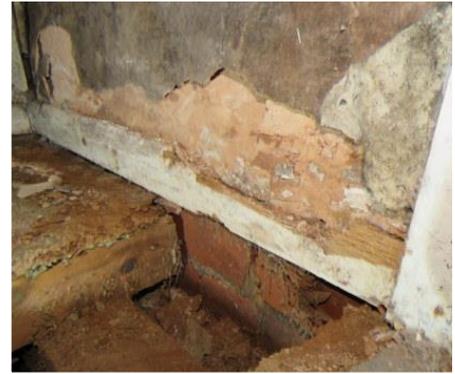
Rot to floor and skirtings in kitchen.

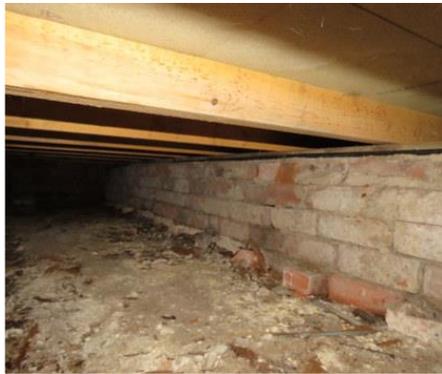
Kitchen floor void.

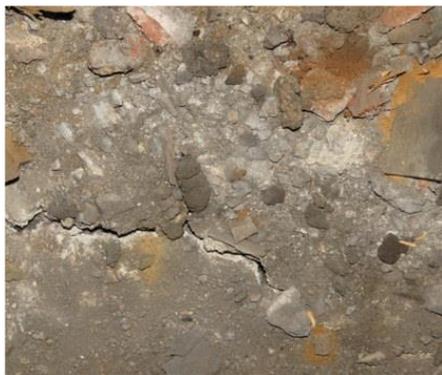
Floor beneath void has a degrading surface.

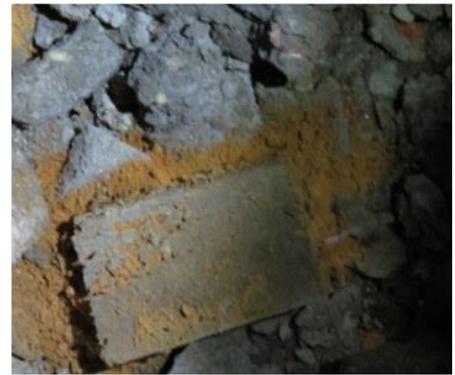
Beetle activity in floor void.

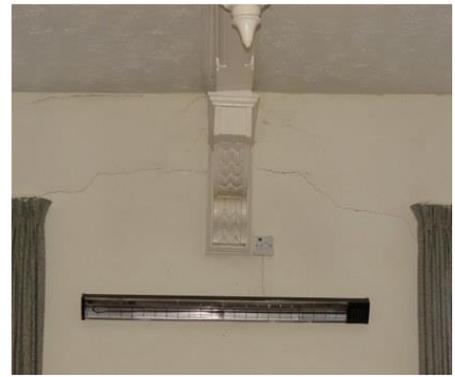
Cracking either side of roof structure in hall.

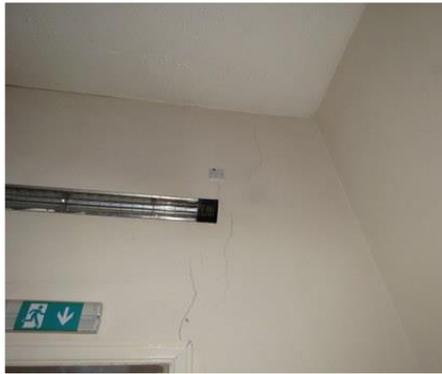
Cracking to wall above entrance into hall.

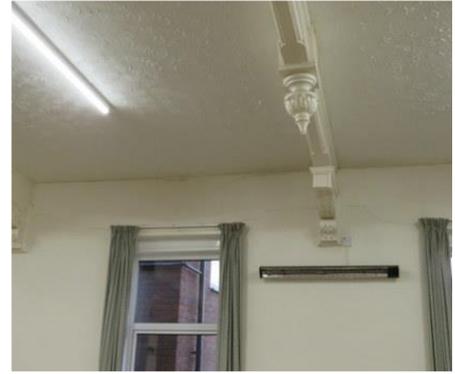
Cracking either side of roof structure in hall.

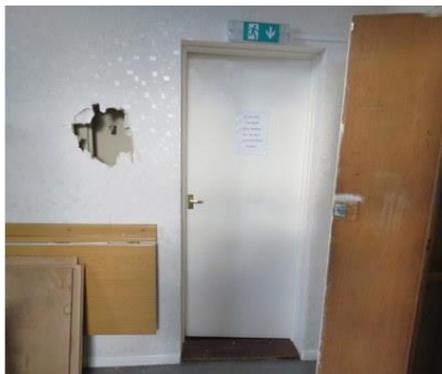
None fire doors to all areas.

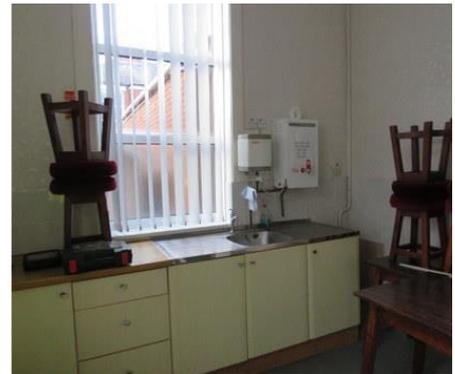
Kitchen dated, water heating dilapidated.
