REPORT TO CLIENT
ASBESTOS REFURBISHMENT SURVEY

WITHIN
Boveney Lock House
On Behalf Of
Environment Agency
Contract Code: L-04849
Date of Issue: 15 August 2019

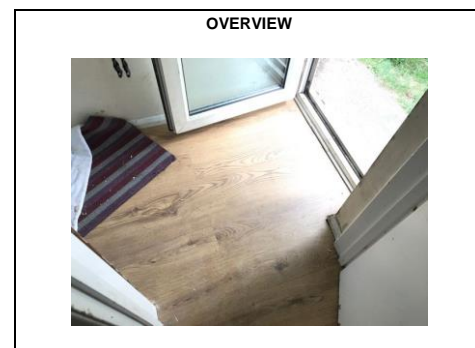
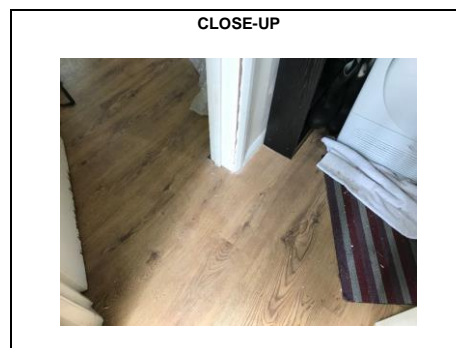
Floor:	G	Location description:	Porch
Room/Area:	001	Sample Number:	SP
Material:	Paper	Item:	Paper backed floor below laminate flooring
Measured Extent:	3 m ²	Asbestos Type:	Asbestos Present
Damage/Condition:	Good condition		
Notes:	Paper backed floor covering is present in adjacent rooms. It is not possible to lift the laminate flooring in this area.

Material Assessment							
Product:	2	Condition/damage:	0	Surface treatment:	1	Asbestos Type:	3

Scores					
Material Assessment Score:	6	Priority Assessment Score:		Total Risk Score:

Recommendations:	Remove
-------------------------	--------

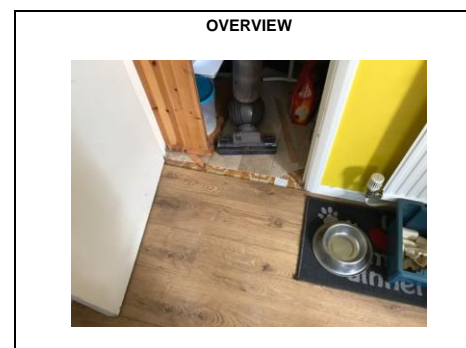
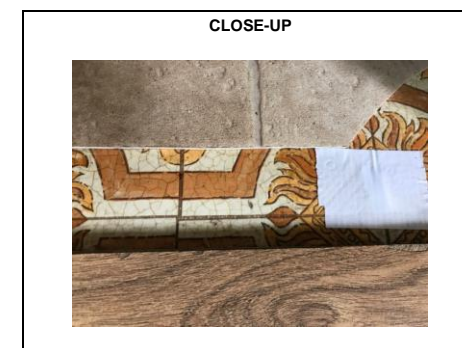
Floor:	G	Location description:	Kitchen
Room/Area:	002	Sample Number:	010
Material:	Paper	Item:	Paper backed floor covering below laminate
Measured Extent:	9 m ²	Asbestos Type:	Chrysotile
Damage/Condition:	Good condition		
Notes:	Modern mastic cement around extractor hood; no suspect materials within cooker hood boxing and riser below; timber window sill below ceramic tiles.

Material Assessment							
Product:	2	Condition/damage:	0	Surface treatment:	1	Asbestos Type:	1

Recommendations:	Remove
-------------------------	--------

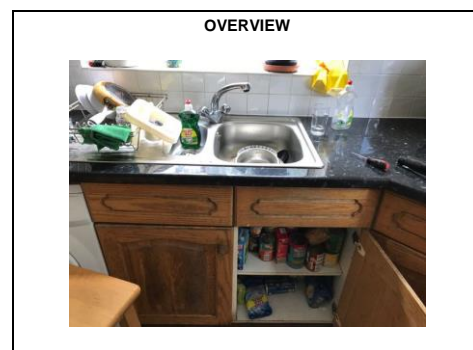
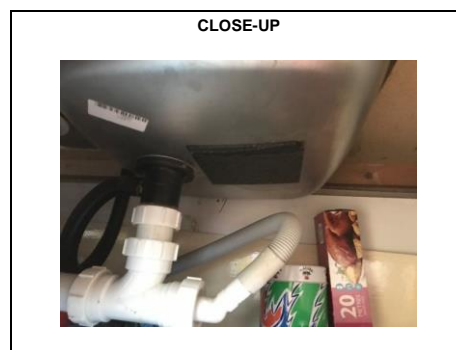
Floor:	G	Location description:	Kitchen
Room/Area:	002	Sample Number:	011
Material:	Bituminous	Item:	Sink pad
Measured Extent:	1 no.	Asbestos Type:	No asbestos detected
Damage/Condition:	Good condition

Recommendations:	No Action Required
-------------------------	--------------------

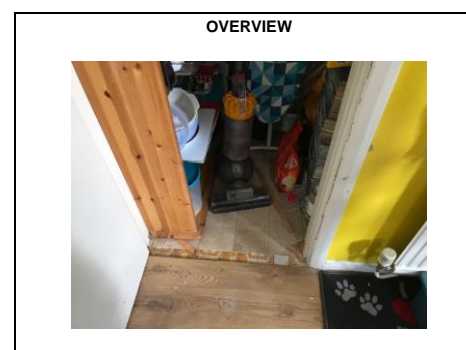
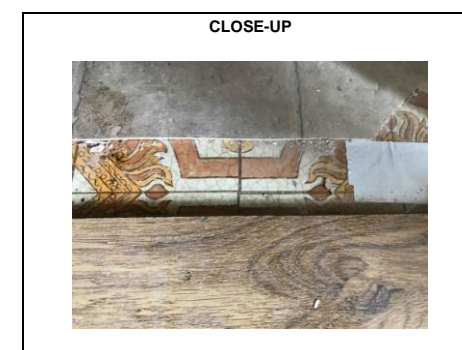
Floor:	G	Location description:	Cupboard
Room/Area:	003	Sample Number:	X010
Material:	Paper	Item:	Paper backed floor covering below laminate
Measured Extent:	1 m²	Asbestos Type:	Chrysotile
Damage/Condition:	Good condition

Notes:	Timber surround vent.
---------------	-----------------------

Material Assessment					
Product:	2	Condition/damage:	0	Surface treatment:	0
				Asbestos Type:	1

Recommendations:	Remove
-------------------------	--------

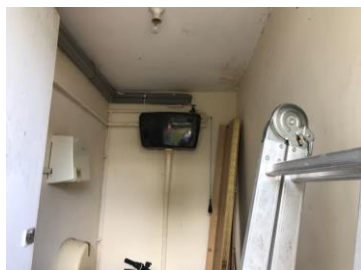
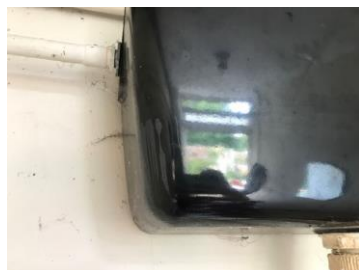
Floor:	G	Location description:	Outside toilet
Room/Area:	005	Sample Number:	012
Material:	Composites	Item:	Cistern
Measured Extent:	1 no.	Asbestos Type:	Amosite
Damage/Condition:	Good condition		
Notes:	Foam insulated pipe work.

Product:	1	Condition/damage:	0	Surface treatment:	0	Asbestos Type:	2
-----------------	---	--------------------------	---	---------------------------	---	-----------------------	---

Recommendations: Manage

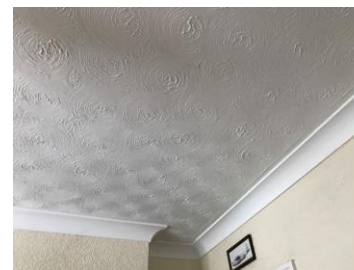
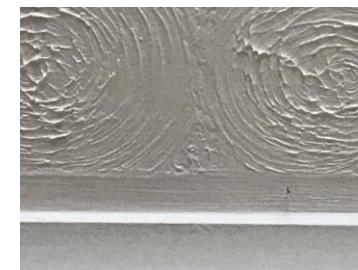
Floor:	G	Location description:	Dining room
Room/Area:	006	Sample Number:	013
Material:	Textured coating	Item:	Textured coating to ceiling
Measured Extent:	6 m ²	Asbestos Type:	No asbestos detected
Damage/Condition:	Good condition		
Notes:

Recommendations: No Action Required

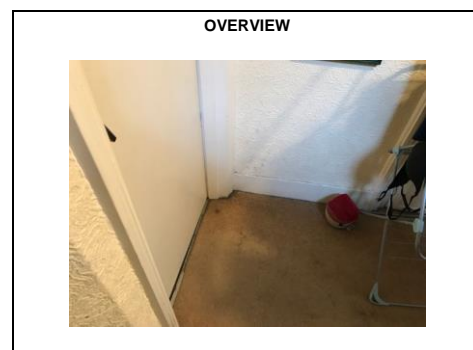
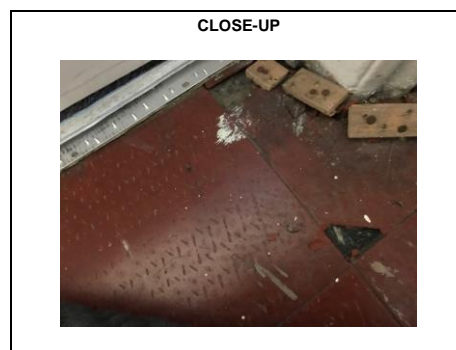
Floor:	G	Location description:	Hallway
Room/Area:	007	Sample Number:	014
Material:	Vinyl/ Thermo plastic	Item:	Floor tiles below carpet
Measured Extent:	8 m ²	Asbestos Type:	Chrysotile
Damage/Condition:	Good condition

Material Assessment							
Product:	1	Condition/damage:	0	Surface treatment:	0	Asbestos Type:	1

Recommendations:	Manage
-------------------------	--------

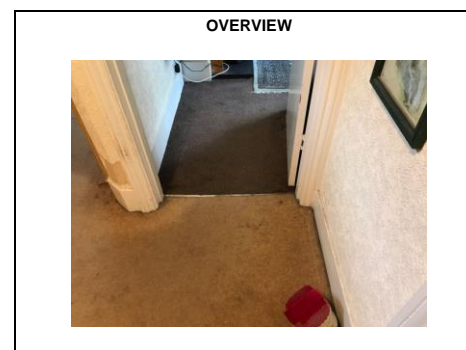
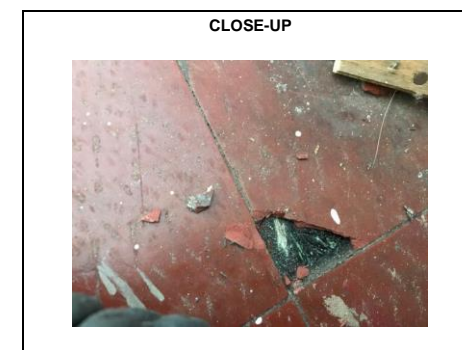
Floor:	G	Location description:	Hallway
Room/Area:	007	Sample Number:	015
Material:	Bituminous	Item:	Floor tile adhesive
Measured Extent:	8 m ²	Asbestos Type:	Chrysotile
Damage/Condition:	Good condition

Material Assessment							
Product:	1	Condition/damage:	0	Surface treatment:	0	Asbestos Type:	1

Recommendations:	Manage
-------------------------	--------

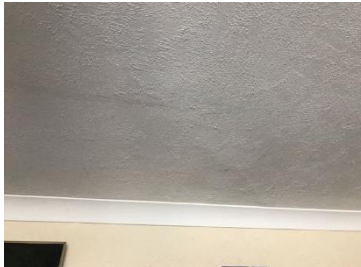
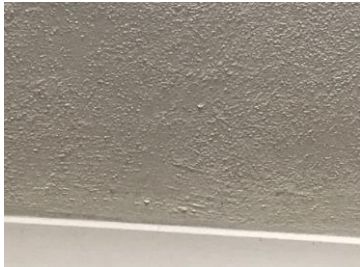
Floor:	G	Location description:	Lounge
Room/Area:	008	Sample Number:	016
Material:	Textured coating	Item:	Textured coating to ceiling
Measured Extent:	15 m²	Asbestos Type:	No asbestos detected
Damage/Condition:	Good condition		
Notes:	No suspect materials under PVC strips to window.

Recommendations:	No Action Required		
-------------------------	--------------------	--	--

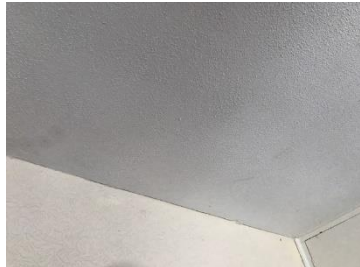
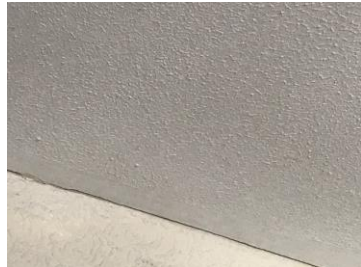
Floor:	01	Location description:	Bedroom
Room/Area:	002	Sample Number:	017
Material:	Textured coating	Item:	Textured coating to ceiling
Measured Extent:	12 m²	Asbestos Type:	No asbestos detected
Damage/Condition:	Good condition		
Notes:

Recommendations:	No Action Required		
-------------------------	--------------------	--	--

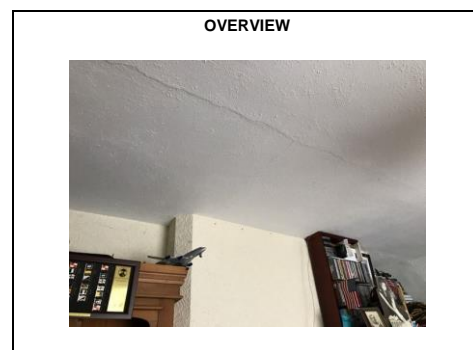
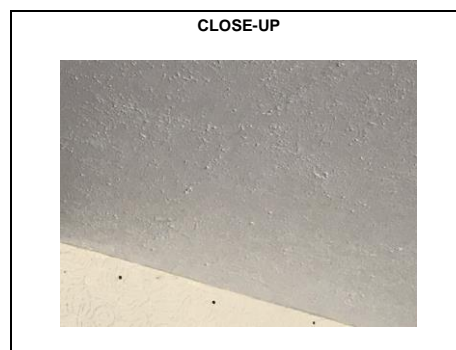
Floor:	01	Location description:	Bedroom
Room/Area:	004	Sample Number:	018
Material:	Textured coating	Item:	Textured coating to ceiling
Measured Extent:	12 m ²	Asbestos Type:	No asbestos detected
Damage/Condition:	Good condition

Recommendations:	No Action Required
-------------------------	--------------------

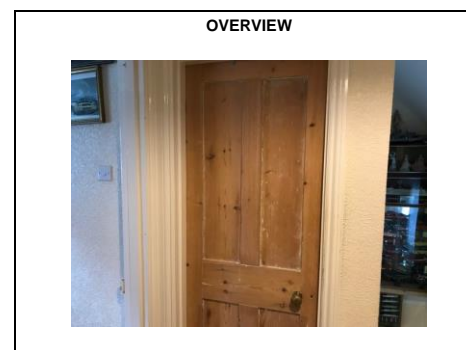
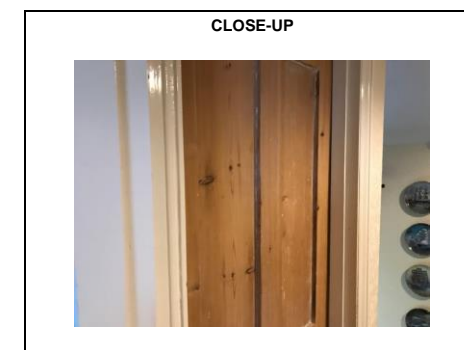
Floor:	01	Location description:	Bedroom
Room/Area:	005	Sample Number:	P
Material:	No Access Gained	Item:	Within room
Measured Extent:		Asbestos Type:	
Damage/Condition:

Notes:	No access due to tenant asleep in room
---------------	--

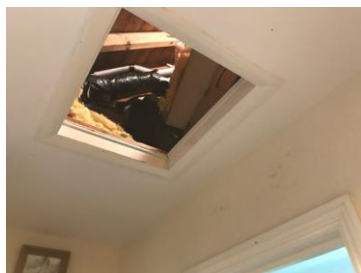
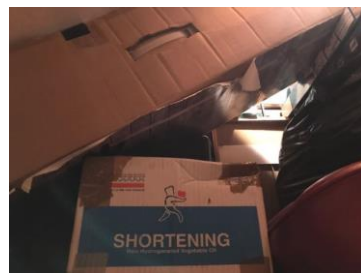
Floor:	02	Location description:	Loft
Room/Area:	001	Sample Number:	P
Material:	Limited Access Gained	Item:	Within loft
Measured Extent:		Asbestos Type:	
Damage/Condition:			
Notes:	Limited access gained due to stored items; MMMF insulated water tank; foam insulated pipe work.

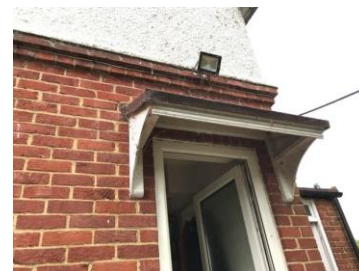
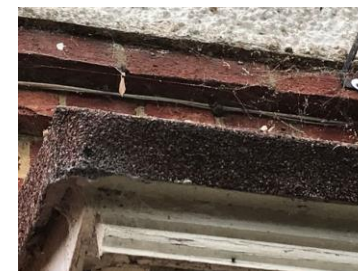
Floor:	Ext	Location description:	Elevations
Room/Area:	EX01	Sample Number:	SP
Material:	Bituminous	Item:	Roof felt to canopy
Measured Extent:	0.5 m ²	Asbestos Type:	Asbestos Present
Damage/Condition:	Low Damage		
Notes:

Product:	1	Condition/damage:	1	Surface treatment:	0	Asbestos Type:	3
-----------------	---	--------------------------	---	---------------------------	---	-----------------------	---

Material Assessment Score:	5	Priority Assessment Score:		Total Risk Score:	
-----------------------------------	---	-----------------------------------	--	--------------------------	--

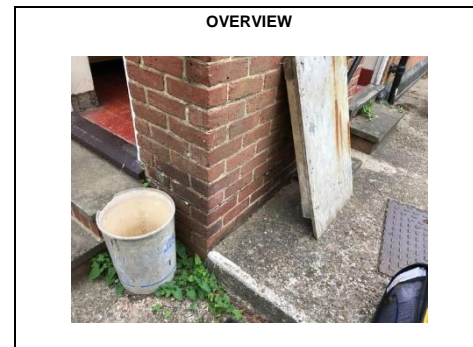
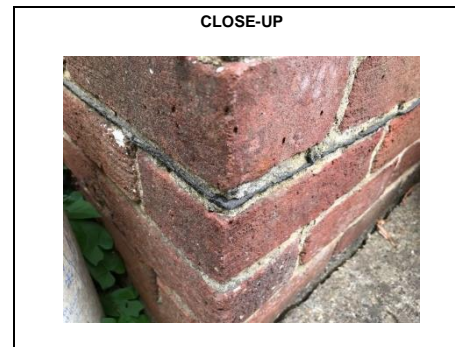
Floor:	Ext	Location description:	Elevations
Room/Area:	EX01	Sample Number:	001
Material:	Bituminous	Item:	Damp proof course
Measured Extent:	14 m	Asbestos Type:	No asbestos detected
Damage/Condition:	Good condition		
Notes:	Newspaper packing to toilet door frame; plastic and cast iron rain water goods; open timber eaves and fascia; rectangle panel to the front door. Present in the extension.

Recommendations:	No Action Required				
Material Assessment					
Product:	0	Condition/damage:	0	Asbestos Type:	0
Priority Assessment					
Normal occupant Activity:					
Location:					
Accessibility:					
Extent / amount:					
Number of occupants:		Frequency of use of area:			
Average time area is in use:		Type of maintenance activity:			
Frequency of maintenance activity:					
Scores					
Material Assessment Score:	0	Priority Assessment Score:		Total Risk Score:

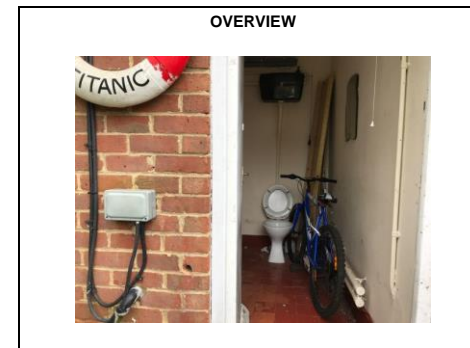
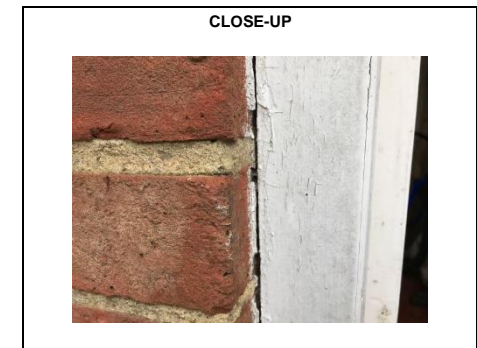
Floor:	Ext	Location description:	Elevations
Room/Area:	EX01	Sample Number:	002
Material:	Composites	Item:	Putty to door frames
Measured Extent:	3 no.	Asbestos Type:	No asbestos detected
Damage/Condition:	Low damage		
Notes:

Recommendations:	No Action Required						
Material Assessment							
Product:	0	Condition/damage:	0	Surface treatment:	0	Asbestos Type:	0
Priority Assessment							
Normal occupant Activity:							
Location:							
Accessibility:							
Extent / amount:							
Number of occupants:		Frequency of use of area:					
Average time area is in use:		Type of maintenance activity:					
Frequency of maintenance activity:							
Scores							
Material Assessment Score:	0	Priority Assessment Score:		Total Risk Score:

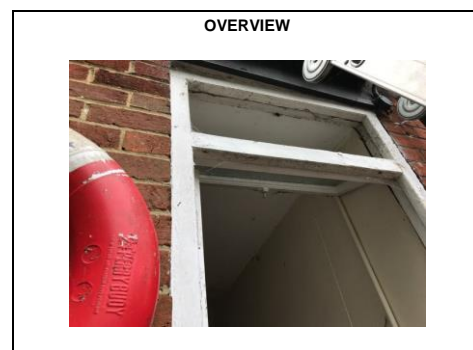
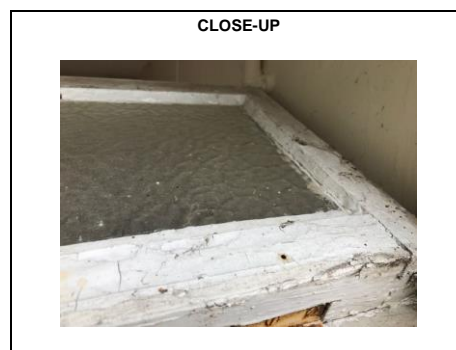
Floor:	Ext	Location description:	Elevations
Room/Area:	EX01	Sample Number:	003
Material:	Composites	Item:	Putty to timber window frames
Measured Extent:	3 no.	Asbestos Type:	No asbestos detected
Damage/Condition:	Low damage

Recommendations:	No Action Required
-------------------------	--------------------

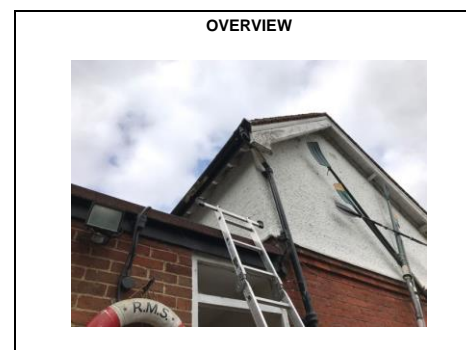
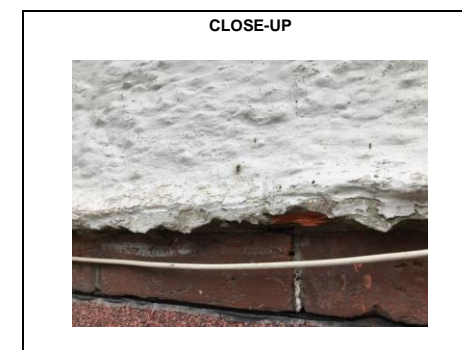
Floor:	Ext	Location description:	Elevations
Room/Area:	EX01	Sample Number:	004
Material:	Composites	Item:	Render to walls
Measured Extent:	70 m²	Asbestos Type:	No asbestos detected
Damage/Condition:	Good condition

Recommendations:	No Action Required
-------------------------	--------------------

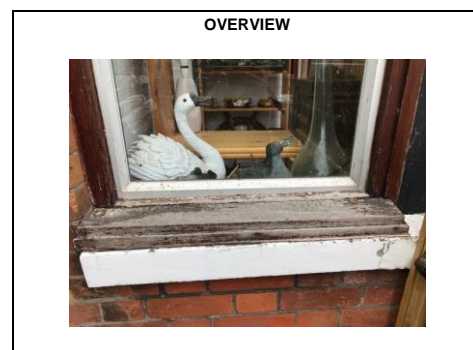
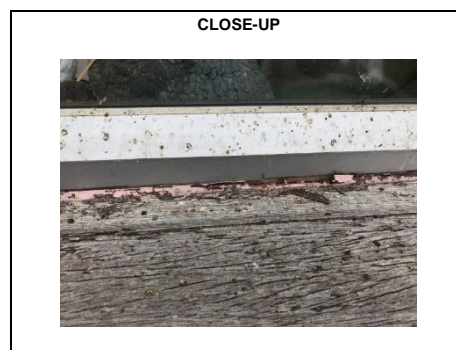
Floor:	Ext	Location description:	Elevations
Room/Area:	EX01	Sample Number:	007
Material:	Composites	Item:	Pink mastic to metal frames windows and door
Measured Extent:	5 no.	Asbestos Type:	Chrysotile
Damage/Condition:	Good condition

Material Assessment					
Product:	1	Condition/damage:	0	Surface treatment:	0
Asbestos Type:	1

Recommendations:	Remove
-------------------------	--------

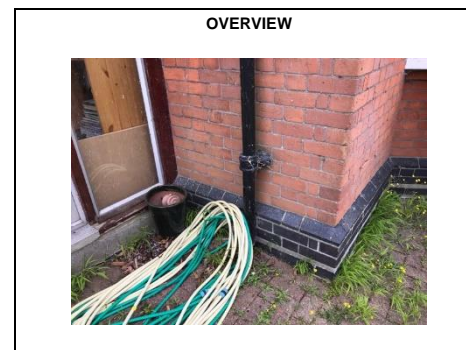
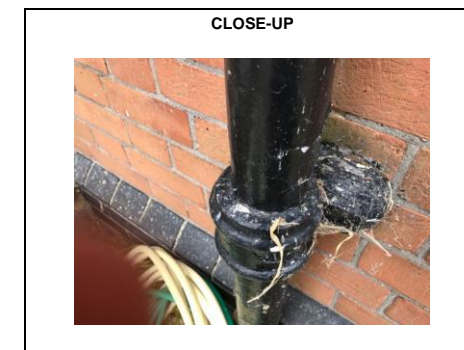
Floor:	Ext	Location description:	Elevations
Room/Area:	EX01	Sample Number:	008
Material:	Composites	Item:	Putty seal to cast iron down pipe
Measured Extent:	1 no.	Asbestos Type:	No asbestos detected
Damage/Condition:	Good condition

Recommendations:	No Action Required
-------------------------	--------------------

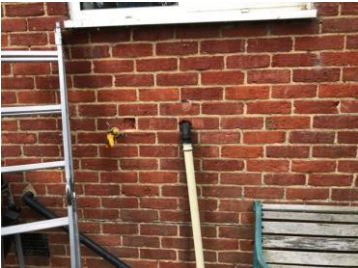
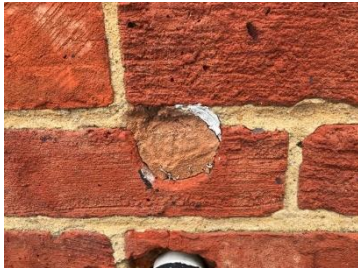
Floor:	Ext	Location description:	Elevations
Room/Area:	EX01	Sample Number:	009
Material:	Composites	Item:	Mastic to sealed wall penetration
Measured Extent:	1 no.	Asbestos Type:	No asbestos detected
Damage/Condition:	Good condition

Recommendations:	No Action Required
-------------------------	--------------------
