TASK NO.	TASK/DESCRIPTION	NOTES
	H2 HULL AND STRUCTURE – EXTERNAL DECKS AND ASSOCIATED FITTINGS	
H2.13	<p><b>Flight Deck Paint Coating</b></p>

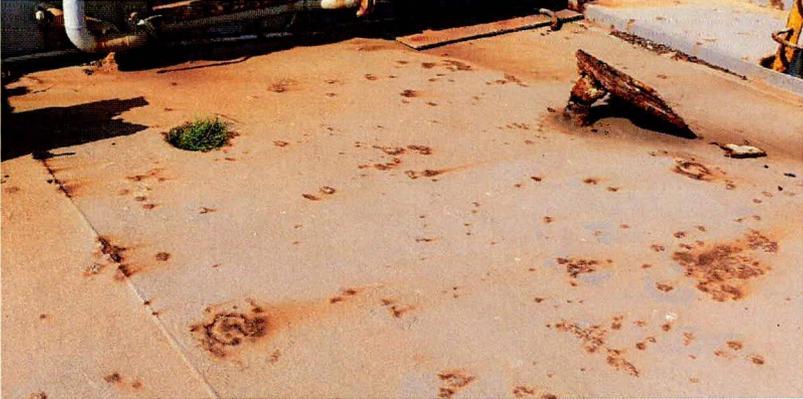
<p>The flight deck has many areas of paint coating breakdown leading to active corrosion of the deck. Carry out patch repair REPRESENTATION.</p> <p>ALLOW for 25m<sup>2</sup>. REPRESENTATION.</p>	<p>IAW Paint scheme -General 12 and Annex B refer.</p> <p>To be completed in conjunction with H2.14.</p>

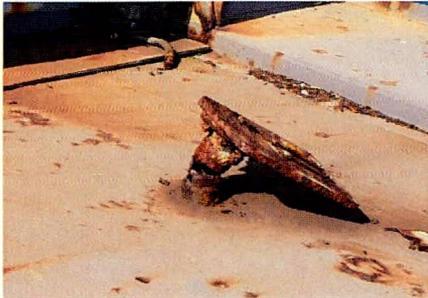
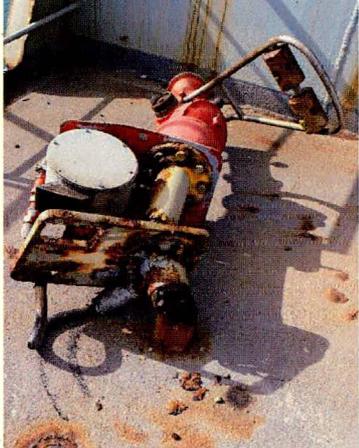
TASK NO.	TASK/DESCRIPTION	NOTES
H2	HULL AND STRUCTURE – EXTERNAL DECKS AND ASSOCIATED FITTINGS	
H2.14	<p><b>Flight Deck Monitors</b></p> <div style="display: flex; justify-content: space-around;">

</div> <p>Both flight deck monitors are redundant, and excessive pipe corrosion has resulted in them becoming detached from the deck. Contractor to dispose of both monitors, cut remaining pipework to deck level and weld blanks in place. REPRESENTATION on completion.</p> <p>ALLOW for 2m<sup>2</sup> REPRESENTATION.</p>	<p>Hotwork Required – Appropriate precautions to be taken iaw General 8.4.</p> <p>IAW Paint scheme -General 12 and Annex B refer.</p> <p>To be completed in conjunction with H2.13.</p>

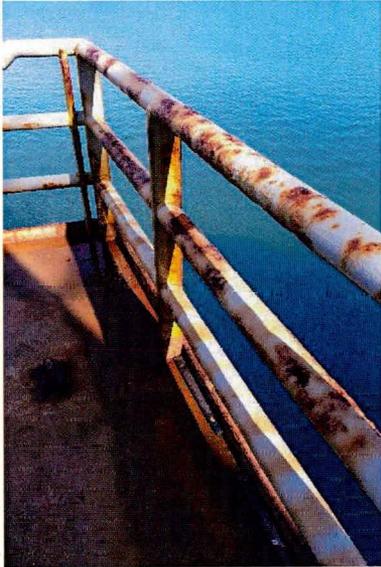
TASK NO.	TASK/DESCRIPTION	NOTES
H2.15	<p data-bbox="432 327 1145 383">H2 HULL AND STRUCTURE – EXTERNAL DECKS AND ASSOCIATED FITTINGS</p> <p data-bbox="397 416 858 450"><b>Port and Stbd Bridge Wing Decks</b></p>

<p data-bbox="397 1043 1238 1144">Port and stbd Bridge Wing decks have large areas of paint coating breakdown and active corrosion present. REPRESERVE deck coatings. Allow for 30m<sup>2</sup> total. REPRESENTATION.</p>	<p data-bbox="1248 416 1445 528">IAW Paint scheme -General 12 and Annex B refer.</p> <p data-bbox="1248 562 1445 640">To be completed in conjunction with H3.05.</p>
