ASBESTOS REFURBISHMENT SURVEY REPORT

J289521

FOR: Whaley Bridge Town Council
AT: Mechanics Institute, 27 Market Street, Whaley Bridge

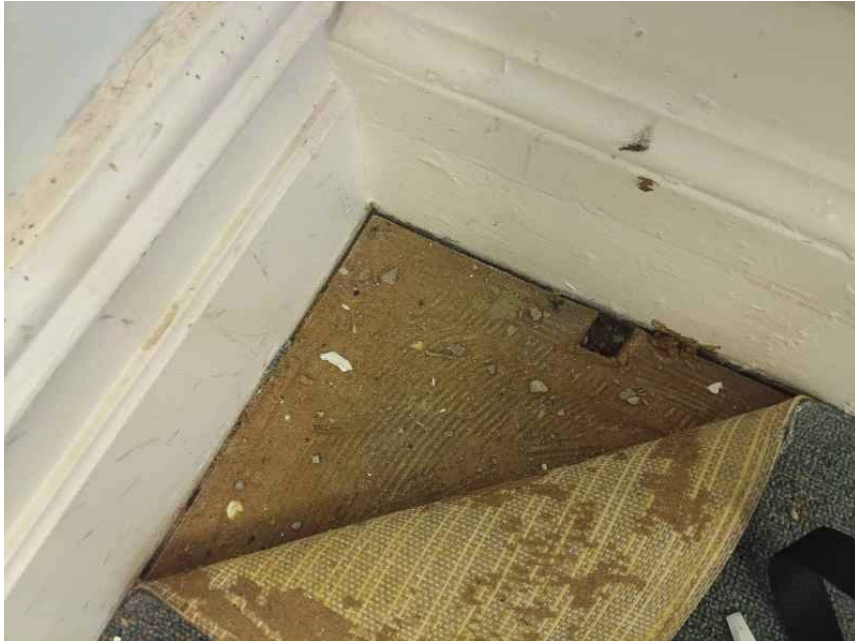
Sample N°	RT000019		
Location	Mechanics institute 27 Market Street whalley Bridge G.01 - Meeting Room

Item:	Vinyl flooring	Identification:	Identified
Approx. Quantity:	60m ²	Accessibility:	Difficult
Product Type: <small>See Appendix VII: Glossary of terms</small>	Vinyl floor tile		0
Extent of damage:	Good Condition		0
Surface treatment:	Completely Sealed		0
Asbestos type:	No Asbestos Detected		0
		Material Assessment Score:	0
Action:	No Further Action Required		
Comments:

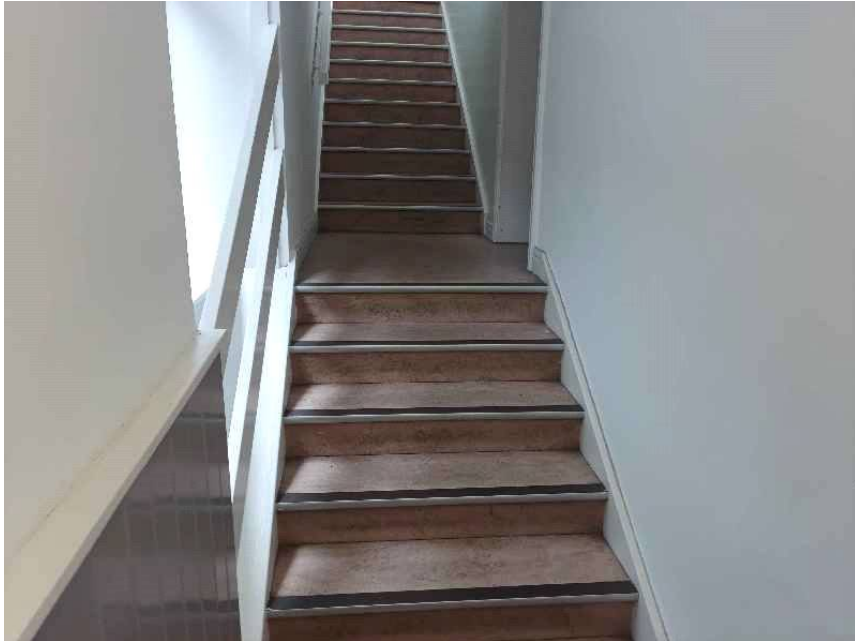
Sample N°	RT000021		
Location	Mechanics institute 27 Market Street whalley Bridge G.02 - Corridor

Item:	Stair nosings	Identification:	Identified
Approx. Quantity:	1<	Accessibility:	Medium
Product Type: <small>See Appendix VII: Glossary of terms</small>	Reinforced Composite		0
Extent of damage:	Good Condition		0
Surface treatment:	Completely Sealed		0
Asbestos type:	No Asbestos Detected		0
		Material Assessment Score:	0
Action:	No Further Action Required		
Comments:
