**The Harlington
236 Fleet Road
Fleet
Hampshire
GU51 4BY**

Auditorium Ceiling Inspection Report

July 2020

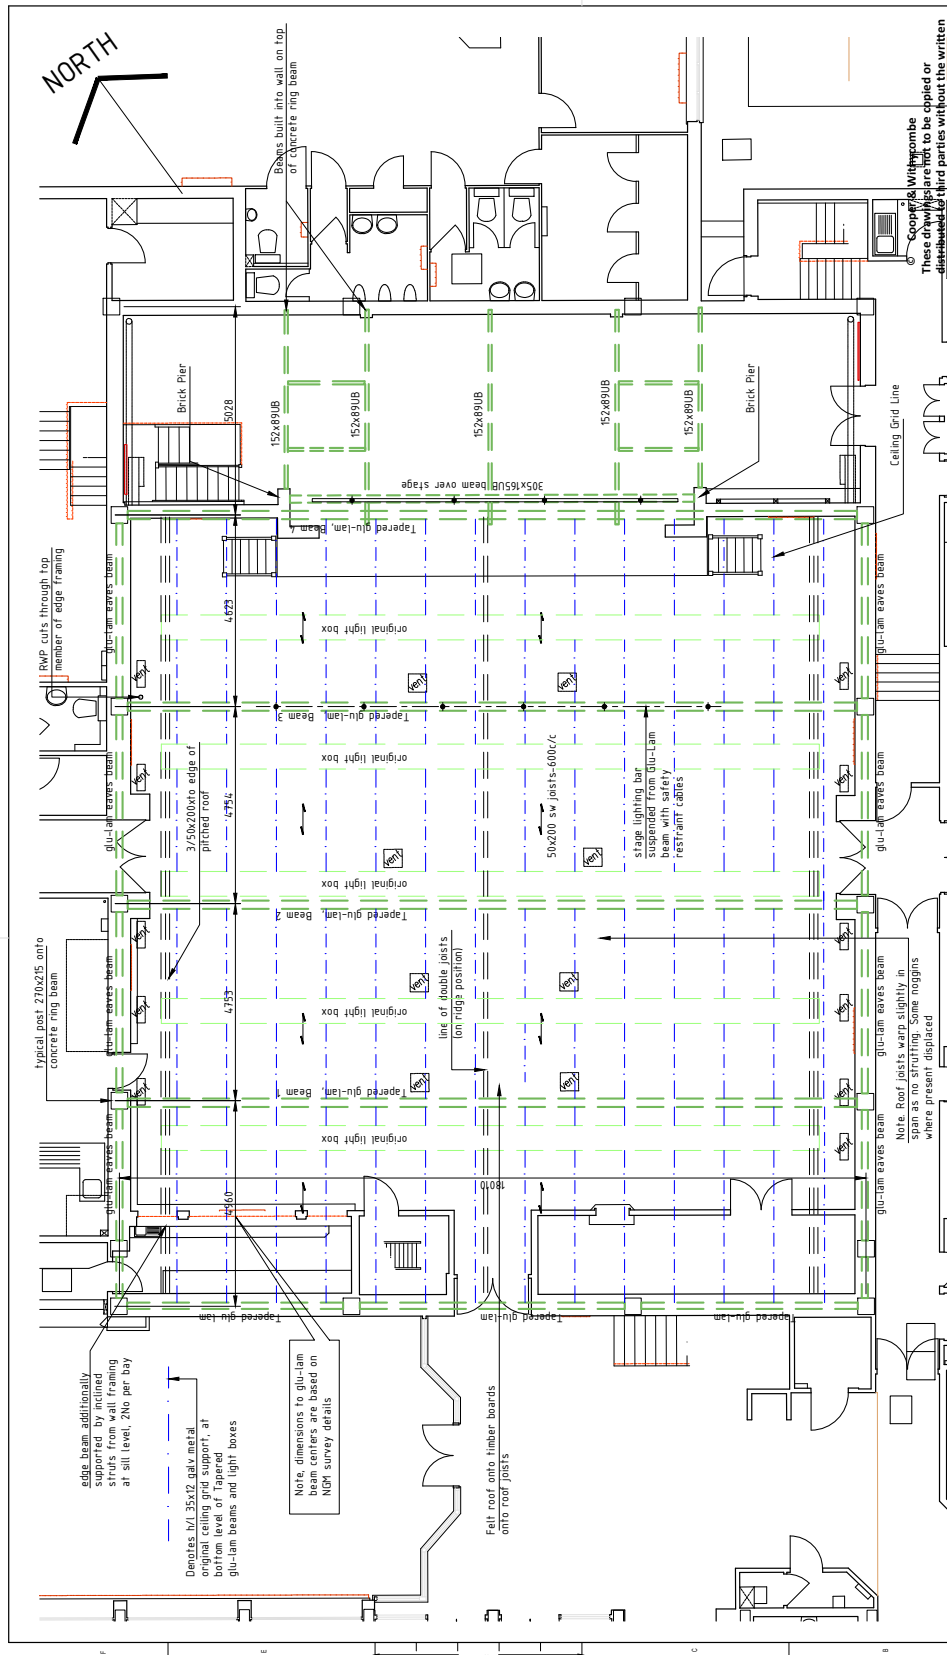
- 3.2.1.2 The roof coverings are laid onto timber boards supported on 50 x 200mm softwood roof joists at 600mm centres. These are supported on the main laminated beams that span across the hall. The roof joists are butt jointed over the top of the laminated beams and fixed with two nails into the top of the beam. See Drawing 19-1962/91.

Cooper & Withycombe CONSULTING ENGINEERS Newmarket Road Fleet, Hampshire GU51 4BY Tel: 01489 7720 Fax: 01489 591115		PROJECT 19-1962	DRAWING NO. 91	REV. DATE A
CLIENT Fleet Town Council PROJECT The Harlington Fleet Road Fleet, Hampshire TITLE Suspended Ceiling Survey High Level Grid		APPROVED BY DATE 	DRAWN BY DATE 	CHECKED BY DATE
A. Additional notes 		DESCRIPTION BIS	DATE 	SCALE 1:100 @ A3
Note: This drawing is to be read in conjunction with all relevant Project drawings together with the Project Specification and any other drawings. Dimensions are to be reported promptly to the Contract Administrator.		Note: Roof joists were slightly in span as no strutting. Some ruggins where present displaced.

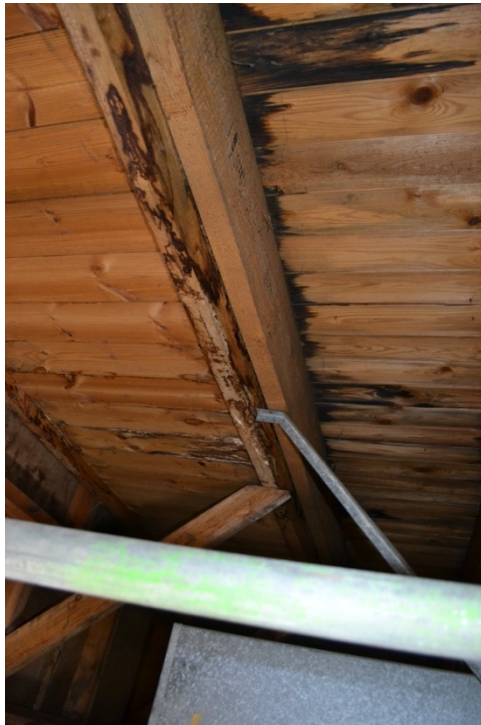
Except for the perimeter edge beams there was no significant indication of water penetration or decay to these elements. The roof space was considered to be dry.

R9 Roof edge beam. Historic water penetration.

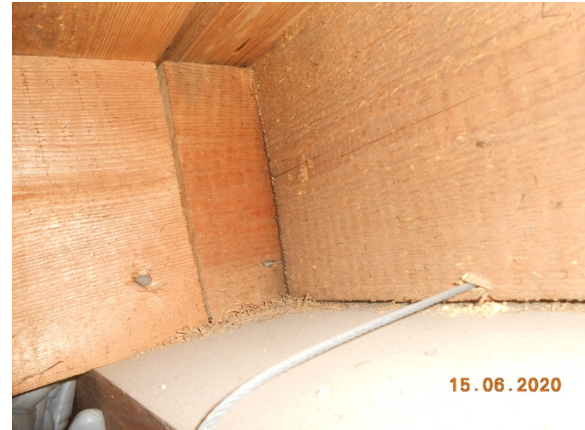
The bearing of the roof joists onto the laminated beams is variable. There is only limited fixity at this point with 2 No nails in the bottom of the beam. Whilst there are noggins between them, these do not appear to be fixed to the roof joists themselves. In places these have been removed to facilitate the introduction of services.

R10 Butt joint of roof joists over laminated beam

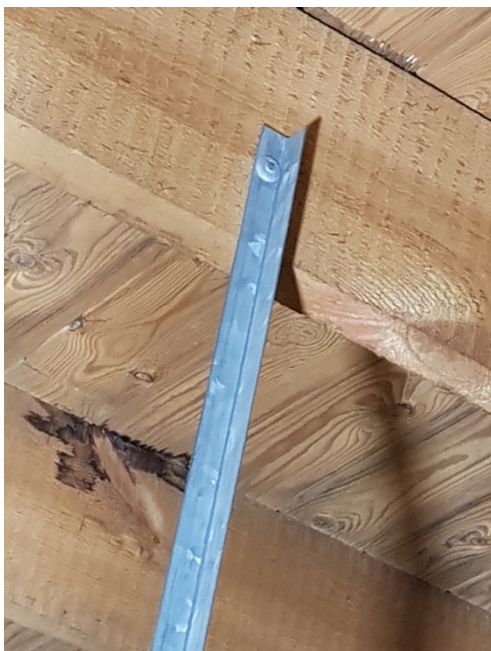
Overall the ceiling system appears to rely on a single fixing at each of the connection points. At upper level these appear to be a small, single screw into the side of the roof joists, or a nail fixing completely through the roof joist. The original nail fixings appear to be lightly corroding on the surface.

R11 Typical screw fixing for ceiling hanger

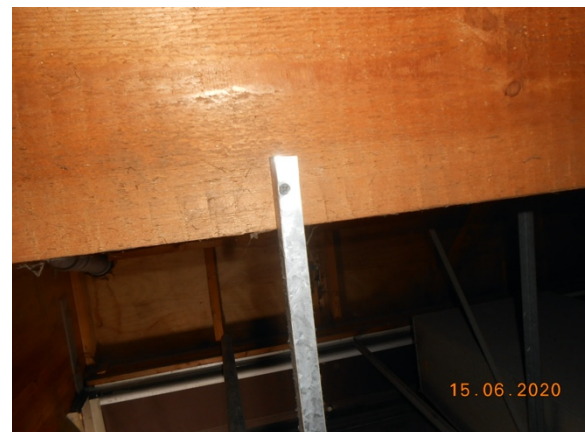
R12 Typical nail fixing to ceiling joist

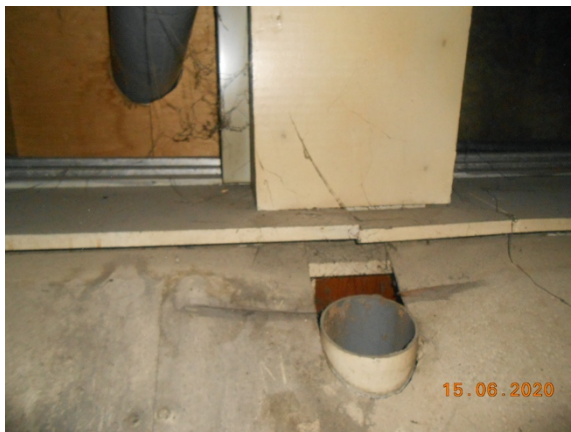
- 3.2.1.5 Further support is provided to this edge beam with inclined timber struts down to the base of the original glazed panel to the perimeter.
- 3.2.1.6 Originally the rainwater downpipes from the edge gutter ran as vertical pipes alongside the laminated timber bearings. Presumably as part of the previous alterations / extensions these have been diverted at high level through the perimeter wall. The end of the original pipe remains open and not sealed.

R19 Open ended redundant pipe

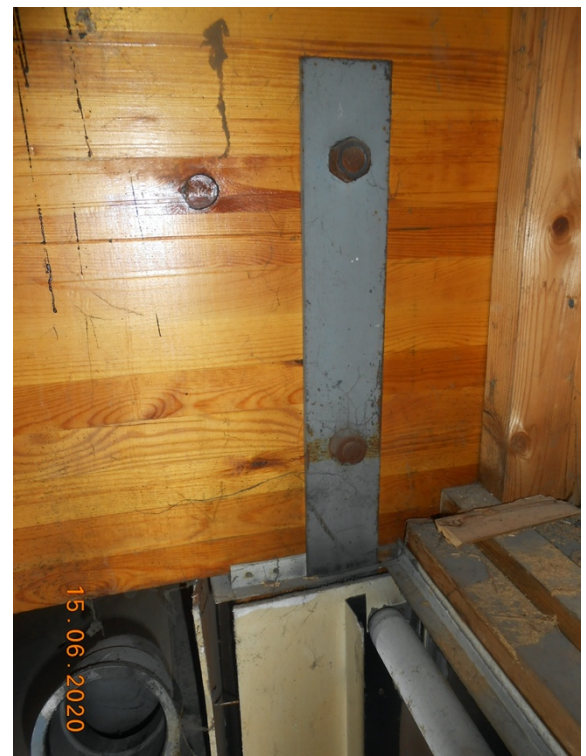
At the laminated beam bearings, it is not certain whether there is any further fixity other than the vertical metal straps on each side of the beams. The laminated beams appear to rest directly onto the timber posts below which then subsequently rest onto the concrete ring beam at the lower level. Whilst the plate itself appears to be corrosion free, surface corrosion was evident to the bolted connection.

R20 Laminated beam post fixing

- a) Resin inject the open joints in all the glued, laminated beams, where checks/fractures have been noted and where they can be accessed.
- b) Clean all connections to the laminated beam of any loose rust and paint with rust inhibitor before any further painting with an appropriate paint system. This relates to the laminated beam connections only.

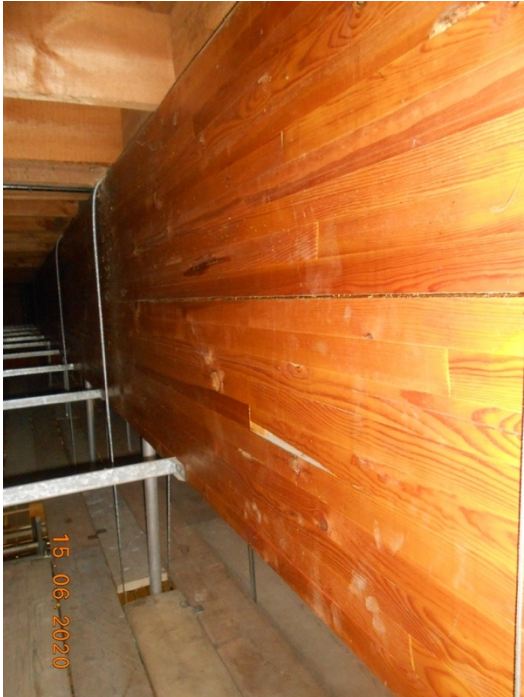
A typical defect in the laminated beams is a horizontal fracture / check just at the level of the top of the plate or just above it at each of the bearings. Typically this was in lamination four, from the top. The crack appears to extend between 500mm – 1,000mm from the face of the support, with a width of approximately 2mm. This may reflect slight rotation at the support causing high stress in the lamination above the bolt fixing.

The fractures / checks on the beam faces, although relatively consistent they are not extensive either in terms of their length or number in the glued, laminated beam depths. These appear to be a separation of the glued joint. Frequently on one face only, but with some reflected on the opposing face, particularly at the bearings.

These cracks may reflect higher joint stresses in the beams as loads have been applied, deflections developed and shrinkage in the beam depth. The latter due to the location in a dry, heated environment. There was no indication of recent movement or development of the cracks nor was adverse deflection noted.

R21 Beam 3 – Horizontal crack

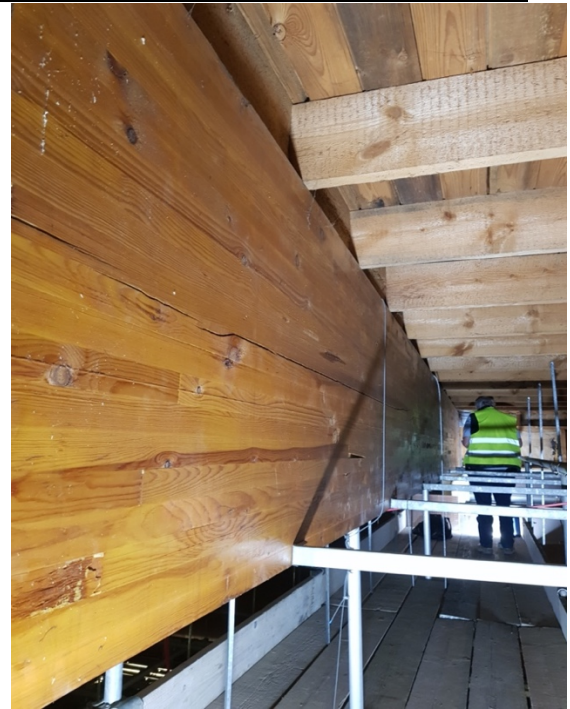
R22 Beam 3 – Horizontal check / crack

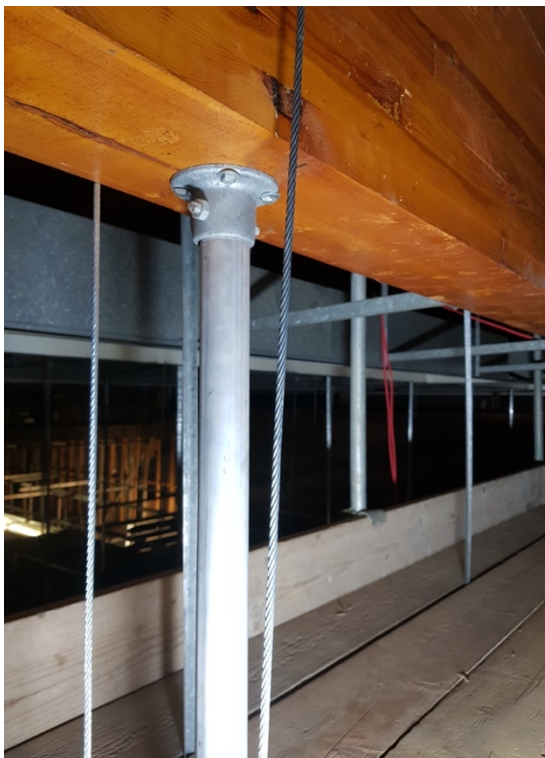
- a) Auditorium Lighting Bar. The fixing to the soffit of the laminated beam is questionable as this is relying on 4 No, 8mm diameter coach bolt screws into the beam soffit providing a tension fixing. As previously noted to the client, these are not wholly reliable and would preferably need a fixing across the top of the beam. However, at present there is no sign of any distress in this lighting beam support.
- b) Stage / Production Lighting Supports. These are at high level and there is no direct access to them. They are painted and appear in reasonable condition. The Hall staff advised that no safe working load had been designated to these beams. This was an issue that had been raised by the authorities / insurers. In view of this, a Structural Appraisal of their load capacity has been undertaken.

R23 Lighting bar support – Beam 3

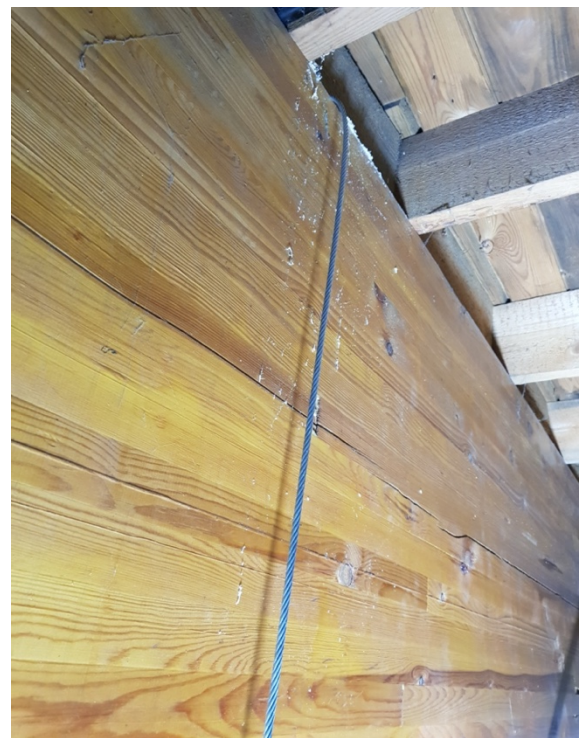
R24 Beam 3 – Safety wire

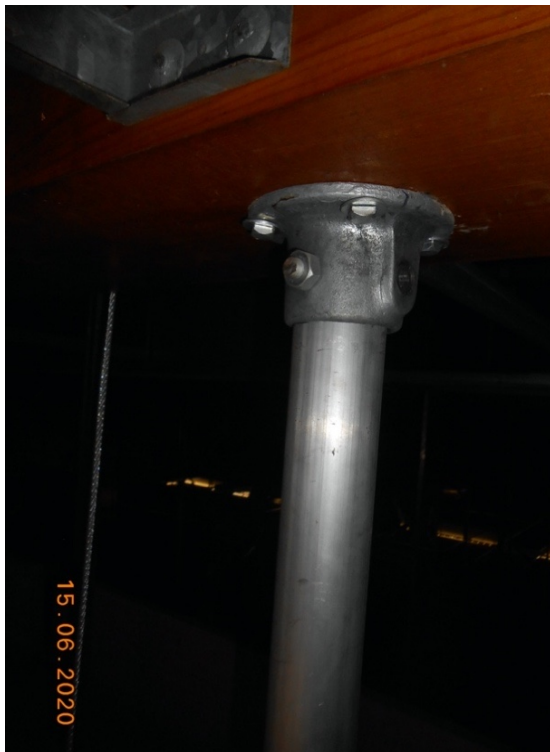
R25 Lighting bar fixing

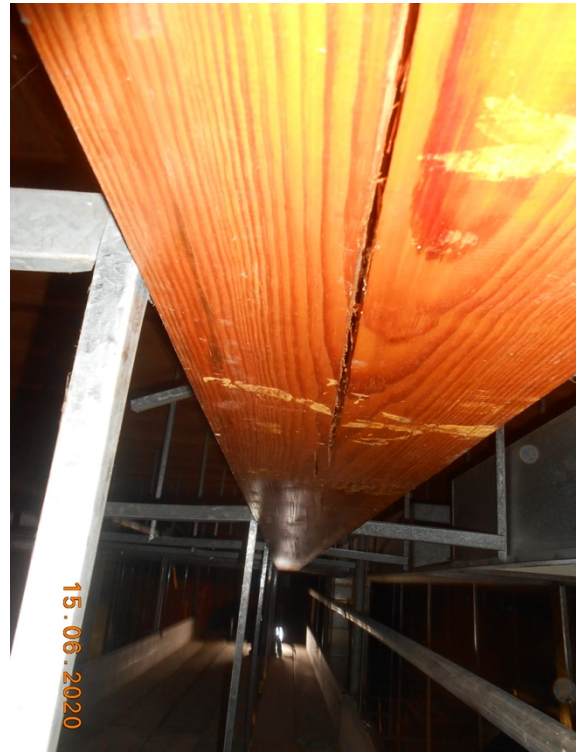
R26 Beam 3 – Fracture to beam soffit

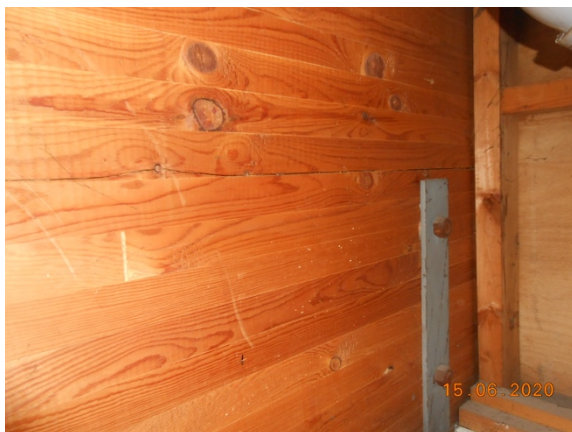
This beam exhibits cracks / checks at the south-west end, extending from the bearing almost along to the centre line. These cracks step from the bearing towards the centre line.

The cracking in the soffit to Beam 1 is discontinuous and with some separation of fibres. This may suggest it is primarily a shrinkage related crack, although as the beam supports different roof spans to each side may also reflect torsional stresses.

R27 Beam 1 – Check / crack above beam
fixing

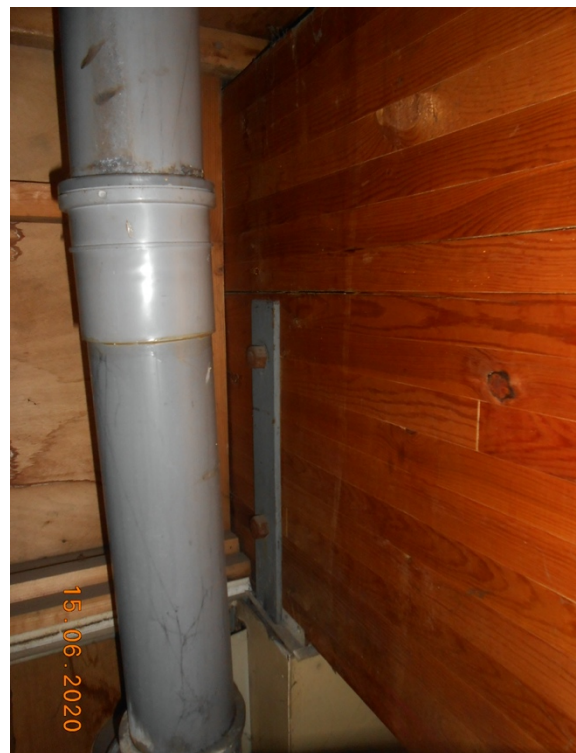
R28 Beam 1 – Check / crack at beam
bearing

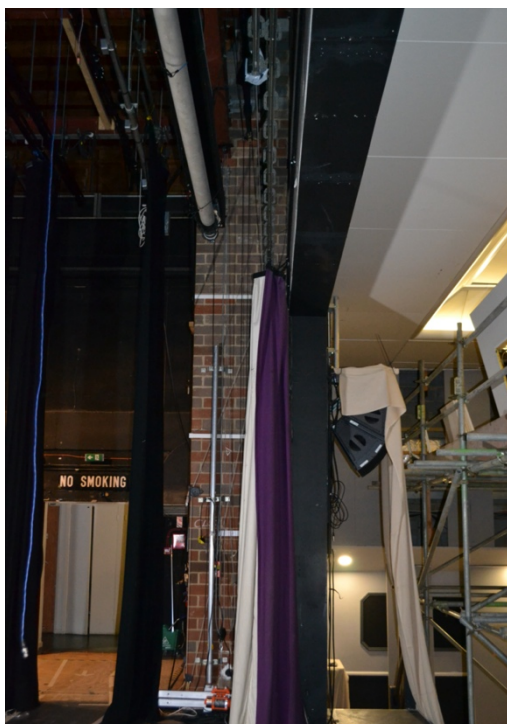
by the connection to the bottom, together with where it is built into the cavity wall. No other bracing was provided. The connection to the laminated beam itself is a simple plate fixed to the side of the laminated beam. This would also not provide effective restraint to the head of the post. It is clear from the observations that some rotation has occurred at the post position, possibly reflecting relaxation of any pre-camber in the laminated beam. The fracture just above the bulk connection may be a consequence of this.

R35 Beam built into brick pier
