The Harlington Centre

Gas Boilers – Visual Condition Report

Report produced on the 11th October 2018

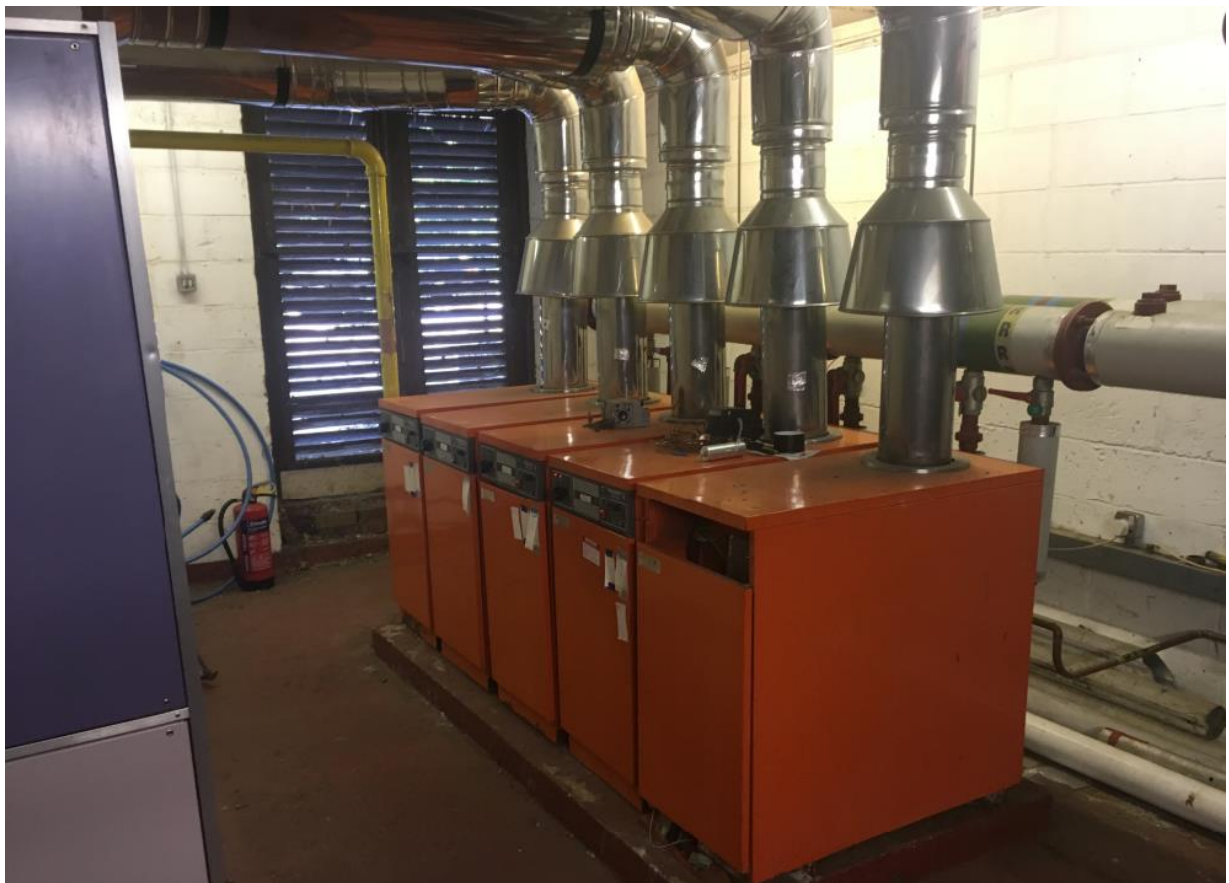
Regency GBS series 2

The heating system is supplied from five (5) Sangiorgio Regency GBS Series 2 gas fired boilers. Each boiler has a heat output of 67.0 Kw. The boiler data plate did not provide a “date of manufacturer” but following conversations with the boiler manufacturer, it is estimated that these boiler are in excess of 25 years. The boilers would appear to supply the heating system as I was unable to identify any hot water plant. There was no hot water pumps labelled on the control panel so it is assumed the hot water in the building would be fed from local point of use water heaters.

Boiler size	221-52	N° of boiler section	7
Serial N°	627027	Date of manufacture	
Heat input	286,600 Btu/h		84.0 kW
Heat output	227,500 Btu/h		67.0 kW
Burner setting pressure	12.0 mbar		4.8 in. w.g.
Main injector diameter	4.30 mm		
Heat input of pilot	0.27 kW	Gas family:	Natural Gas Cat 1N
Max working pressure	5 bar (167 ft)	Max flow temperature	90°C
Rated voltage	240 V · 50 Hz	Fuse rating	3 A
This appliance has been tested and certificated by BRITISH GAS			
n°	41 504 - 09	Country of origin: ITALY	
U.K. Distributor: MODULAR HEATING SALES LTD.			
35, Nobel square Burnt Mills industrial estate - Basildon - Essex - SS131LT			
Ph. no. (0268) 591010			
Manufacturer: SANGIORGIO

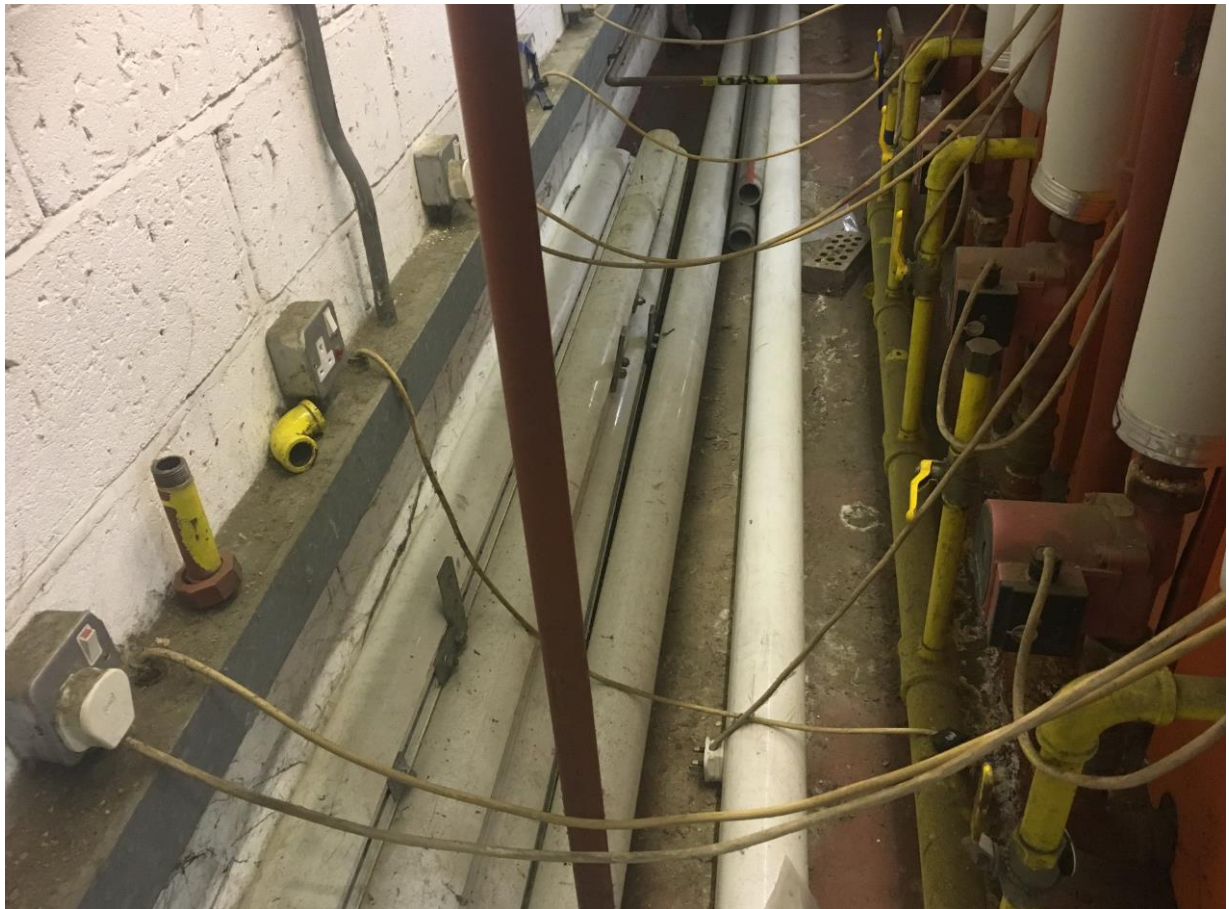
Boiler No. 2 shut down and the gas supply to boiler isolated and capped off. The electrical supply to boiler was also disconnected.

Since my site visit on the 19th July 2018, I have received a worksheet completed by the current maintenance provider, which is attached in section 3 in the report. The contractor carried out a PPM on 18th September and the worksheet would indicate that boiler No. 2 has been repaired and is now operational.

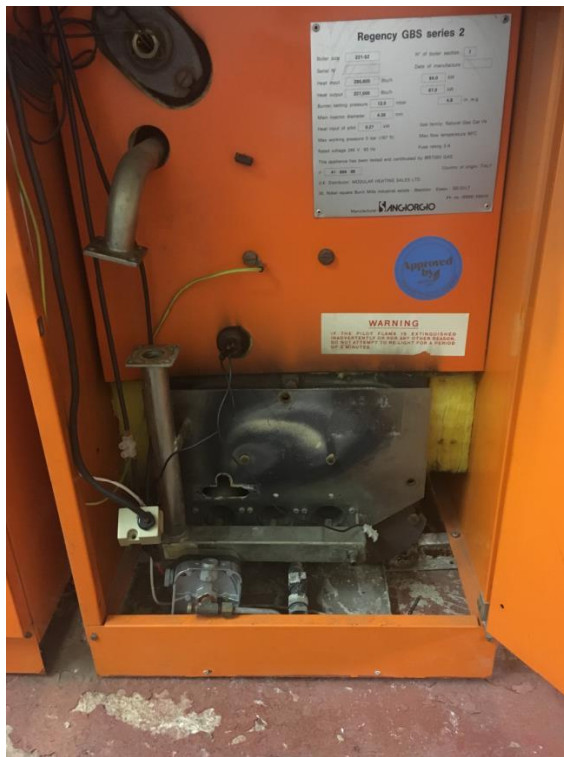
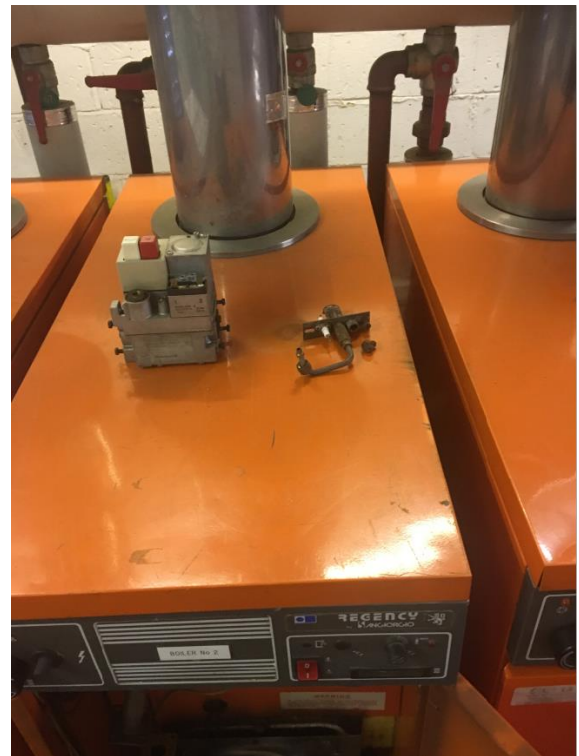
The multifunctional gas valve and pilot assembly had been removed from the boiler and would appear to have been left on top of the boiler.

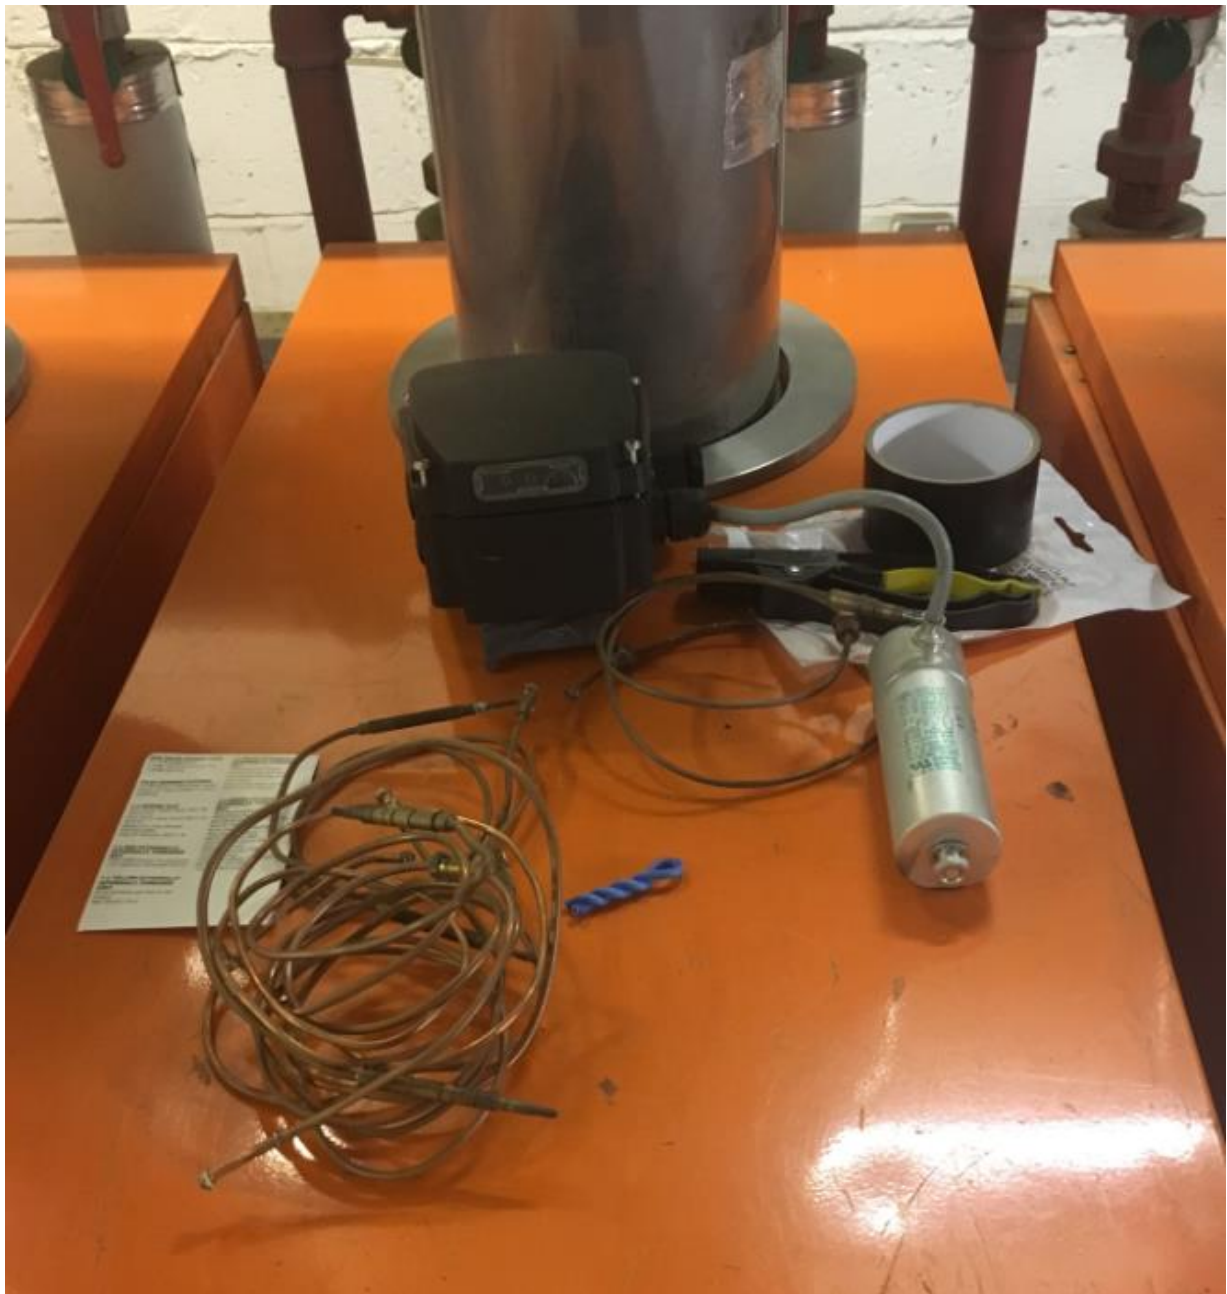
Boiler No. 4 was not operational. Following visual investigation no parts had been removed from the boiler and it was found that the pilot flame was extinguished. The pilot flame being extinguished could be due to a faulty part which could include the thermocouple, multifunctional gas valve or high limit interrupter. Several used thermocouples had been left on top of the boiler.

Since my site visit on the 19th July 2018, I have received a worksheet from the current maintenance provider, which is attached in section 3 in the report. The contractor carried out a PPM visit on the 18th September and the worksheet would indicate that boiler No. 4 is not operational.

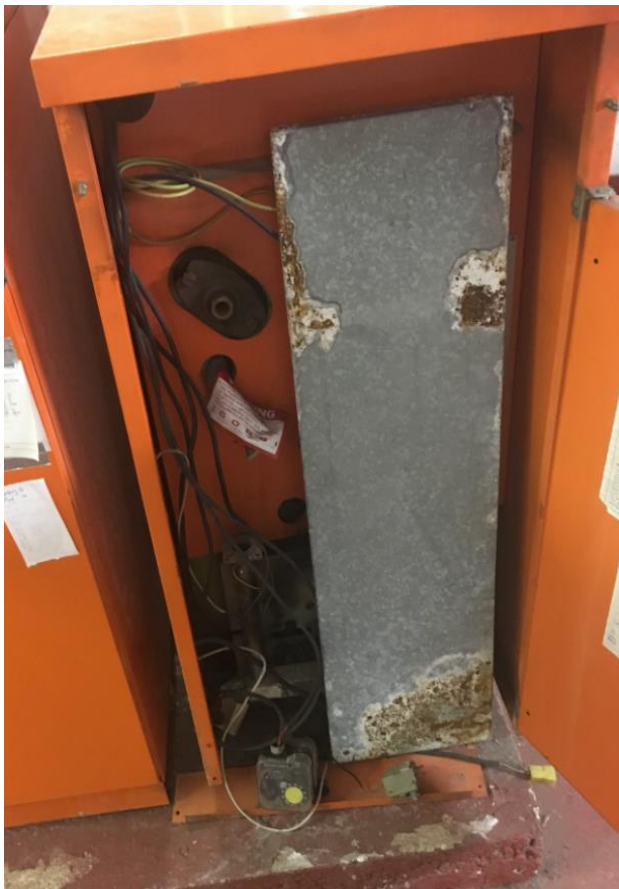
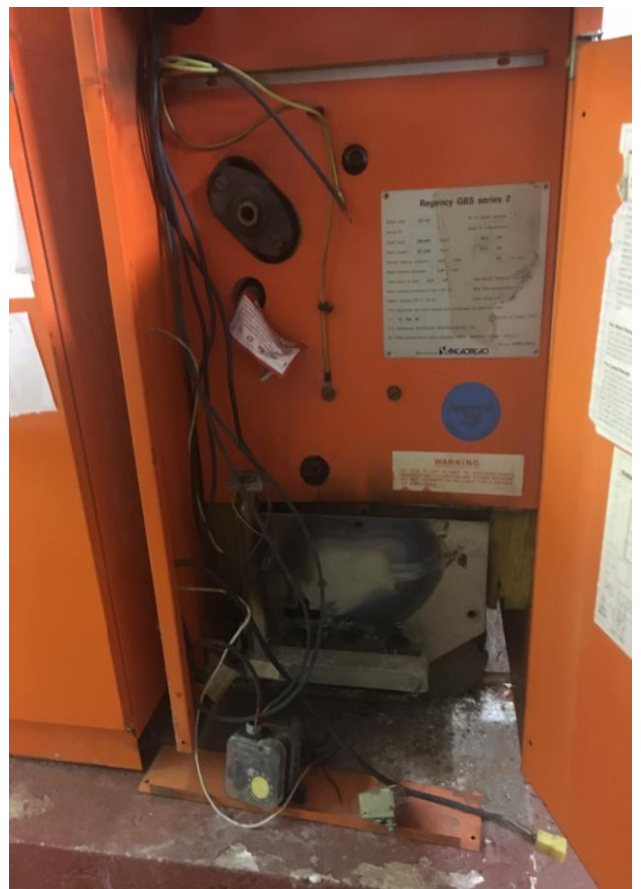
Boiler No. 5 was shut down and electrically disconnected with a warning notice attached internally in the boiler. The multifunctional gas valve, pilot assembly, overheat thermostat and control panel had all been removed from the boiler.

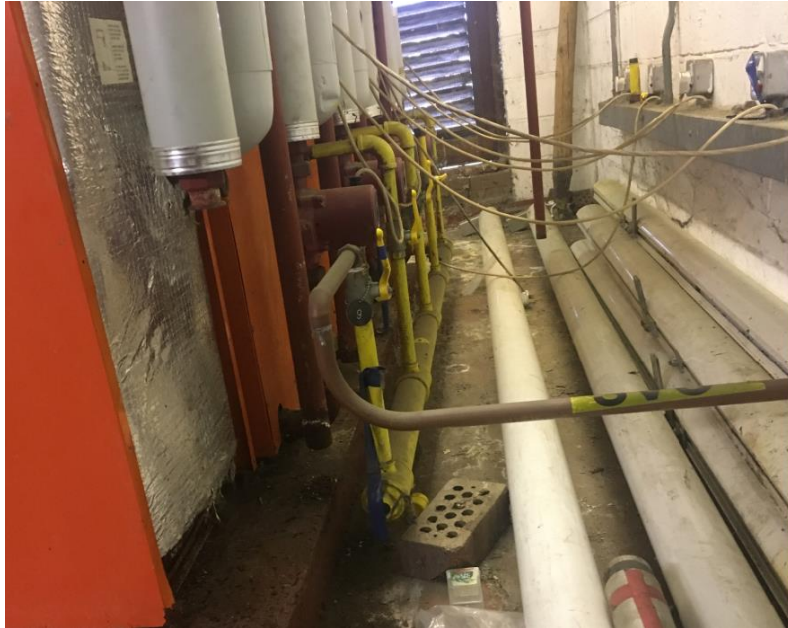
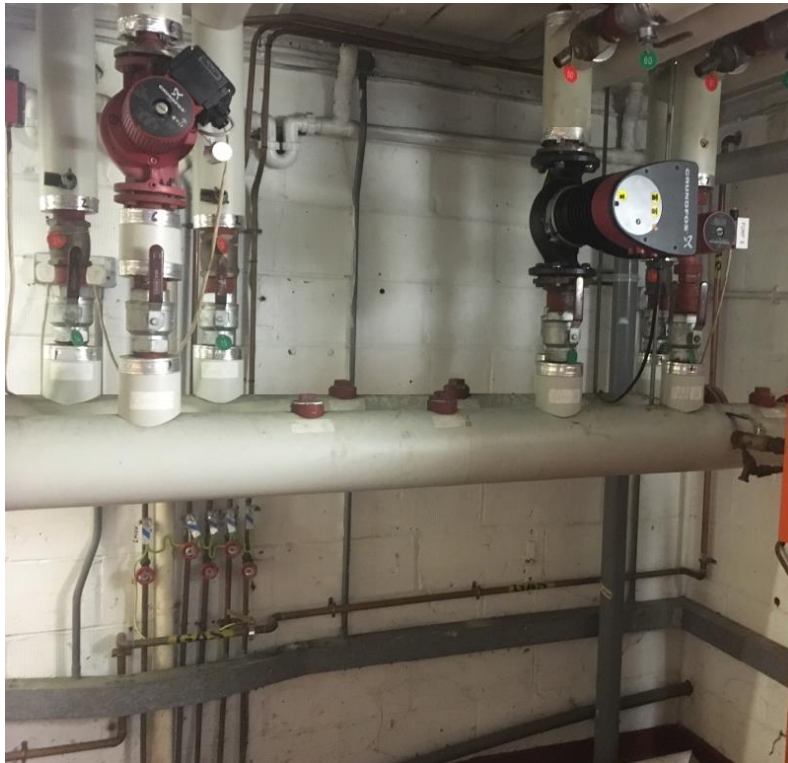
At some time in the past the gas supply for boiler No. 5 has been disconnected and utilized to supply gas an appliance not located in the main plant room.

On further investigation, I located a valve chart which confirmed that that the gas supply that original supplied boiler No. 5 had been altered to supply a Worcester gas boiler located in reception.
