TASK NO.	TASK/DESCRIPTION	NOTES
H2.11	<p data-bbox="400 327 1150 383">H2 HULL AND STRUCTURE – EXTERNAL DECKS AND ASSOCIATED FITTINGS</p> <p data-bbox="400 416 512 450">02 Deck</p> <div data-bbox="400 465 1107 1070">

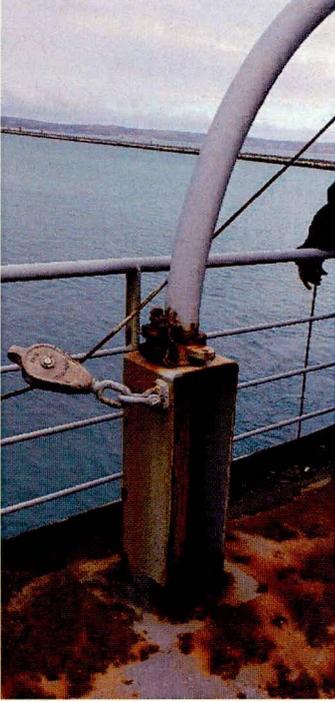
TASK NO.	TASK/DESCRIPTION	NOTES
H2.10	<p data-bbox="408 416 967 450">Redundant Accommodation Ladder Davit</p>

<p data-bbox="408 1182 1214 1294">Active corrosion and paint coating breakdown at base of redundant accommodation ladder davit. Davit no longer used therefore davit to be REMOVED and deck area REPRESENTED. Contractor to dispose of all removed materials on completion.</p> <p data-bbox="408 1312 836 1339">ALLOW for 1m² REPRESENTATION.</p>	<p data-bbox="1254 423 1452 591">Hotwork Required – Appropriate precautions to be taken in accordance with General 8.4.</p> <p data-bbox="1254 622 1406 734">To be completed in conjunction with H2.17</p> <p data-bbox="1254 766 1401 902">I/AW Paint scheme - General 12 and Annex B refer.</p>

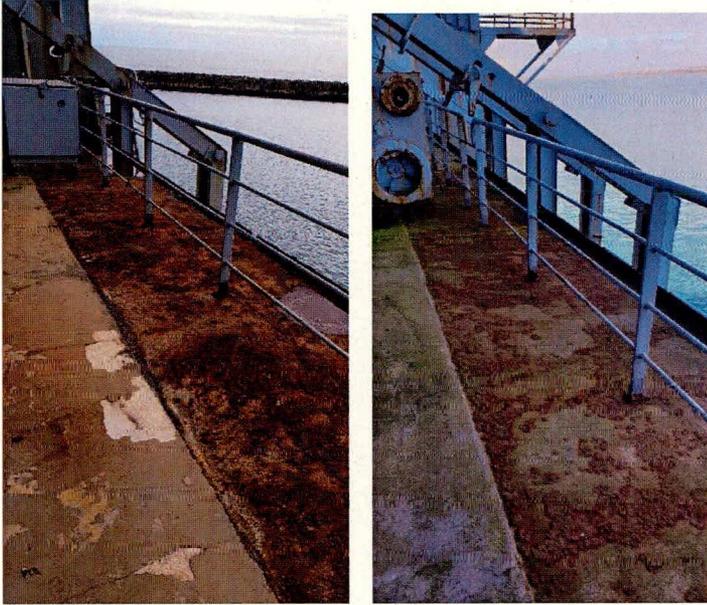
</div> <p data-bbox="400 1084 1214 1173">Port and stbd 02 deck waist decks have had deck screeding removed and are heavily corroded. Decks to be REPRESENTED with non slip paint coating.</p> <p data-bbox="400 1182 847 1211">ALLOW for 80m² REPRESENTATION.</p>	<p data-bbox="1249 421 1401 562">IAW Paint scheme - General 12 and Annex B refer.</p> <p data-bbox="1249 591 1449 674">To be completed in conjunction with H3.04.</p>

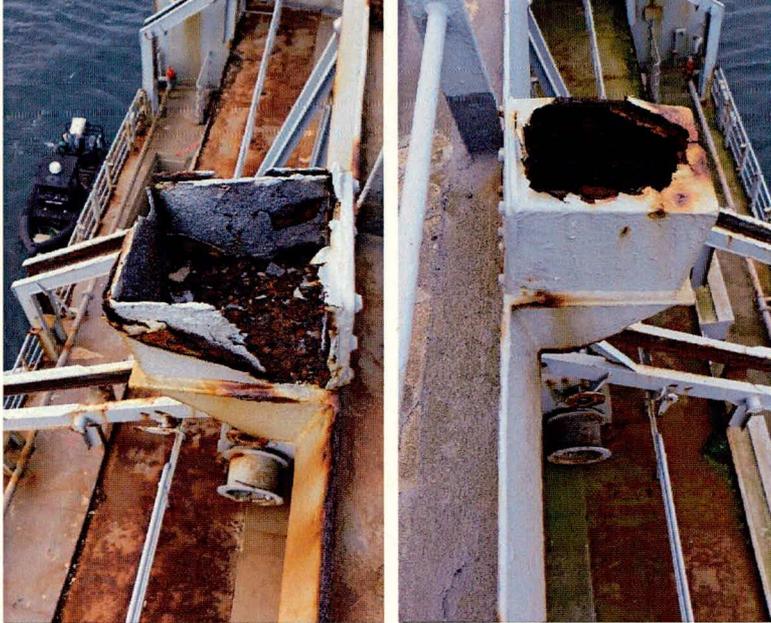
TASK NO.	TASK/DESCRIPTION	NOTES
	H2 HULL AND STRUCTURE – EXTERNAL DECKS AND ASSOCIATED FITTINGS	
H2.12	<p>Gundeck Aerial Boxes</p>

<p>Port and stbd aerial mounting boxes have corroded to the extent aerials have now become detached. Aerials are redundant. Remove both mounting boxes and REPRESENT affected area. Contractor to dispose of removed items.</p> <p>ALLOW for 2m² REPRESENTATION.</p>	<p>Hotwork Required – Appropriate precautions to be taken iaw General 8.4.</p> <p>IAW Paint scheme -General 12 and Annex B refer.</p>
