**Project:** MARKET HOUSE ROSS-ON-WYE

**Inspection:** Friday 16<sup>th</sup> February, 2018

**Reason for Visit:** Inspection of Clock Tower Timber Framing with Fred Hamer of RRA

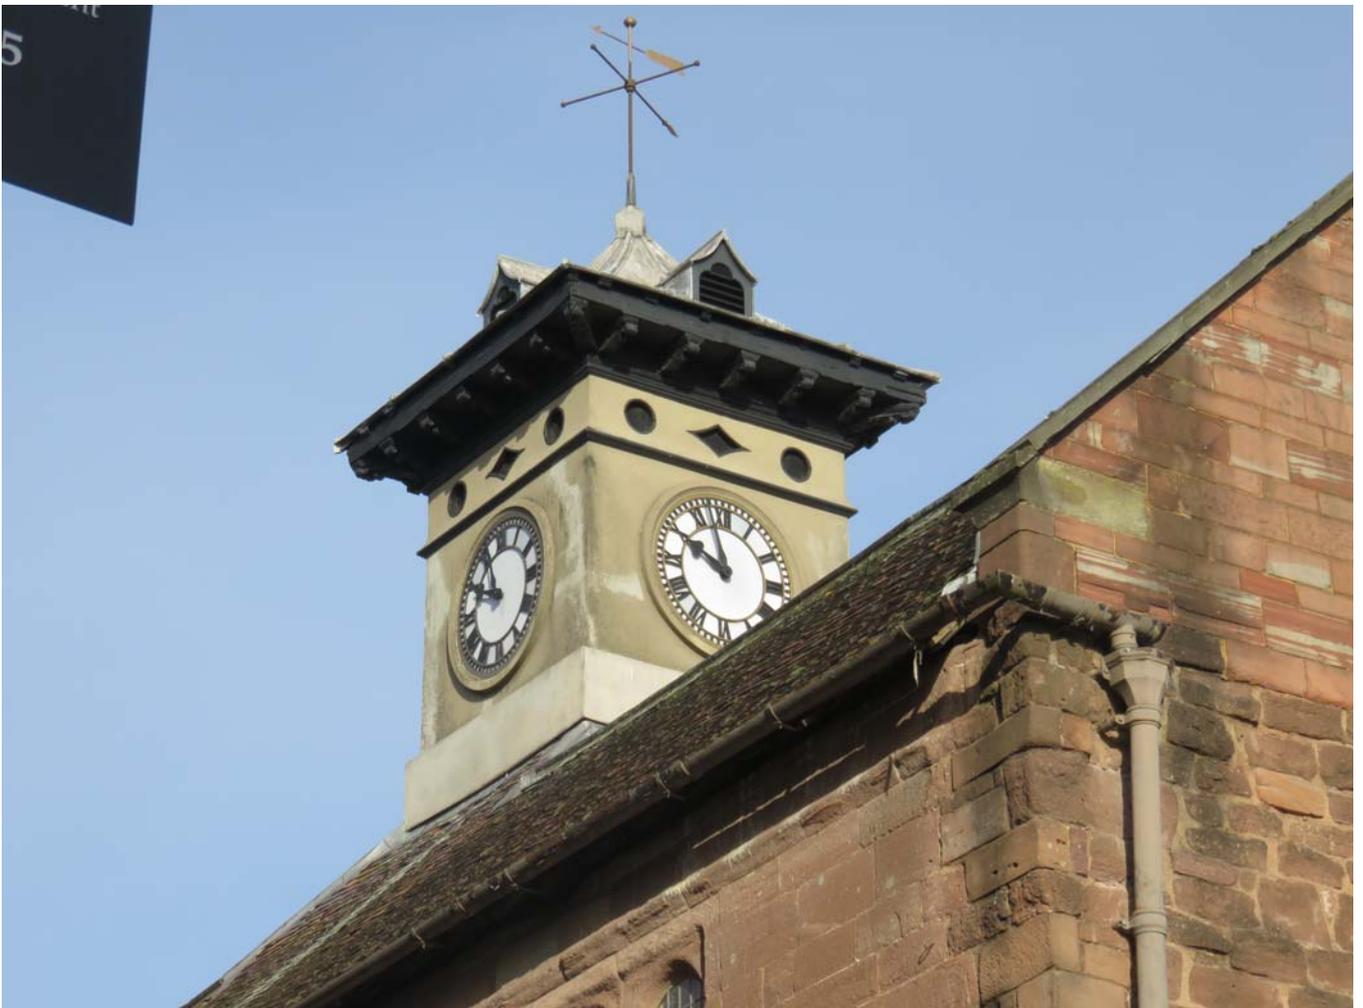
IMG\_6247

1. Exterior of clock tower in fair order as seen by inspection from the street. Four sides are grey cement render on timber backing. Slight cracking, good timbering and leadwork ventilators etc., above. (P6247).

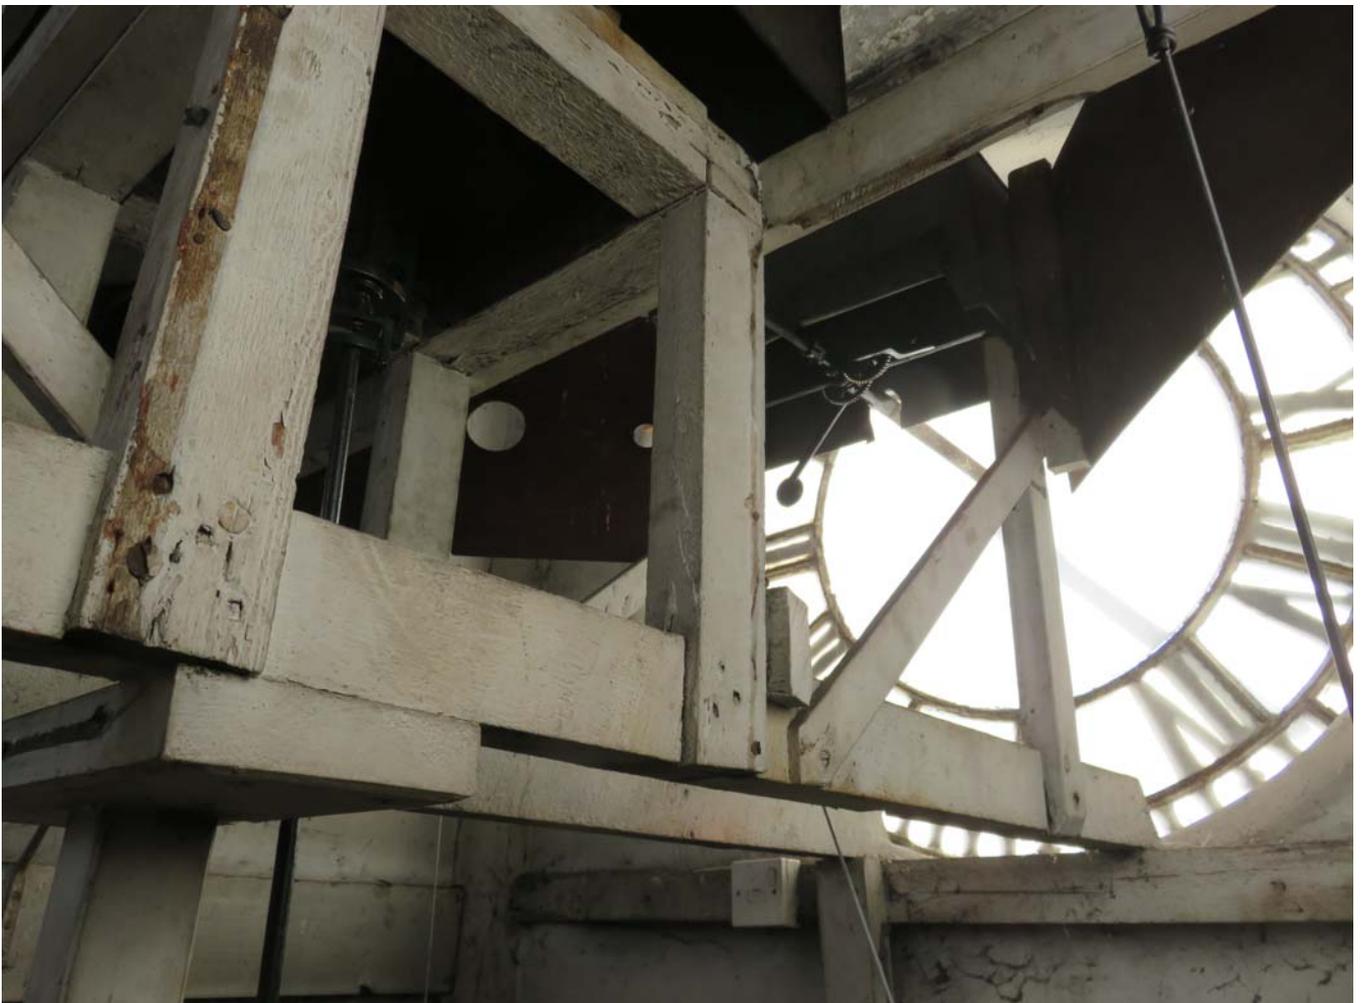
IMG\_6251

2. Ground floor Market Hall, first floor Art Gallery, trap door above and ladder access only on to the attic floor. Attic floor houses clock mechanism and ladder to small room with clock faces to four compass points. (P6251).

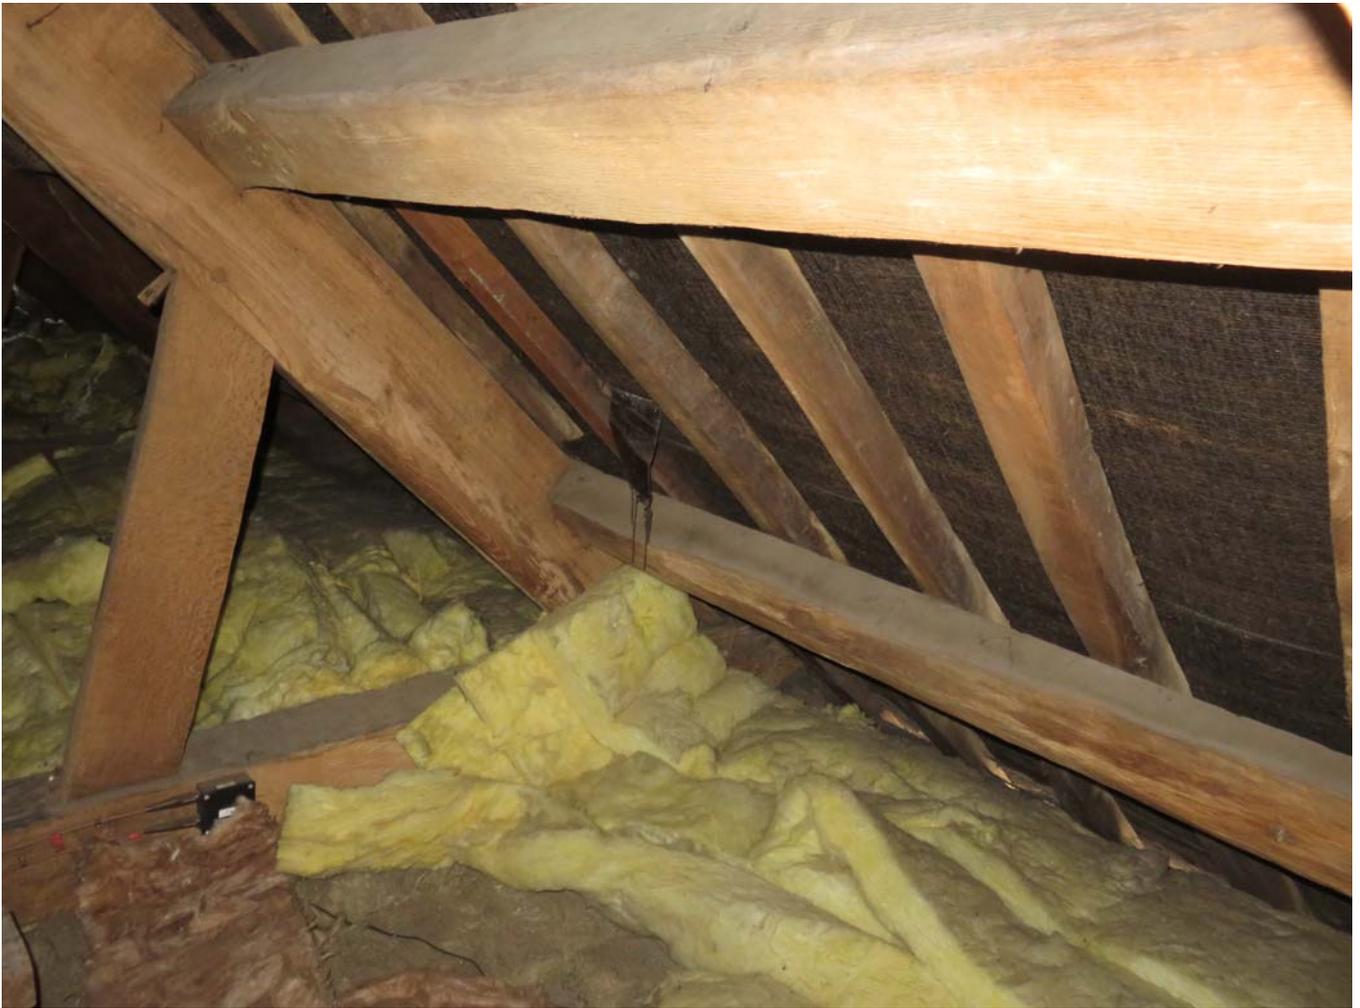
IMG\_6255

18. The framing at roof level generally seems very substantial, the whole building really quite well put together, and with the fundamental benefit that the area is well ventilated, and any minor moisture intrusion soon dries off. (P6255).

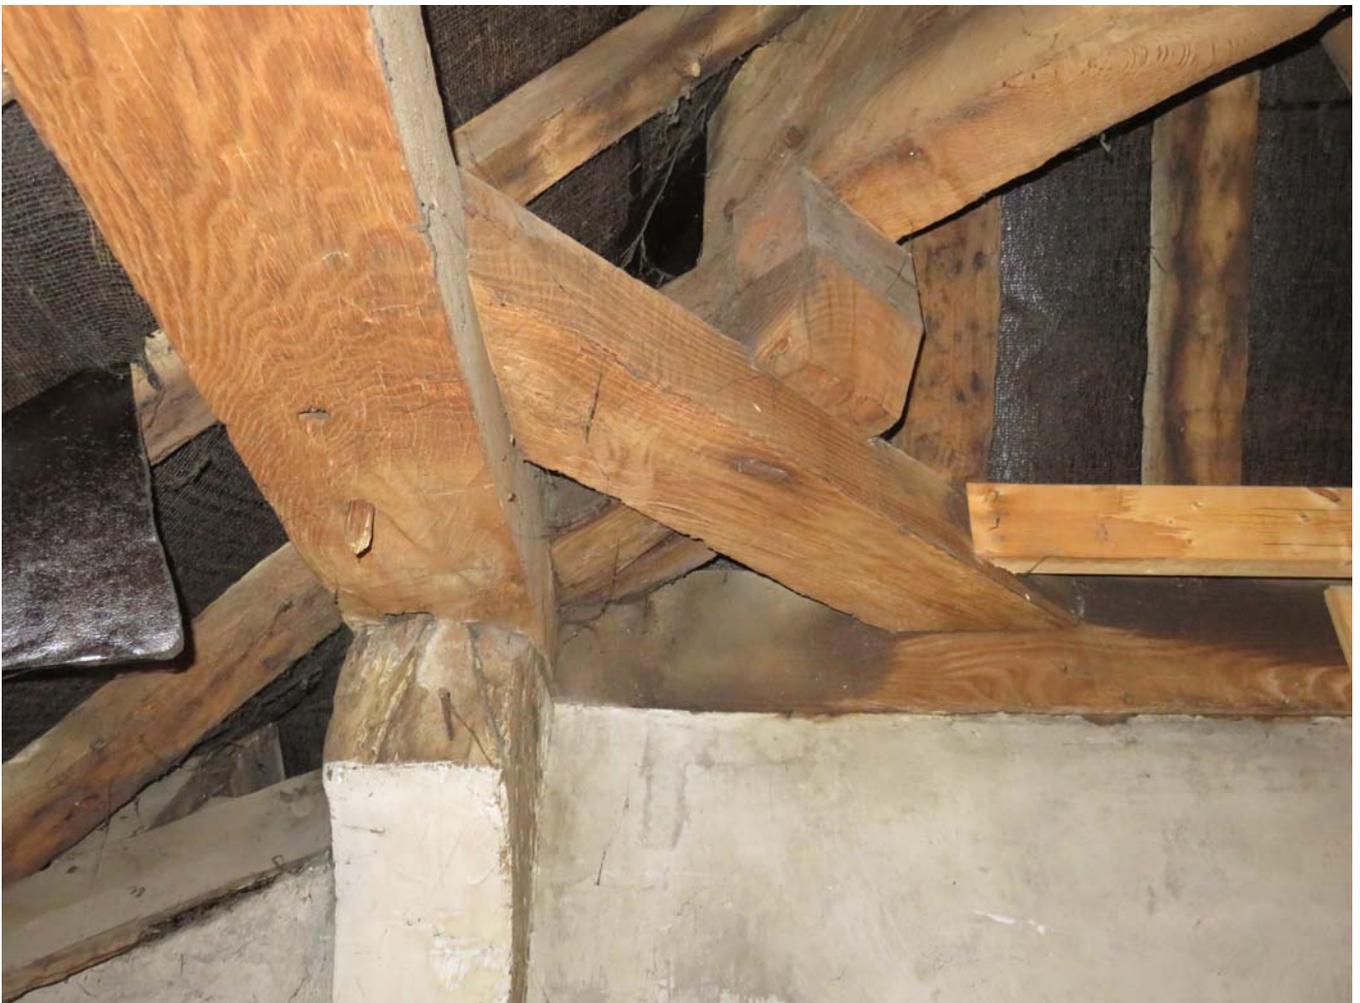
IMG\_6256

7. Going clockwise from the west at the foot of the ladder into the upper clock face chamber.
8. North south beam held on natural corbel on the wall panel, and corbel brackets above on diagonal beams, all good. (P6256).

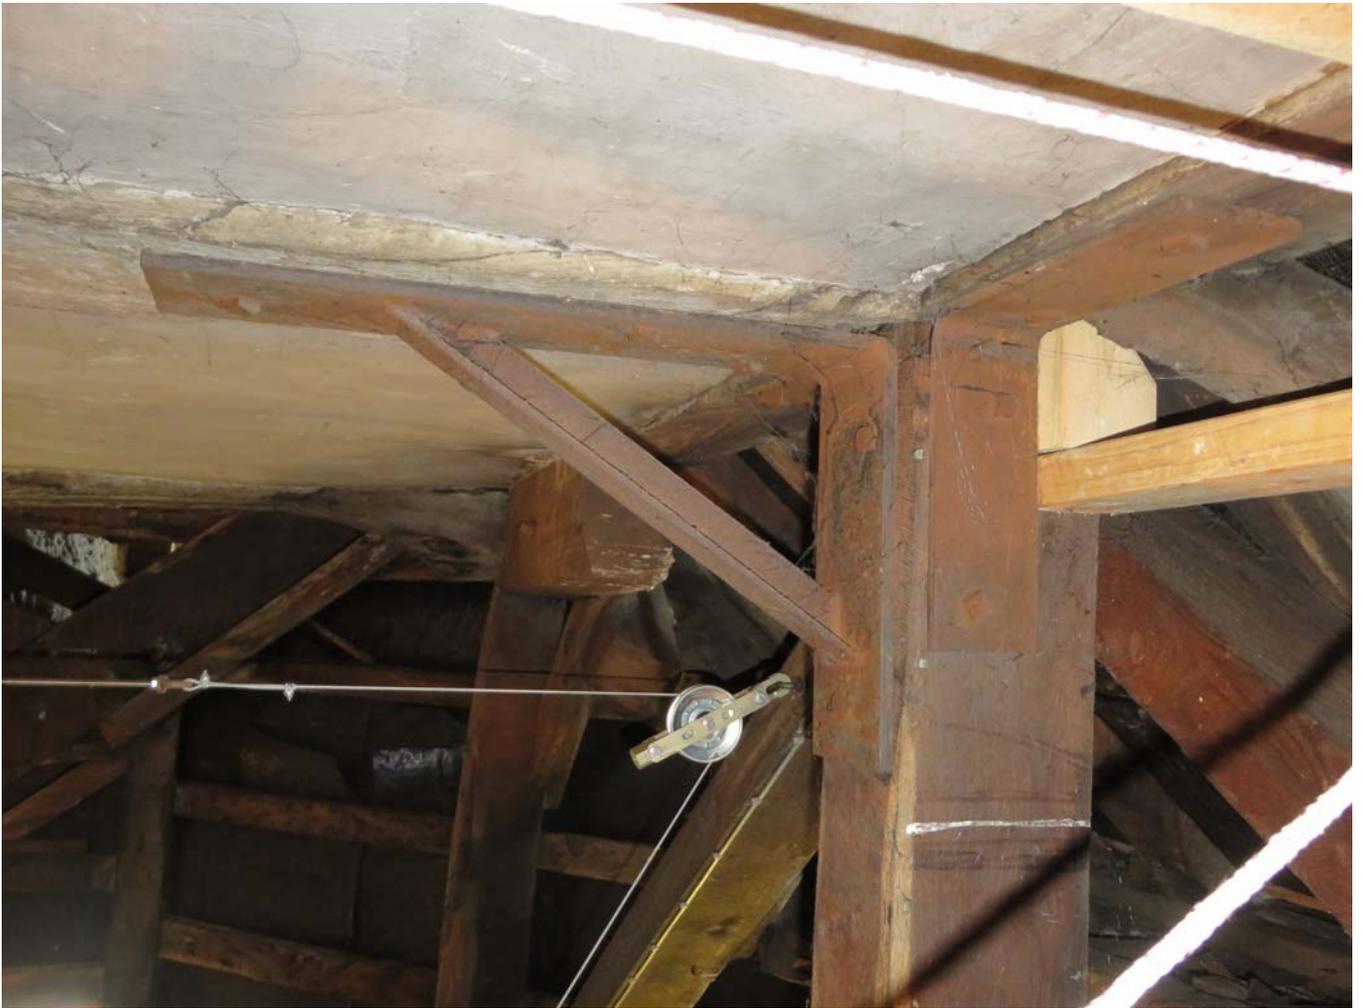
IMG\_6257

9. Mid length of the north and south sides, mild steel "gallows" brackets supporting a modern beam 200mm x 140mm. Clearly an addition to help support the room above, but in fair order. All the mild steel additions are unpainted have surface corrosion only which is perfectly acceptable. (P6257).

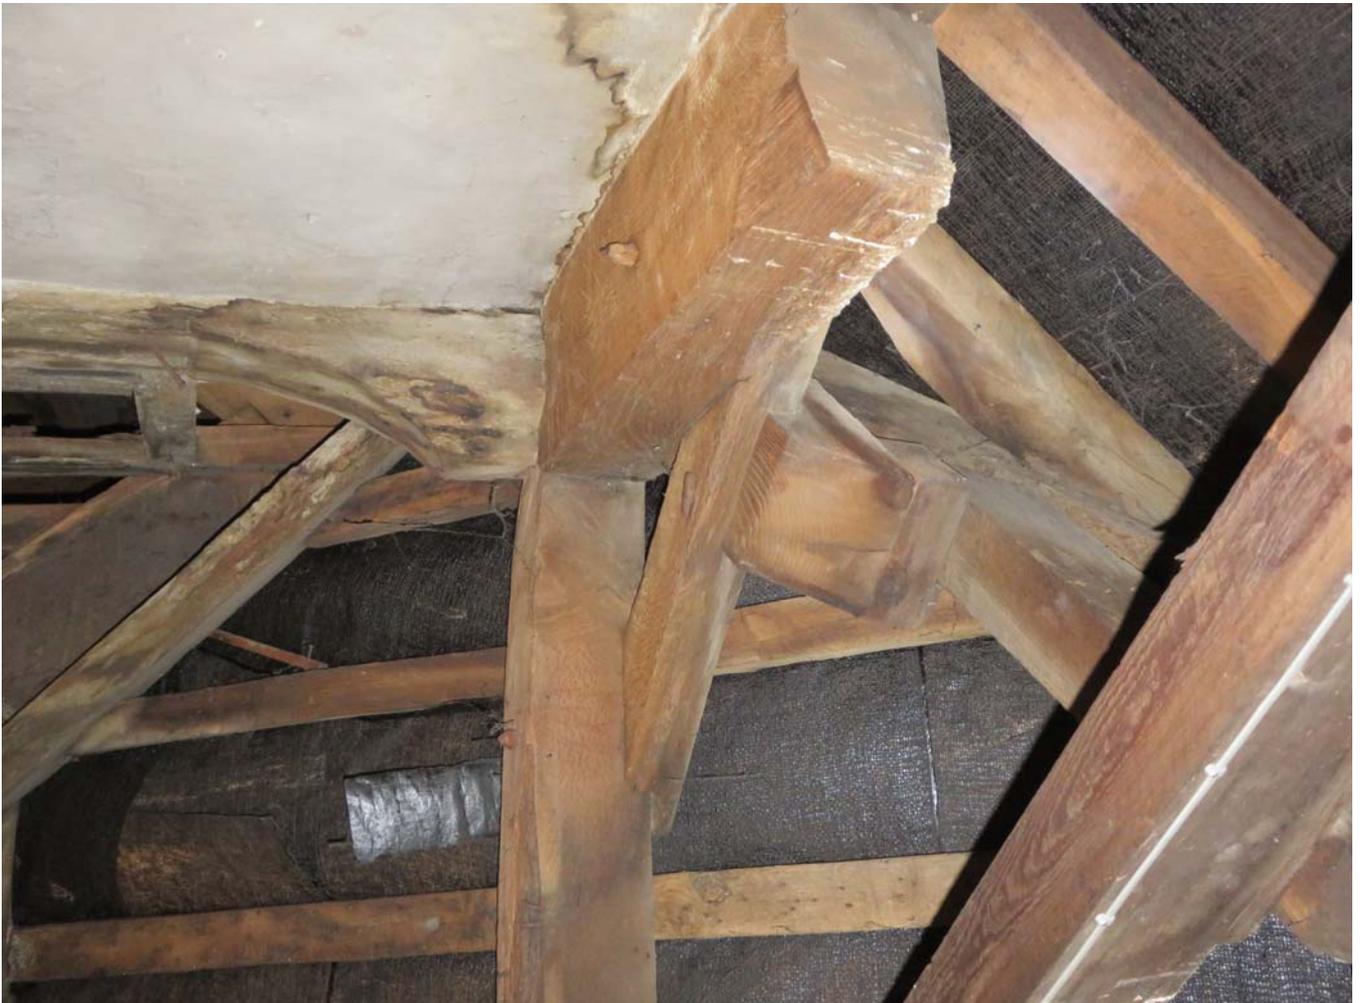
IMG\_6258

10. North east corner, again corbel bracket natural formation on the timber post supporting north south beam. (P6258).

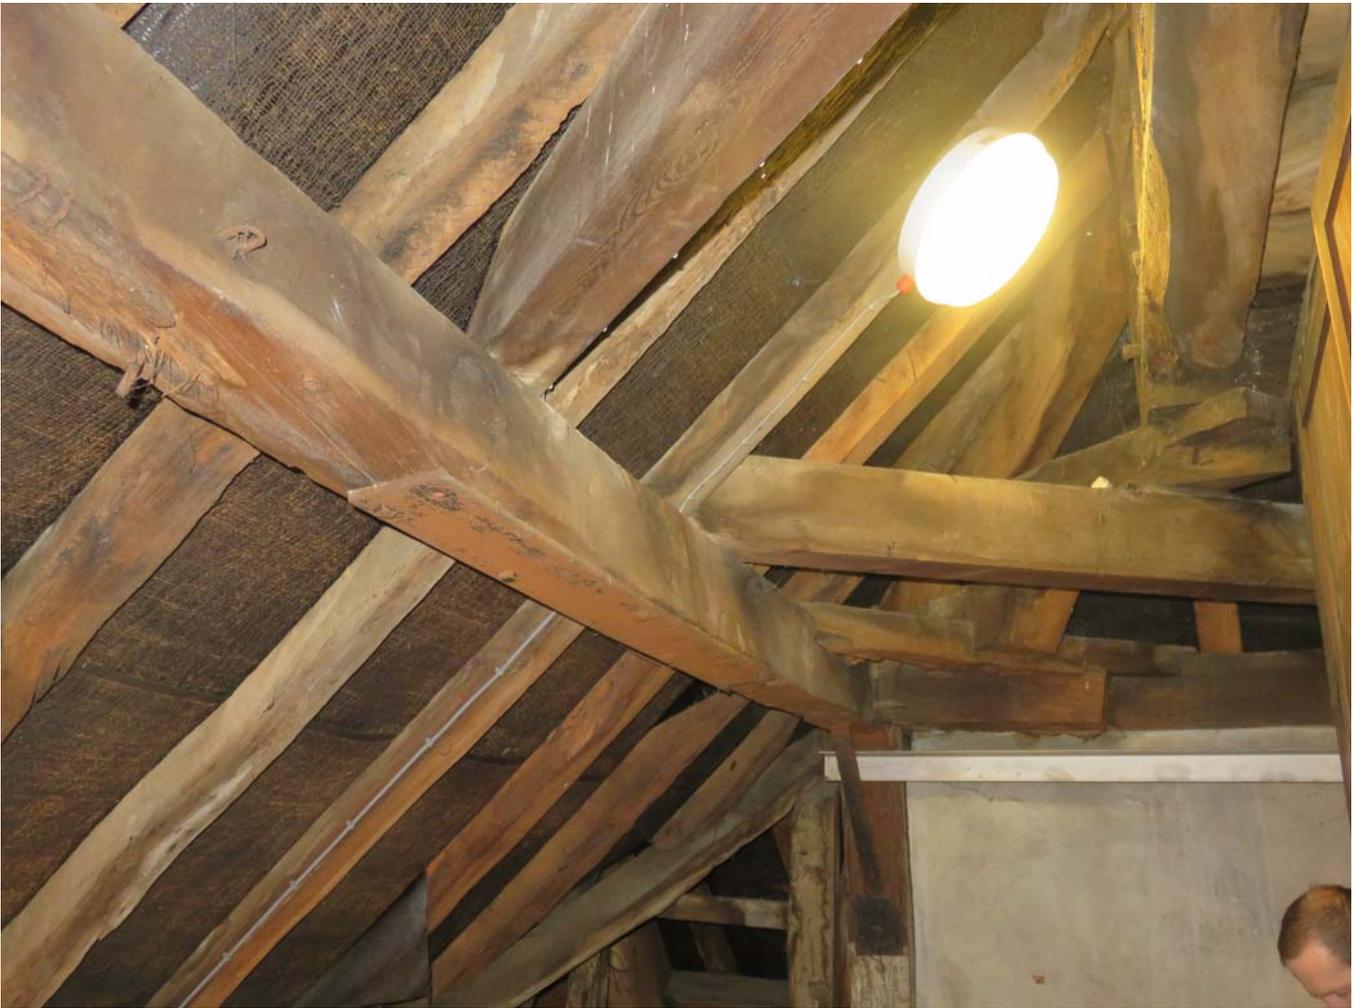
IMG\_6259

11. This beam has “shake” at mid length and is twisted slightly and an iron strengthening plate to the base looks as if it comes adrift, but in fact it is mostly due to the beam being distorted. (P6259).

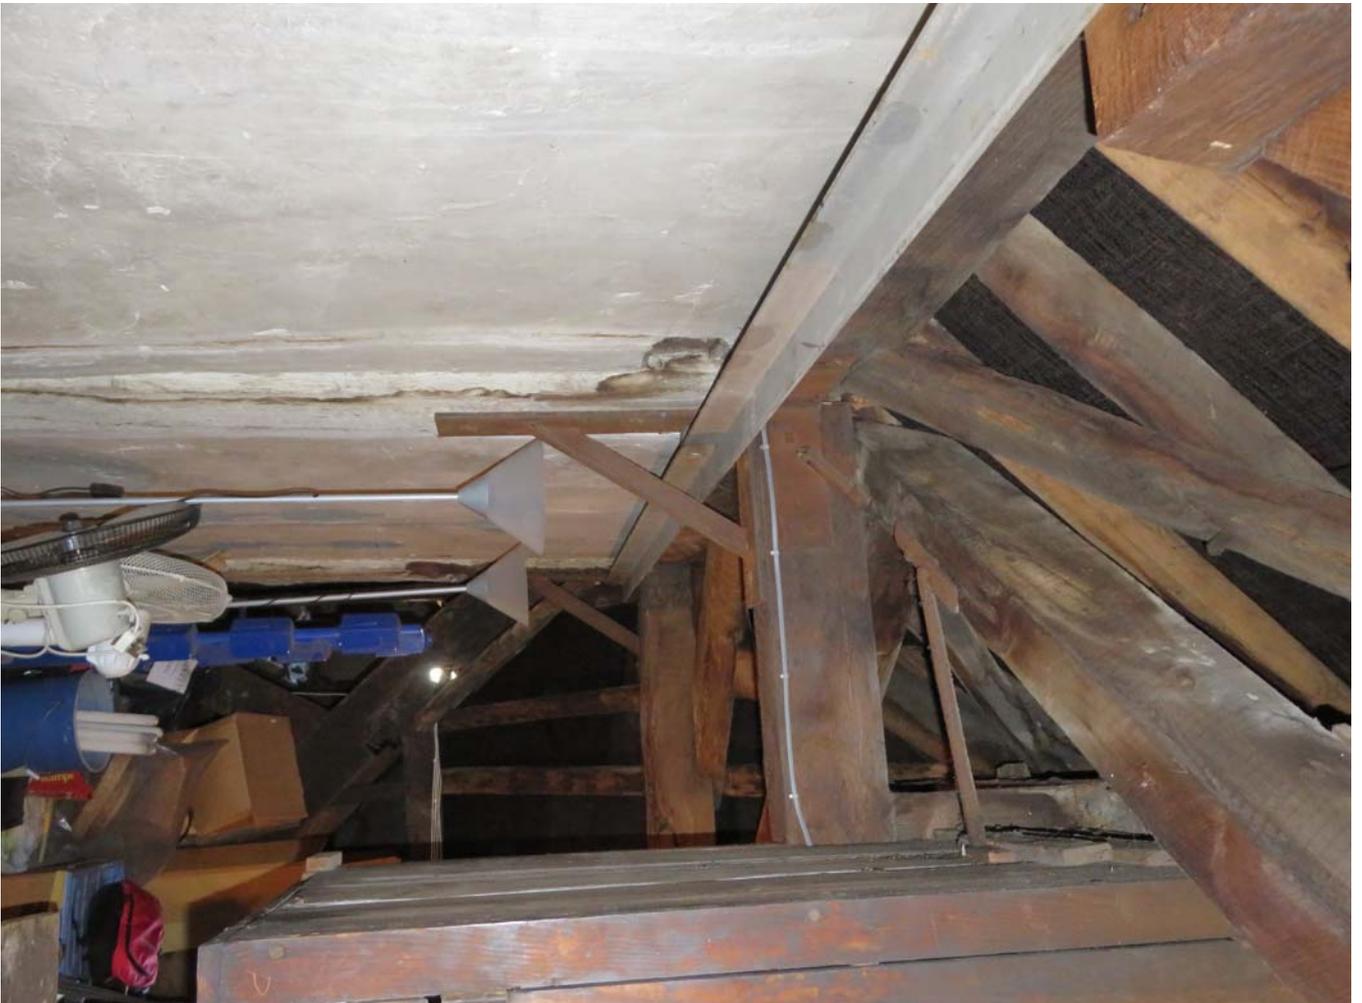
IMG\_6261

16. South face steel angle runs full length between the top of the “gallows” brackets presumably to provide some lateral tension, but would not in itself stop racking or distortion, since there is no diagonal brace or tie. (P6261).

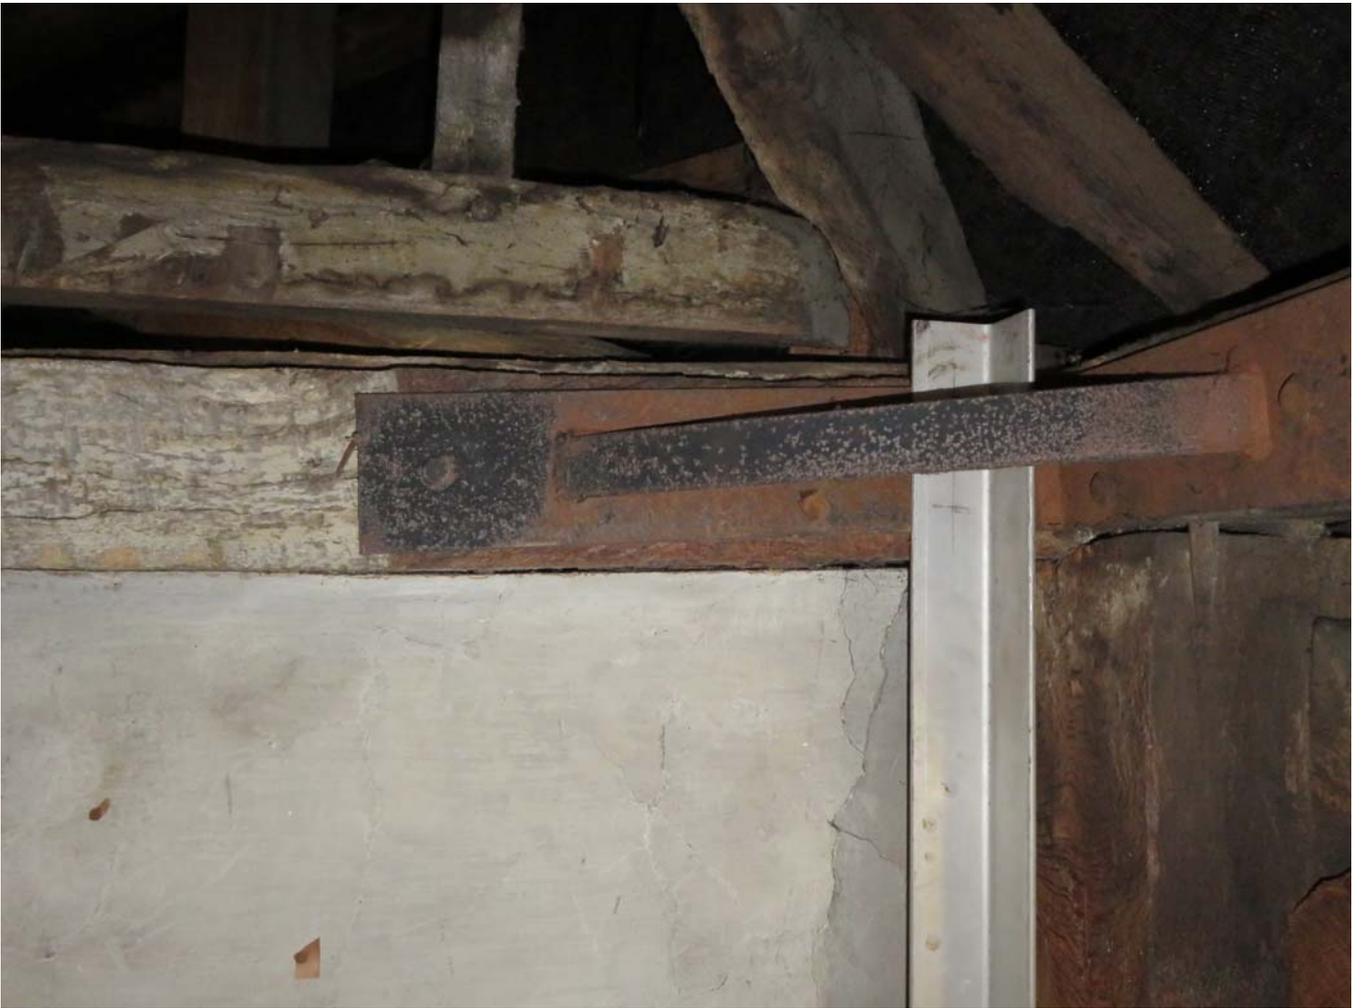
IMG\_6263

12. South east corner, again the steel “gallows” bracket distorted from the vertical, was positioned in this way presumably because the beam above is twisted. (P6263).

14. It would be perfectly reasonable simply to fill this crack see and see if it re-opens in the future.
15. Alternatively bracing could be added for example 100mm x 5mm mild steel flat fixed to the middle post at the base, and fixed to the mild steel “gallows” bracket using one of the existing bolts. (P6263).

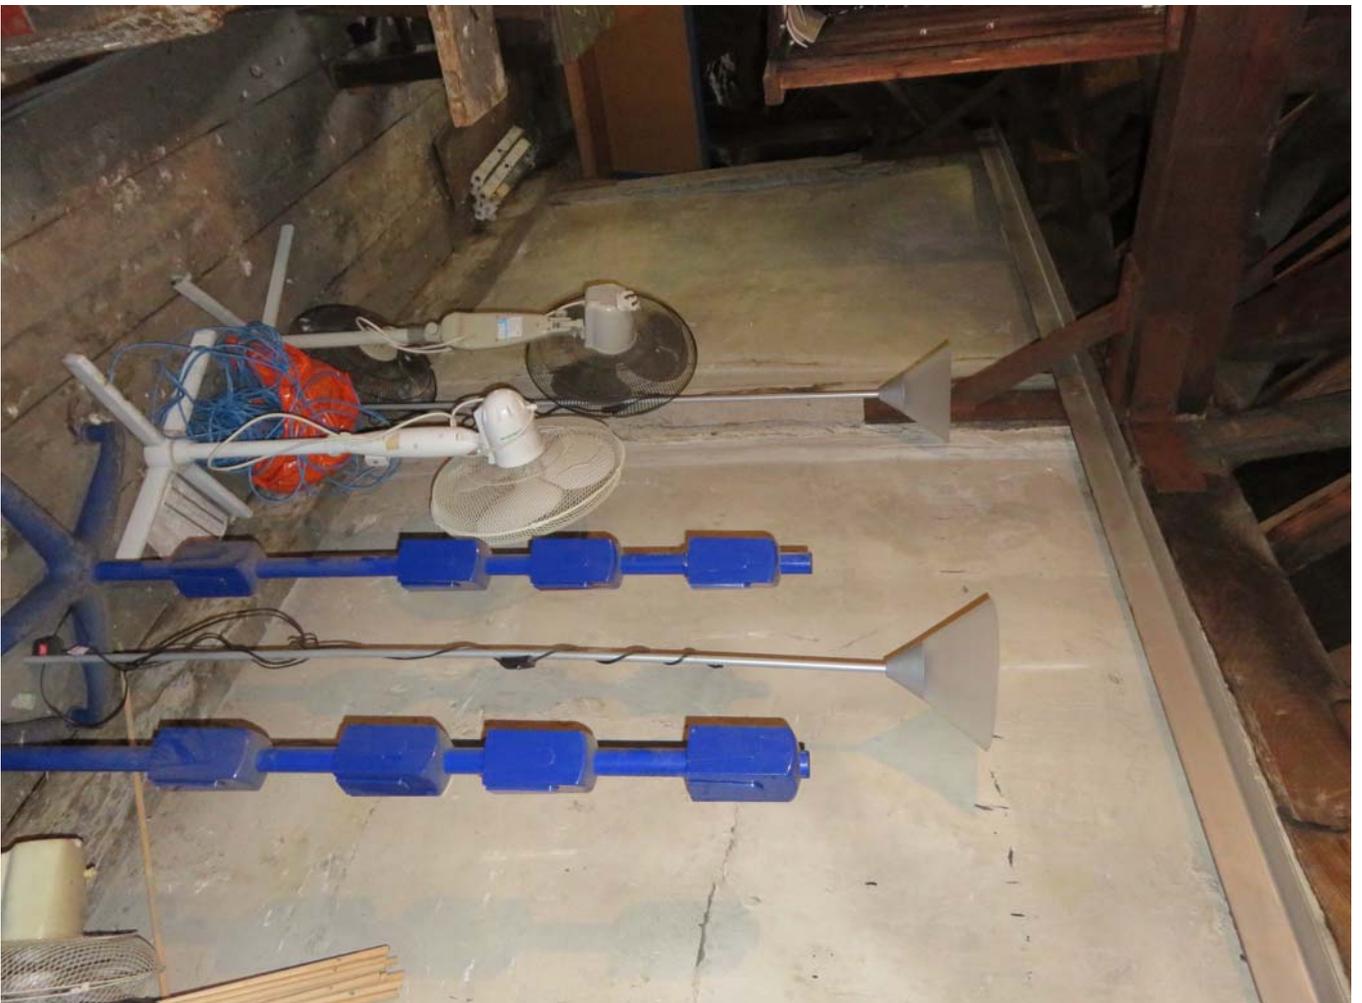
IMG\_6268

5. The upper turret held on a series of diagonal beams supported on timber posts around the sides of what was probably an original room lined out with lathe and plaster walling. (P6268).

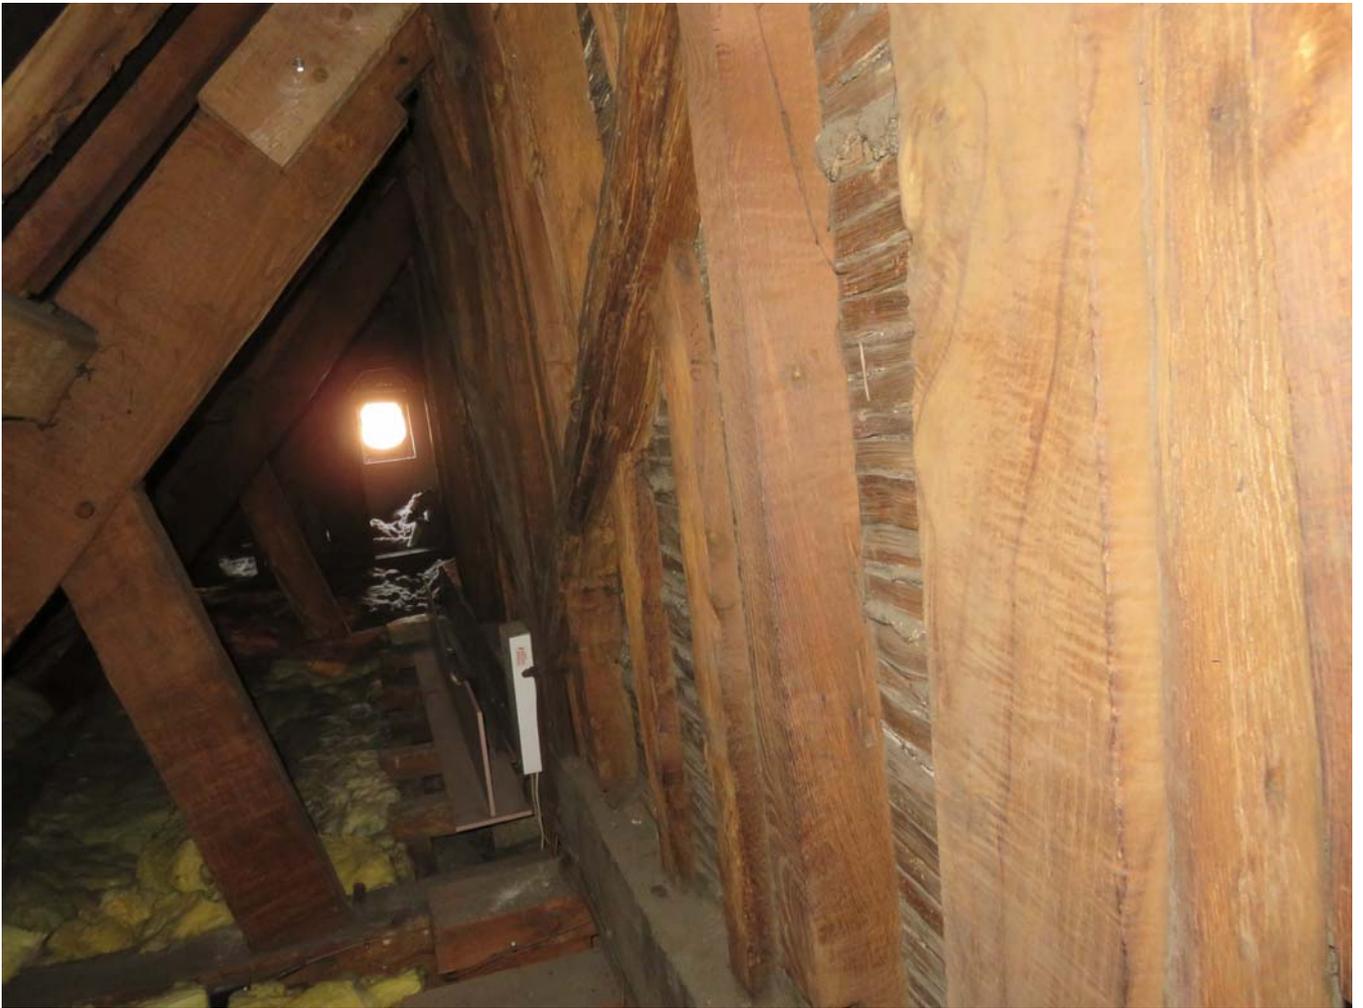
IMG\_6274

13. Cracking at the side of this post increasing in height from nothing to about 3mm suggesting perhaps a tendency of the south wall to distort to the east. This movement is slight and the wall is braced by timber framing on the back face. (P6274).
