2.0. Asbestos Survey Summary Table

North Wales Fire & Rescue Service

Site Name: Tywyn Fire Station, Frankwell Street, Tywyn, Gwynedd, LL36 9EW

Information based upon D.M.W. Survey P25915 Survey Date 31st January 2007.

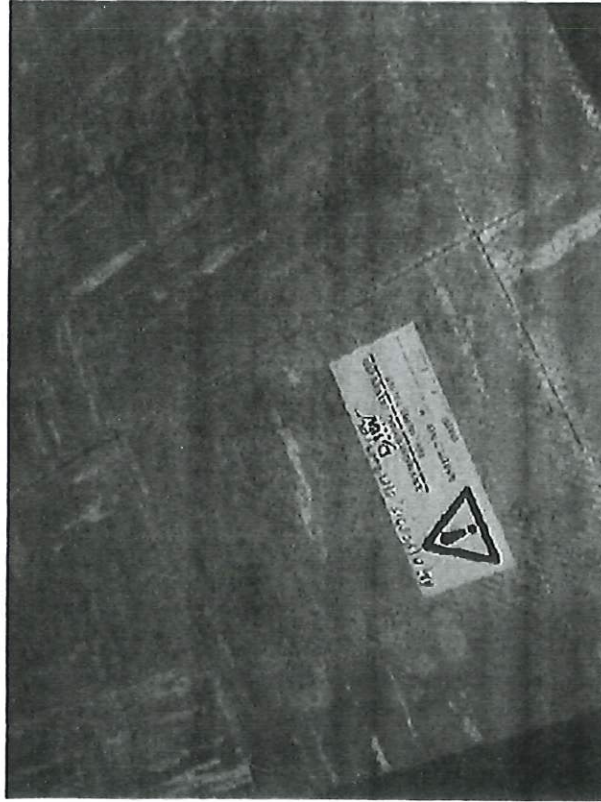
Site ID	Location ID	Building	Floor	Room / Area	Description	Lab Certificate Number
W21	P25915/01	Main	Ground	G02	Blue floor tiles below carpet tiles & adhesive	P25915

Material Assessment	Asbestos Type	Product Type	Amount	Extent of Damage	Surface Treatment	Material Assessment
	Chrysotile (White)	Floor Tile	< 14 Sq M	Low Damage: a few scratches or surface marks	Sealed Composite Materials	
Score	1	1	-	1	0	3
Priority Score	Occupancy Activity Score		Human Exposure Score		Maintenance Activity Score	Priority Assessment Score
	1		2		1	
Score	1		2		1	6

Comments: The material was seen to be in good condition at the time of the initial inspection.

Due to the nature of this composite material, asbestos is tightly bound within the dense substrate, posing a lower risk of respirable fibre release. However work with this material should still be conducted in compliance with the Control of Asbestos Regulations (CAR) 2006.

Recommendations: The condition of the material should be monitored by a competent person/company and its presence made aware to those at risk, as part of a Control of Asbestos Regulations (CAR) 2006 compliant management strategy.

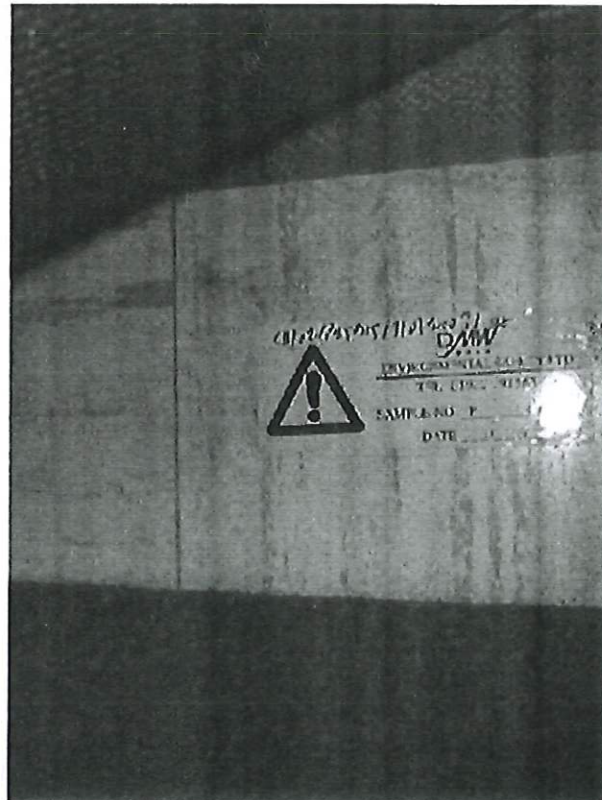
Site ID	Location ID	Building	Floor	Room / Area	Description	Lab Certificate Number
W21	P25915/02	Main	Ground	G04	Beige & red floor tiles below carpet tiles & adhesive	P25915

Material Assessment	Asbestos Type	Product Type	Amount	Extent of Damage	Surface Treatment	Material Assessment
Score	1	1	< 70 Sq M	Low Damage: a few scratches or surface marks	Sealed Composite Materials	3

Comments: The material was seen to be in good condition at the time of the initial inspection. Due to the nature of this composite material, asbestos is tightly bound within the dense substrate, posing a lower risk of respirable fibre release. However work with this material should still be conducted in compliance with the Control of Asbestos Regulations (CAR) 2006.

Recommendations: The condition of the material should be monitored by a competent person/company and its presence made aware to those at risk, as part of a Control of Asbestos Regulations (CAR) 2006 compliant management strategy.

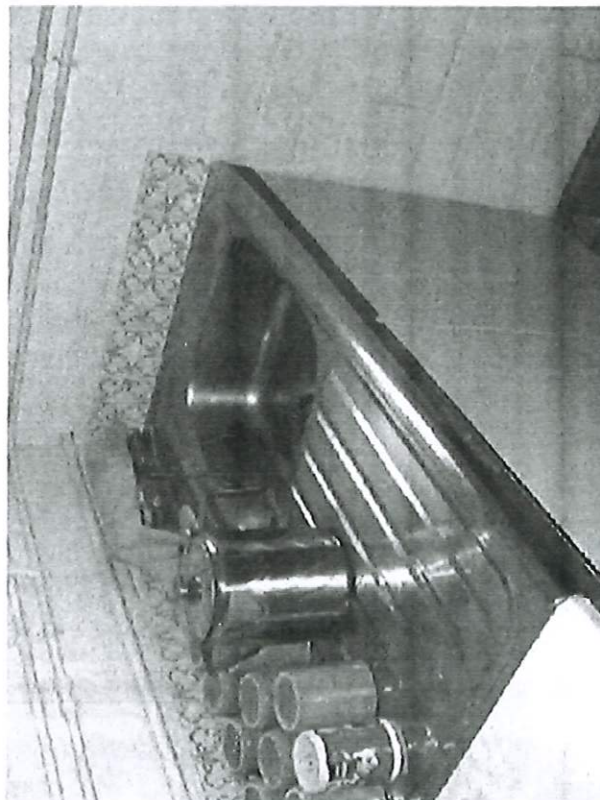
Site ID	Location ID	Building	Floor	Room / Area	Description	Lab Certificate Number
W21	P25915/03	Main	Ground	G05	Bitumen sink & drainer pad	P25915

Material Assessment	Asbestos Type	Product Type	Amount	Extent of Damage	Surface Treatment	Material Assessment
Score	1	1	< 1 Sq M	Good condition: No visible damage	Sealed Composite Materials	2

Comments: The material was seen to be in good condition at the time of the initial inspection. Due to the nature of this composite material, asbestos is tightly bound within the dense substrate, posing a lower risk of respirable fibre release. However work with this material should still be conducted in compliance with the Control of Asbestos Regulations (CAR) 2006.

Recommendations: The condition of the material should be monitored by a competent person/company and its presence made aware to those at risk, as part of a Control of Asbestos Regulations (CAR) 2006 compliant management strategy.

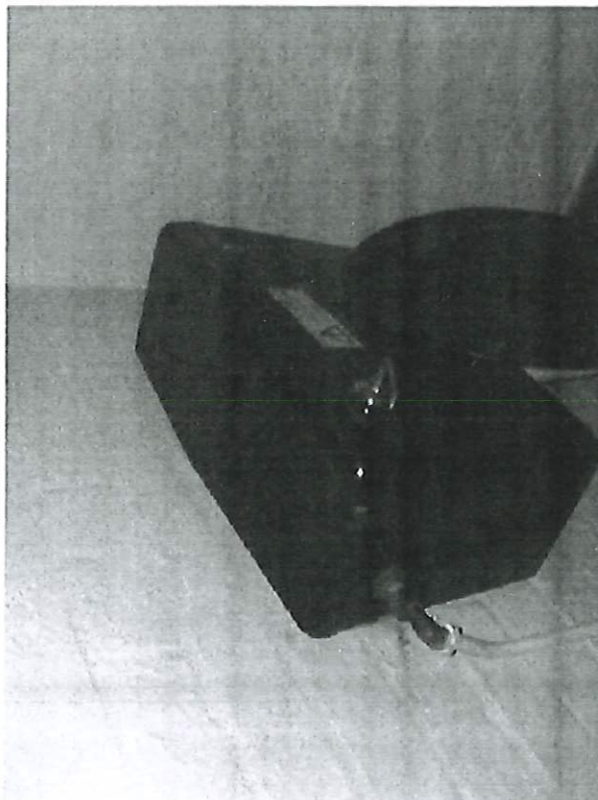
Site ID	Location ID	Building	Floor	Room / Area	Description	Lab Certificate Number
W21	P25915/04	Main	Ground	G06	Reinforced resin toilet cistem	P25915

Material Assessment	Asbestos Type	Product Type	Amount	Extent of Damage	Surface Treatment	Material Assessment
	Amphibole Asbestos Excluding Crocidolite	Reinforced Resin	< 1 Sq M	Good condition: No visible damage	Sealed Composite Materials	
Score	2		-	0	0	4

Comments: The material was seen to be in good condition at the time of the initial inspection. Due to the nature of this composite material, asbestos is tightly bound within the dense substrate, posing a lower risk of respirable fibre release. However work with this material should still be conducted in compliance with the Control of Asbestos Regulations (CAR) 2006.

Recommendations: The condition of the material should be monitored by a competent person/company and its presence made aware to those at risk, as part of a Control of Asbestos Regulations (CAR) 2006 compliant management strategy.

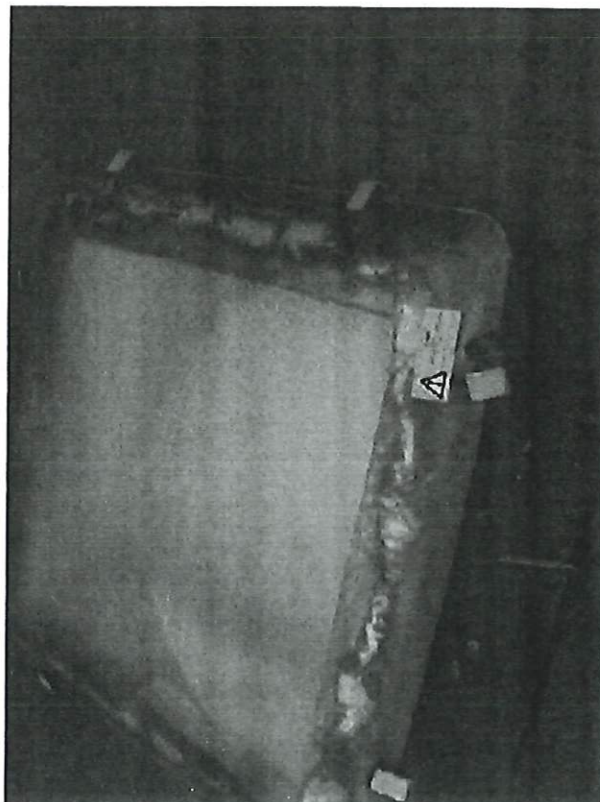
Site ID	Location ID	Building	Floor	Room / Area	Description	Lab Certificate Number
W21	P25915/05	Main	Ground	EX01	Rope seals to metal latches on skylight covers	P25915

Material Assessment	Asbestos Type	Product Type	Amount	Extent of Damage	Surface Treatment	Material Assessment
Score	Chrysotile (White)	Woven Fabric	< 1 Sq M	Low Damage: a few scratches or surface marks	Unsealed Non-Composite Materials	
1		2		1	3	7

Comments: The material was seen to be in fair condition at the time of the initial inspection.

Recommendations: The condition of the material should be monitored by a competent person/company and its presence made aware to those at risk, as part of a Control of Asbestos Regulations (CAR) 2006 compliant management strategy.

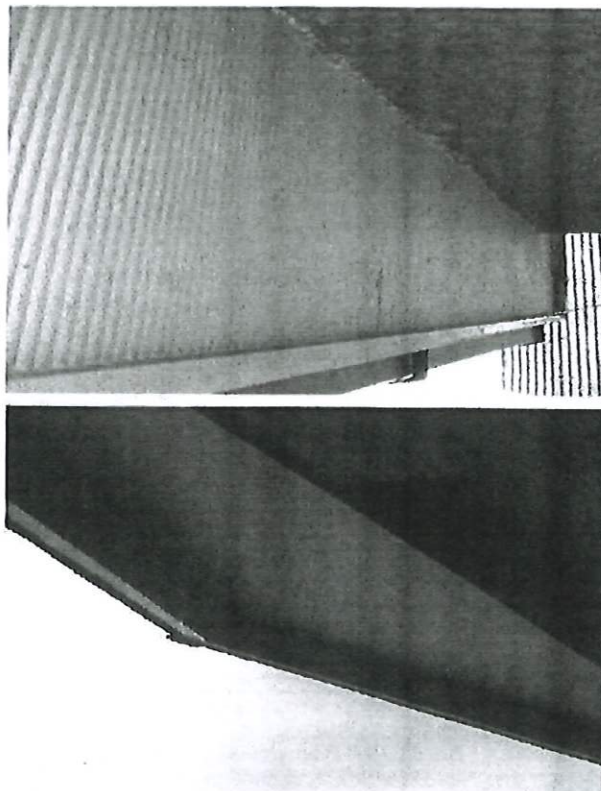
Site ID	Location ID	Building	Floor	Room / Area	Description	Lab Certificate Number
W21	P25915/06	Main	Ground	EX01	Cement soffits - high level only front fascias to appliance bay	P25915
Last Inspection Date	Next Inspection Date	Survey Type	Source of Info	HSE Notifiable	Action Assessment	
31 Jan 2007	31 Jan 2008	Type 2 (MDHS 100)	Dave Cox	No	Manage and label	
Material Assessment	Asbestos Type	Product Type	Amount	Extent of Damage	Surface Treatment	Material Assessment
Score	Chrysotile (White)	Cement	< 100 Sq M	Good condition: No visible damage	Sealed Composite Materials	
1	1		-	0	0	2
Priority Score	Occupancy Activity Score	Disturbance Likelihood Score	Human Exposure Score	Maintenance Activity Score	Priority Assessment Score	
Score	0	1	0	1	2

Comments: The material was seen to be in good condition at the time of the initial inspection.

Recommendations: The condition of the material should be monitored by a competent person/company and its presence made aware to those at risk, as part of a Control of Asbestos Regulations (CAR) 2006 compliant management strategy.

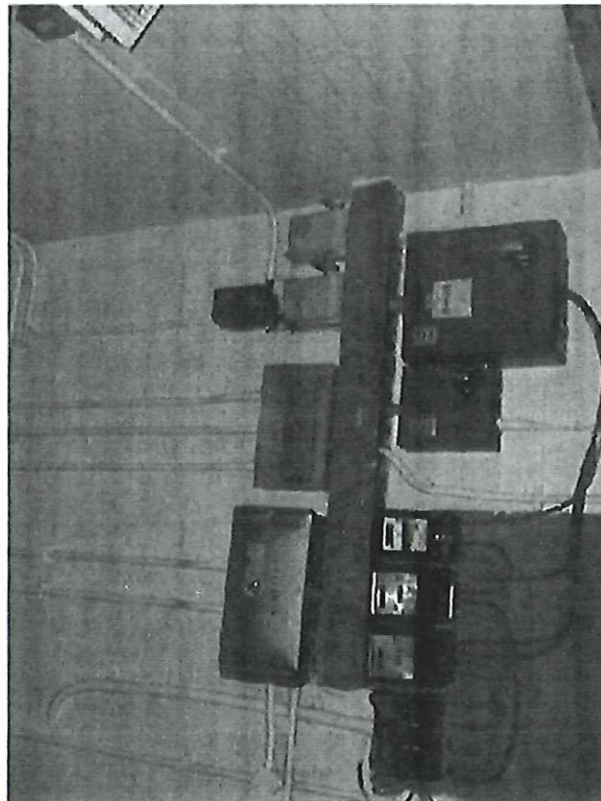
Site ID	Location ID	Building	Floor	Room / Area	Description	Lab Certificate Number
W21	Presumed 01	Main	Ground	G09	Flash pads within live electrics	P25915

Material Assessment	Asbestos Type	Product Type	Amount	Extent of Damage	Surface Treatment	Material Assessment
Score	Presumed To Contain Asbestos	Flash pads	< 1 Sq M	Good condition: No visible damage	Unsealed Non-Composite Materials	
0	2	-	0	3		5

Comments: It has been noted in previous experience that this type of material has been known to contain asbestos.

Recommendations: Until such time as proven otherwise, the material should be labelled as an asbestos containing product and should be subject to management involving regular inspection.
