## Buildings on the Corner of Station Road and Blyth Road, Southwold, Suffolk

### Demolition Specification

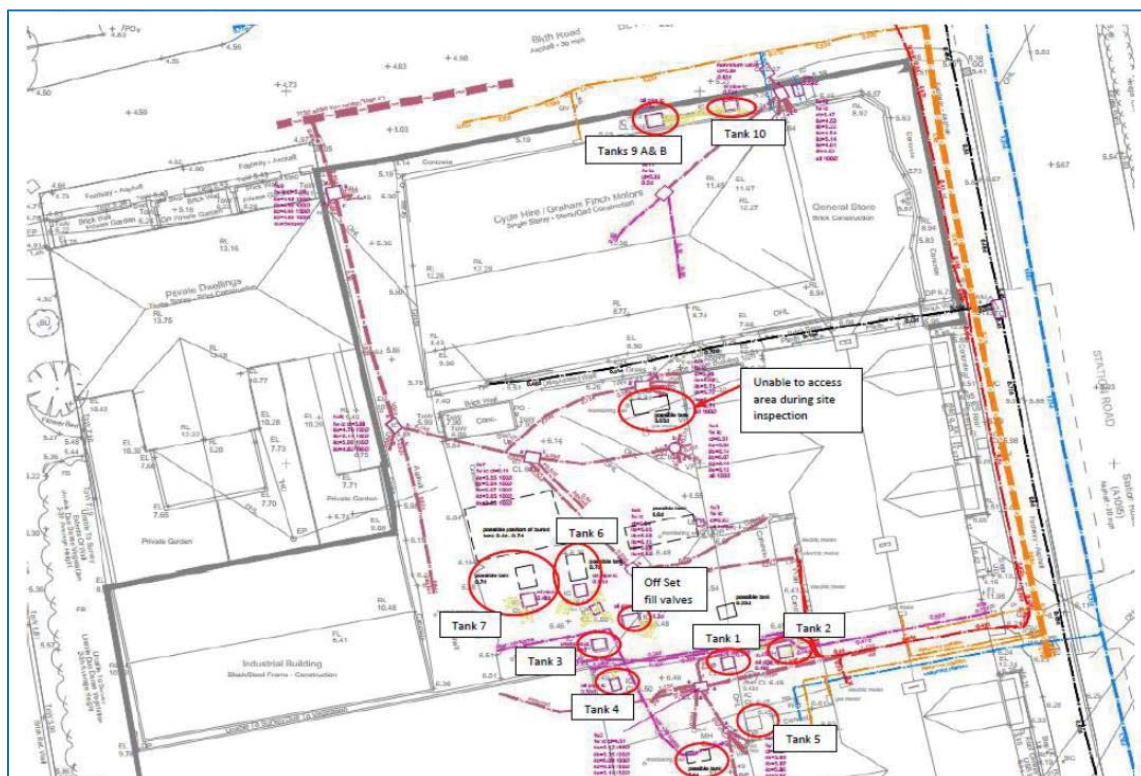
Figure 7 - Extract from JP Chick Structural Report

- 6.05 There are foul and surface water drains on site. These will need to be isolated and protected during demolition to prevent them being damaged/blocked by demolition arisings.
- 6.06 Due to the historic use of the site, there are several vehicle inspection pits which must not be left open during the demolition process. Where excavations cannot be backfilled immediately, the Principal Contractor must ensure that all excavations are securely protected.
- 6.07 There are a number of disused underground petrol tanks within the yard area. We believe there may be further tanks in front of the unit 2 and 3 see figure 7 below.

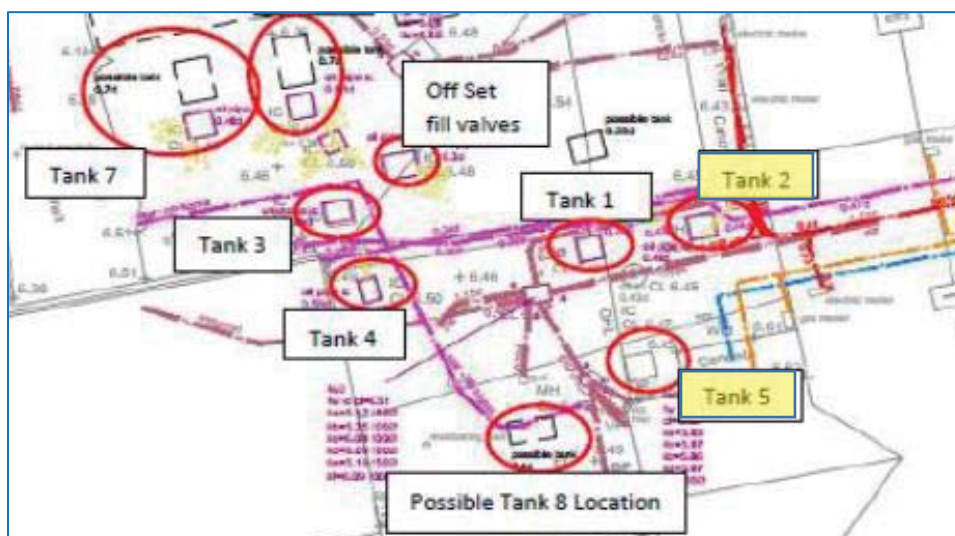
- 13.14 Due to their proximity to existing foundations, it may not be possible to remove tanks 2 and 5 highlighted below these will require further investigation.

- 13.15 If after investigation it is possible to remove the tanks safely, this should be undertaken in consultation with a structural engineer appointed by the Client, to agree any required temporary works.
- 13.16 Further investigation will be required for tanks 9 A&B and 10 due to their proximity to the highway shown in figure below.

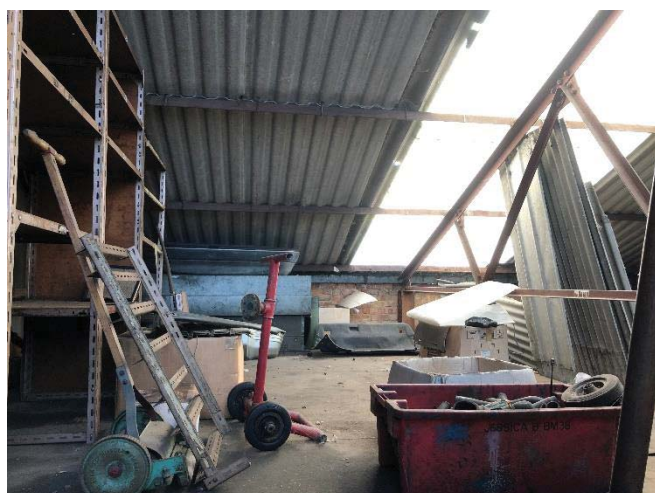
Photograph 33 - Mezzanine Floor of Unit 5 Extension with Loose Sheets of Asbestos

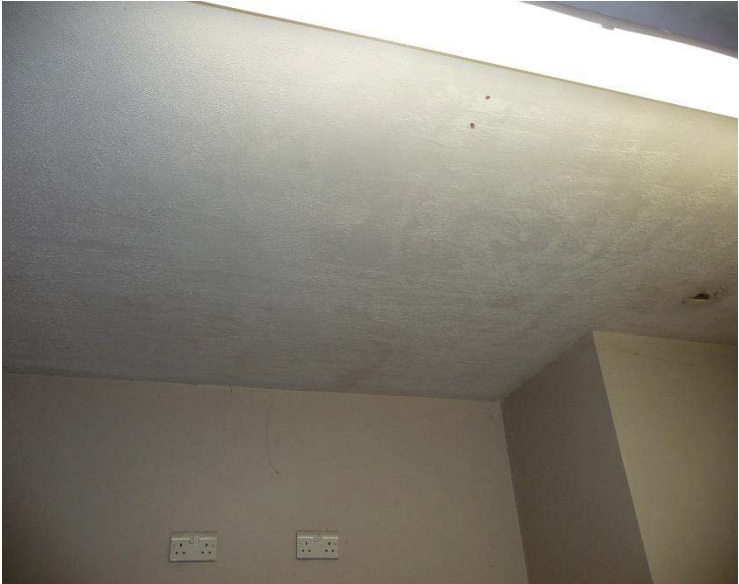
MATERIAL ASSESSMENT / SAMPLE IDENTIFICATION REPORT		
SAMPLE INFORMATION		PHOTOGRAPH
Sample Ref	AR3/1

Sample Date	11/12/2020	
Building	Clancys	
Area Ref/Location	Main shop	
Level	Ground	
Approx. Measurement	12 Square Meters	
Material	Texture Coating	
Position	Ceiling	
Description	Painted textured ceiling to part of the main shop ceiling	
ASSESSMENT OF RISK		
Product Type	Non Asbestos Textured Coating	0
Extent Of Damage	0 - Not Applicable	0
Surface Treatment	0 - Not Applicable	0
Asbestos Type	0 - No Asbestos Detected in Sample	0
Accessibility	0 - Not Applicable	0
RISK SCORE		
PRIORITY SCORE		
Action Required / Control Recommendation	None Required	
DATE IDENTIFIED ASBESTOS WAS REMOVED (If Applicable)

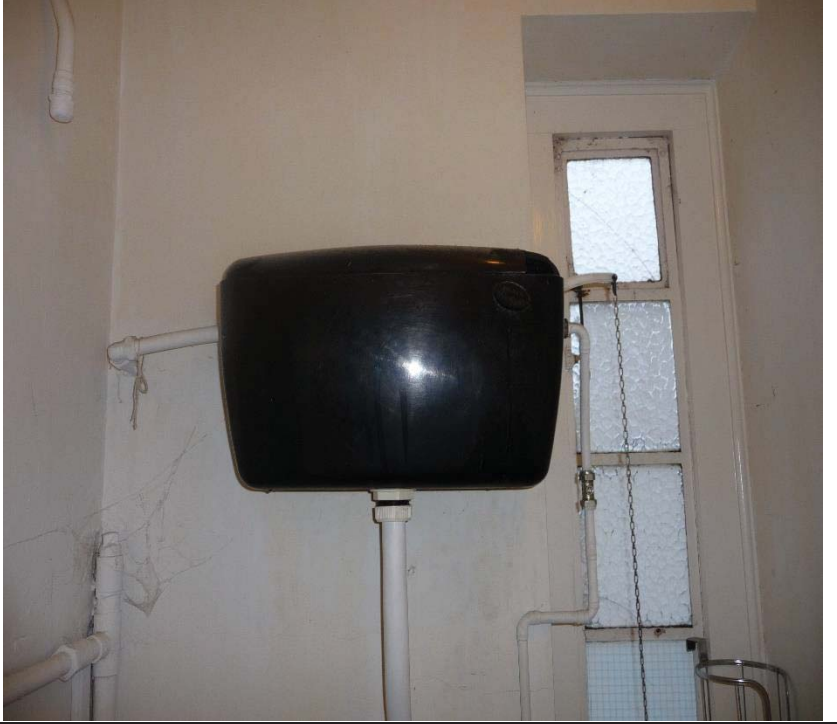
SAMPLE INFORMATION		PHOTOGRAPH
Sample Ref	AR5/2

Sample Date	11/12/2020	
Building	Clancys	
Area Ref/Location	Toilet	
Level	Ground	
Approx. Measurement	Less than 1 Square Meters	
Material	Asbestos composite	
Position	Toilet System	
Description	Black toilet system on toilet wall	
ASSESSMENT OF RISK		
Product Type	Type 1 - Asbestos Reinforced Plastic	1
Extent Of Damage	0 - Good Condition	0
Surface Treatment	0 - Sealed (Composite Material)	0
Asbestos Type	2 - Amosite	2
Accessibility	1 - Occasionally Disturbed	1
RISK SCORE		4
PRIORITY SCORE		Very low potential to release fibres
Action Required / Control Recommendation	Material Removal Remove by an asbestos contractor prior to demolition	
DATE IDENTIFIED ASBESTOS WAS REMOVED (If Applicable)

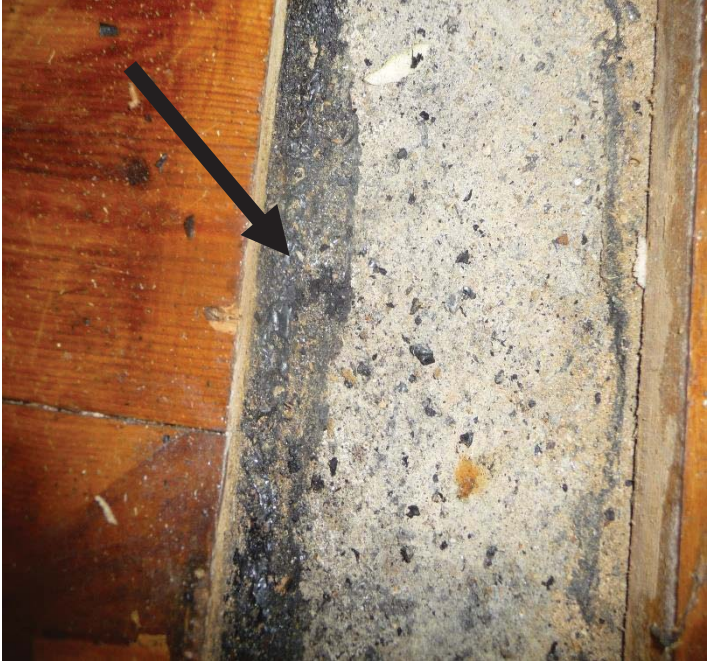
MATERIAL ASSESSMENT / SAMPLE IDENTIFICATION REPORT		
SAMPLE INFORMATION		PHOTOGRAPH
Sample Ref	AR6/3

Sample Date	11/12/2020	
Building	Clancey	
Area Ref/Location	Main shop	
Level	Ground	
Approx. Measurement	12 square meters	
Material	Bitumen glue	
Position	Under wooden floorboards	
Description	Bitumen glue under the wooden floorboards to main shop	
ASSESSMENT OF RISK		
Product Type	Non Asbestos Textured Coating	0
Extent Of Damage	0 - Not Applicable	0
Surface Treatment	0 - Not Applicable	0
Asbestos Type	0 - No Asbestos Detected in Sample	0
Accessibility	0 - Not Applicable	0
		RISK SCORE
		PRIORITY SCORE
Action Required / Control Recommendation	None Required	
DATE IDENTIFIED ASBESTOS WAS REMOVED (If Applicable)

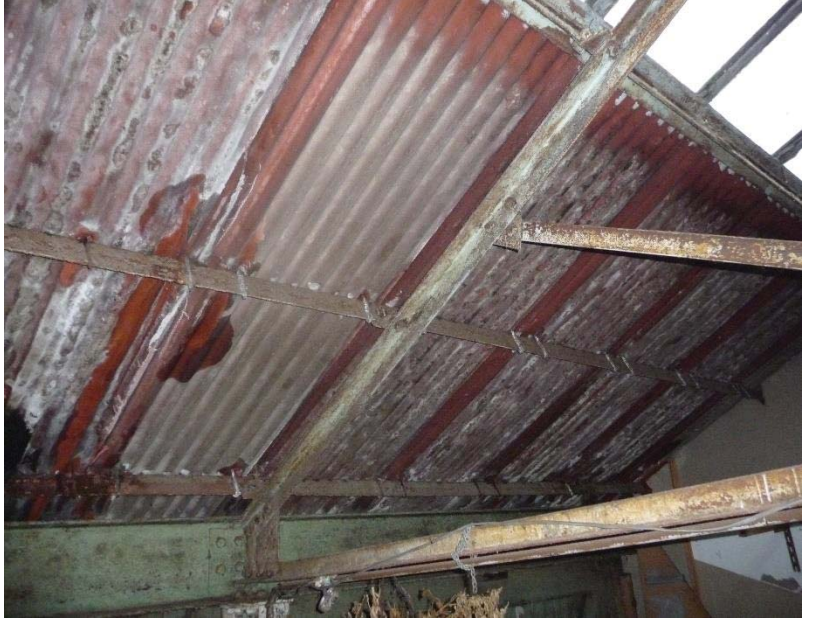
MATERIAL ASSESSMENT / SAMPLE IDENTIFICATION REPORT		
SAMPLE INFORMATION		PHOTOGRAPH
Sample Ref	AR8/4

Sample Date	11/12/2020	
Building	Cycle Shop	
Area Ref/Location	Main roof	
Level	Roof	
Approx. Measurement	56 square Meters	
Material	Asbestos Cement Sheets	
Position	Main roof sheets	
Description	Corrugated roof sheets throughout the unit roof	
ASSESSMENT OF RISK		
Product Type	Type 1 - Asbestos Reinforced Cement	1
Extent Of Damage	1 - Low Damage	1
Surface Treatment	1 - Sealed (Encapsulated or Painted AIB, cement, Enclosed lagging or spray)	1
Asbestos Type	1 - Chrysotile	1
Accessibility	1 - Occasionally Disturbed	1
RISK SCORE		5
PRIORITY SCORE		Low potential to realise fibres
Action Required / Control Recommendation	Material Removal Remove by an asbestos contractor prior to demolition	
DATE IDENTIFIED ASBESTOS WAS REMOVED (If Applicable)

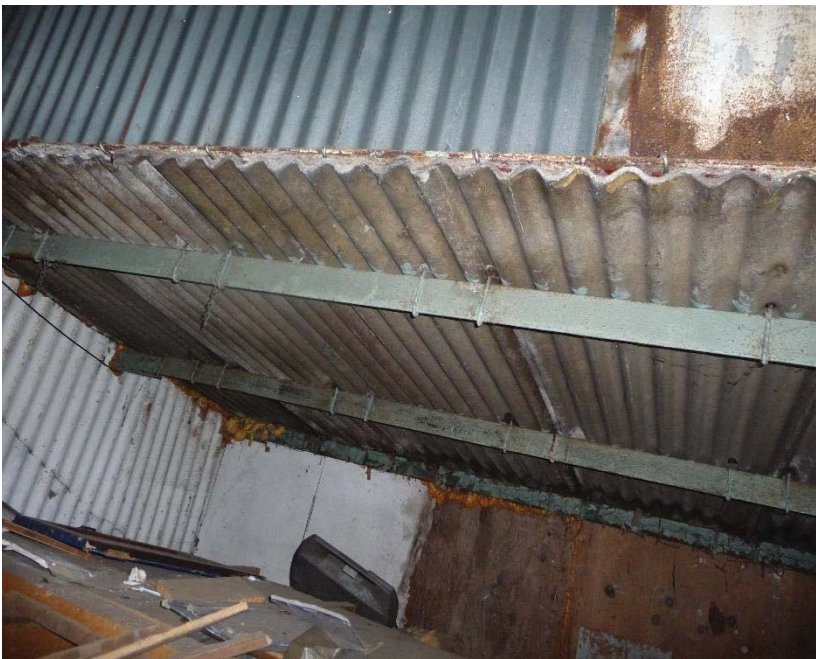
SAMPLE INFORMATION		PHOTOGRAPH
Sample Ref	AR9/5

Sample Date	11/12/2020	
Building	Cycle Shop	
Area Ref/Location	Main roof	
Level	Roof	
Approx. Measurement	10 square Meters	
Material	Asbestos Cement Sheets	
Position	Small lean too ceiling back of shop	
Description	Corrugated roof sheets to the back of the shop mezz floor small lean too	
ASSESSMENT OF RISK		
Product Type	Type 1 - Asbestos Reinforced Cement	1
Extent Of Damage	1 - Low Damage	1
Surface Treatment	1 - Sealed (Encapsulated or Painted AIB, cement, Enclosed lagging or spray)	1
Asbestos Type	1 - Chrysotile	1
Accessibility	1 - Occasionally Disturbed	1
RISK SCORE		5
PRIORITY SCORE		Low potential to realise fibres
Action Required / Control Recommendation	Material Removal Remove by an asbestos contractor prior to demolition	
DATE IDENTIFIED ASBESTOS WAS REMOVED (If Applicable)

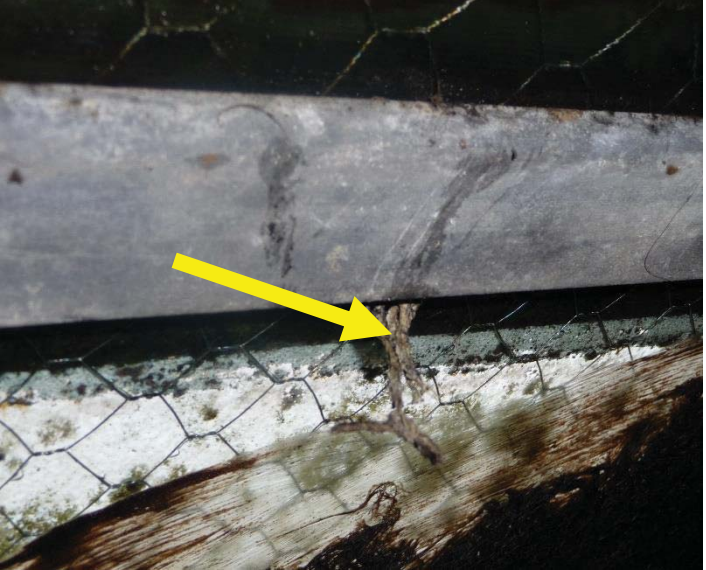
MATERIAL ASSESSMENT / SAMPLE IDENTIFICATION REPORT		
SAMPLE INFORMATION		PHOTOGRAPH
Sample Ref	AR10/6

Sample Date	11/12/2020	
Building	Cycle Shop	
Area Ref/Location	Main roof	
Level	Roof Skylights	
Approx. Measurement	9 Liner Meters	
Material	Asbestos Rope Gasket	
Position	Main glass skylights to main roof	
Description	Rope gaskets under the alloy trimming to the glass skylights	
ASSESSMENT OF RISK		
Product Type	Type 2 - Asbestos Gaskets/Washers/Strings	2
Extent Of Damage	1 - Low Damage	1
Surface Treatment	1 - Sealed (Encapsulated or Painted AIB, cement, Enclosed lagging or spray)	1
Asbestos Type	3 - Chrysotile/Amosite/Crocidolite	3
Accessibility	0 - Usually Inaccessible	1
RISK SCORE		
PRIORITY SCORE		Medium potential to release fibres.
Action Required / Control Recommendation	Material Removal Remove by an asbestos contractor prior to demolition	
DATE IDENTIFIED ASBESTOS WAS REMOVED (If Applicable)

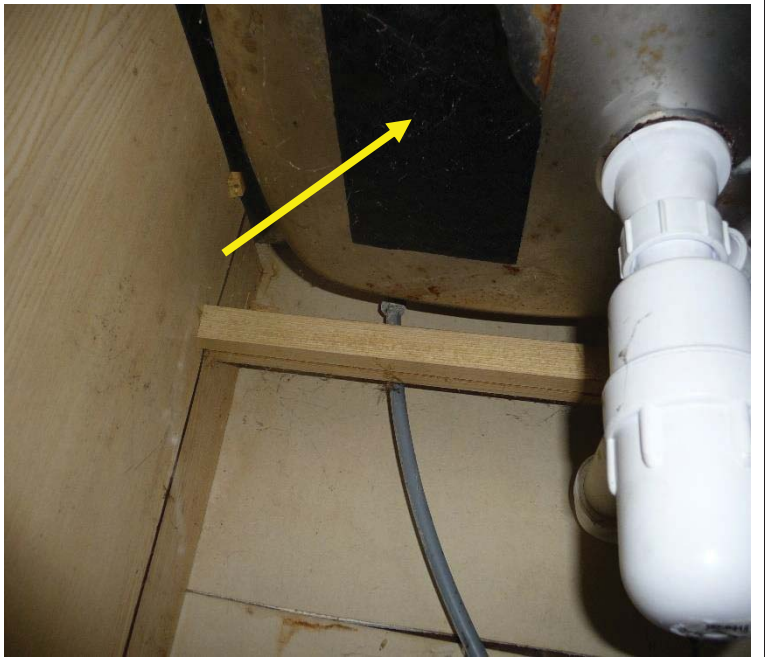
SAMPLE INFORMATION		PHOTOGRAPH
Sample Ref	AR12/8

Sample Date	11/12/2020	
Building	Cycle Shop	
Area Ref/Location	Main shop	
Level	Ground	
Approx. Measurement	Less than 1 square meter	
Material	Bitumen	
Position	Under metal sink	
Description	Bitumen pad under the metal sink	
ASSESSMENT OF RISK		
Product Type	Non Asbestos Textured Coating	0
Extent of Damage	0 - Not Applicable	0
Surface Treatment	0 - Not Applicable	0
Asbestos Type	0 - No Asbestos Detected in Sample	0
Accessibility	0 - Not Applicable	0
RISK SCORE		
PRIORITY SCORE		
Action Required / Control Recommendation	None Required	
DATE IDENTIFIED ASBESTOS WAS REMOVED (If Applicable)

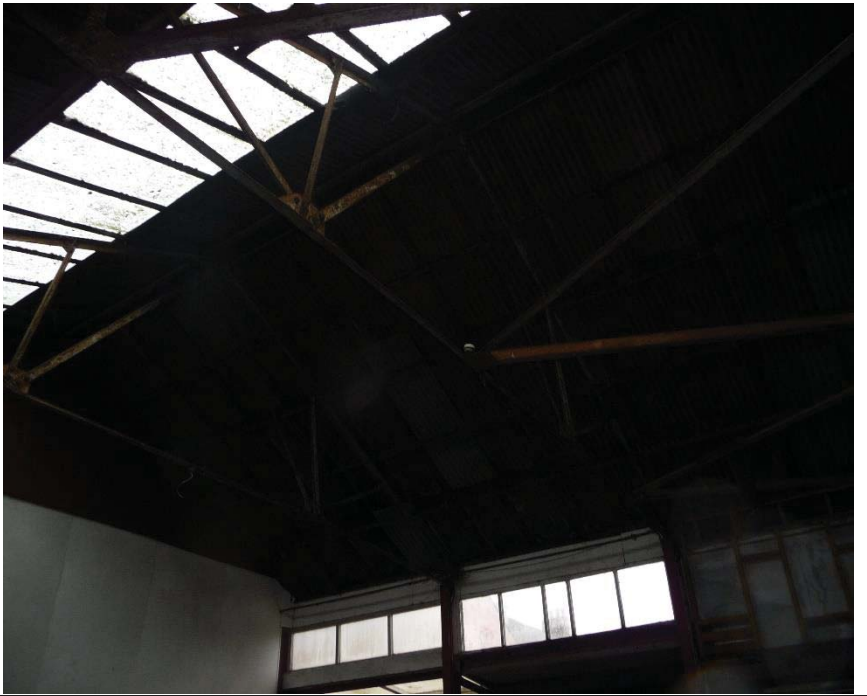
MATERIAL ASSESSMENT / SAMPLE IDENTIFICATION REPORT		
SAMPLE INFORMATION		PHOTOGRAPH
Sample Ref	AR13 Mastered from sample AR8/4

Sample Date	11/12/2020	
Building	Small garage Unit next to cycle shop	
Area Ref/Location	Main roof	
Level	Roof	
Approx. Measurement	140 square Meters	
Material	Asbestos Cement Sheets	
Position	Main roof sheets	
Description	Corrugated roof sheets throughout the unit roof	
ASSESSMENT OF RISK		
Product Type	Type 1 - Asbestos Reinforced Cement	1
Extent of Damage	1 - Low Damage	1
Surface Treatment	1 - Sealed (Encapsulated or Painted AIB, cement, Enclosed lagging or spray)	1
Asbestos Type	1 - Chrysotile	1
Accessibility	1 - Occasionally Disturbed	1
RISK SCORE		5
PRIORITY SCORE		Low potential to realise fibres
Action Required / Control Recommendation	Material Removal Remove by an asbestos contractor prior to demolition	
DATE IDENTIFIED ASBESTOS WAS REMOVED (If Applicable)

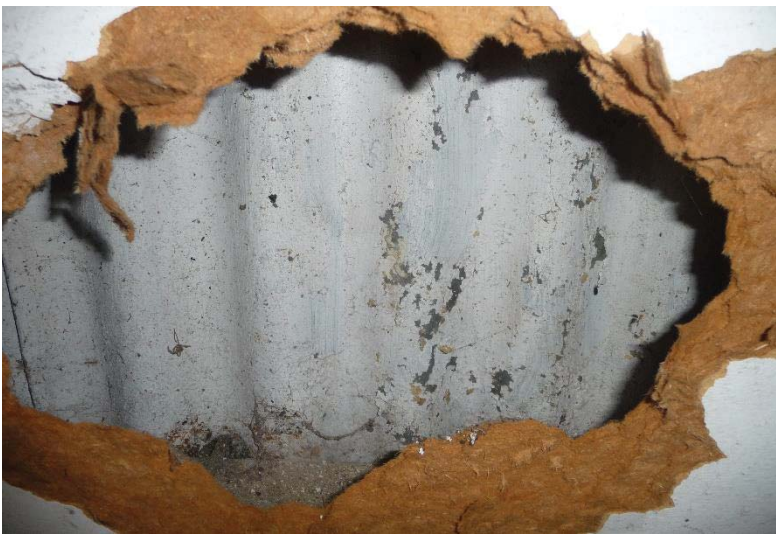
SAMPLE INFORMATION		PHOTOGRAPH
Sample Ref	AR14 mastered from sample AR11/7

Sample Date	11/12/2020	
Building	Small garage Unit next to cycle shop	
Area Ref/Location	Main shop	
Level	Ground	
Approx. Measurement	Throughout	
Material	Mineral fibre boarding	
Position	Behind plaster boarding	
Description	Manmade fibre boarding behind plaster boarding to shop/Unit	
ASSESSMENT OF RISK		
Product Type	Non Asbestos Textured Coating	0
Extent of Damage	0 - Not Applicable	0
Surface Treatment	0 - Not Applicable	0
Asbestos Type	0 - No Asbestos Detected in Sample	0
Accessibility	0 - Not Applicable	0
		RISK SCORE
		PRIORITY SCORE
Action Required / Control Recommendation	None Required	
DATE IDENTIFIED ASBESTOS WAS REMOVED (If Applicable)

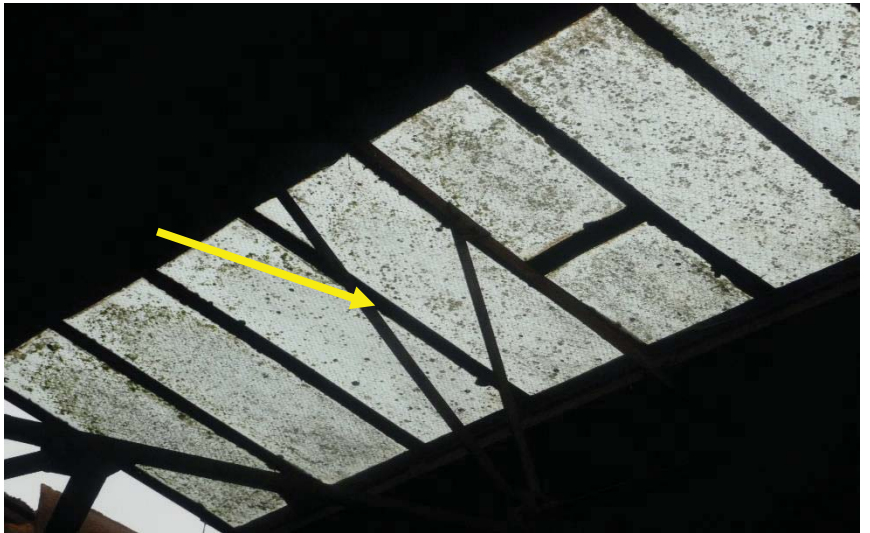
MATERIAL ASSESSMENT / SAMPLE IDENTIFICATION REPORT		
SAMPLE INFORMATION		PHOTOGRAPH
Sample Ref	AR15 mastered from sample AR10/6

Sample Date	11/12/2020	
Building	Small Garage Unit next to cycle shop	
Area Ref/Location	Main roof	
Level	Roof Skylights	
Approx. Measurement	14 Liner Meters	
Material	Asbestos Rope Gasket	
Position	Main skylights to main roof	
Description	Rope gaskets under the alloy trimming to the glass skylights	
ASSESSMENT OF RISK		
Product Type	Type 2 - Asbestos Gaskets/Washers/Strings	2
Extent of Damage	1 - Low Damage	1
Surface Treatment	1 - Sealed (Encapsulated or Painted AIB, cement, Enclosed lagging or spray)	1
Asbestos Type	3 - Chrysotile/Amosite/Crocidolite	3
Accessibility	0 - Usually Inaccessible	1
RISK SCORE		8
PRIORITY SCORE		Medium potential to release fibres.
Action Required / Control Recommendation	Material Removal Remove by an asbestos contractor prior to demolition	
DATE IDENTIFIED ASBESTOS WAS REMOVED (If Applicable)

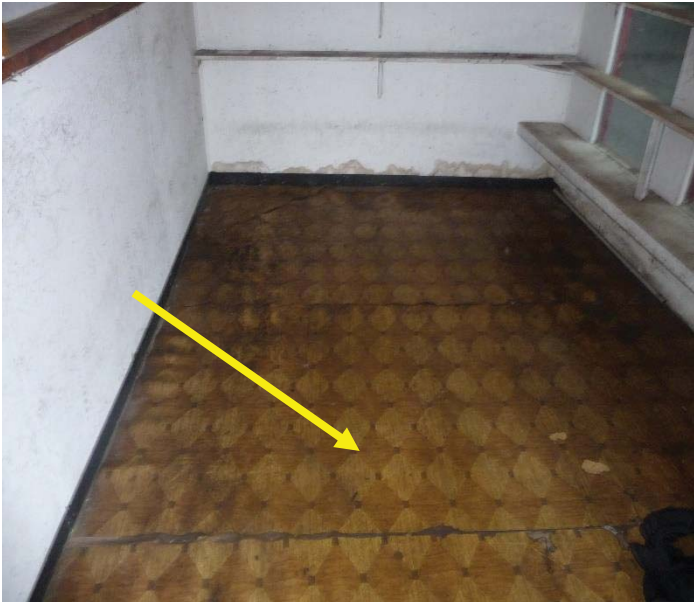
SAMPLE INFORMATION		PHOTOGRAPH
Sample Ref	AR16/9

Sample Date	11/12/2020	
Building	Cycle Shop	
Area Ref/Location	Main shop office	
Level	Ground	
Approx. Measurement	8 Square Meters	
Material	Paper & Lino	
Position	Office floor	
Description	Plastic lino and paper to the office floor	
ASSESSMENT OF RISK		
Product Type	Non Asbestos Textured Coating	0
Extent of Damage	0 - Not Applicable	0
Surface Treatment	0 - Not Applicable	0
Asbestos Type	0 - No Asbestos Detected in Sample	0
Accessibility	0 - Not Applicable	0
RISK SCORE		
PRIORITY SCORE		
Action Required / Control Recommendation	None Required	
DATE IDENTIFIED ASBESTOS WAS REMOVED (If Applicable)

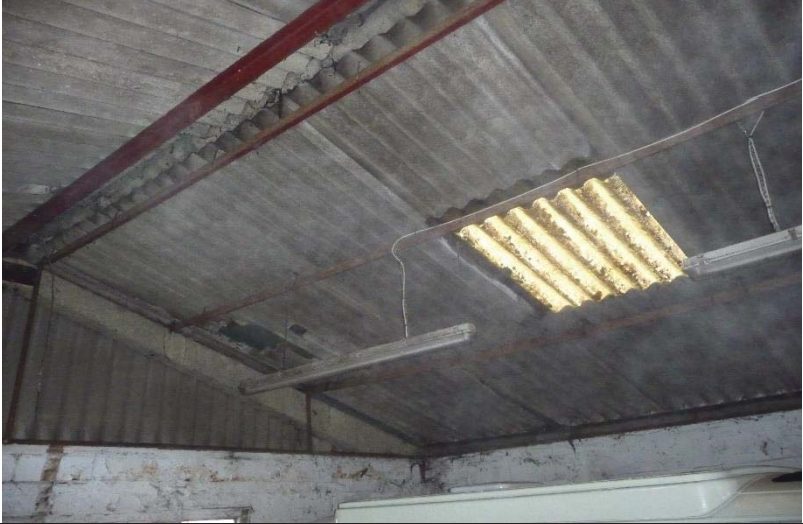
SAMPLE INFORMATION		PHOTOGRAPH
Sample Ref	AR17/10

Sample Date	11/12/2020	
Building	Open garage to the back of the units	
Area Ref/Location	Main roof	
Level	Roof	
Approx. Measurement	120 square Meters	
Material	Asbestos Cement Sheets	
Position	Main roof sheets	
Description	Corrugated roof sheets throughout	
ASSESSMENT OF RISK		
Product Type	Type 1 - Asbestos Reinforced Cement	1
Extent of Damage	1 - Low Damage	1
Surface Treatment	1 - Sealed (Encapsulated or Painted AIB, cement, Enclosed lagging or spray)	1
Asbestos Type	1 - Chrysotile	1
Accessibility	1 - Occasionally Disturbed	1
RISK SCORE		5
PRIORITY SCORE		Low potential to realise fibres
Action Required / Control Recommendation	Material Removal Remove by an asbestos contractor prior to demolition	
DATE IDENTIFIED ASBESTOS WAS REMOVED (If Applicable)

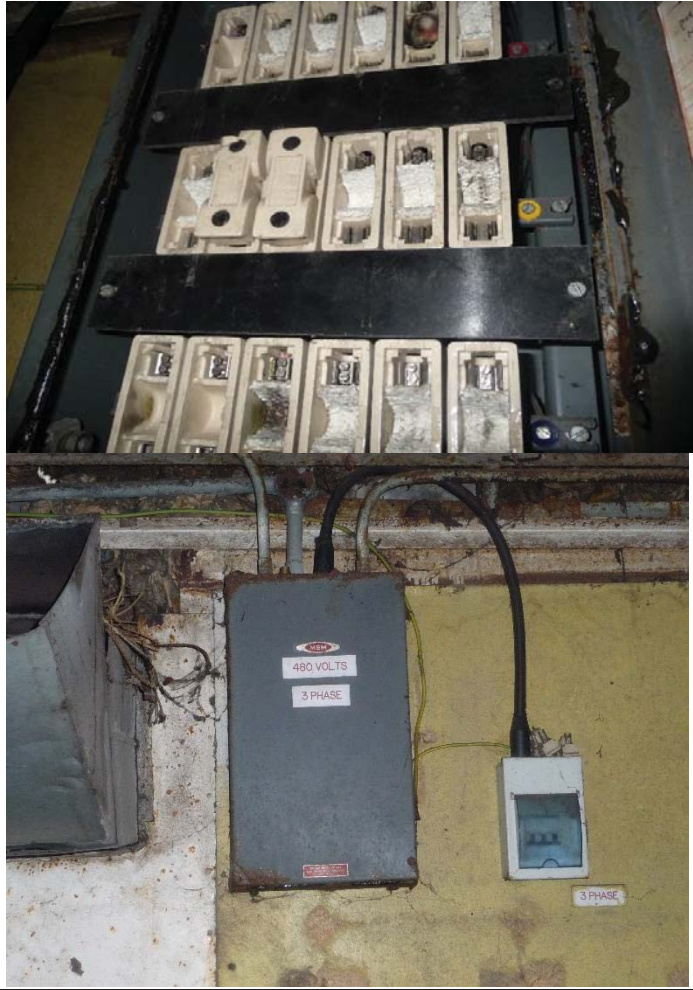
SAMPLE INFORMATION		PHOTOGRAPH
Sample Ref	AR19/11

Sample Date	11/12/2020	
Building	Open garage to the back of the units	
Area Ref/Location	Left hand side wall	
Level	Ground	
Approx. Measurement	1 X fuse box	
Material	Asbestos Flash Guards	
Position	Inside of fuse box on wall	
Description	Cloth fuse guards behind porcelain fuses	
ASSESSMENT OF RISK		
Product Type	Type 2 - Asbestos Gaskets/Washers/Strings	2
Extent of Damage	1 - Low Damage	1
Surface Treatment	2 - Unsealed (Raw AIB / Encapsulated Lagging or Spray)	2
Asbestos Type	1 - Chrysotile	1
Accessibility	1 - Occasionally Disturbed	1
RISK SCORE		7
PRIORITY SCORE		Medium potential to release fibres.
Action Required / Control Recommendation	Material Removal Remove by an asbestos contractor prior to demolition	
DATE IDENTIFIED ASBESTOS WAS REMOVED (If Applicable)

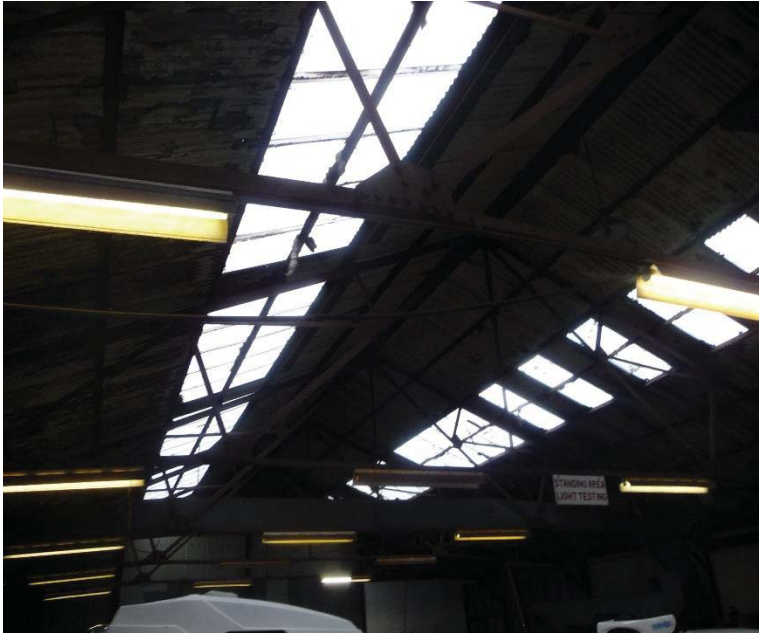
SAMPLE INFORMATION		PHOTOGRAPH
Sample Ref	AR20/12

Sample Date	11/12/2020	
Building	Main working garage	
Area Ref/Location	Main roof	
Level	Roof	
Approx. Measurement	640 square Meters	
Material	Asbestos Cement Sheets	
Position	Main roof sheets	
Description	Corrugated roof sheets throughout	
ASSESSMENT OF RISK		
Product Type	Type 1 - Asbestos Reinforced Cement	1
Extent of Damage	1 - Low Damage	1
Surface Treatment	1 - Sealed (Encapsulated or Painted AIB, cement, Enclosed lagging or spray)	1
Asbestos Type	3 - Chrysotile/Crocidolite	3
Accessibility	1 - Occasionally Disturbed	1
RISK SCORE		5
PRIORITY SCORE		Low potential to realise fibres
Action Required / Control Recommendation	Material Removal      Remove by an asbestos contractor prior to demolition	
DATE IDENTIFIED ASBESTOS WAS REMOVED (If Applicable)

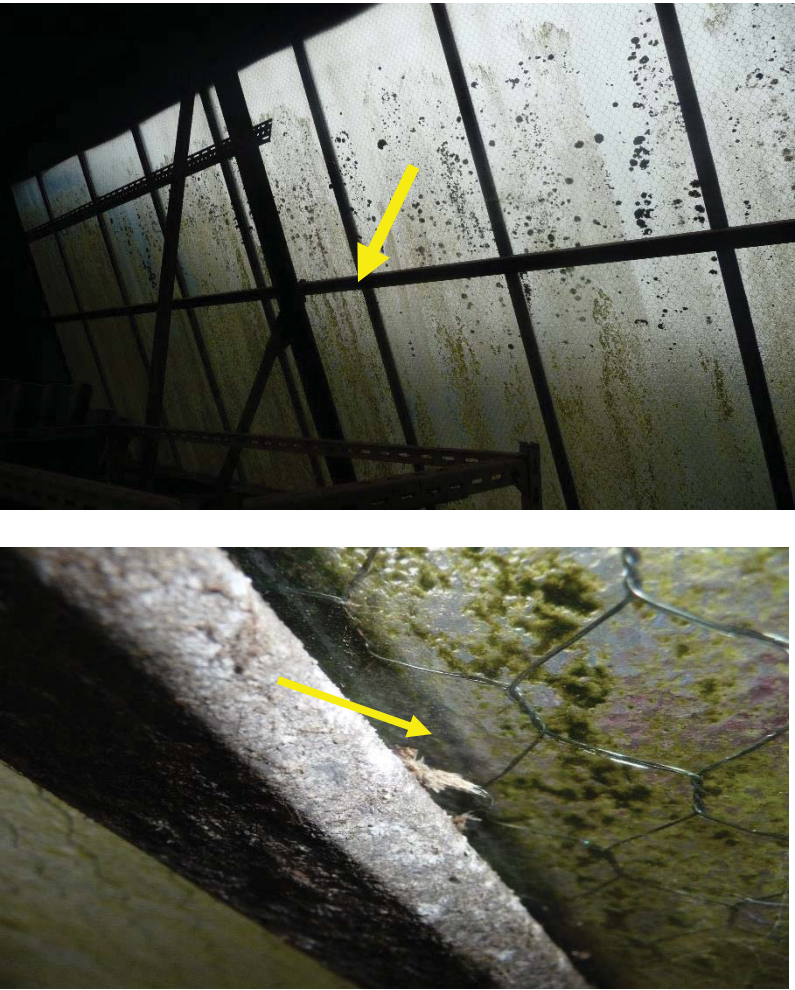
SAMPLE INFORMATION		PHOTOGRAPH
Sample Ref	AR21/13

Sample Date	11/12/2020	
Building	Main working garage	
Area Ref/Location	Main roof	
Level	Roof Skylights	
Approx. Measurement	20 Liner Meters	
Material	Asbestos Rope Gasket	
Position	Main skylights to main roof	
Description	Rope gaskets under the alloy trimming to the glass skylights	
ASSESSMENT OF RISK		
Product Type	Type 2 - Asbestos Gaskets/Washers/Strings	2
Extent of Damage	1 - Low Damage	1
Surface Treatment	1 - Sealed (Encapsulated or Painted AIB, cement, Enclosed lagging or spray)	1
Asbestos Type	1 - Chrysotile	1
Accessibility	0 - Usually Inaccessible	1
RISK SCORE		5
PRIORITY SCORE		Low potential to realise fibres
Action Required / Control Recommendation	Material Removal Remove by an asbestos contractor prior to demolition	
DATE IDENTIFIED ASBESTOS WAS REMOVED (If Applicable)

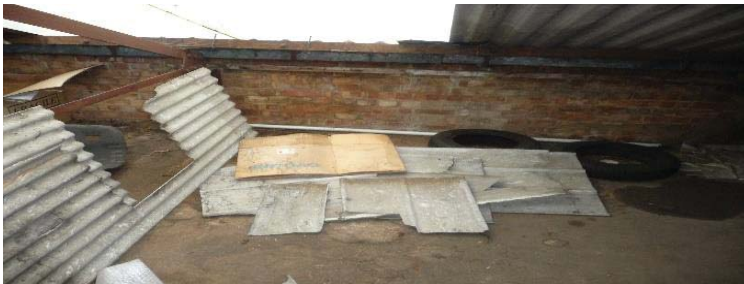
Sample Date	11/12/2020	
Building	Main working garage	
Area Ref/Location	Store area	
Level	Mezz floor

Approx. Measurement	Approx. 17 sheets	
Material	Asbestos Cement Sheets	
Position	Laying around on the mezz floor	
Description	Corrugated roof sheets throughout the store area on the mezz floor lying around theses will need to be removed prior to demolition works

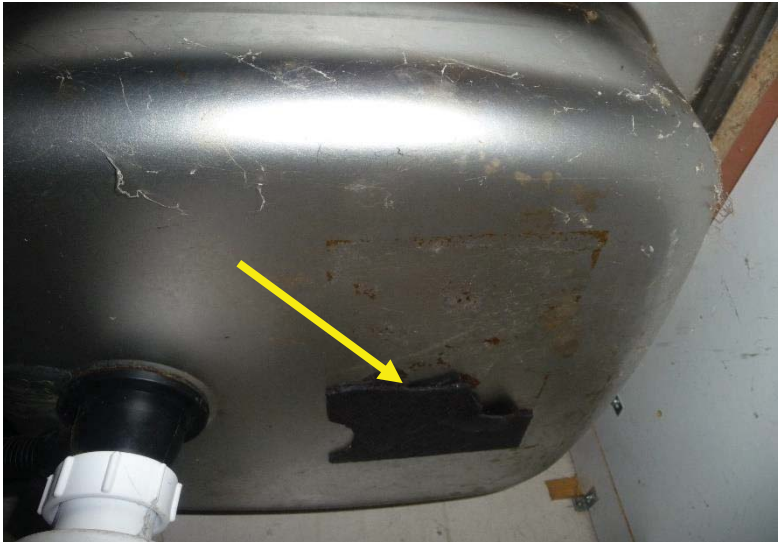
SAMPLE INFORMATION		PHOTOGRAPH
Sample Ref	AR23/14

Sample Date	11/12/2020	
Building	Main working garage	
Area Ref/Location	Kitchen	
Level	Ground	
Approx. Measurement	Less than 1 square meter	
Material	Bitumen	
Position	Under metal sink	
Description	Bitumen pad under the metal sink	
ASSESSMENT OF RISK		
Product Type	Non Asbestos Textured Coating	0
Extent of Damage	0 - Not Applicable	0
Surface Treatment	0 - Not Applicable	0
Asbestos Type	0 - No Asbestos Detected in Sample	0
Accessibility	0 - Not Applicable	0
RISK SCORE		
PRIORITY SCORE		
Action Required / Control Recommendation	None Required	
DATE IDENTIFIED ASBESTOS WAS REMOVED (If Applicable)

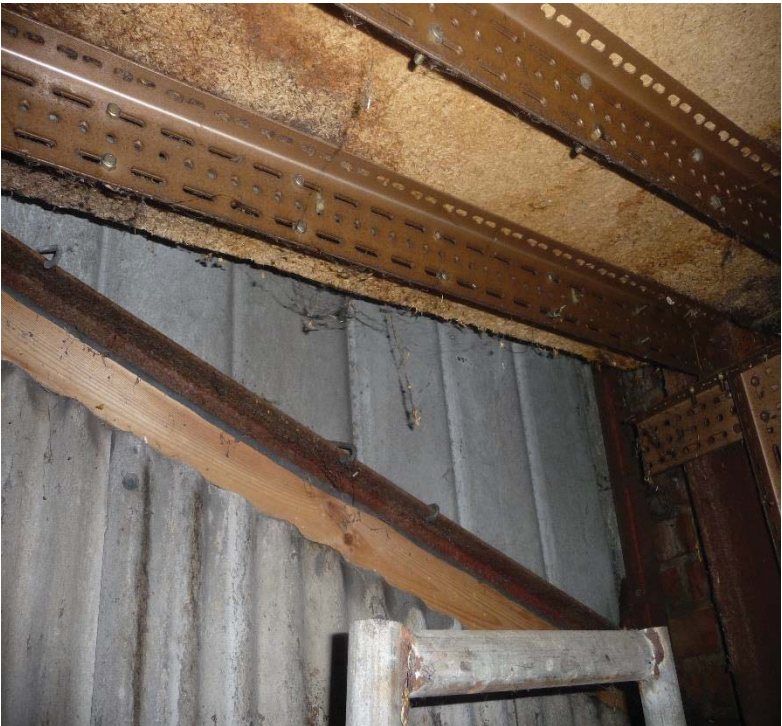
SAMPLE INFORMATION		PHOTOGRAPH
Sample Ref	AR24 Mastered from AR20/12

Sample Date	11/12/2020	
Building	Main working garage	
Area Ref/Location	Back wall to mezz & ground floor	
Level	Mezz & Ground floors	
Approx. Measurement	20 square Meters	
Material	Asbestos Cement Sheets	
Position	Wall	
Description	Corrugated wall sheets from mezz floor down to ground floor behind the metal corrugated wall sheets	
ASSESSMENT OF RISK		
Product Type	Type 1 - Asbestos Reinforced Cement	1
Extent of Damage	1 - Low Damage	1
Surface Treatment	1 - Sealed (Encapsulated or Painted AIB, cement, Enclosed lagging or spray)	1
Asbestos Type	3 - Chrysotile/Crocidolite	3
Accessibility	1 - Occasionally Disturbed	1
RISK SCORE		7
PRIORITY SCORE		Medium potential to release fibres.
Action Required / Control Recommendation	Material Removal Remove by an asbestos contractor prior to demolition	
DATE IDENTIFIED ASBESTOS WAS REMOVED (If Applicable)

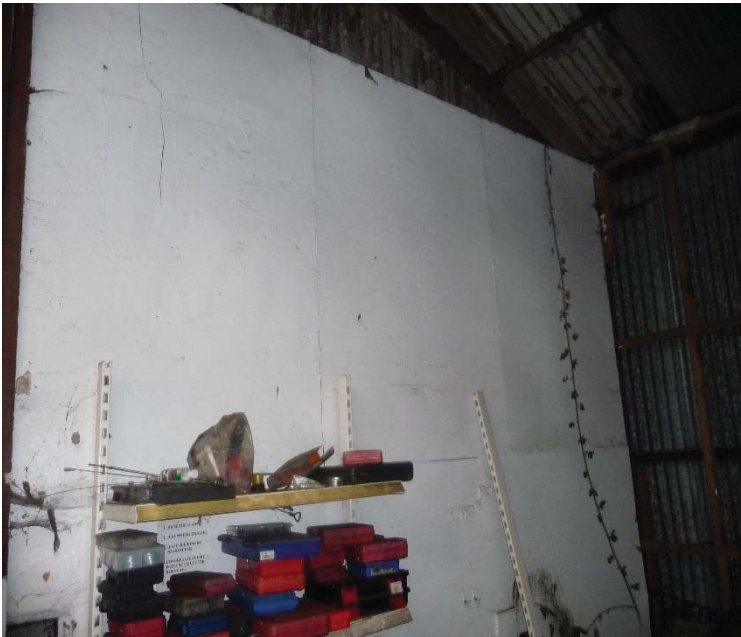
SAMPLE INFORMATION		PHOTOGRAPH
Sample Ref	AR26/15

Sample Date	11/12/2020	
Building	Main working garage	
Area Ref/Location	Side wall at back	
Level	Ground	
Approx. Measurement	8 Square meters	
Material	Painted boarding	
Position	Wall boarding	
Description	Manmade boarding painted white	
ASSESSMENT OF RISK		
Product Type	Non Asbestos Textured Coating	0
Extent of Damage	0 - Not Applicable	0
Surface Treatment	0 - Not Applicable	0
Asbestos Type	0 - No Asbestos Detected in Sample	0
Accessibility	0 - Not Applicable	0
		RISK SCORE
		PRIORITY SCORE
Action Required / Control Recommendation	None Required	
DATE IDENTIFIED ASBESTOS WAS REMOVED (If Applicable)
